**Contract No.: CV/2013/06  
Handling of Surplus Public Fill  
(2014-2016)**

**TUEN MUN AREA 38 FILL BANK  
MONTHLY EM&A REPORT NO.34  
(OCTOBER 2016)**

**Report No.: ENA65562**

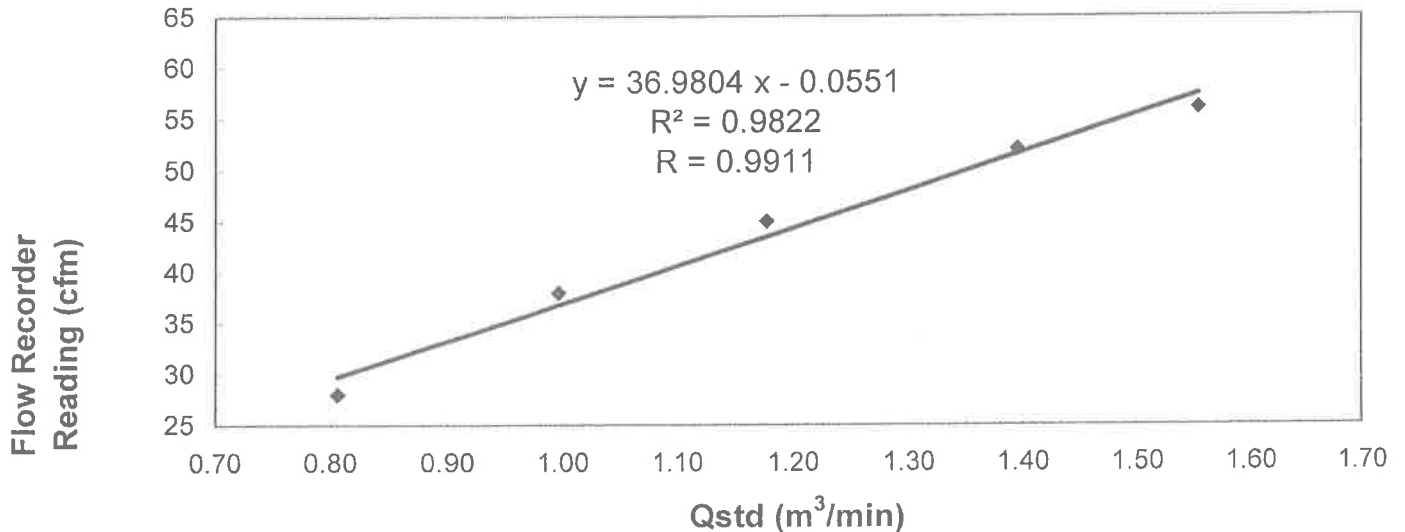
**Sampler 10347 Calibration Curve**  
**Site: Tuen Mun 38 (TM-A1)**

<b>Results</b> :	Flow recorder reading (cfm)	56	52	45	38	28
	Qstd (Actual flow rate, m <sup>3</sup> /min)	1.55	1.40	1.18	1.00	0.81
	Pressure :	747.06 mm Hg			Temp. :	299 K

Acceptance Criteria : Correlation coefficient (r) of the calibration curve greater than 0.990 after a 5-point calibration

The high volume sampler complies\* / ~~does not comply~~\* with the specified requirements and is deemed acceptable\*/ ~~unacceptable~~\* for use.

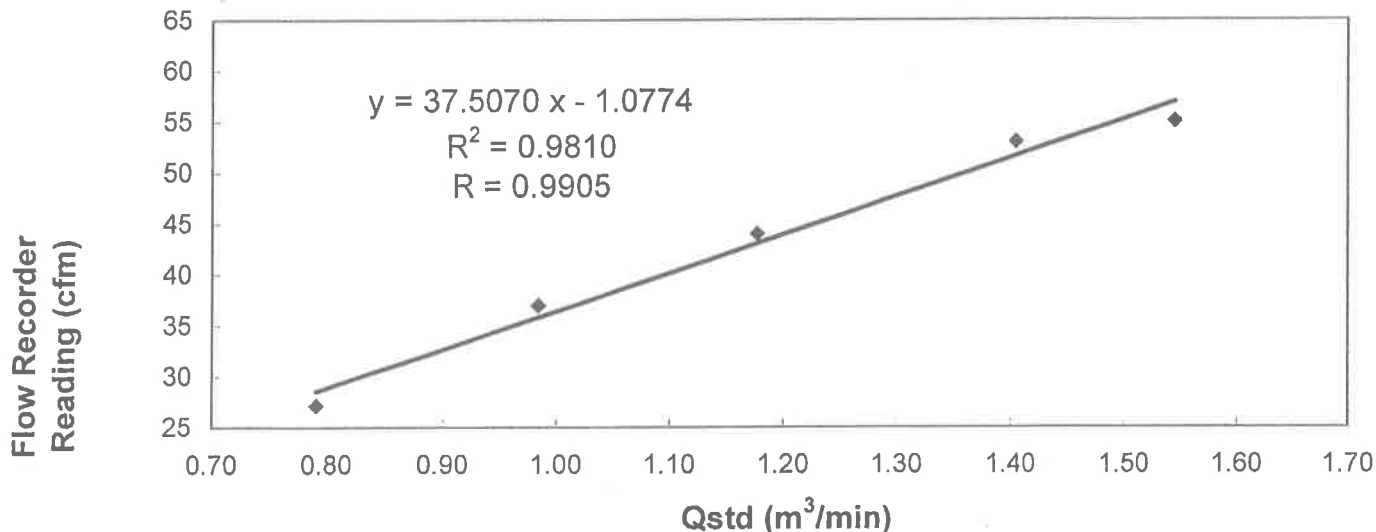
**Sampler 10347 Calibration Curve**  
Site: Tuen Mun 38 (TM-A1)

Results	Flow recorder reading (cfm)	55	53	44	37	27
	Qstd (Actual flow rate, m <sup>3</sup> /min)	1.55	1.40	1.18	0.98	0.79
	Pressure : 747.06 mm Hg	Temp. : 299 K

Acceptance Criteria : Correlation coefficient (r) of the calibration curve greater than 0.990 after a 5-point calibration

The high volume sampler complies\* / ~~does not comply\*~~ with the specified requirements and is deemed acceptable\* / ~~unacceptable\*~~ for use.

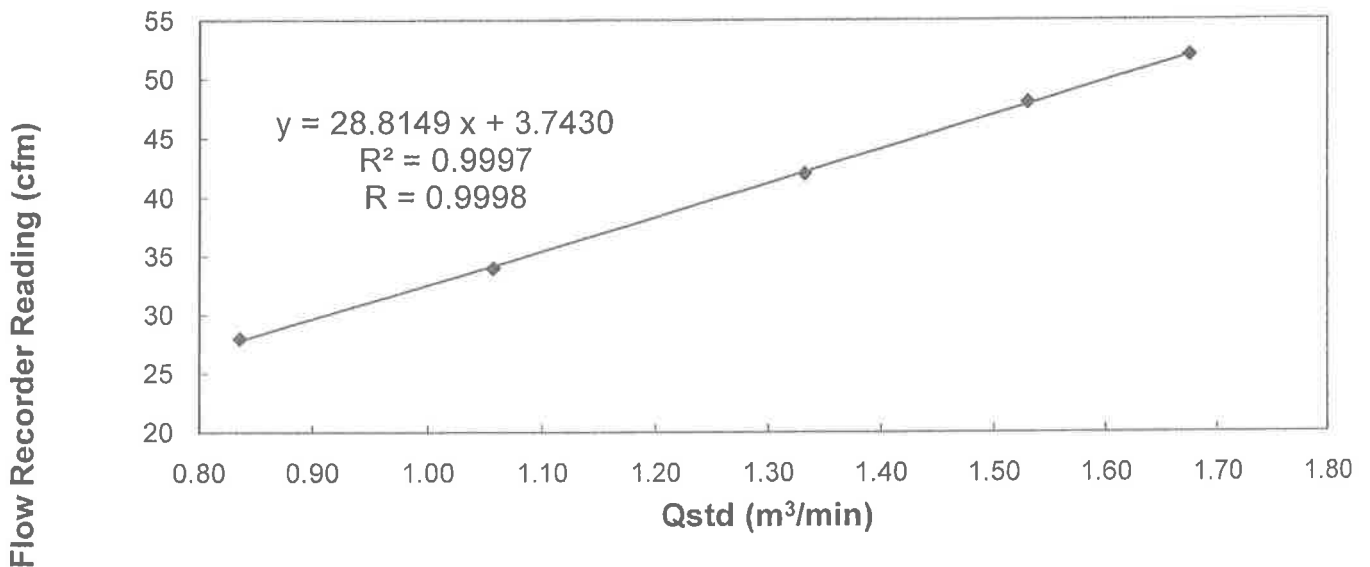
**Sampler 9864 Calibration Curve**  
Site: Tuen Mun (TM-RA2)

Results	Flow recorder reading (cfm)	52	48	42	34	28
	Qstd (Actual flow rate, m <sup>3</sup> /min)	1.67	1.53	1.33	1.06	0.84
	Pressure : 747.06 mm Hg	Temp. : 299 K

Acceptance Criteria : Correlation coefficient (r) of the calibration curve greater than 0.990 after a 5-point calibration

The high volume sampler complies\* / ~~does not comply\*~~ with the specified requirements and is deemed acceptable\* / ~~unacceptable\*~~ for use.

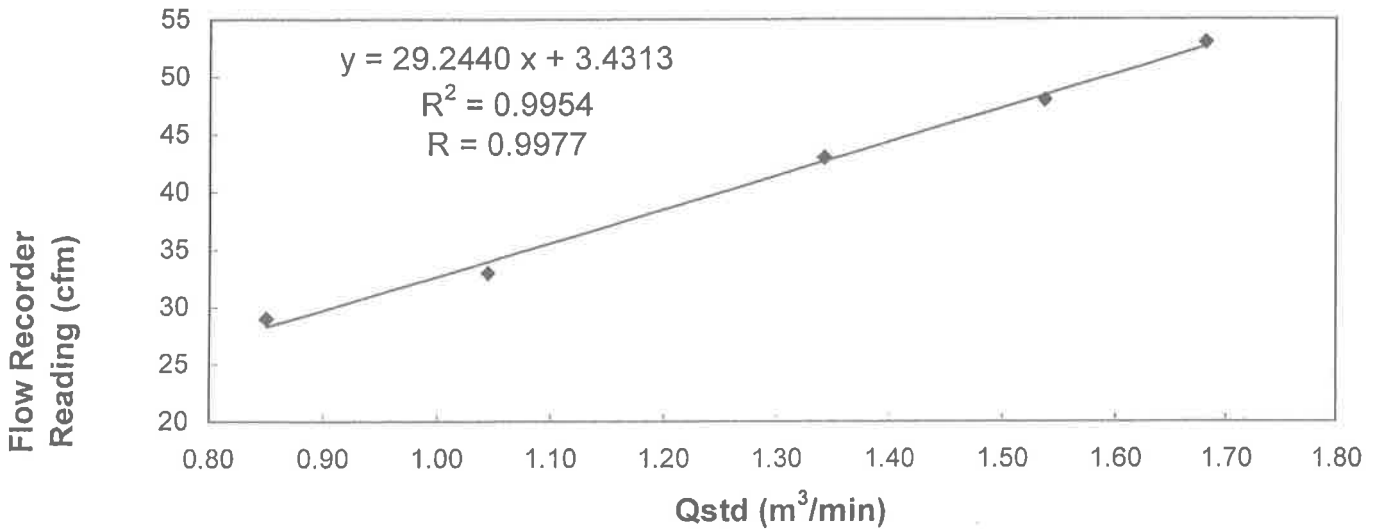
**Sampler 9864 Calibration Curve**  
**Site: Tuen Mun (TM-RA2)**

<b>Results</b>	Flow recorder reading (cfm)	53	48	43	33	29
	Qstd (Actual flow rate, m <sup>3</sup> /min)	1.68	1.54	1.34	1.04	0.85
	Pressure :                      747.06 mm Hg	Temp. :                      299 K

Acceptance Criteria : Correlation coefficient (r) of the calibration curve greater than 0.990 after a 5-point calibration

The high volume sampler complies\* / ~~does not comply\*~~ with the specified requirements and is deemed acceptable\* / unacceptable\* for use.

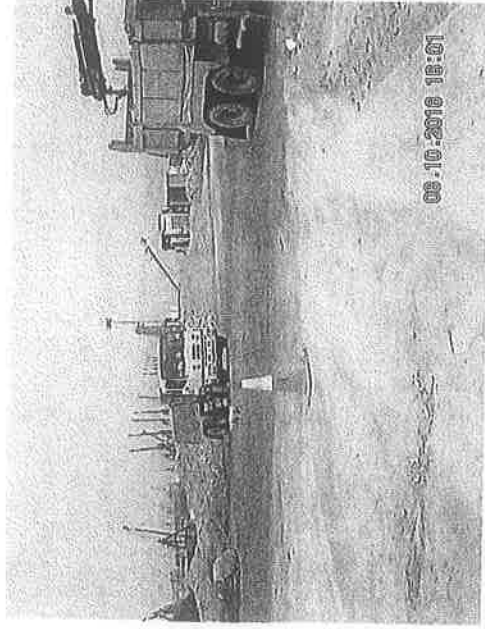
Photo 161006\_001 (Dry mud zone) (Improved)

<i>Date</i>	<i>Key Findings</i>	<i>Action(s) Taken recommended by ET</i>	<i>Action(s) Taken by the Contractor during the site audit</i>	<i>Rectification Status by ET</i>
06 October 2016	Dry mud zone was noted dusty. (Previous item)	To water the dry mud zone properly to avoid dust generation.	No dust was observed at dry mud zone.	Closed
	Rubbish was trapped inside the desilting screen at main drainage channel. (New item)	To collect the rubbish and replace / maintain the desilting screen properly.	---	Follow-up
13 October 2016	Rubbish was trapped inside the desilting screen at main drainage channel. (Previous item)	To collect the rubbish and replace / maintain the desilting screen properly.	The rubbish trapped inside the desilting screen at main drainage channel was cleared.	Closed
	The accumulation of mud was noted inside the main drainage channel. (New item)	To clear the accumulated mud properly.	---	Follow-up

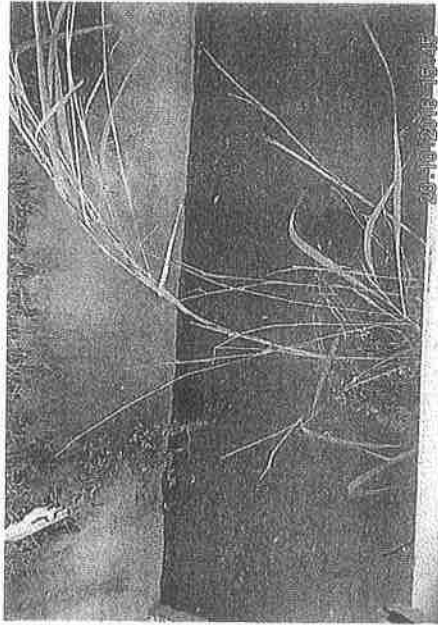
Photo 161020\_001 (Main drainage channel)  
(Improved)

Date	Key Findings	Action(s) Taken recommended by ET	Action(s) Taken by the Contractor during the site audit	Rectification Status by ET
20 October 2016	The accumulation of mud was noted inside the main drainage channel. (Previous item)	To clear the accumulated mud properly.	The mud accumulated inside the main drainage channel was cleared.	Closed
	Muddy water was noted inside the wheel washing bay at B4. (New item)	To replace the muddy water properly.	---	Follow-up
25 October 2016	Muddy water was noted inside the wheel washing bay at B4. (Previous item)	To replace the muddy water properly.	No muddy water was observed inside the wheel washing bay at B4.	Closed
	Rubbish, such as plastic bottles and plastic sheets, were found inside the main drainage channel. (New item)	To collect the rubbish and dispose of properly.	---	Follow-up
