**Contract No.: CV/2013/06  
Handling of Surplus Public Fill  
(2014-2016)**

**TUEN MUN AREA 38 FILL BANK**

**MONTHLY EM&A REPORT NO.38**

**(FEBRUARY 2017)**

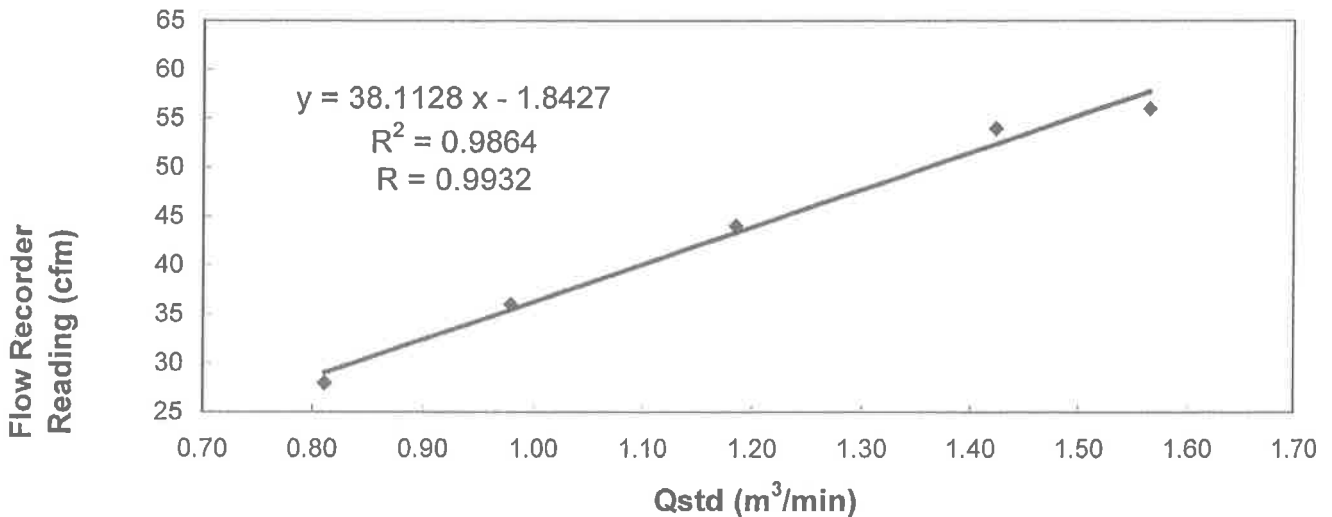
**Sampler 10347 Calibration Curve**  
Site: Tuen Mun 38 (TM-A1)

Results	Flow recorder reading (cfm)	56	54	44	36	28
	Qstd (Actual flow rate, m <sup>3</sup> /min)	1.56	1.42	1.19	0.98	0.81
	Pressure :	747.06 mm Hg		Temp. :	295 K

Acceptance Criteria : Correlation coefficient (r) of the calibration curve greater than 0.990 after a 5-point calibration

The high volume sampler complies\* / ~~does not comply\*~~ with the specified requirements and is deemed acceptable\*/ ~~unacceptable\*~~ for use.

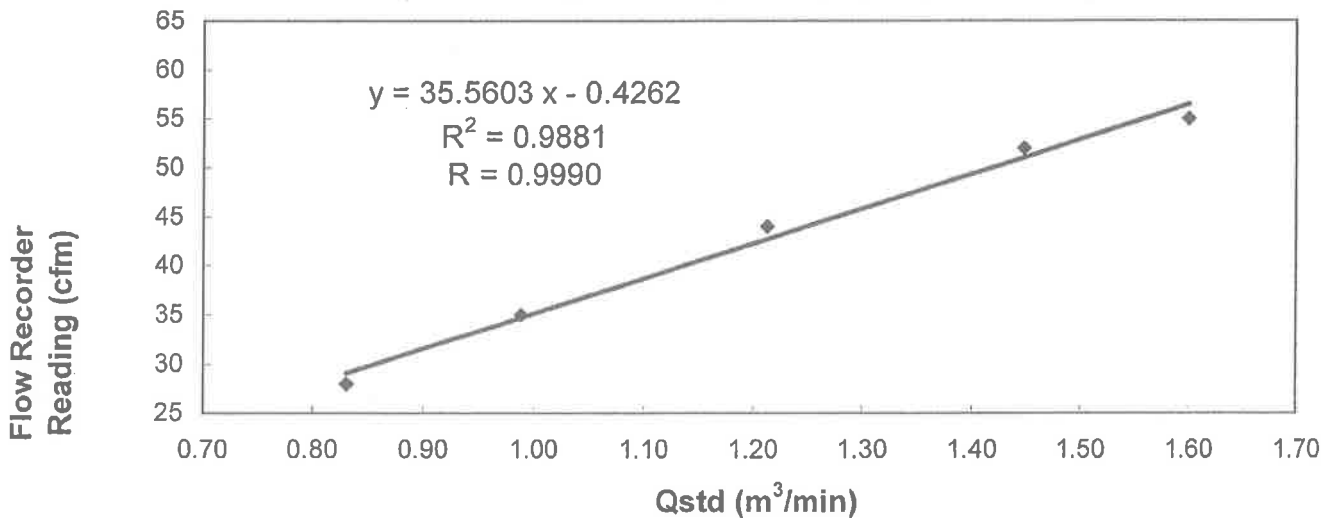
**Sampler 10347 Calibration Curve**  
**Site: Tuen Mun 38 (TM-A1)**

Flow recorder reading (cfm)	55	52	44	35	28
Qstd (Actual flow rate, m <sup>3</sup> /min)	1.60	1.45	1.21	0.99	0.83
Pressure :	766.56 mm Hg			Temp. :	289 K

Acceptance Criteria : Correlation coefficient (r) of the calibration curve greater than 0.990 after a 5-point calibration

The high volume sampler complies\* / ~~does not comply\*~~ with the specified requirements and is deemed acceptable\* / unacceptable\* for use.

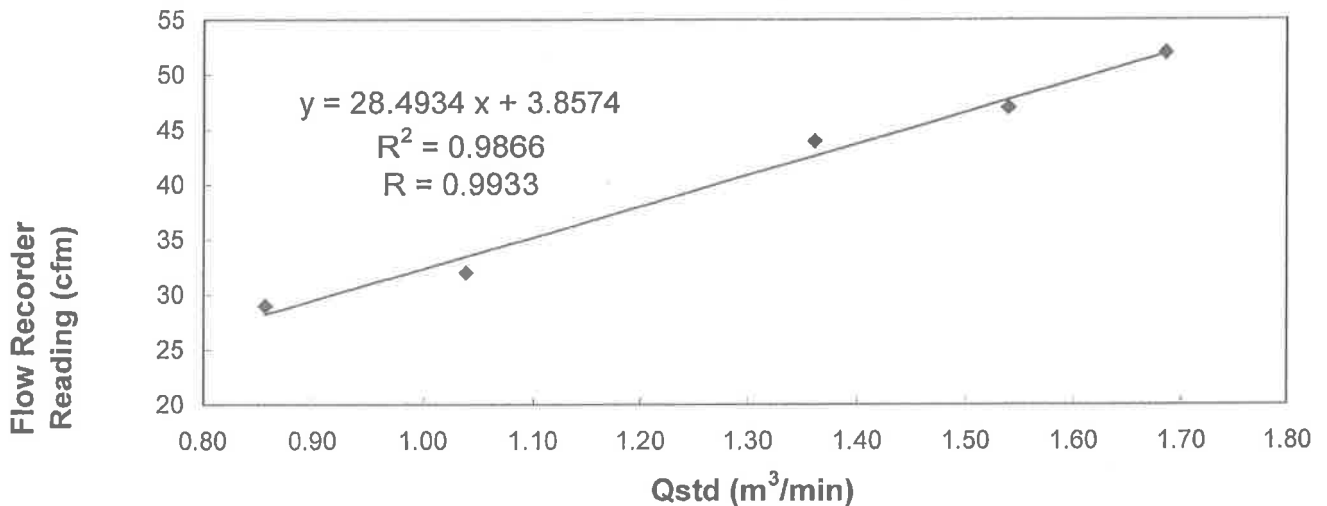
**Sampler 9864 Calibration Curve**  
**Site: Tuen Mun (TM-RA2)**

<b>Results</b> :	Flow recorder reading (cfm)	52	47	44	32	29
	Qstd (Actual flow rate, m <sup>3</sup> /min)	1.69	1.54	1.36	1.04	0.86
	Pressure :                      747.06 mm Hg	Temp. :                      295 K

Acceptance Criteria : Correlation coefficient (r) of the calibration curve greater than 0.990 after a 5-point calibration

The high volume sampler complies\* / ~~does not comply\*~~ with the specified requirements and is deemed acceptable\* / unacceptable\* for use.

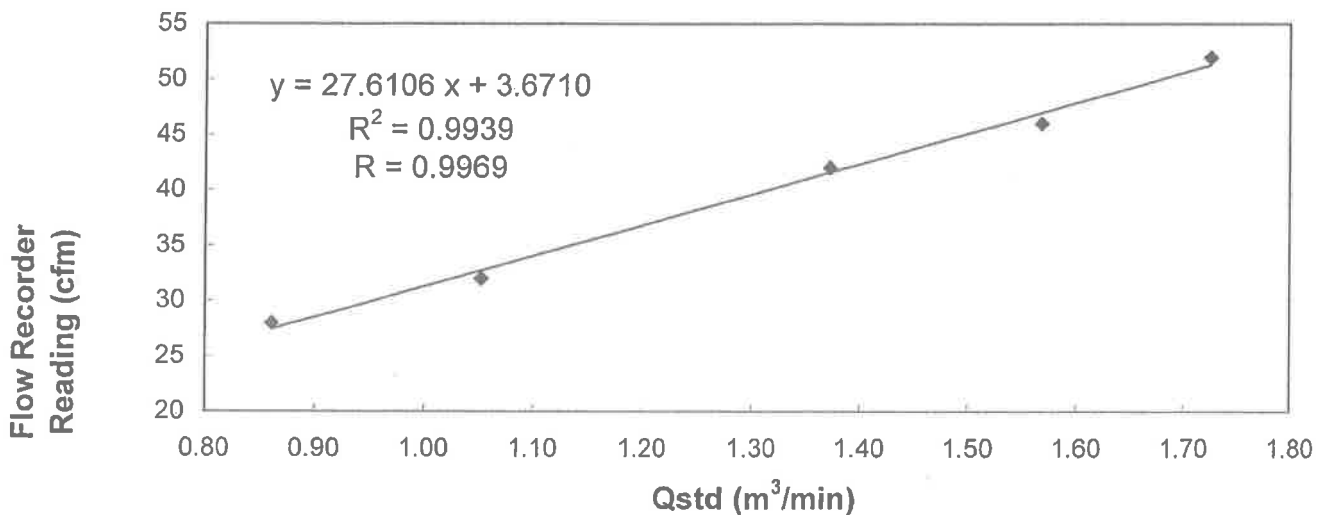
**Sampler 9864 Calibration Curve**  
**Site: Tuen Mun (TM-RA2)**

Results	Flow recorder reading (cfm)	52	46	42	32	28
	Qstd (Actual flow rate, m <sup>3</sup> /min)	1.73	1.57	1.37	1.05	0.86
	Pressure :	766.56 mm Hg			Temp. :	289 K

Acceptance Criteria : Correlation coefficient (r) of the calibration curve greater than 0.990 after a 5-point calibration

The high volume sampler complies\* / does not comply\* with the specified requirements and is deemed acceptable\* / unacceptable\* for use.

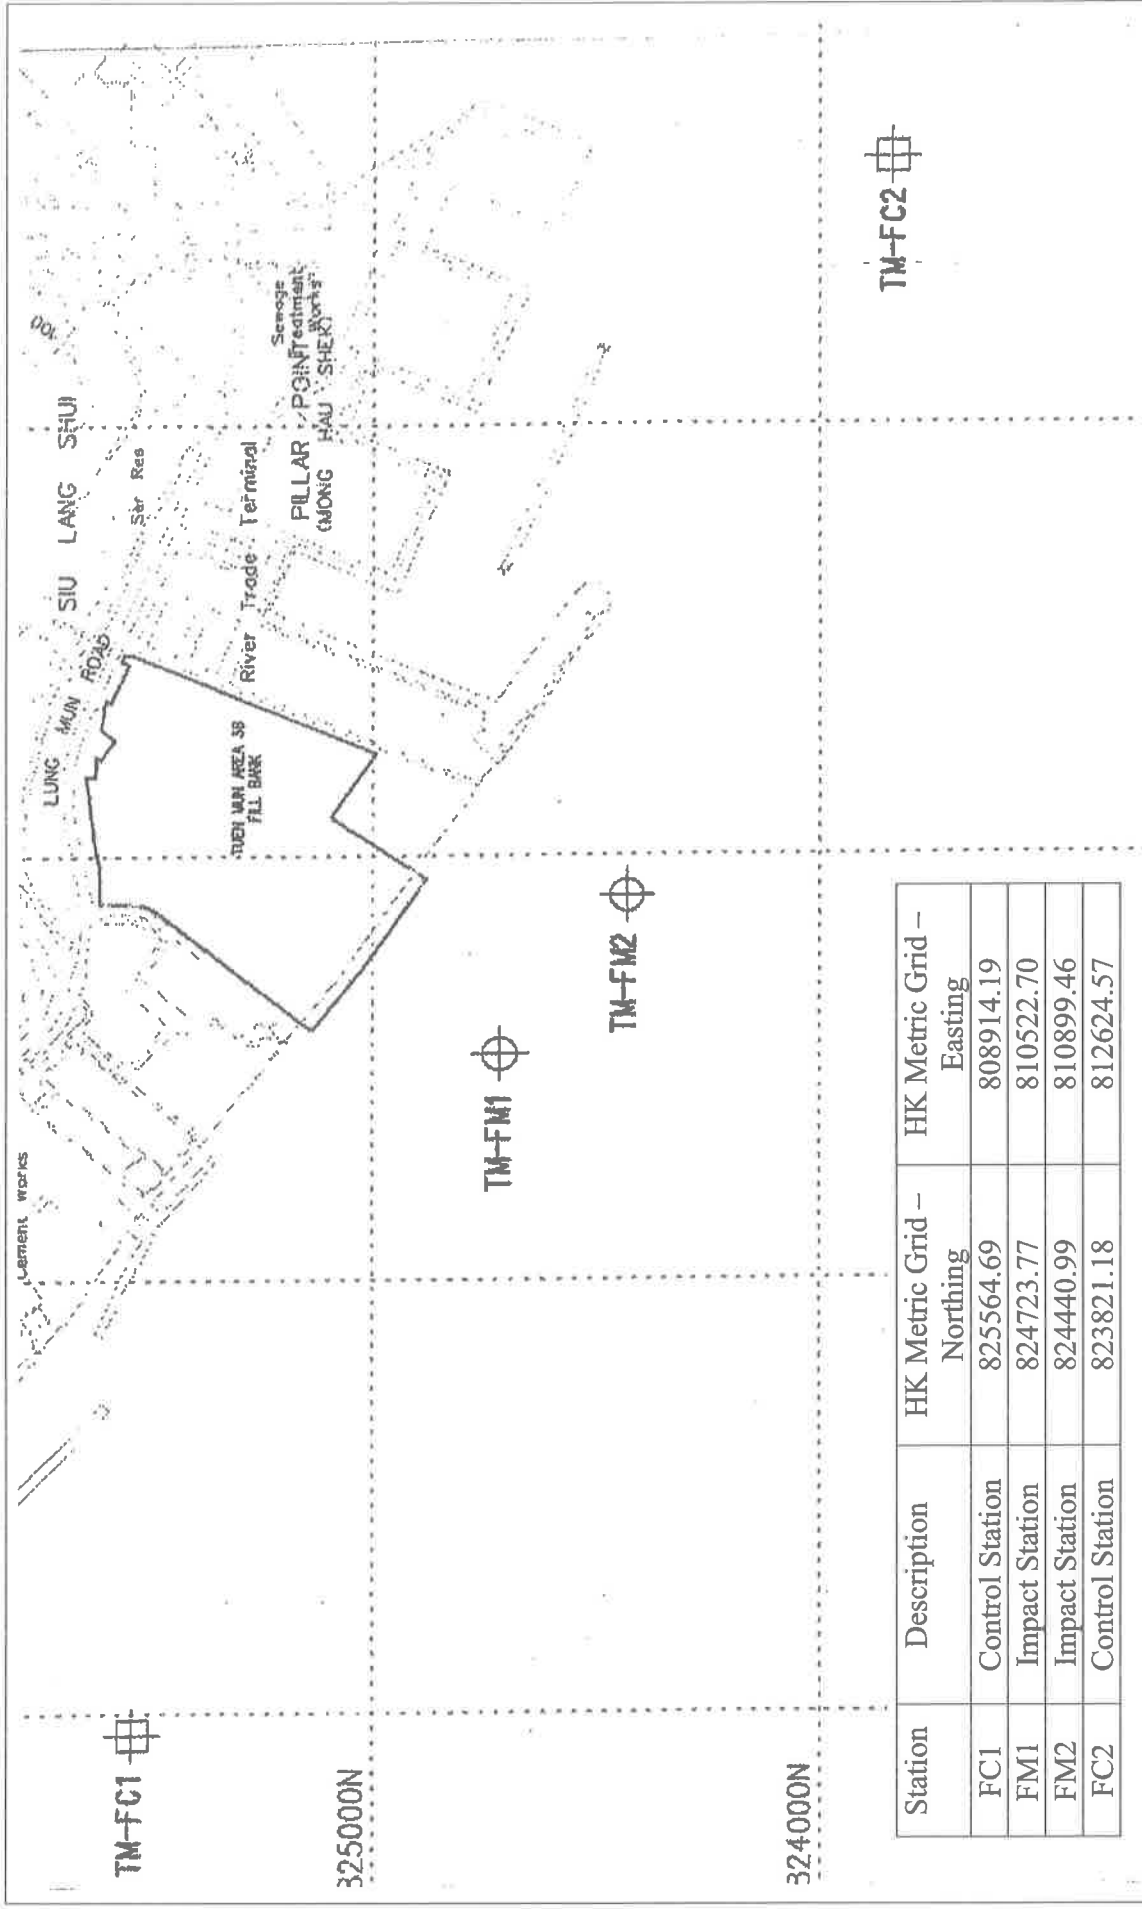
Figure 2  
 Locations of Water Quality Monitoring Station –  
 Tuenshan Area 38 Fill Bank

Station	Description	HK Metric Grid – Northing	HK Metric Grid – Easting
FC1	Control Station	825564.69	808914.19
FM1	Impact Station	824723.77	810522.70
FM2	Impact Station	824440.99	810899.46
FC2	Control Station	823821.18	812624.57
