Dragages -China Harbour-VSL JV

Contract HY/2011/09
Hong Kong-Zhuhai-Macao Bridge
Hong Kong Link Road-Section between
HKSAR Boundary and Scenic Hill
Monthly EM&A Report
August 2013
(Version 2.0)

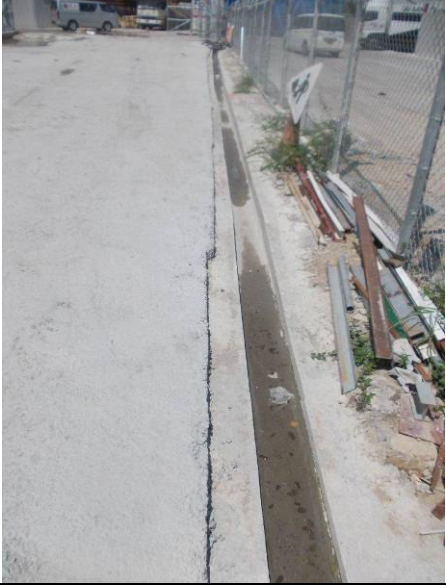
<p>Ref No: 130806-R02</p> <p>Impact: Waste / Chemical Management (F6)</p> <p>Details: To clear the drainage channels at Portion C.</p> <p>Follow Up: The drainage channel at Portion C has been cleared.</p>

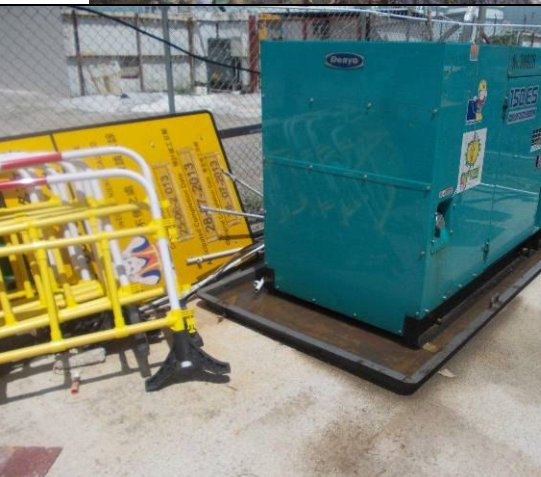
<p>Ref No: 130806-R04</p> <p>Impact: Waste / Chemical Management (F9)</p> <p>Details: To seal the hole of the drip tray and clear the oil leakage at near the office containers at Portion C.</p> <p>Follow Up: The oil leakage has been cleared and the drip tray was removed.</p>

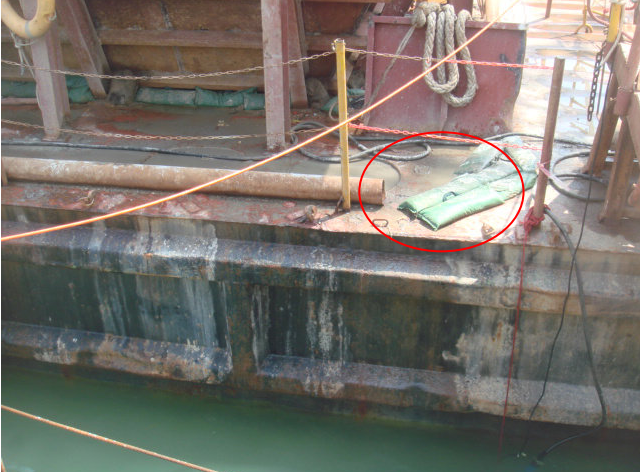
<p>Ref No: 130820-R02</p> <p>Impact: Water Quality (B22)</p> <p>Details: To reinforce the sand bag bund at P49.</p>
