**HyD Contract No. HY/2011/09  
Hong Kong-Zhuhai-Macao Bridge  
Hong Kong Link Road – Section between HKSAR Boundary and Scenic Hill  
Submission under Environmental Permit (EP-352/2009/C - Condition 4.4)  
Monthly EM&A Report – November 2013**

**Contract No. HY/2011/09 HZMB Hong Kong Link Road –  
Section between HKSAR Boundary and Scenic Hill  
Revised Monthly EM&A Report for November 2013 (EP-352/2009/C)**

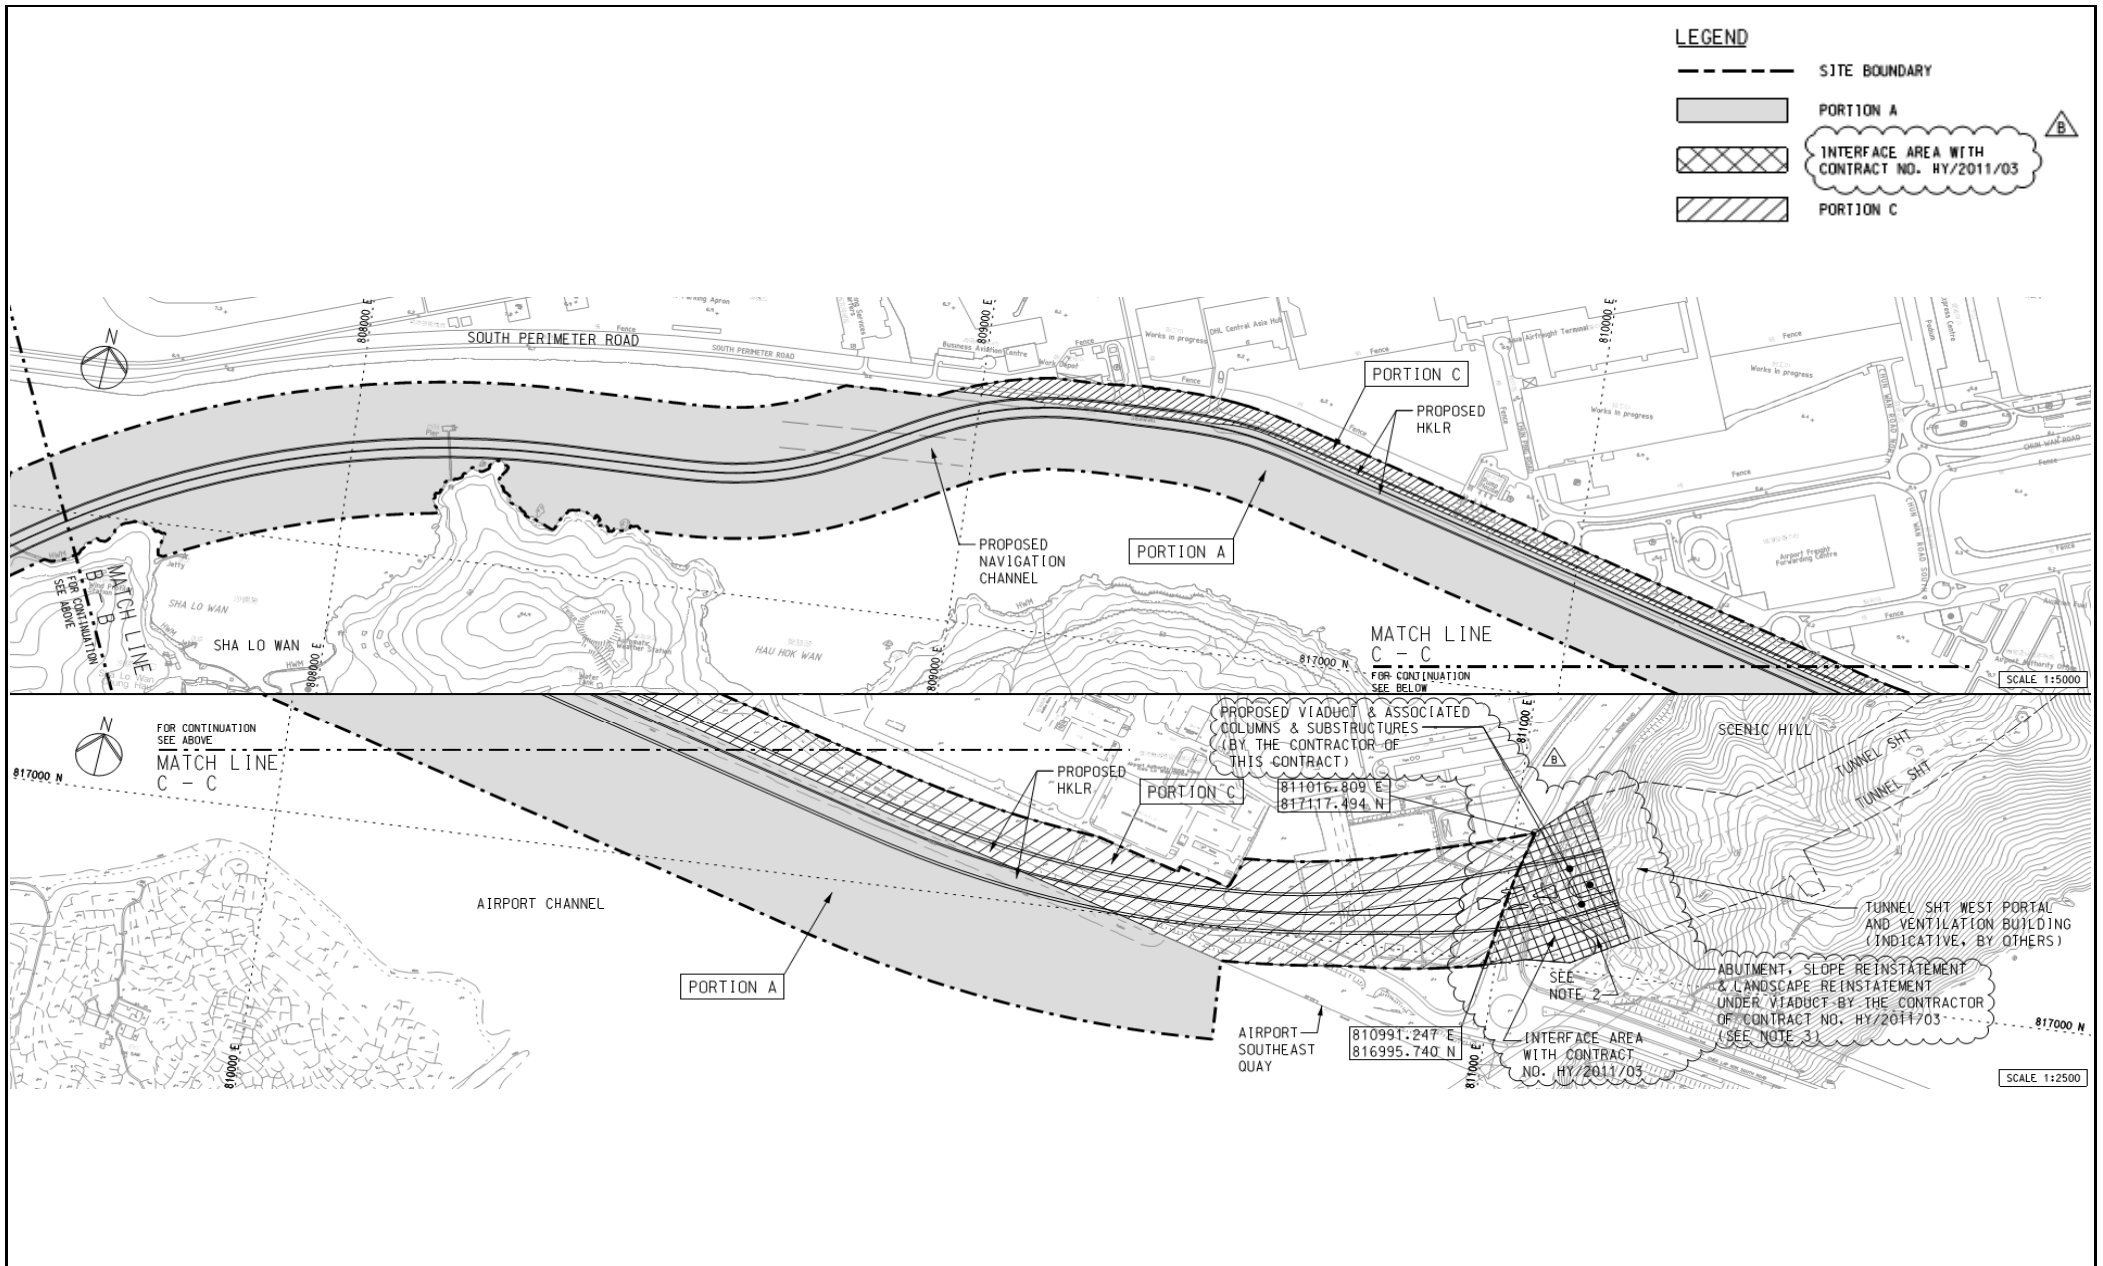
Title	Contract No. HY/2011/09		Scale	Propose	CINOTECH
	Hong Kong-Zhuhai-Macao Bridge		N.T.S	No. MA12014	
	Hong Kong Link Road – Section between HKSAR Boundary and Scenic Hill		Date	Figure	
	Site Layout Plan (Portion A)		May-13	1b

- 2.5 **Figure 1a-d** shows the layout of the Contract and the scope of the Contract works comprises the following major items:
  - a dual 3-lane carriageway in the form of viaduct from the HKSAR boundary (connecting with the HZMB Main Bridge) to the Scenic Hill (connecting with the tunnel under separate Contract No. HY/2011/03), of approximately 9.4km in length with a hard shoulder for each bound of carriageway and a utilities trough on the outer edge of each bound of viaducts;

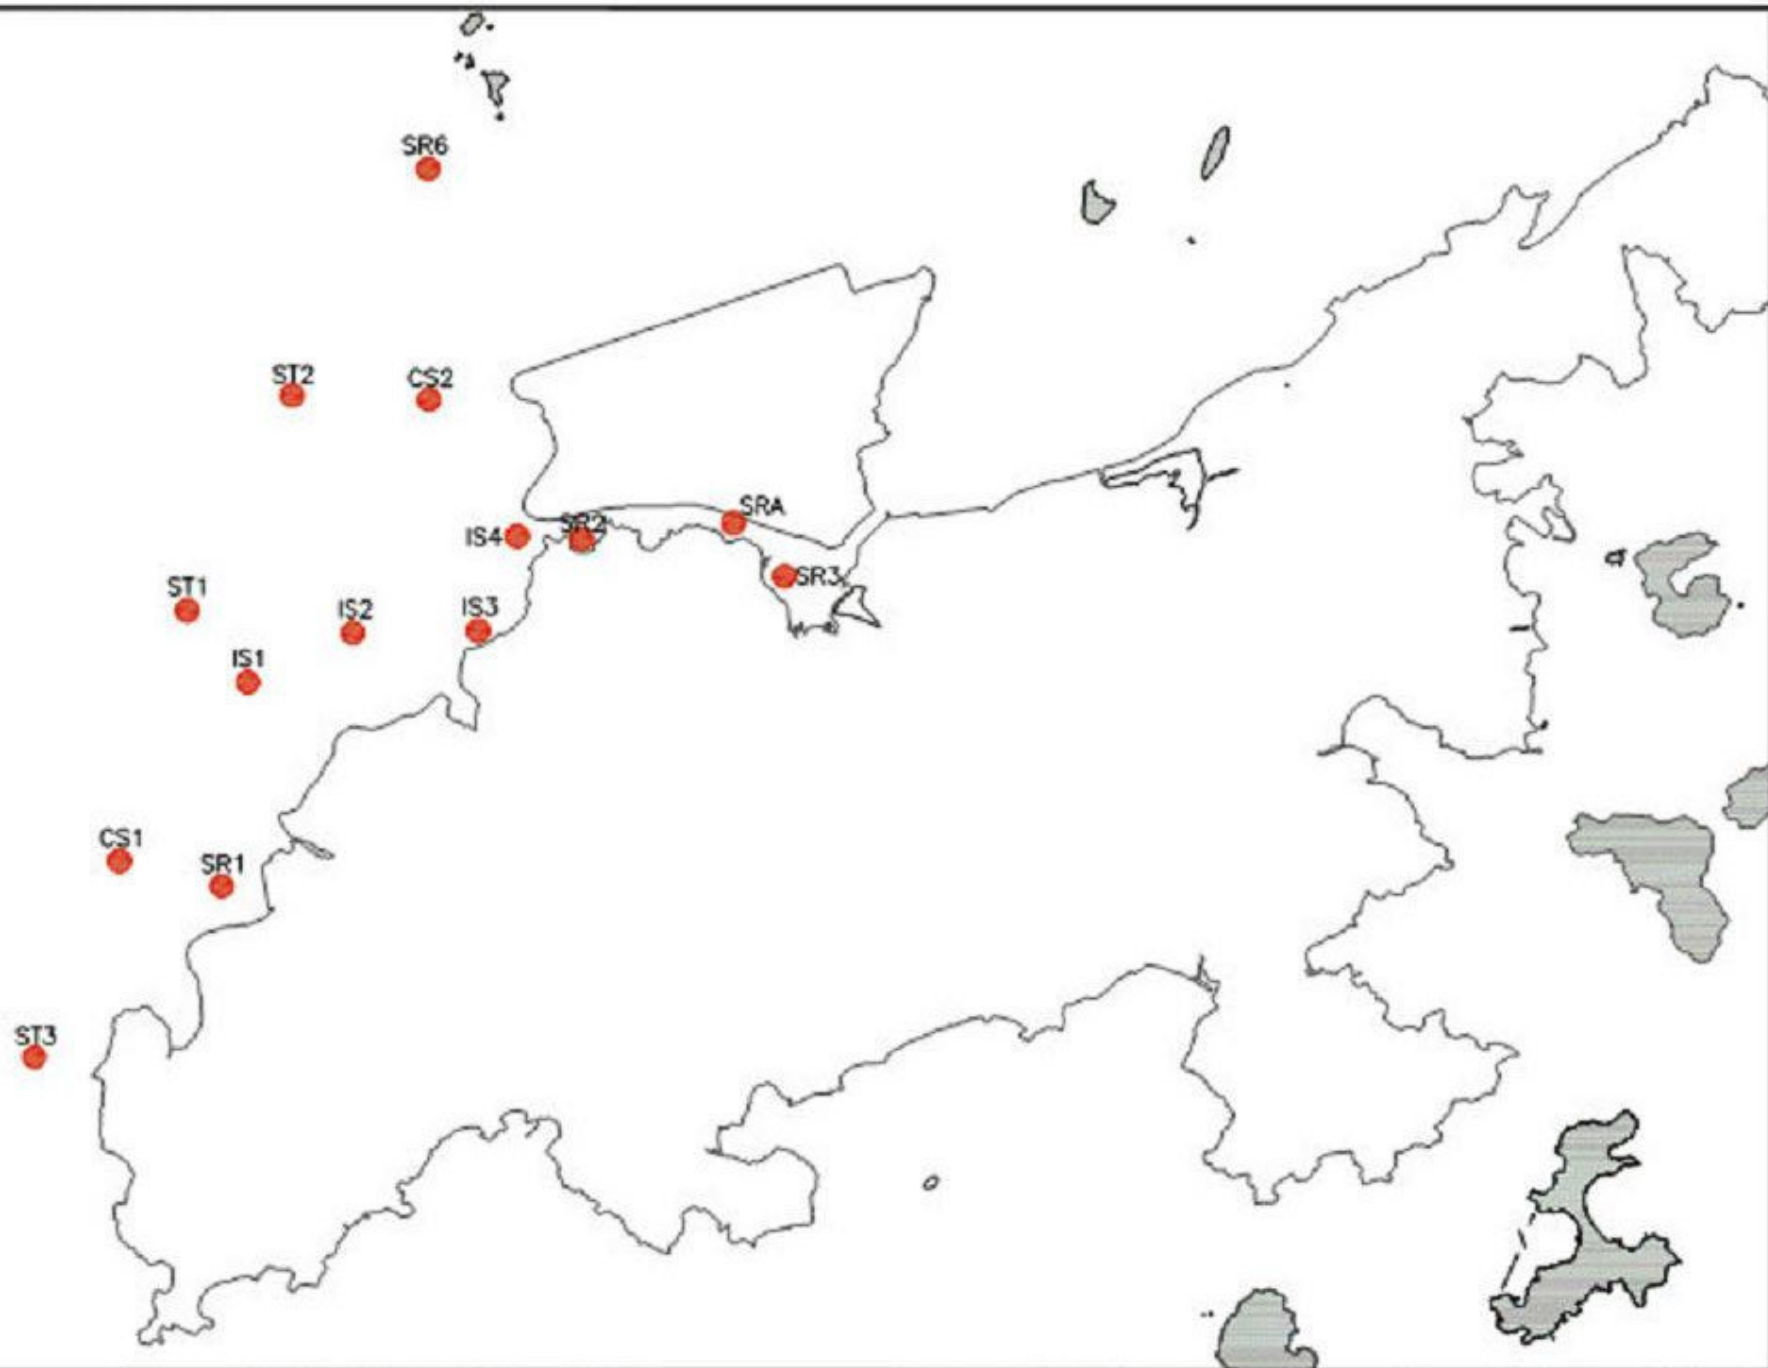
Title	Contract No. HY/2011/09 Hong Kong-Zhuhai-Macao Bridge Hong Kong Link Road – Section between HKSAR Boundary and Scenic Hill		Scale	N.T.S	Propose No.	MA12014	CINOTECH
	Locations of Air Quality and Noise Monitoring Stations		Date	Feb-13	Figure	3

- 3.3 Impact air quality monitoring was conducted at the 2 monitoring stations under the Contract, as shown in **Figure 3**. **Table 3.1** describes the locations of the air quality monitoring stations.

- 3.17 The wind speed and wind direction were recorded by the installed Wind Anemometer set at AMS4. The location is shown in **Figure 3**.
- 3.18 The wind data for the reporting month is summarized in **Appendix J**.

- 4.2 Impact noise monitoring was conducted at the 2 monitoring stations under the Contract, as shown in **Figure 3**. **Table 4.1** describes the locations of the air quality monitoring stations.

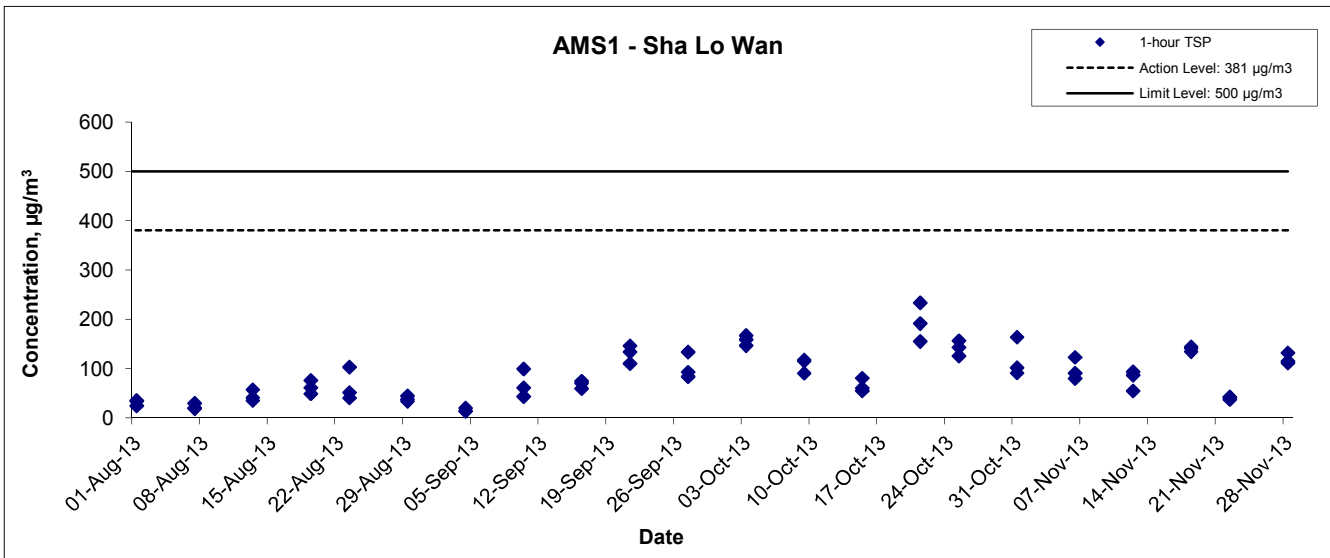
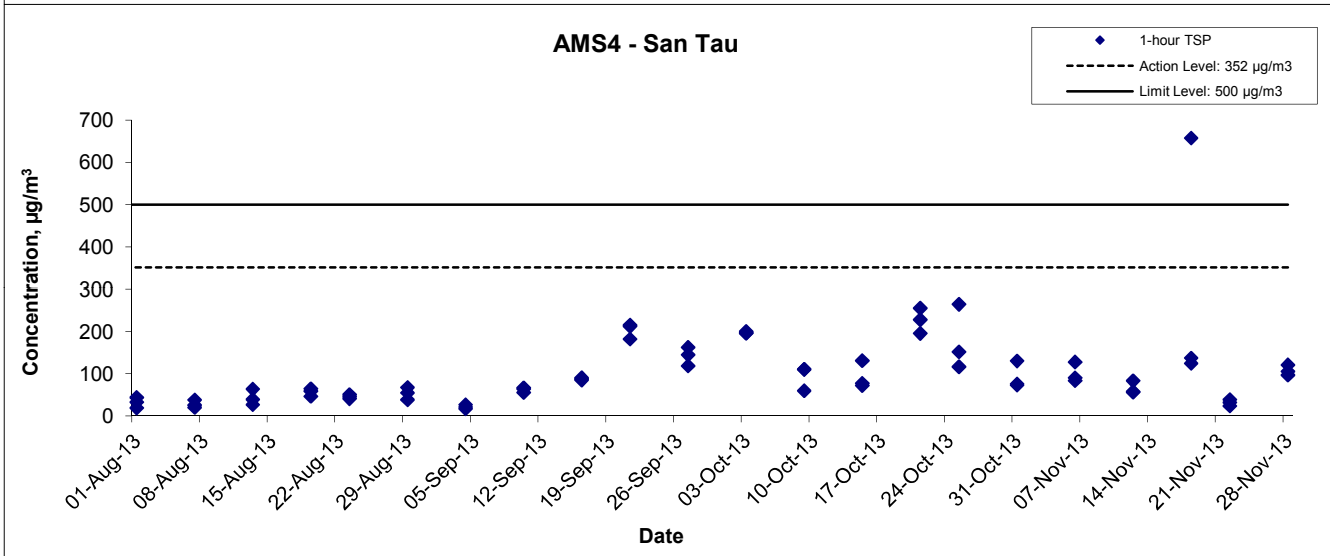
Title Contract No. HY/2011/09 Hong Kong-Zhuhai-Macao Bridge Hong Kong Link Road – Section between HKSAR Boundary and Scenic Hill  Graphical Presentation of 1-hour TSP Monitoring Results	Scale	N.T.S	Project No.	MA12014	CINOTECH
	Date	Nov 13	Appendix	E

### 1-hour TSP Concentration Levels

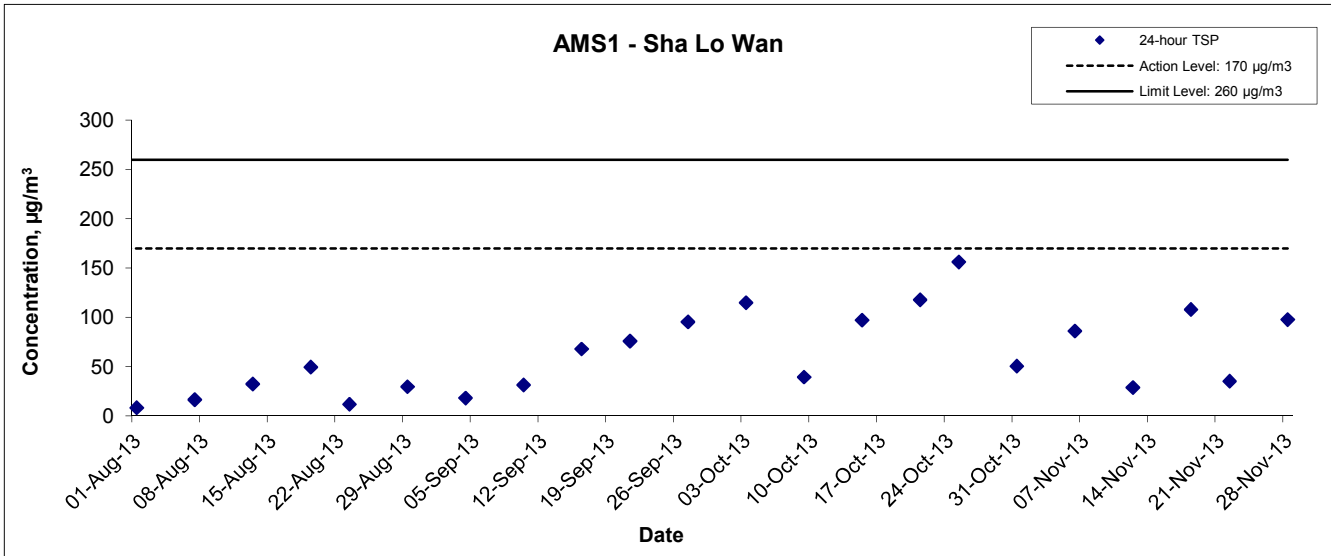
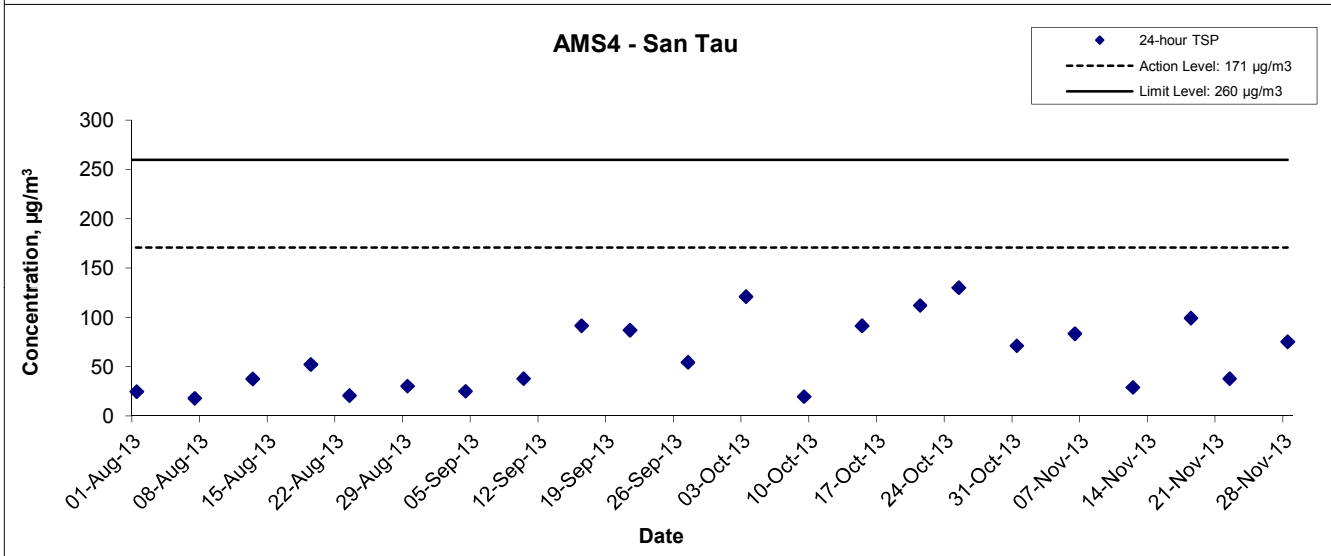
Title Contract No. HY/2011/09 Hong Kong-Zhuhai-Macao Bridge Hong Kong Link Road – Section between HKSAR Boundary and Scenic Hill  Graphical Presentation of 24-hour TSP Monitoring Results	Scale N.T.S	Project No. MA12014	
	Date Nov 13	Appendix F

## 24-hour TSP Concentration Levels

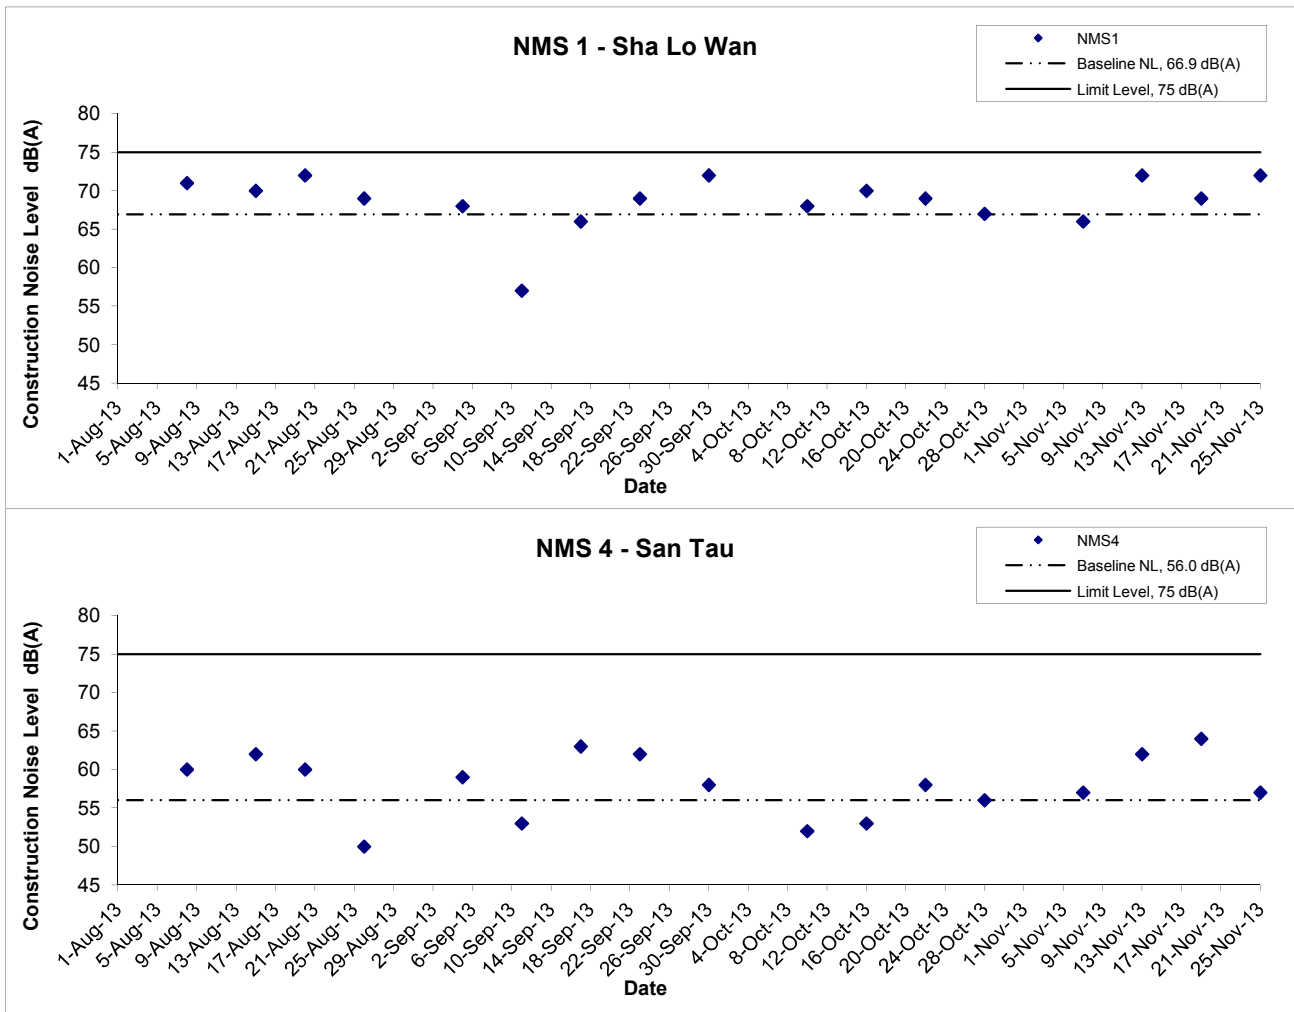
Title Contract HY/2011/09 Hong Kong-Zhuhai-Macao Bridge Hong Kong Link Road-Section between HKSAR Boundary and Scenic Hill Graphical Presentation of Construction Noise Monitoring Results	Scale N.T.S	Project No. MA12014	
	Date Nov 13	Appendix G

## Noise Levels

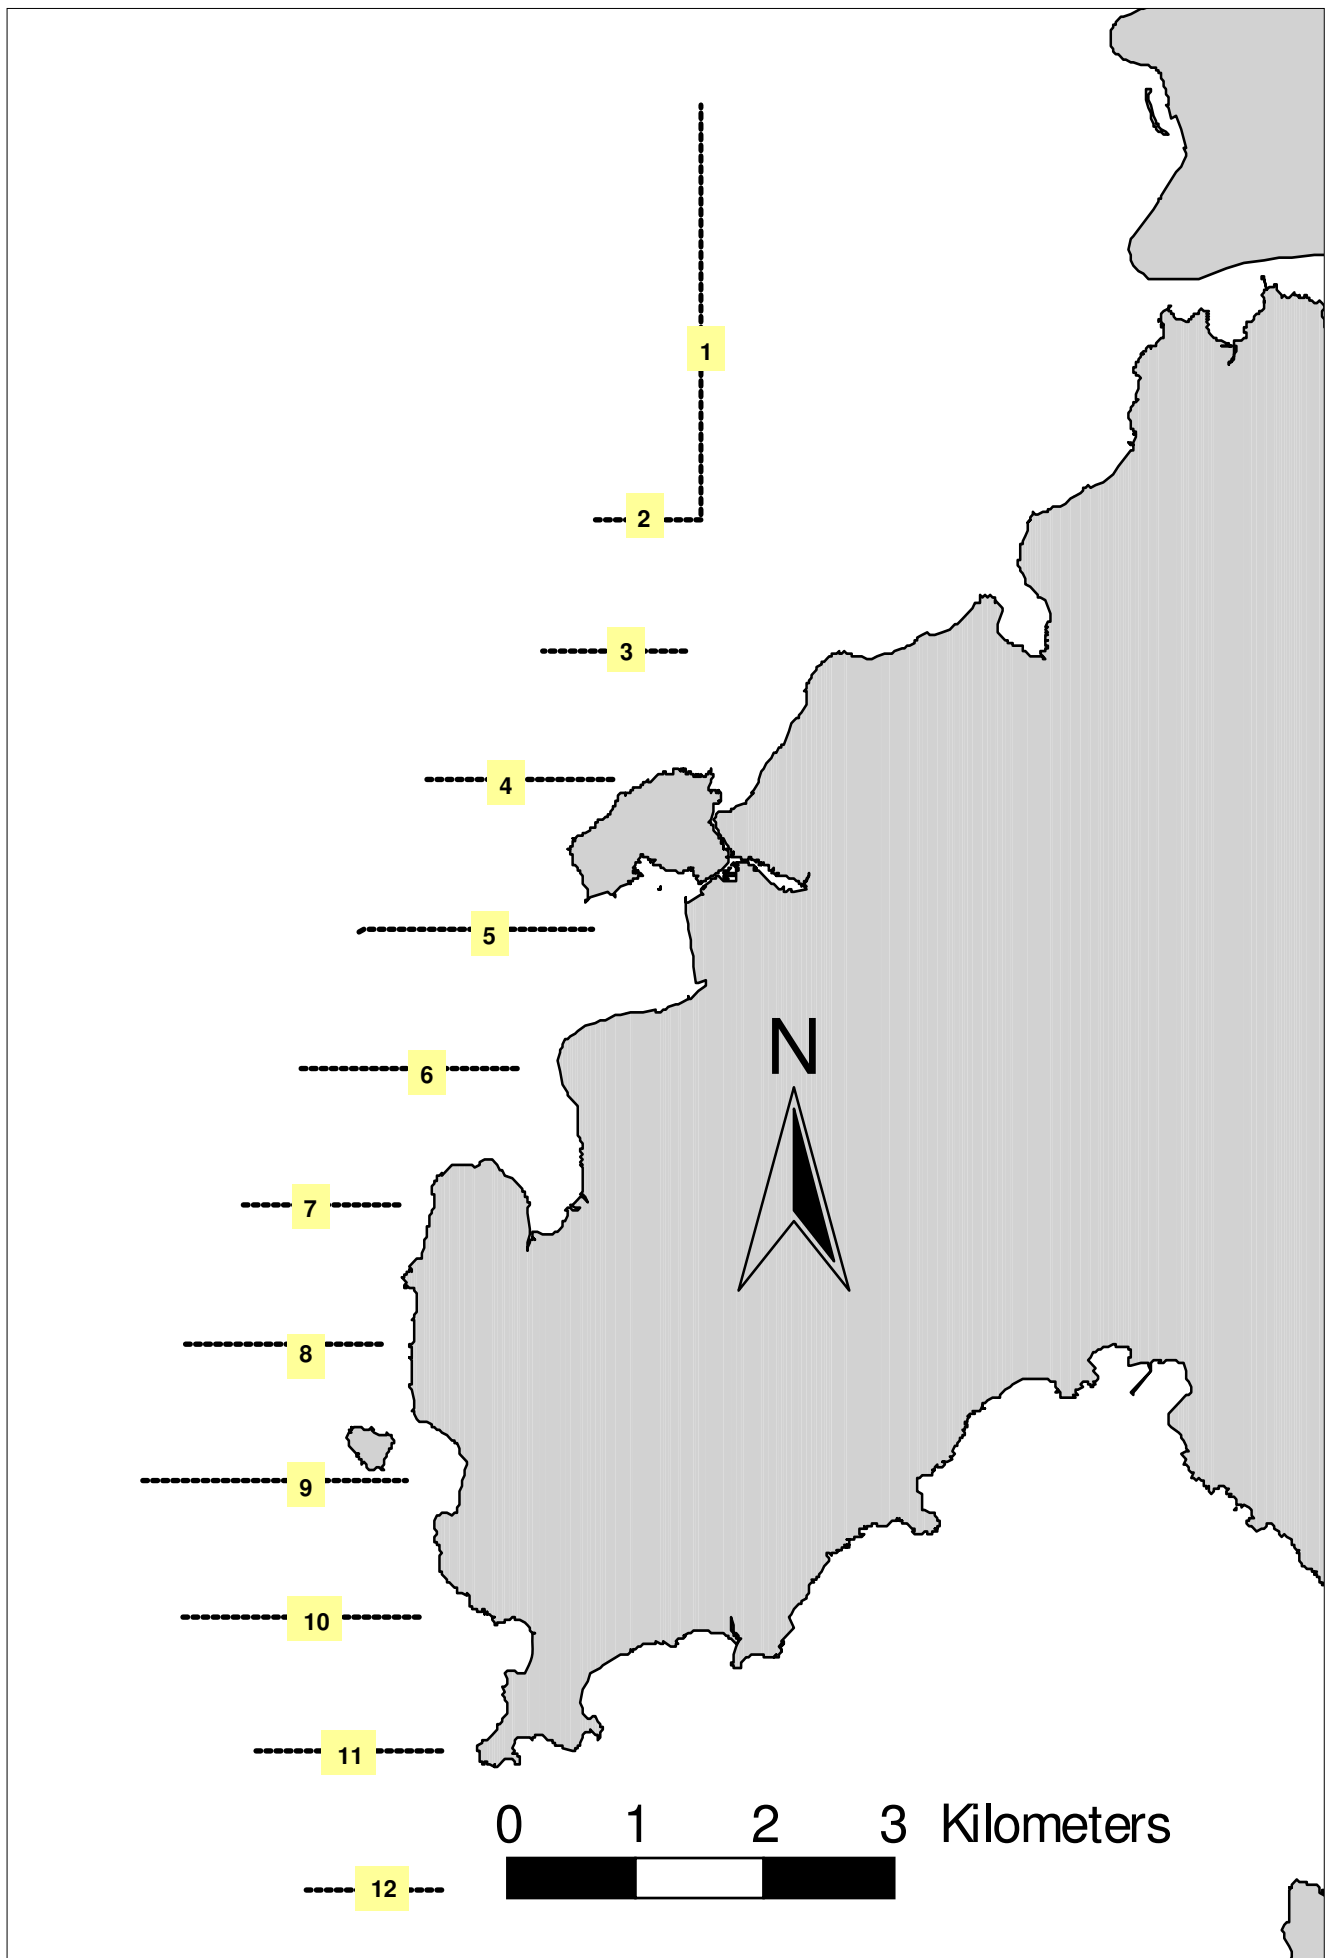
Figure 1. Transect Line Layout in West Lantau Survey Areas

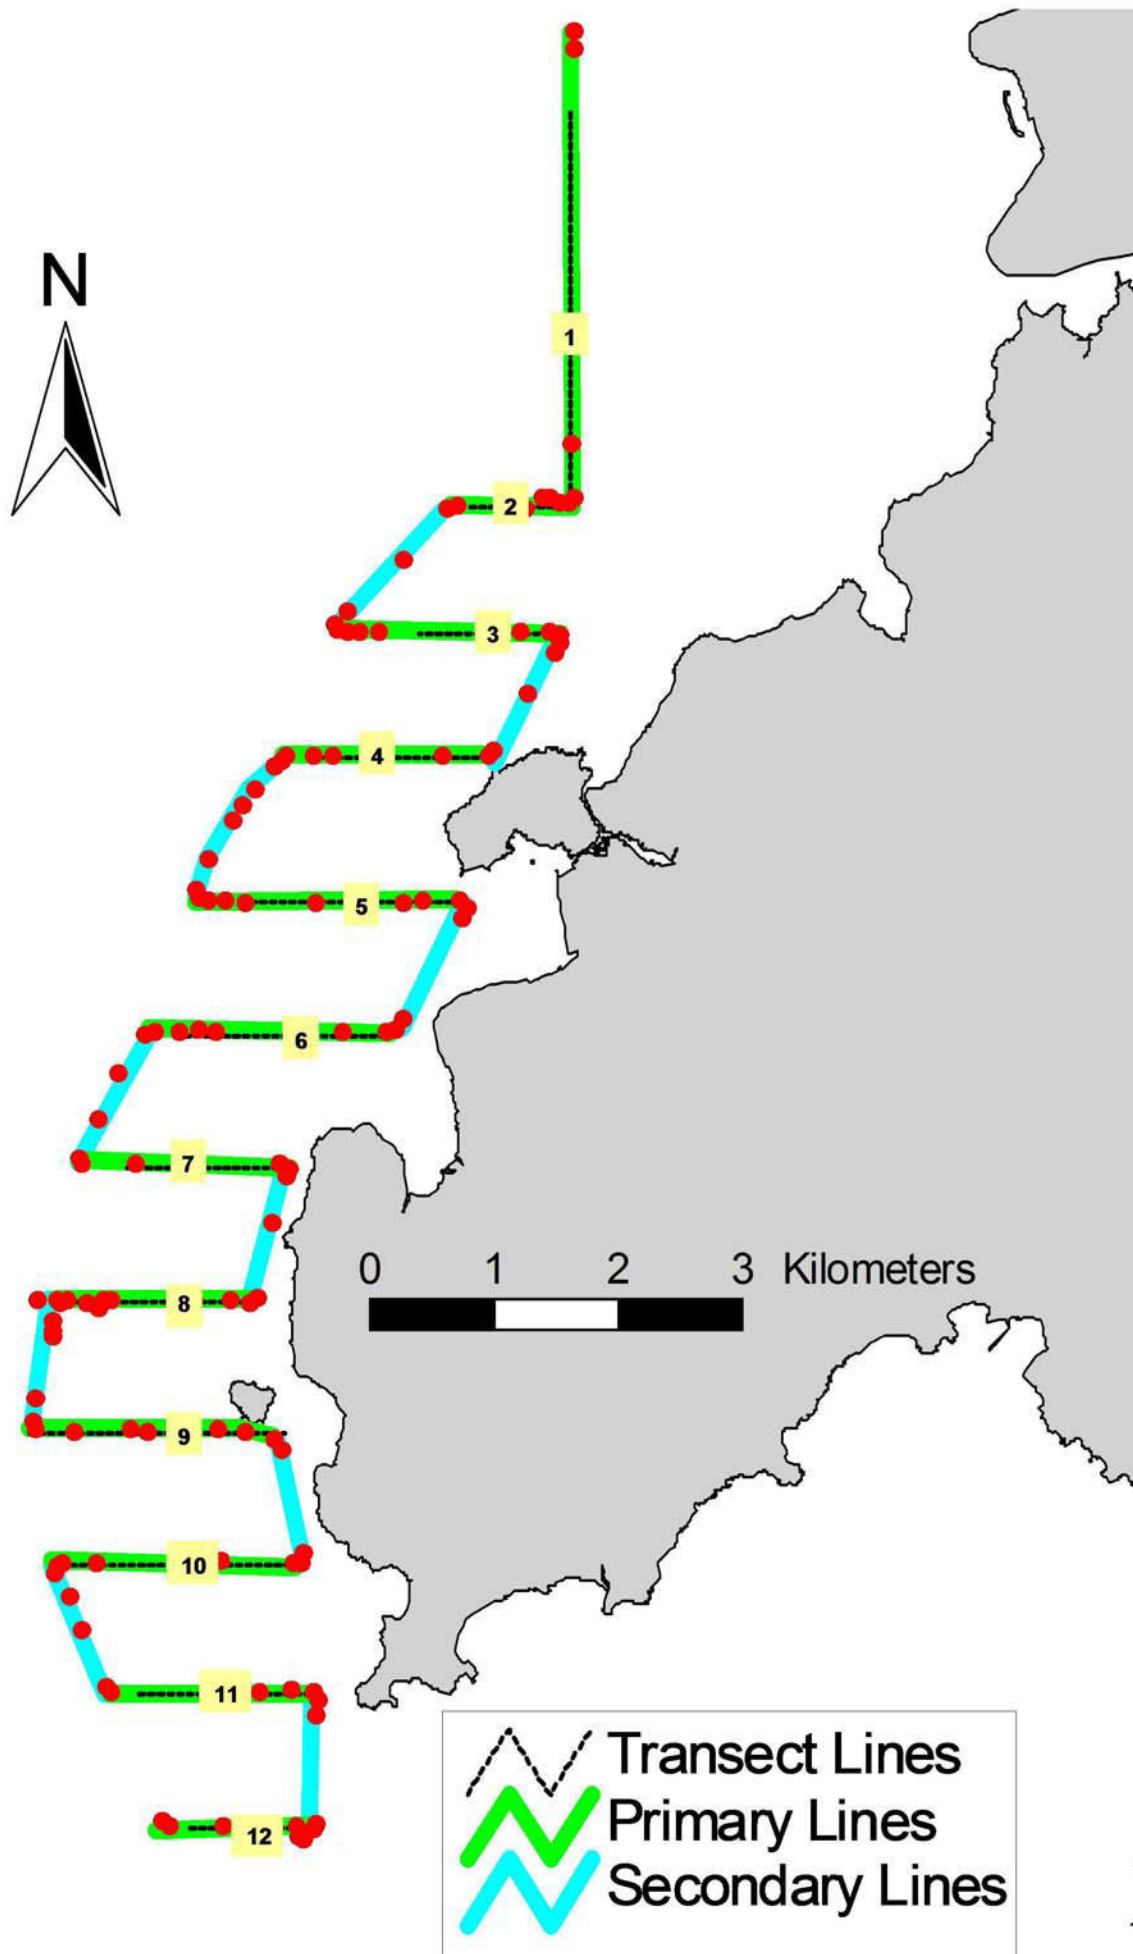
Figure 2. Survey Route on November 6<sup>th</sup>, 2013 (note: red dots represent the tracked positions of survey boat logged continuously by GPS throughout the course of the survey)

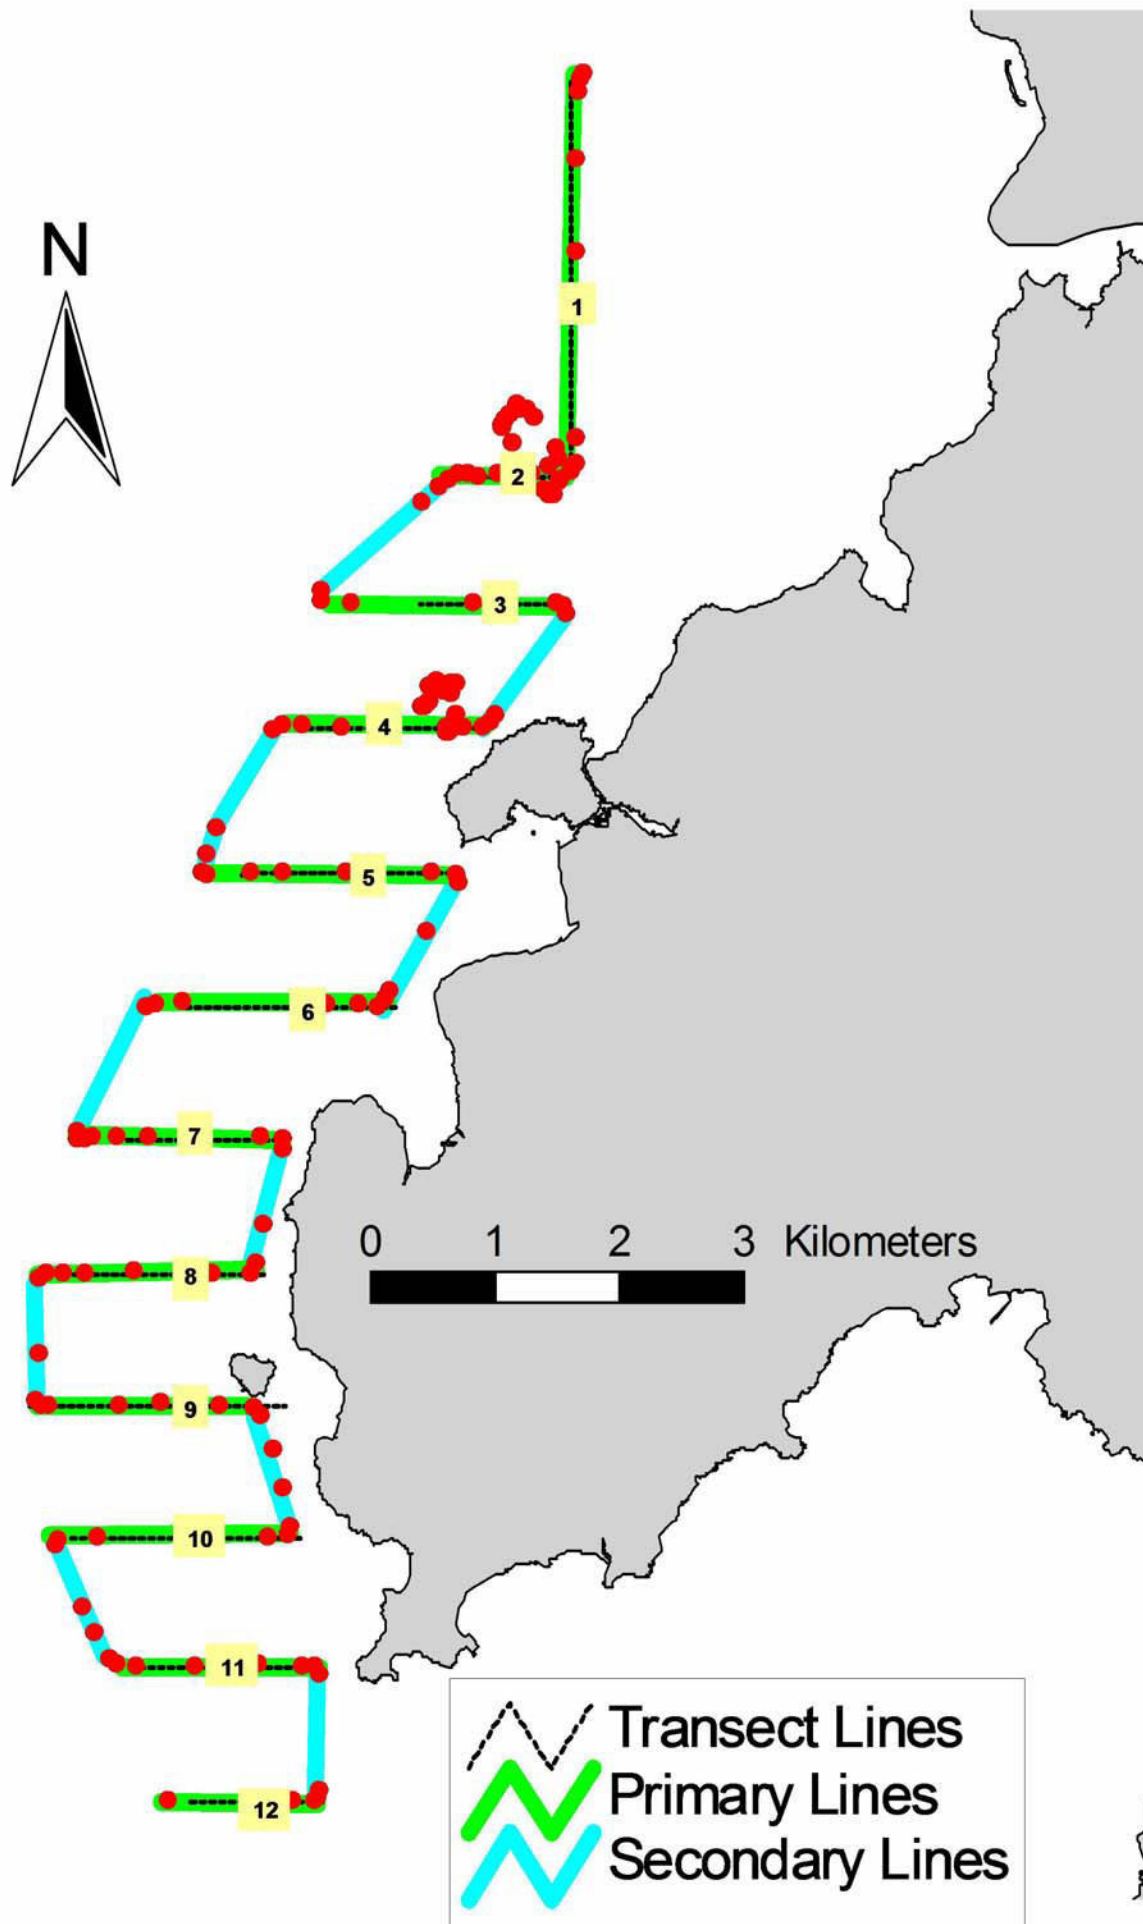
Figure 3. Survey Route on November 15<sup>th</sup>, 2013 (note: red dots represent the tracked positions of survey boat logged continuously by GPS throughout the course of the survey)

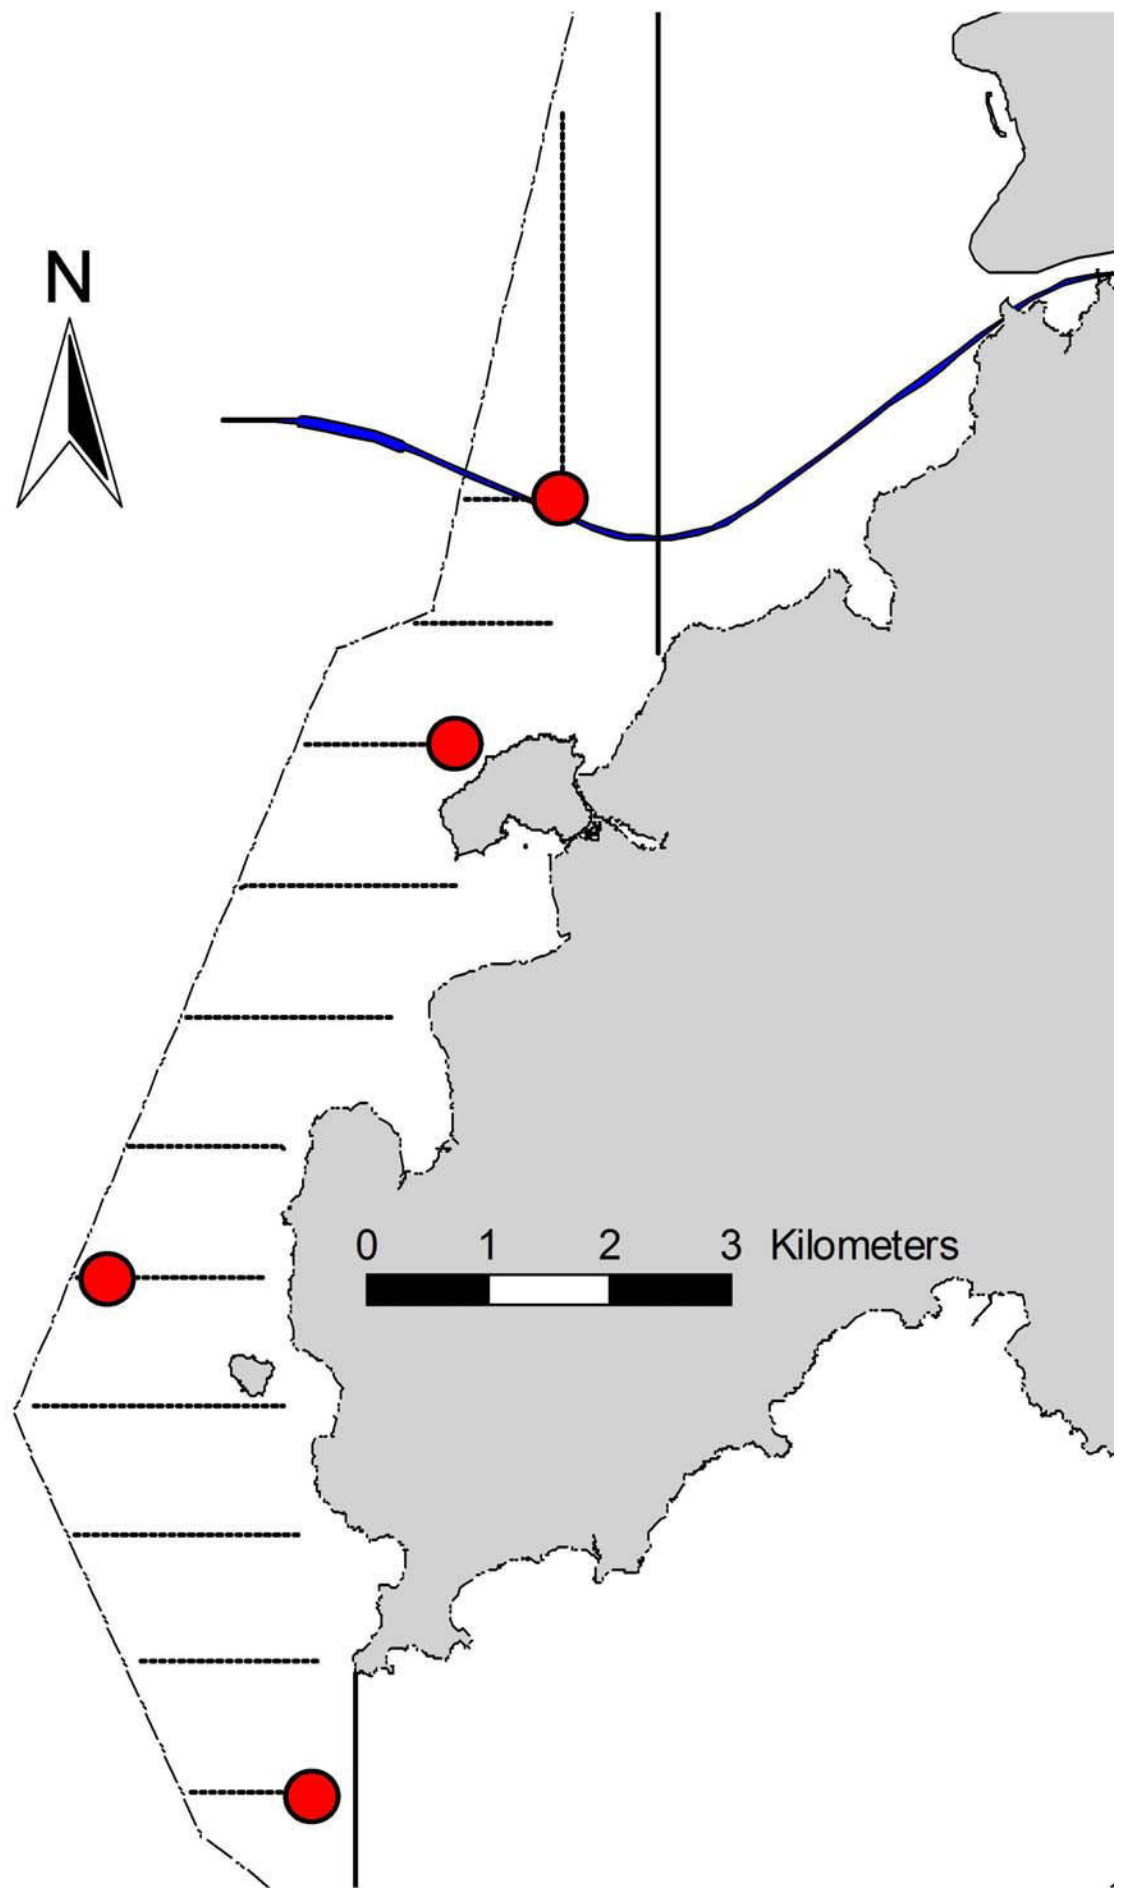
Figure 4. Distribution of Chinese White Dolphin Sighting during November 2013 HKLR09 Monitoring Surveys

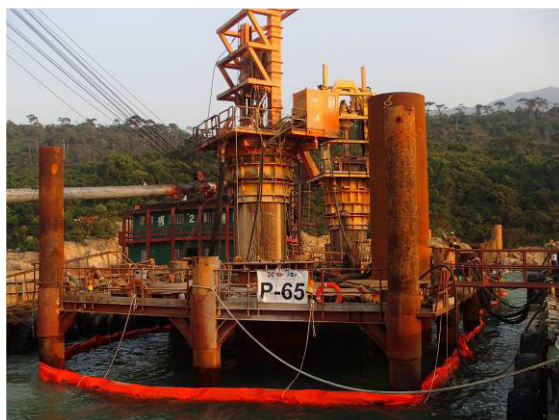
- \*Remarks
- (1) – No major marine construction activity was conducted.
  - (2) – No pollution discharge from construction activity was observed.
  - (3) – Control Station value already exceeded either the Baseline Action or Limit Levels.
  - (4) – The exceeded results were similar or within the ranges baseline monitoring results.
  - (5) – Monitoring station is situated at the upstream of the construction sites.
  - (6) – Other(s): Please specify – a) Sediment plume due to natural fluctuation of shallow water was observed.  
b) Bored piling works were conducted at near the monitoring station. However, water quality mitigation measures such as casing and silt curtains were properly implemented (see photos below).

**Part C – Recommendation:** As the exceedances were not related to the contract works, no further action to be required.

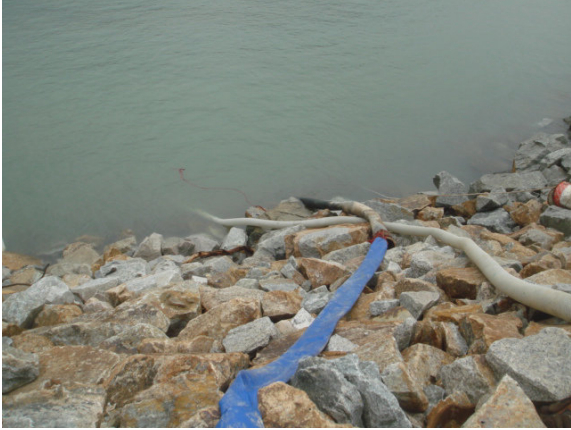
<p><b>Ref No:</b> 131105-O01</p> <p><b>Impact:</b> Water Quality (B3)</p> <p><b>Details:</b> A blue tube with pump was observed connecting to the sea directly at P103. The contractor was reminded to ensure all site discharge should be treated with desilting facilities before discharging out.</p>

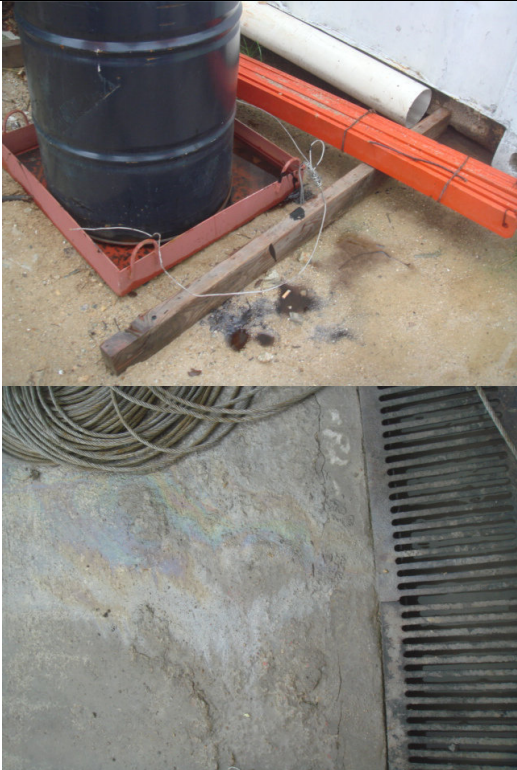
<p><b>Ref No:</b> 131105-R02</p> <p><b>Impact:</b> Waste/Chemical Management (F8)</p> <p><b>Details:</b> Clear the oil stain at near the chemical container and drainage channel at Portion C.</p>

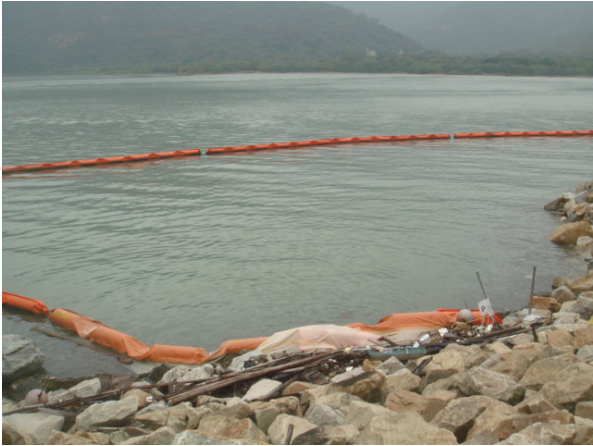
<p><b>Ref No:</b> 131105-R03</p> <p><b>Impact:</b> Waste/Chemical Management (F7)</p> <p><b>Details:</b> Clear the waste materials at the seawall area at P105.</p>

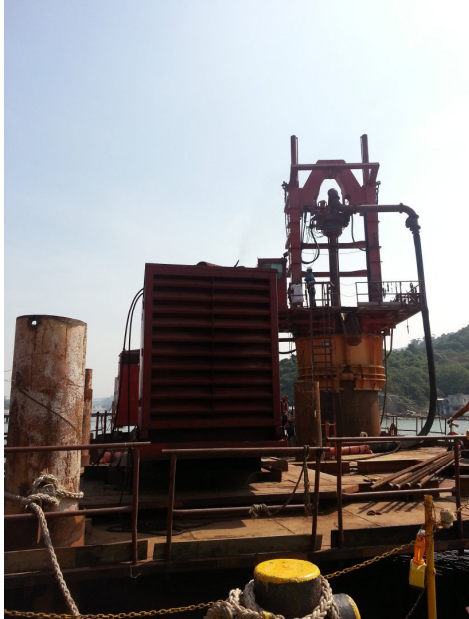
<p><b>Ref No:</b> 131029-R02</p> <p><b>Impact:</b> Air Quality (D19)</p> <p><b>Details:</b> To check and repair the air compressor at P73 to avoid emitting heavy smoke.</p> <p><b>Follow up:</b> The air compressor was repaired with no heavy smoke emitted.</p>

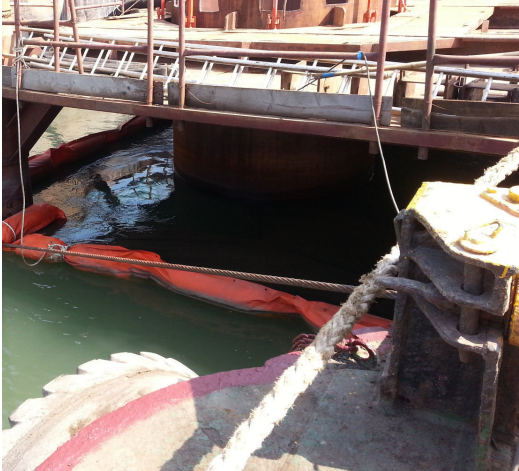
<p><b>Ref No:</b> 131029-R03</p> <p><b>Impact:</b> Water Quality (B25)</p> <p><b>Details:</b> To repair the damage silt curtain at P73 ASAP.</p> <p><b>Follow up:</b> The silt curtain was repaired</p>

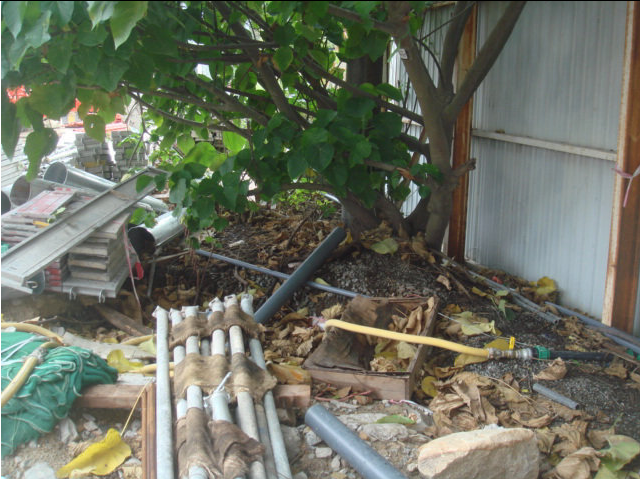
<p><b>Ref No:</b> 131112-R01</p> <p><b>Impact:</b> Ecology (B3)</p> <p><b>Details:</b> Provide fencing for protecting the tree at Portion C.</p>

<p><b>Ref No:</b> 131112-R01</p> <p><b>Impact:</b> Ecology (B3)</p> <p><b>Details:</b> Provide fencing for protecting the tree at Portion C.</p> <p><b>Follow Up:</b> The construction materials at near the tree were removed by the workers.</p>

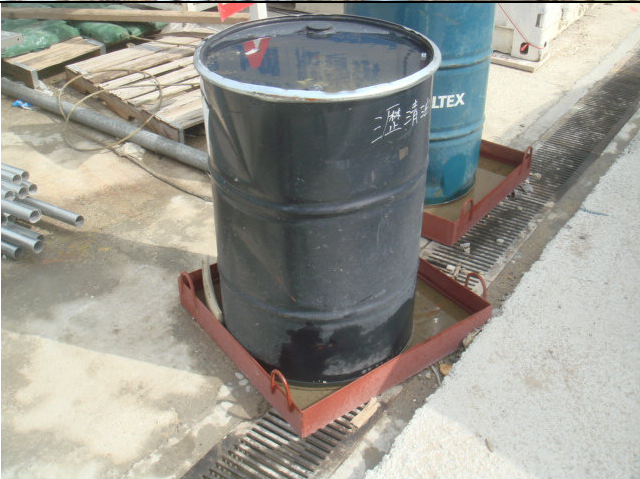
<p><b>Ref No:</b> 131112-R02</p> <p><b>Impact:</b> Waste/Chemical Management (F3iii)</p> <p><b>Details:</b> To remove the chemical containers along from the drain at Portion C.</p>

<p><b>Ref No:</b> 131112-R02</p> <p><b>Impact:</b> Waste/Chemical Management (F3iii)</p> <p><b>Details:</b> To remove the chemical containers along from the drain at Portion C.</p> <p><b>Follow Up:</b> The chemical containers were moved away from the drainage channel.</p>

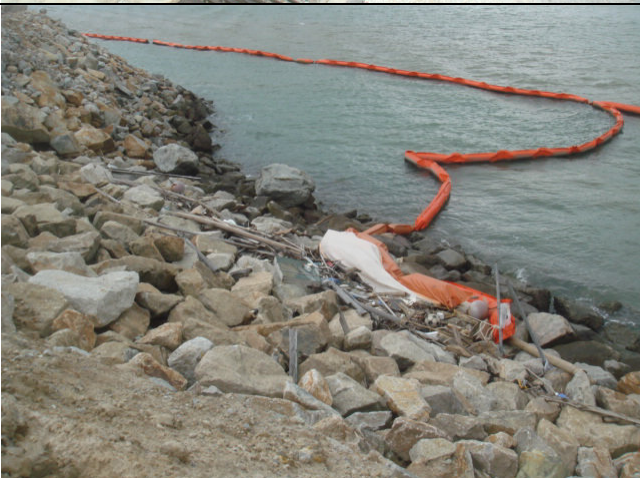
<p><b>Ref No:</b> 131112-R03</p> <p><b>Impact:</b> Waste/Chemical Management (F7)</p> <p><b>Details:</b> To clear the waste materials at the seawall area at P105.</p>

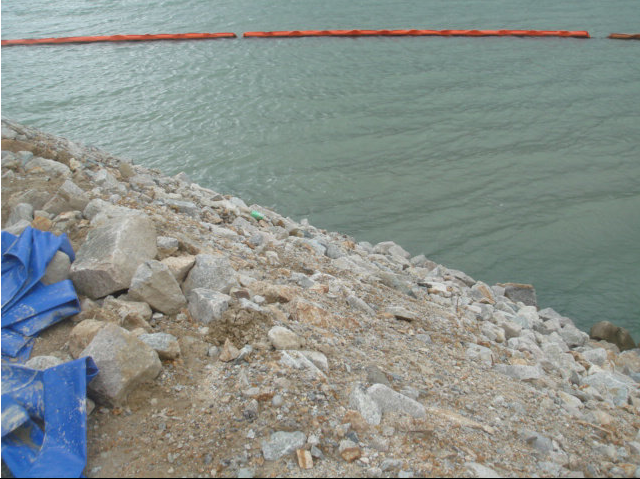
<p><b>Ref No:</b> 131105-O01</p> <p><b>Impact:</b> Water Quality (B3)</p> <p><b>Details:</b> A blue tube with pump was observed connecting to the sea directly at P103. The contractor was reminded to ensure all site discharge should be treated with desilting facilities before discharging out.</p> <p><b>Follow up:</b> The blue tube was removed.</p>
