**HyD Contract No. HY/2011/09  
Hong Kong-Zhuhai-Macao Bridge  
Hong Kong Link Road – Section between HKSAR Boundary and Scenic Hill  
Submission under Environmental Permit (EP-352/2009/C - Condition 4.4)  
Monthly EM&A Report – November 2013**

**Contract No. HY/2011/09 HZMB Hong Kong Link Road –  
Section between HKSAR Boundary and Scenic Hill  
Revised Monthly EM&A Report for November 2013 (EP-352/2009/C)**

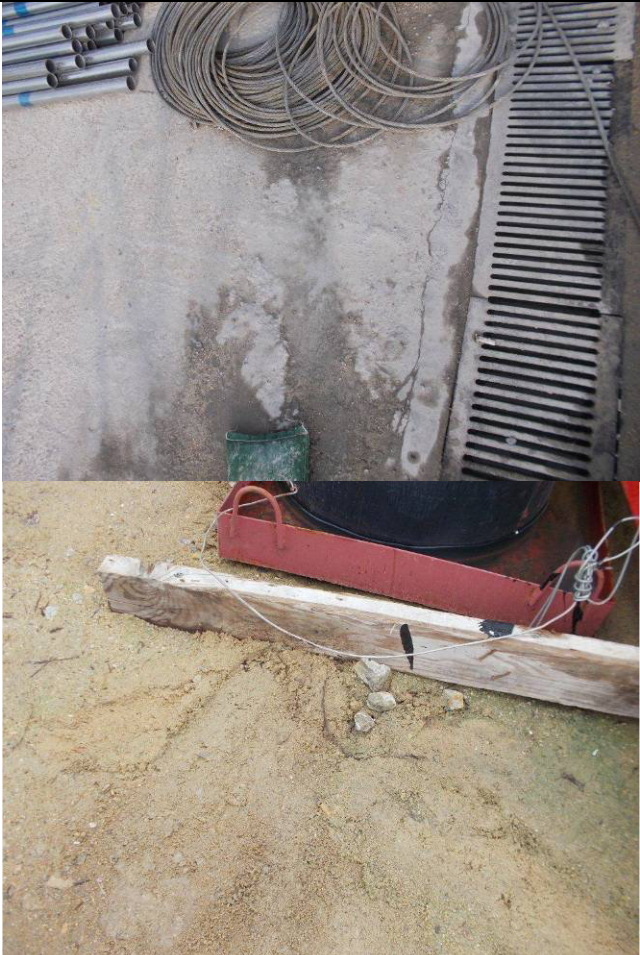
<p><b>Ref No:</b> 131105-R02</p> <p><b>Impact:</b> Waste/Chemical Management (F8)</p> <p><b>Details:</b> Clear the oil stain at near the chemical container and drainage channel at Portion C.</p> <p><b>Follow up:</b> The oil stain in identified area was cleared.</p>

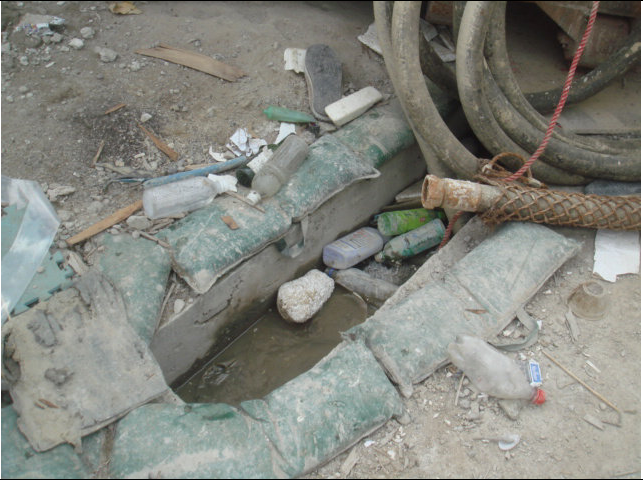
<p><b>Ref No:</b> 131119-R03</p> <p><b>Impact:</b> Water Quality (B4) Waste/Chemical Management (F6)</p> <p><b>Details:</b> Clear the wastes and sediment at the drainage channel at Portion C.</p>

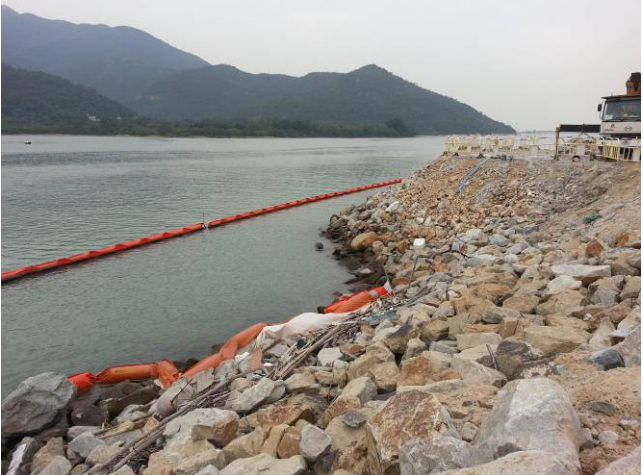
<p><b>Ref No:</b> 131119-R04</p> <p><b>Impact:</b> Waste/Chemical Management (F7)</p> <p><b>Details:</b> Clear the wastes material at the seawall area at P105.</p>

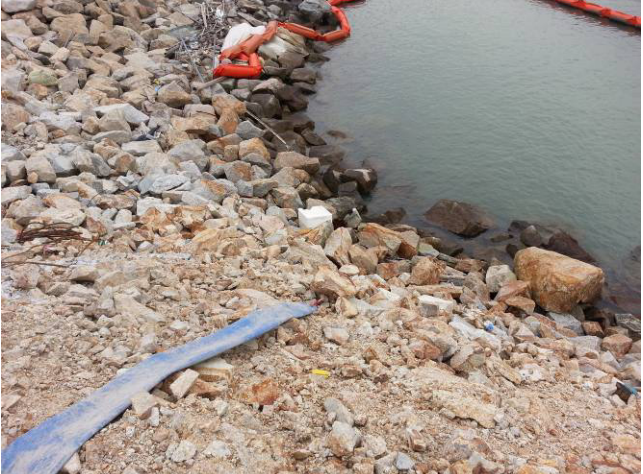
<p><b>Ref No:</b> 131119-R05</p> <p><b>Impact:</b> Water Quality (B3)</p> <p><b>Details:</b> To remove the blue pipe which directly connecting to the sea at P105.</p>

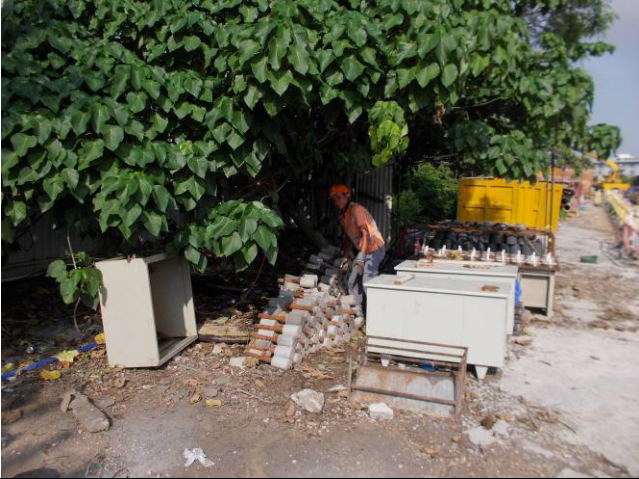
<p><b>Ref No:</b> 131112-R01</p> <p><b>Impact:</b> Ecology (B3)</p> <p><b>Details:</b> Provide fencing for protecting the tree at Portion C.</p> <p><b>Follow Up:</b> The construction materials at near the tree were removed by the workers.</p>

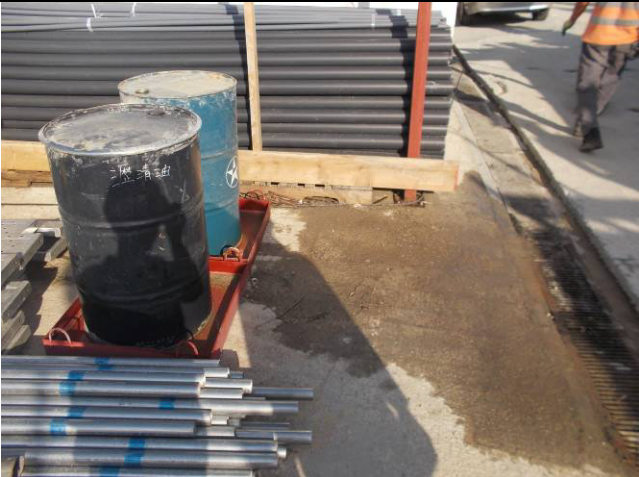
<p><b>Ref No:</b> 131112-R02</p> <p><b>Impact:</b> Waste/Chemical Management (F3iii)</p> <p><b>Details:</b> To remove the chemical containers along from the drain at Portion C.</p> <p><b>Follow Up:</b> The chemical containers were moved away from the drainage channel.</p>

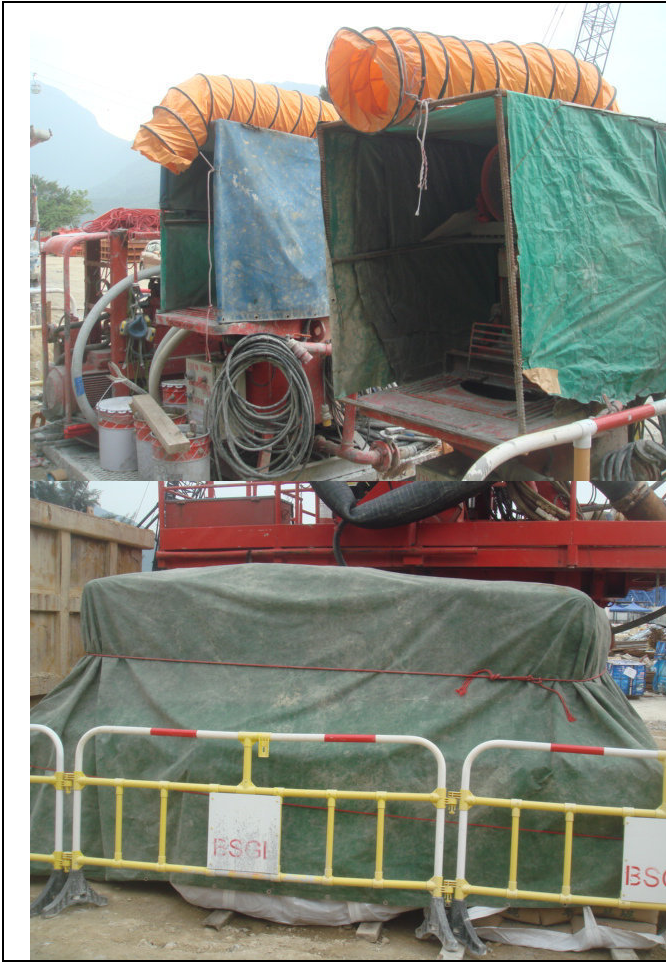
**Ref No:** 131112-004

Cement bags were not covered and dust generation was observed from the cement de-bagging works at P105. The Contractor was reminded to modify the enclosure and cover the cement bags properly.

No cement de-bagging works were observed and the enclosure for grouting machine was waiting to modify. The cement bags were covered with tarpaulin sheet.

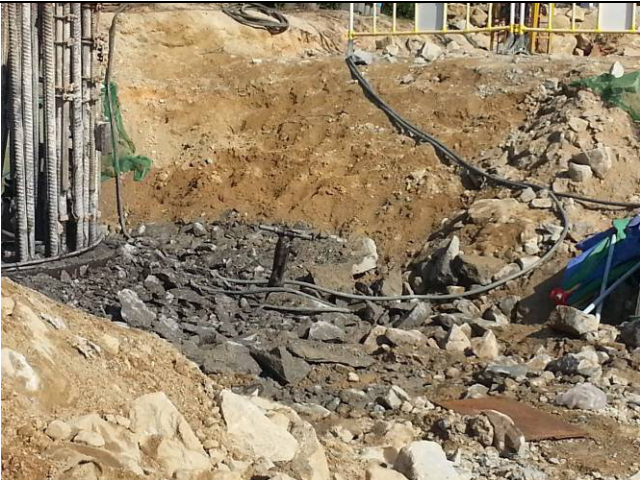
<p><b>Ref No:</b> 131129-R04</p> <p><b>Impact:</b> Noise (E8)</p> <p><b>Details:</b> Provide the noise emission label for the breaker (&gt;10kg) at near P104.</p>

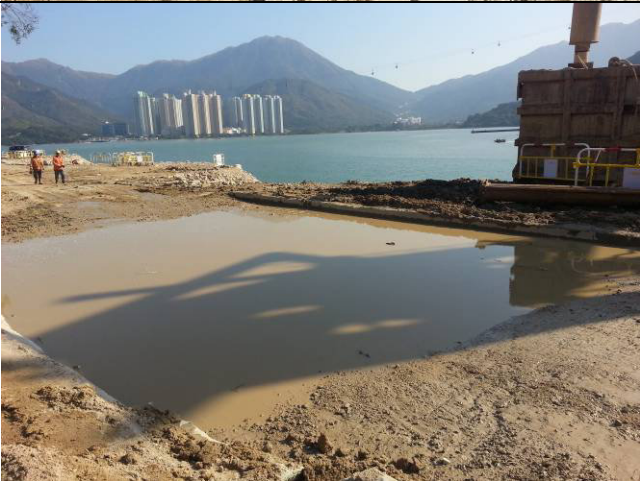
<p><b>Ref No:</b> 131129-R05</p> <p><b>Impact:</b> Water Quality (B10iv.)</p> <p><b>Details:</b> The water at the wheel washing bay a Portion A should be cleared.</p>

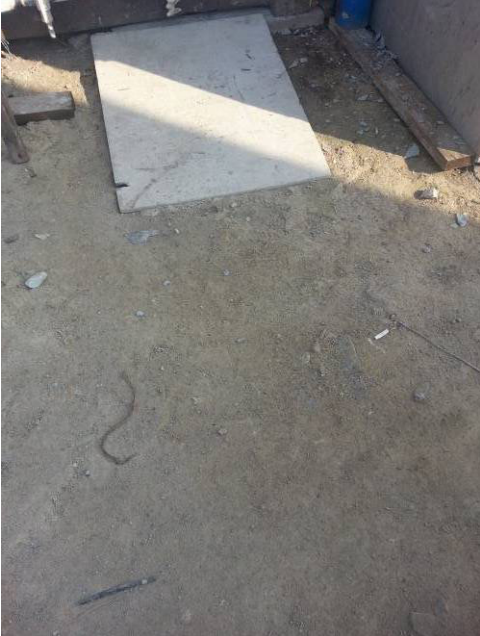
<p><b>Ref No:</b> 131119-R01</p> <p><b>Impact:</b> Waste/Chemical Management (F8)</p> <p><b>Details:</b> Clear the oil leakage from the breaker and oil container at Portion C.</p> <p><b>Follow Up:</b> The breaker was removed and spill response kit was provided to clear the oil leakage.</p>

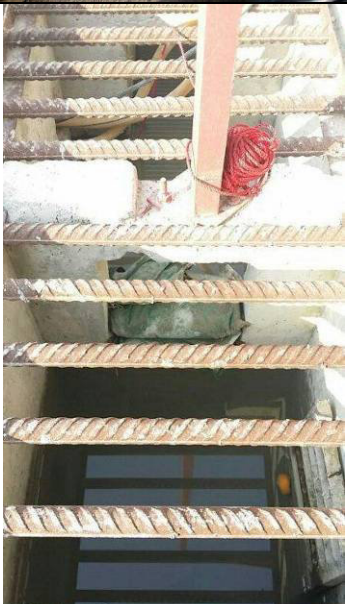
<p><b>Ref No:</b> 131119-R02</p> <p><b>Impact:</b> Water Quality (B3 &amp; 3i.)</p> <p><b>Details:</b> To provide de-silting facilities for treating muddy water at Portion C.</p> <p><b>Follow Up:</b> No discharge of muddy water directly was observed.</p>

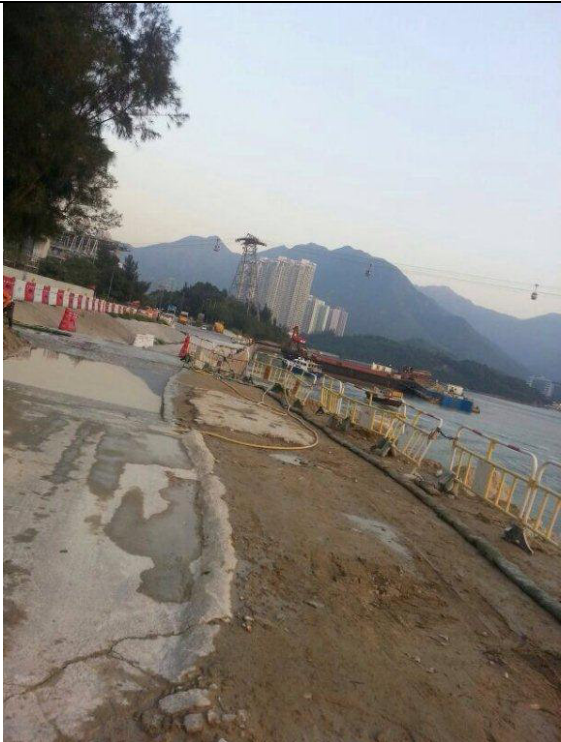
<p><b>Ref No:</b> 131119-R06</p> <p><b>Impact:</b> Water Quality (B16)</p> <p><b>Details:</b> Provide sand bag bund to surround area of works at near the site entrance at Portion A.</p> <p><b>Follow Up:</b> Sand bag bund was provided to surround area of works.</p>

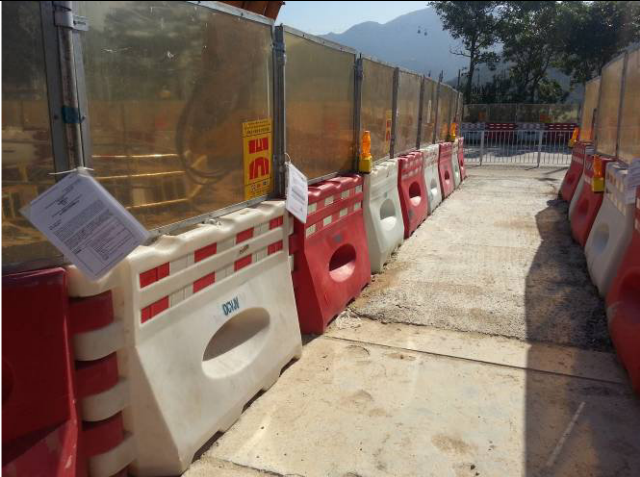
<p><b>Ref No:</b> 131119-R07</p> <p><b>Impact:</b> Permits/Licences (G5)</p> <p><b>Details:</b> To display the environmental permit at the new site entrance at Portion C.</p> <p><b>Follow Up:</b> Environmental permit was displayed at the new site entrance.</p>
