**Re: Agreement No. CE 48/2011 (EP)
Environmental Project Office for the
HZMB Hong Kong Link Road, HZMB Hong Kong Boundary Crossing Facilities,
and Tuen Mun-Chek Lap Kok Link – Investigation**

**Contract No. HY/2011/09 HZMB Hong Kong Link Road –
Section between HKSAR Boundary and Scenic Hill
Revised Monthly EM&A Report for December 2013 (EP-352/2009/C)**

Contract HY/2011/09
Hong Kong-Zhuhai-Macao Bridge
Hong Kong Link Road-Section between
HKSAR Boundary and Scenic Hill
Monthly EM&A Report
December 2013
(Version 2.0)

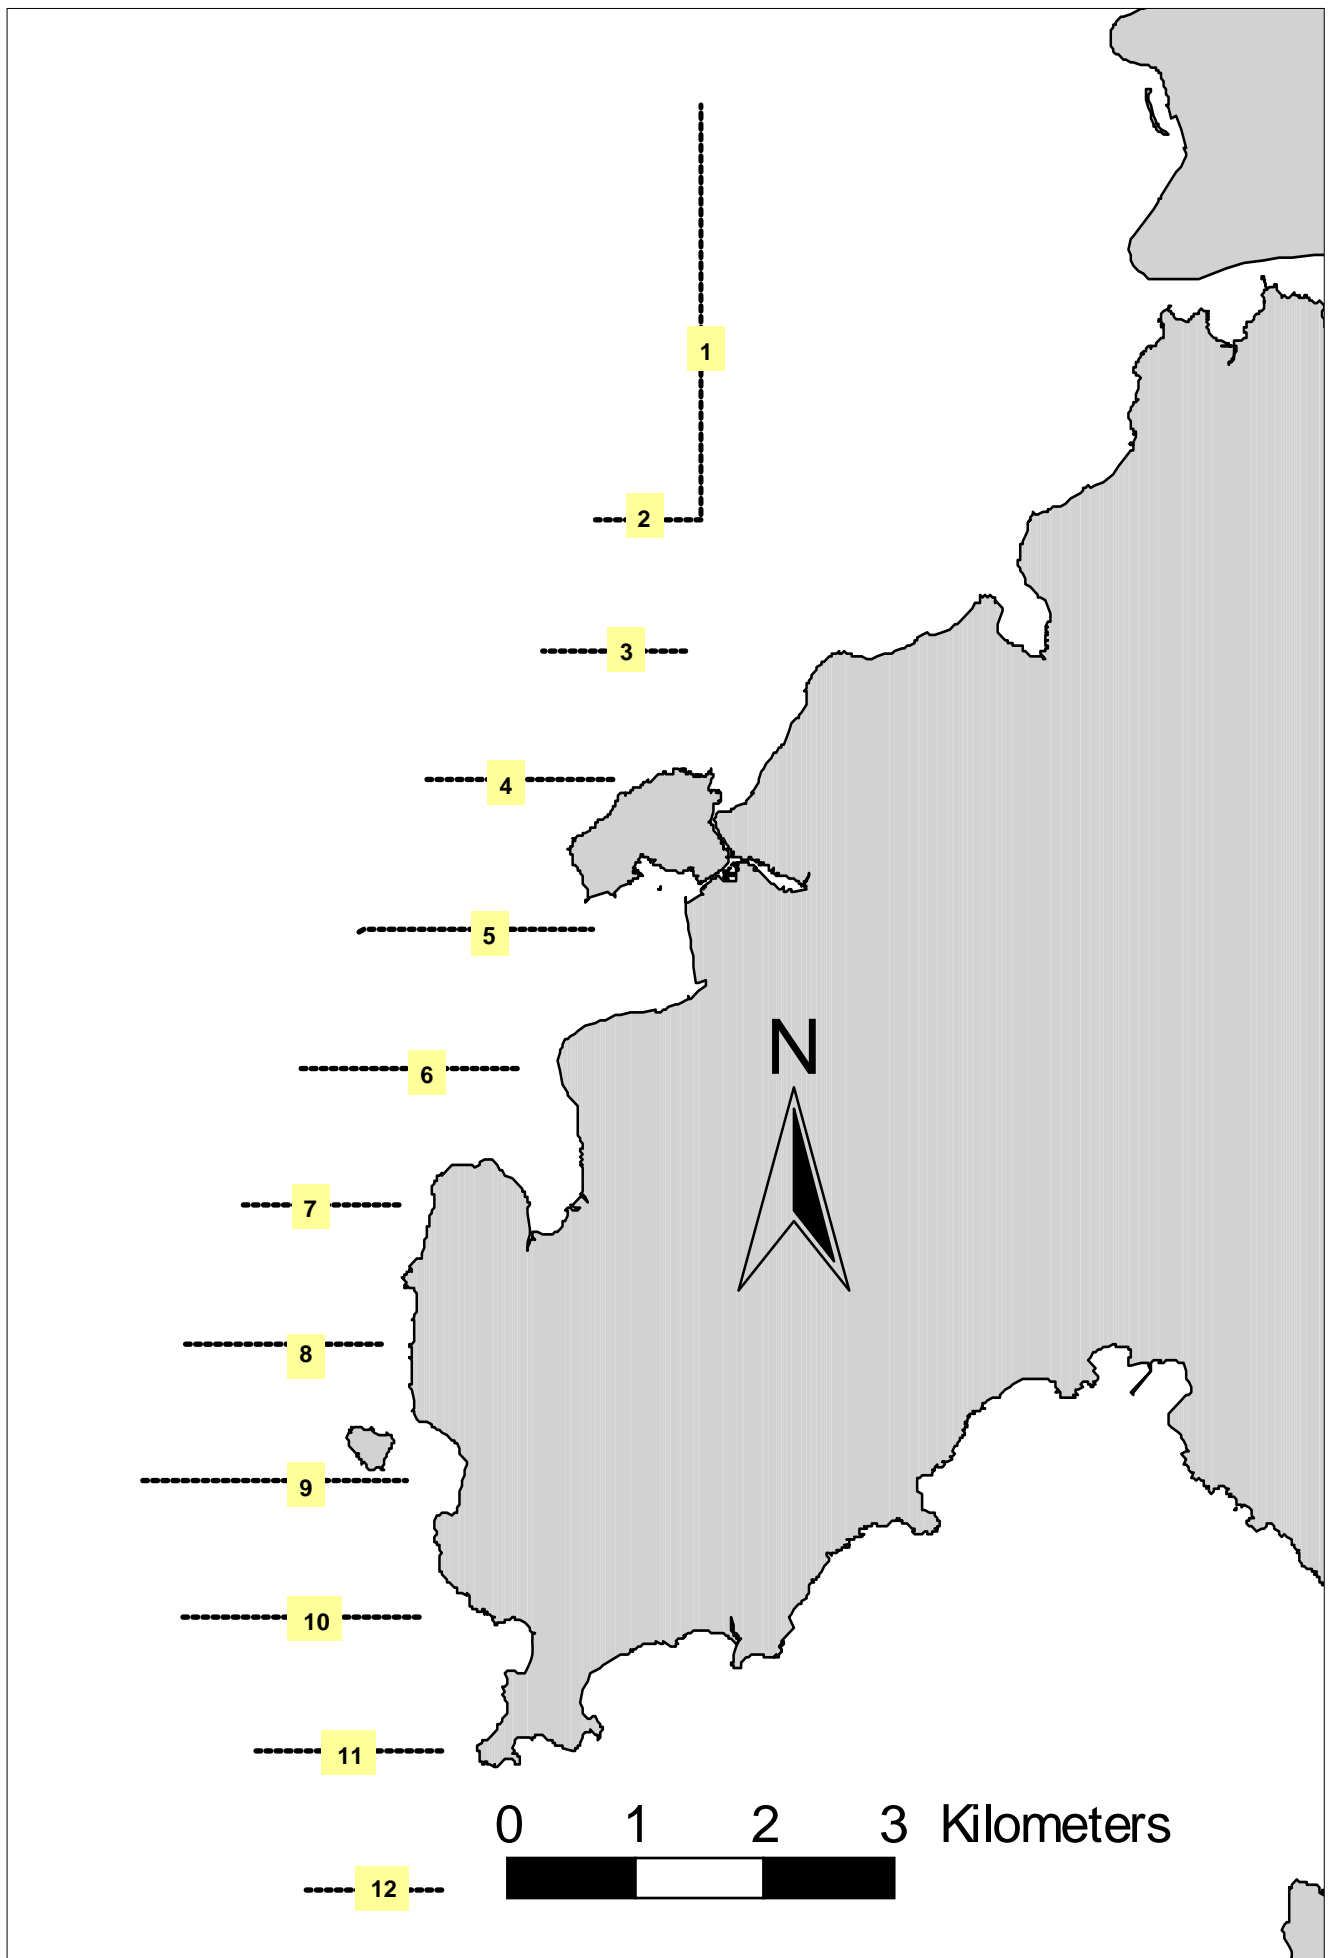
Figure 1. Transect Line Layout in West Lantau Survey Areas

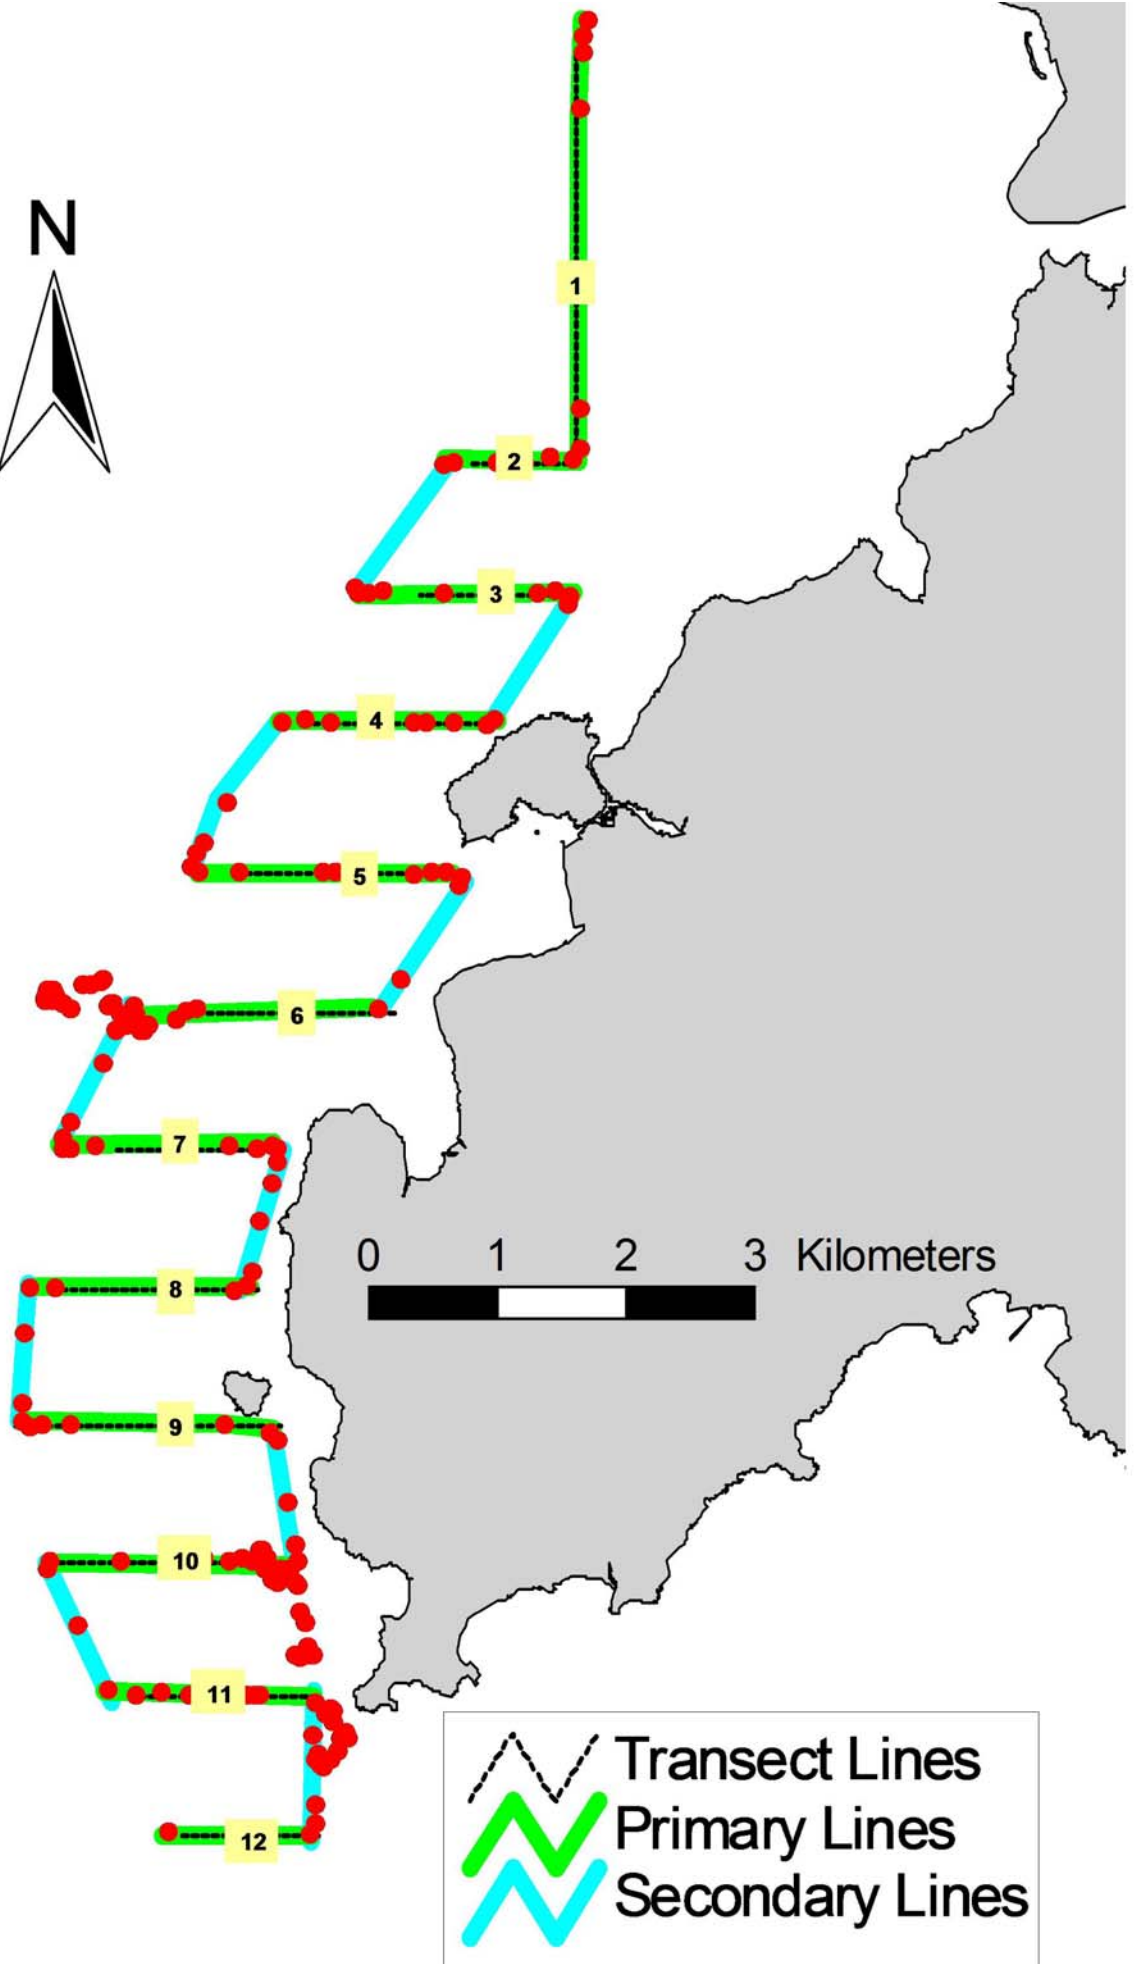
Figure 2. Survey Route on December 3rd, 2013 (note: red dots represent the tracked positions of survey boat logged continuously by GPS throughout the course of the survey)

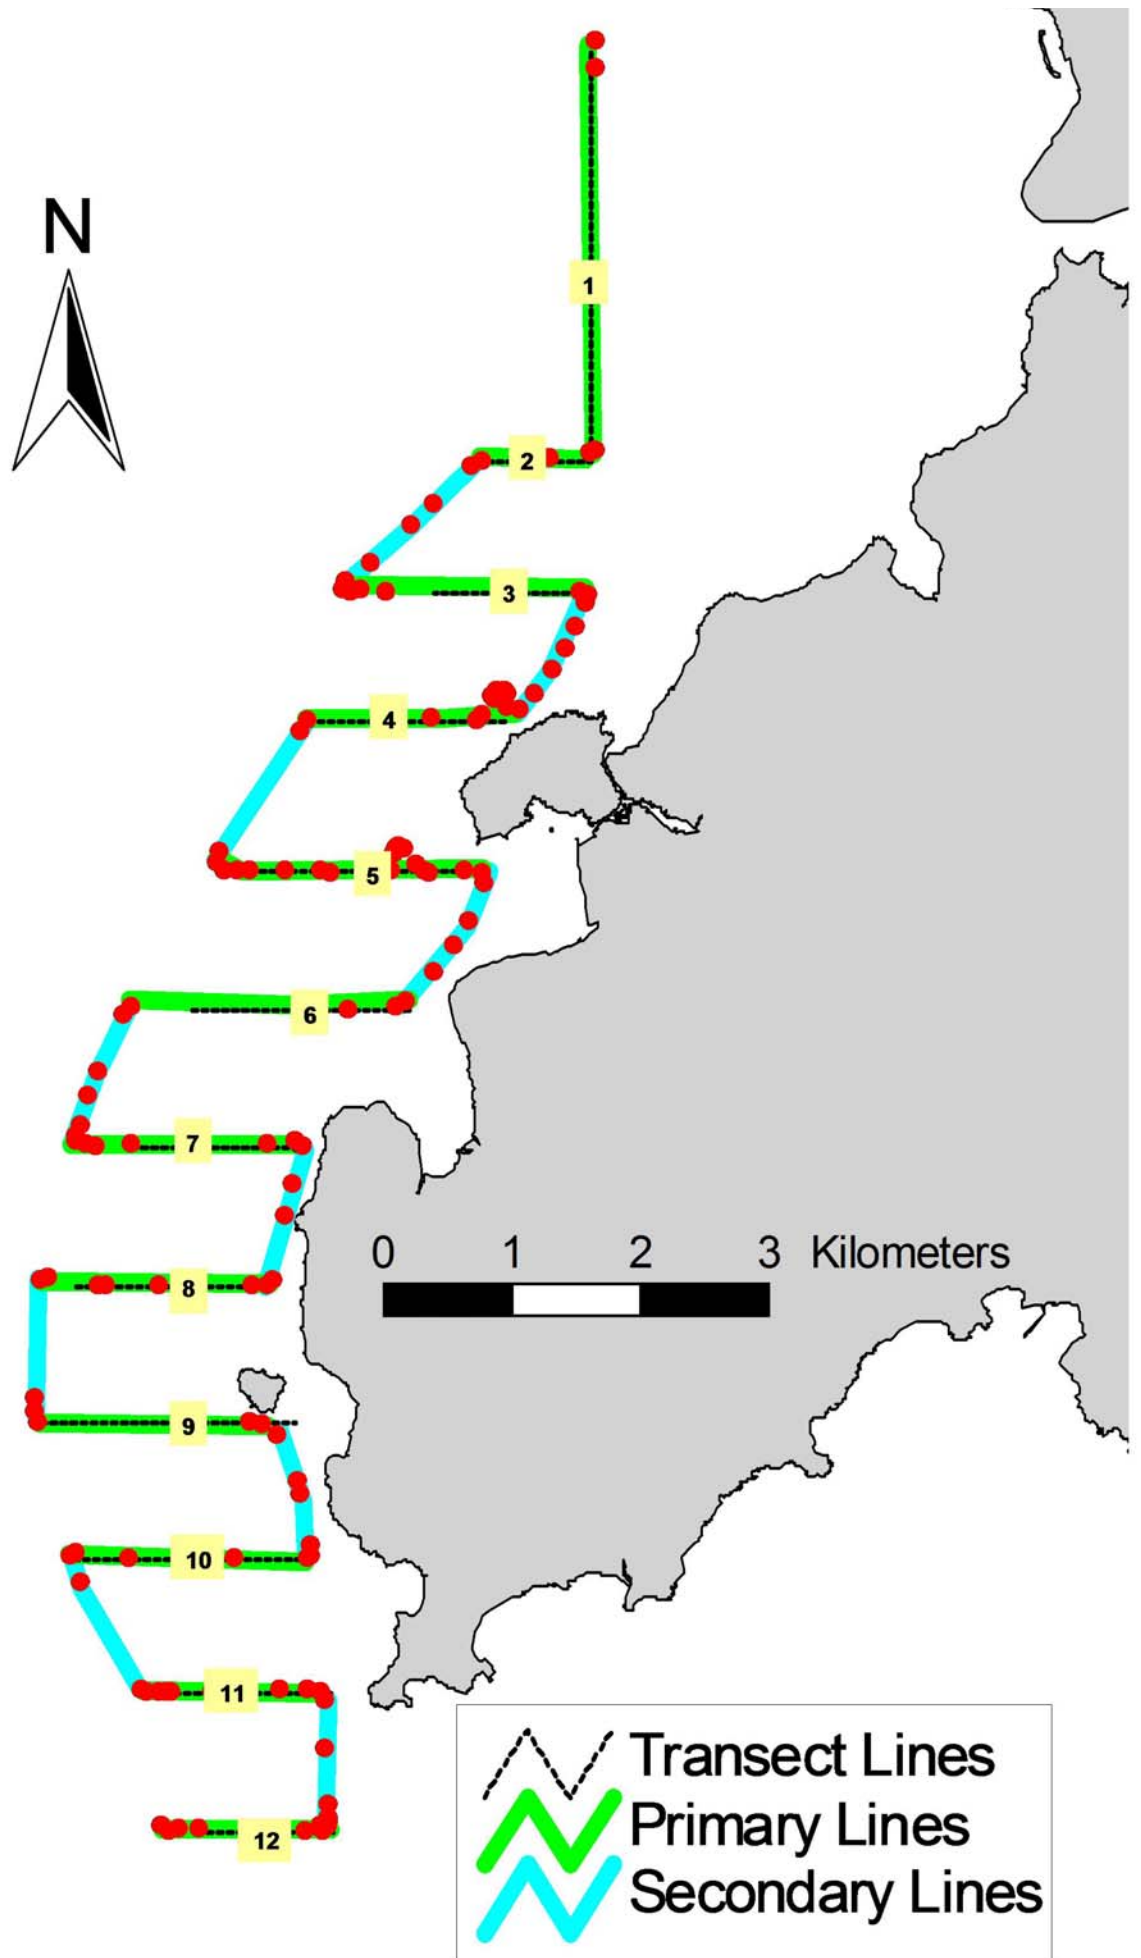
Figure 3. Survey Route on December 20th, 2013 (note: red dots represent the tracked positions of survey boat logged continuously by GPS throughout the course of the survey)

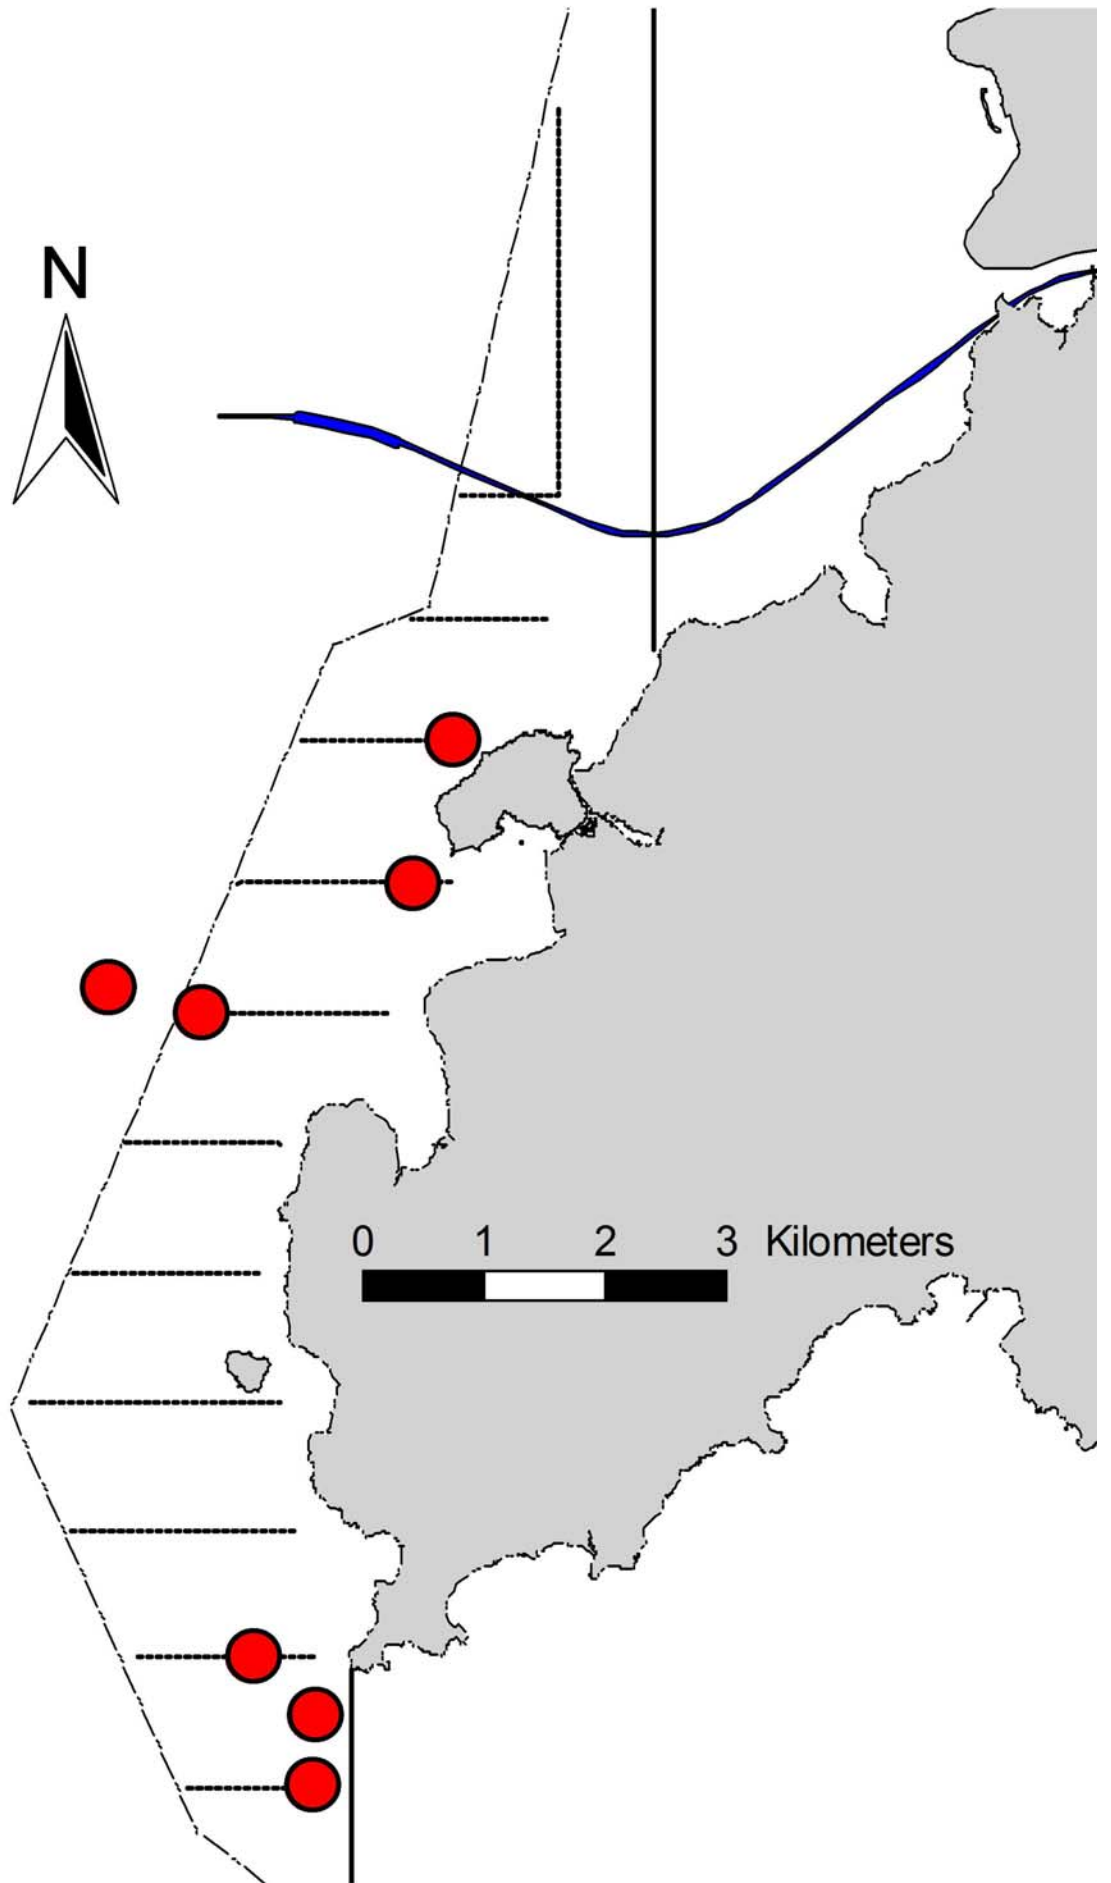
Figure 4. Distribution of Chinese White Dolphin Sighting during December 2013 HKLR09 Monitoring Surveys

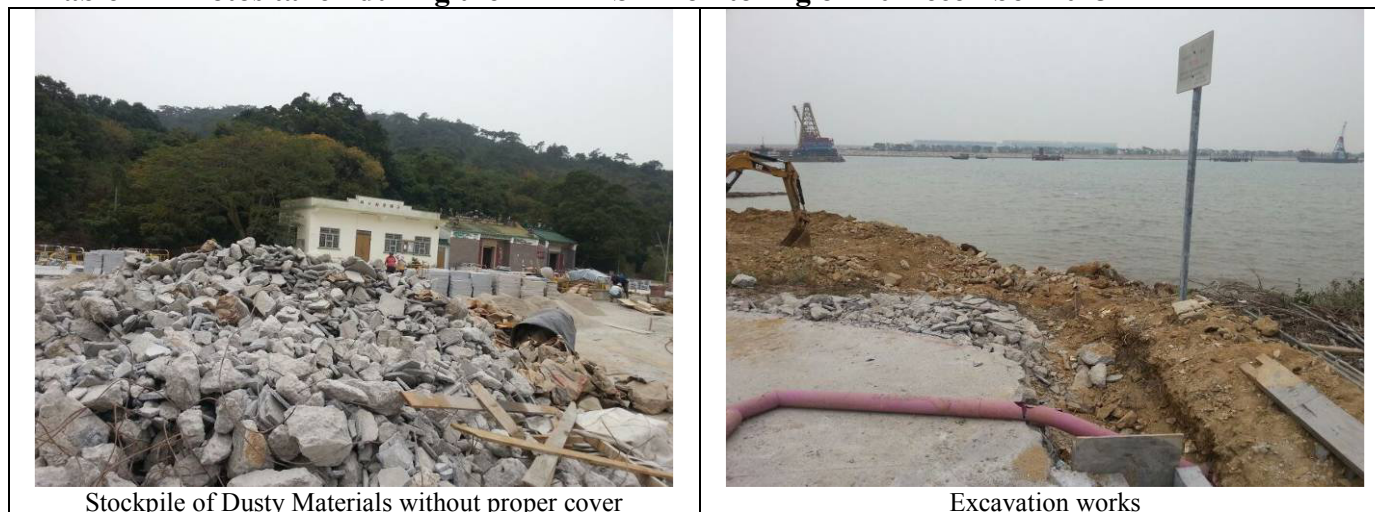
Stockpile of Dusty Materials without proper cover

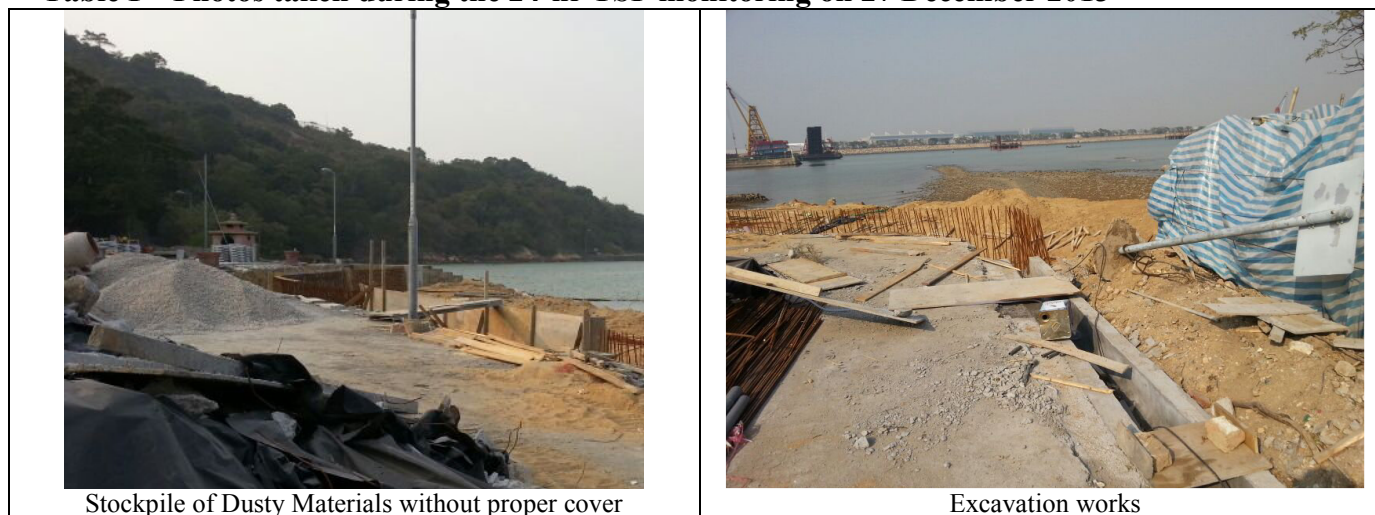
Stockpile of Dusty Materials without proper cover

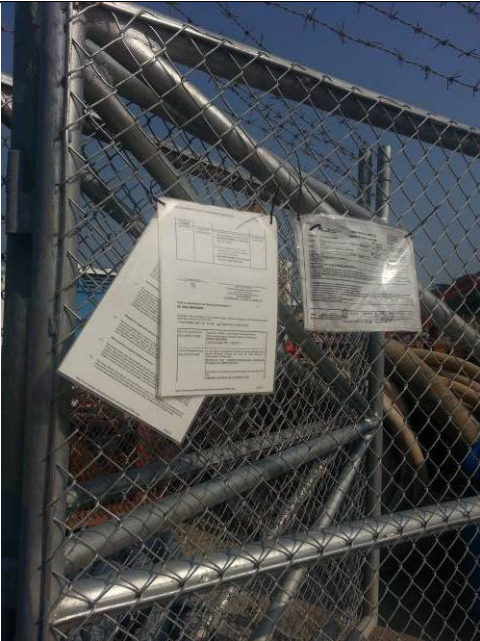
<p>Ref No: 131203-R04</p> <p>Impact: Permits/Licences (G5)</p> <p>Details: To replace the incomplete environmental permit at Portion C.</p>

Landscape & Visual Impact	N/A ⁽¹⁾	N/A ⁽¹⁾	N/A ⁽¹⁾
Permits/Licences	03/12/2013	To replace the incomplete environmental permit at Portion C.	Rectification/improvement was observed during the follow-up audit session on 10 December 2013.
Other	31/12/2013	To replace the damage banner which indicate the type of marine sediment of the barge (B22338Y).	Rectification/improvement was observed during the follow-up audit session on 7 January 2014
Cultural Heritage (Sha Lo Wan (West) Archaeological Site)	30/12/2013	N/A ⁽¹⁾	N/A ⁽¹⁾

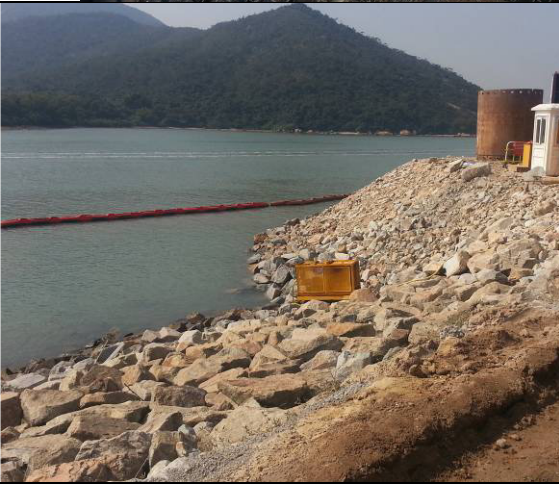
<p>Ref No: 131203-R05</p> <p>Impact: Water Quality (B21)</p> <p>Details: To remove the plant equipment which placed at near the sea at Portion A (P96).</p>

Parameters	Date	Observations and Recommendations	Follow-up
<i>Water Quality</i>	03/12/2013	To remove the plant equipment which placed at near the sea at Portion A (P96).	Rectification/improvement was observed during the follow-up audit session on 10 December 2013.
	03/12/2013	Provide mitigation measures to avoid the muddy water directly discharging to the gully at P92.	Rectification/improvement was observed during the follow-up audit session on 10 December 2013.
	10/12/2013	Clear the floating wastes insides the silt curtain at P19.	Rectification/improvement was observed during the follow-up audit session on 17 December 2013.
	10/12/2013	Clear the silt and debris at the platform at P19.	Rectification/improvement was observed during the follow-up audit session on 17 December 2013.
	17/12/2013	Insufficient wastewater treatment facilities during rainstorm were observed at Portion C. The Contractor was reminded to review the capacity of the de-silting tank to ensure the discharge is comply with discharge license.	Follow-up action was needed for the item.

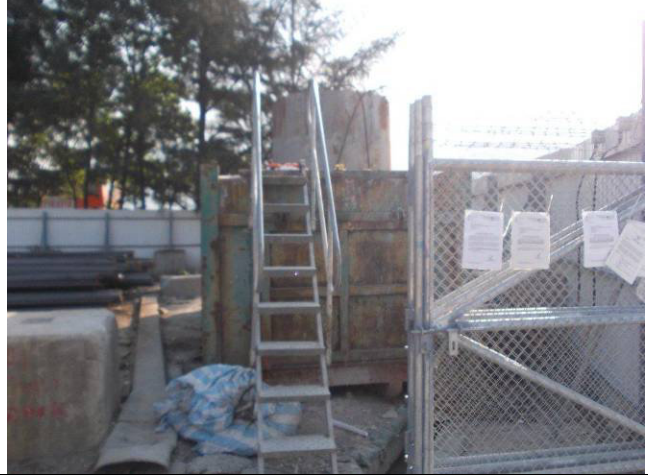
<p>Ref No: 131203-R02</p> <p>Impact: Waste/Chemical Management (F4ii.)</p> <p>Details: Clear the accumulated wastes at the waste skip at Portion C.</p> <p>Follow Up: The accumulated wastes were cleared.</p>

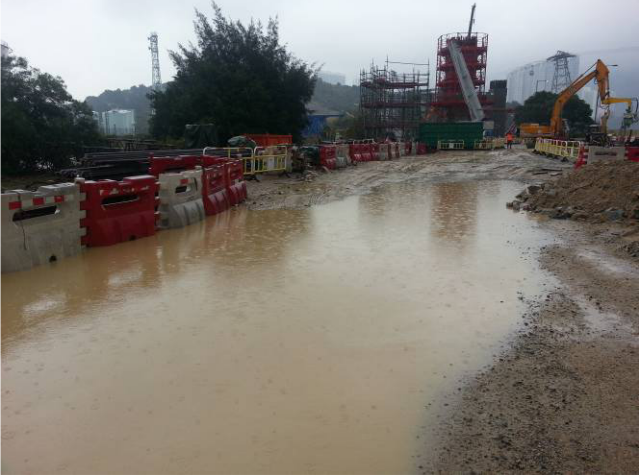
<p>Ref No: 131217-R01</p> <p>Impact: Water Quality (B3iii. & iv.)</p> <p>Details: Insufficient wastewater treatment facilities during rainstorm was observed at Portion C. The Contractor was reminded to review the capacity of the de-silting tank to ensure the discharge is comply with discharge license.</p>

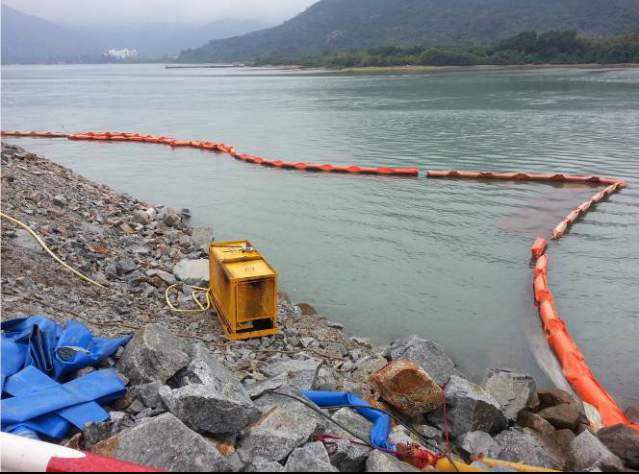
<p>Ref No: 131217-R02</p> <p>Impact: Water Quality (B21)</p> <p>Details: To remove the plant equipment which placed at near the sea at P98.</p>

17/12/2013	To remove the plant equipment which placed at near the sea at P98.	Rectification/improvement was observed during the follow-up audit session on 24 December 2013.
	17/12/2013	Properly cover the stockpile of soil at Portion C.	Rectification/improvement was observed during the follow-up audit session on 31 December 2013.
	24/12/2013	To review the capacity of sedimentation tank at Portion C.	Follow-up action was needed for the item.
	24/12/2013	To clear the wheel washing bay at Portion C.	Rectification/improvement was observed during the follow-up audit session on 31 December 2013.
	24/12/2013	To direct the silty water to sedimentation facilities before discharging out at Portion C (site exit) and Portion A (P94).	Rectification/improvement was observed during the follow-up audit session on 31 December 2013.
<i>Ecology</i>	N/A ⁽¹⁾	N/A ⁽¹⁾	N/A ⁽¹⁾
<i>Air Quality</i>	03/12/2013	Provide water spray for the breaking works at Portion C.	Rectification/improvement was observed during the follow-up audit session on 10 December 2013.

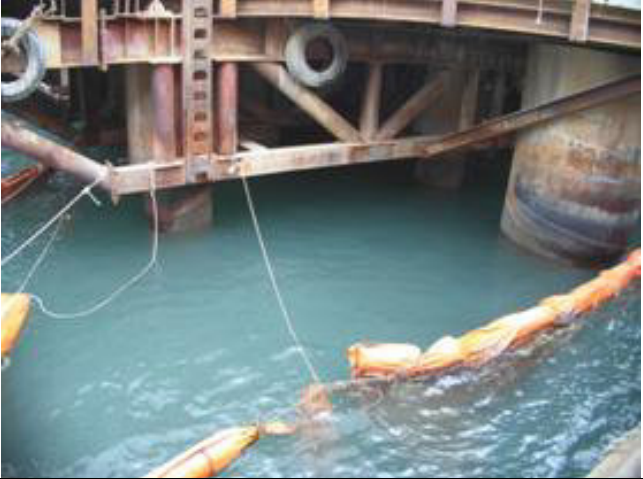
<p>Ref No: 131210-R01</p> <p>Impact: Water Quality (B21)</p> <p>Details: Clear the floating wastes insider the silt curtain at P19.</p> <p>Follow Up: The floating wastes have been cleared.</p>

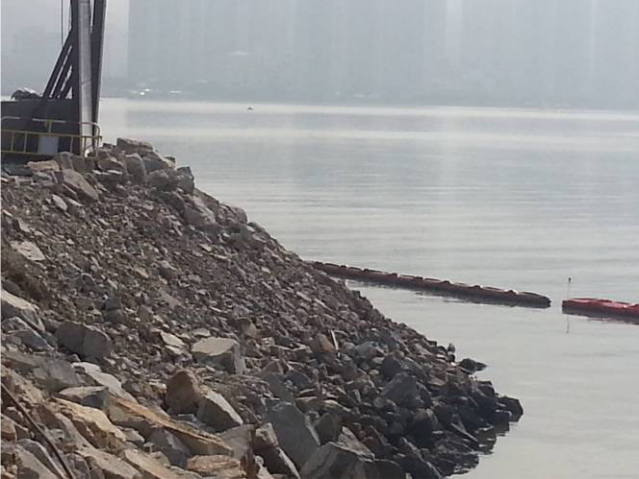
<p>Ref No: 131217-R02</p> <p>Impact: Water Quality (B21)</p> <p>Details: To remove the plant equipment which placed at near the sea at P98.</p> <p>Follow Up: The plant equipment was removed.</p>
