**Re: Agreement No. CE 48/2011 (EP)
Environmental Project Office for the
HZMB Hong Kong Link Road, HZMB Hong Kong Boundary Crossing Facilities,
and Tuen Mun-Chek Lap Kok Link – Investigation**

**Contract No. HY/2011/09 HZMB Hong Kong Link Road –
Section between HKSAR Boundary and Scenic Hill
Revised Monthly EM&A Report for February 2014 (EP-352/2009/C)**

Contract HY/2011/09
Hong Kong-Zhuhai-Macao Bridge
Hong Kong Link Road-Section between
HKSAR Boundary and Scenic Hill
Monthly EM&A Report
February 2014
(Version 1.0)

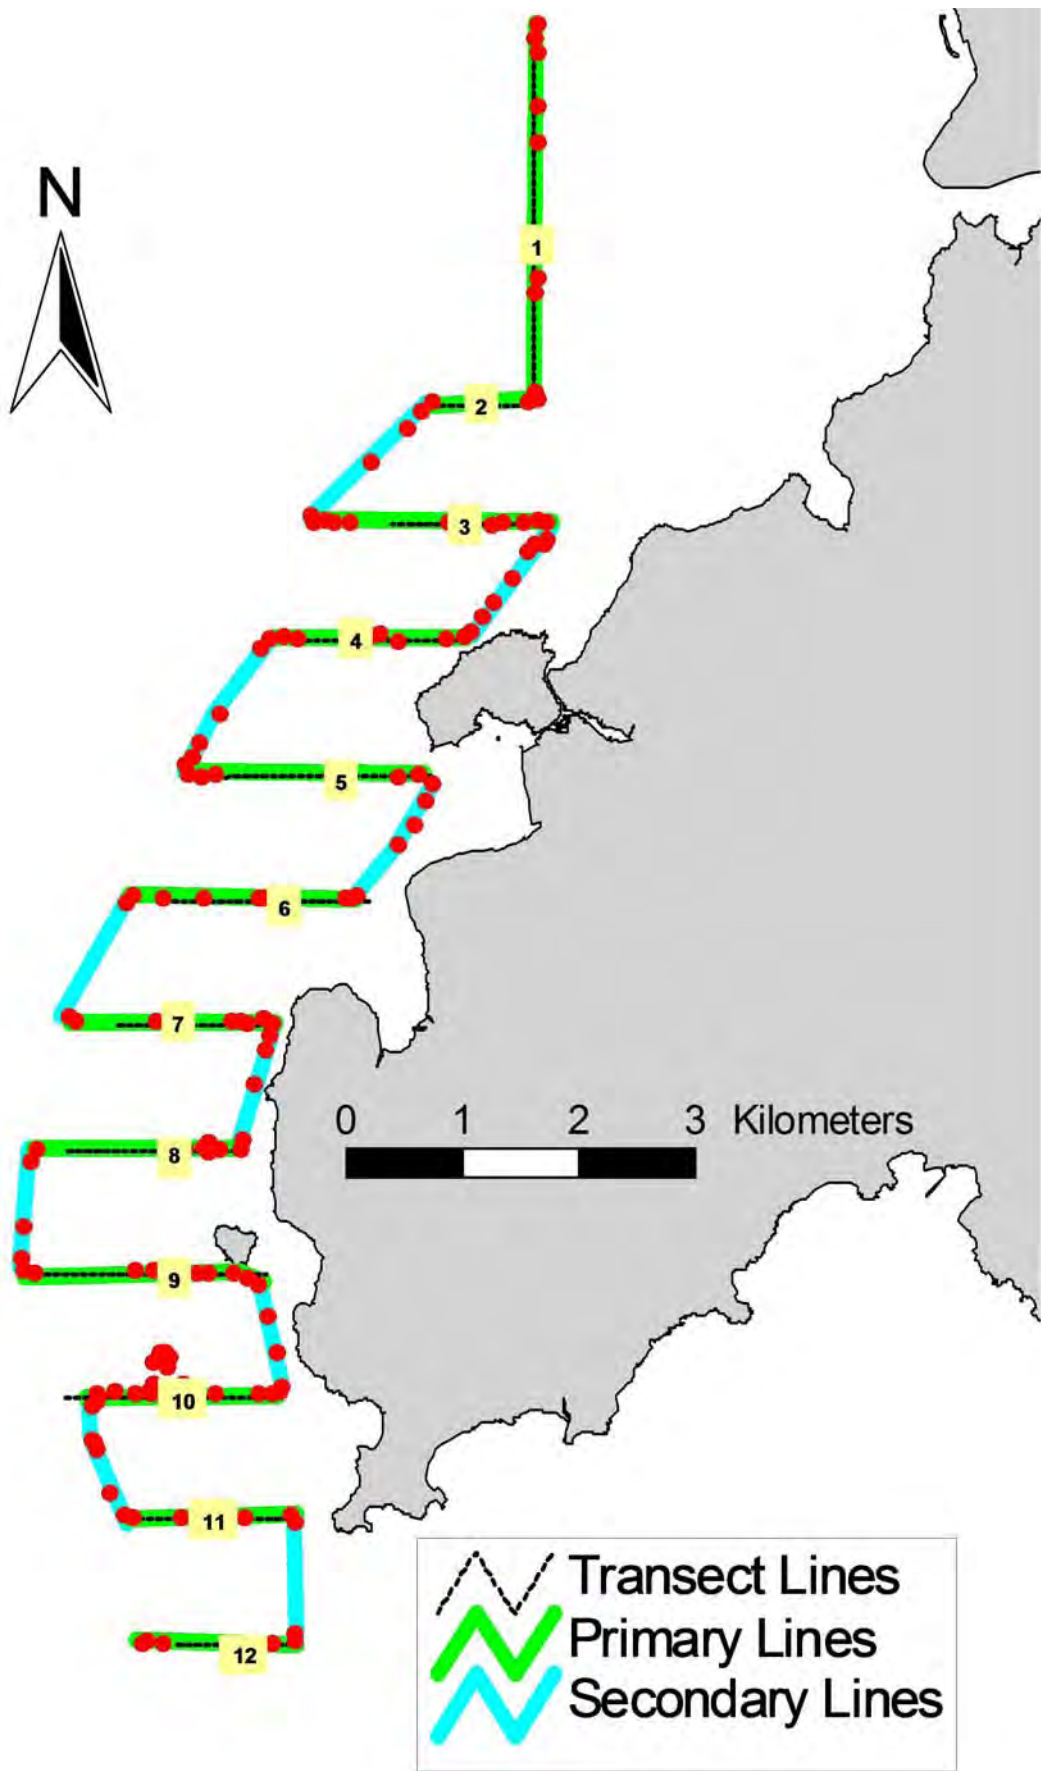
Figure 2. Survey Route on February 24th, 2014 (note: red dots represent the tracked positions of survey boat logged continuously by GPS throughout the course of the survey)

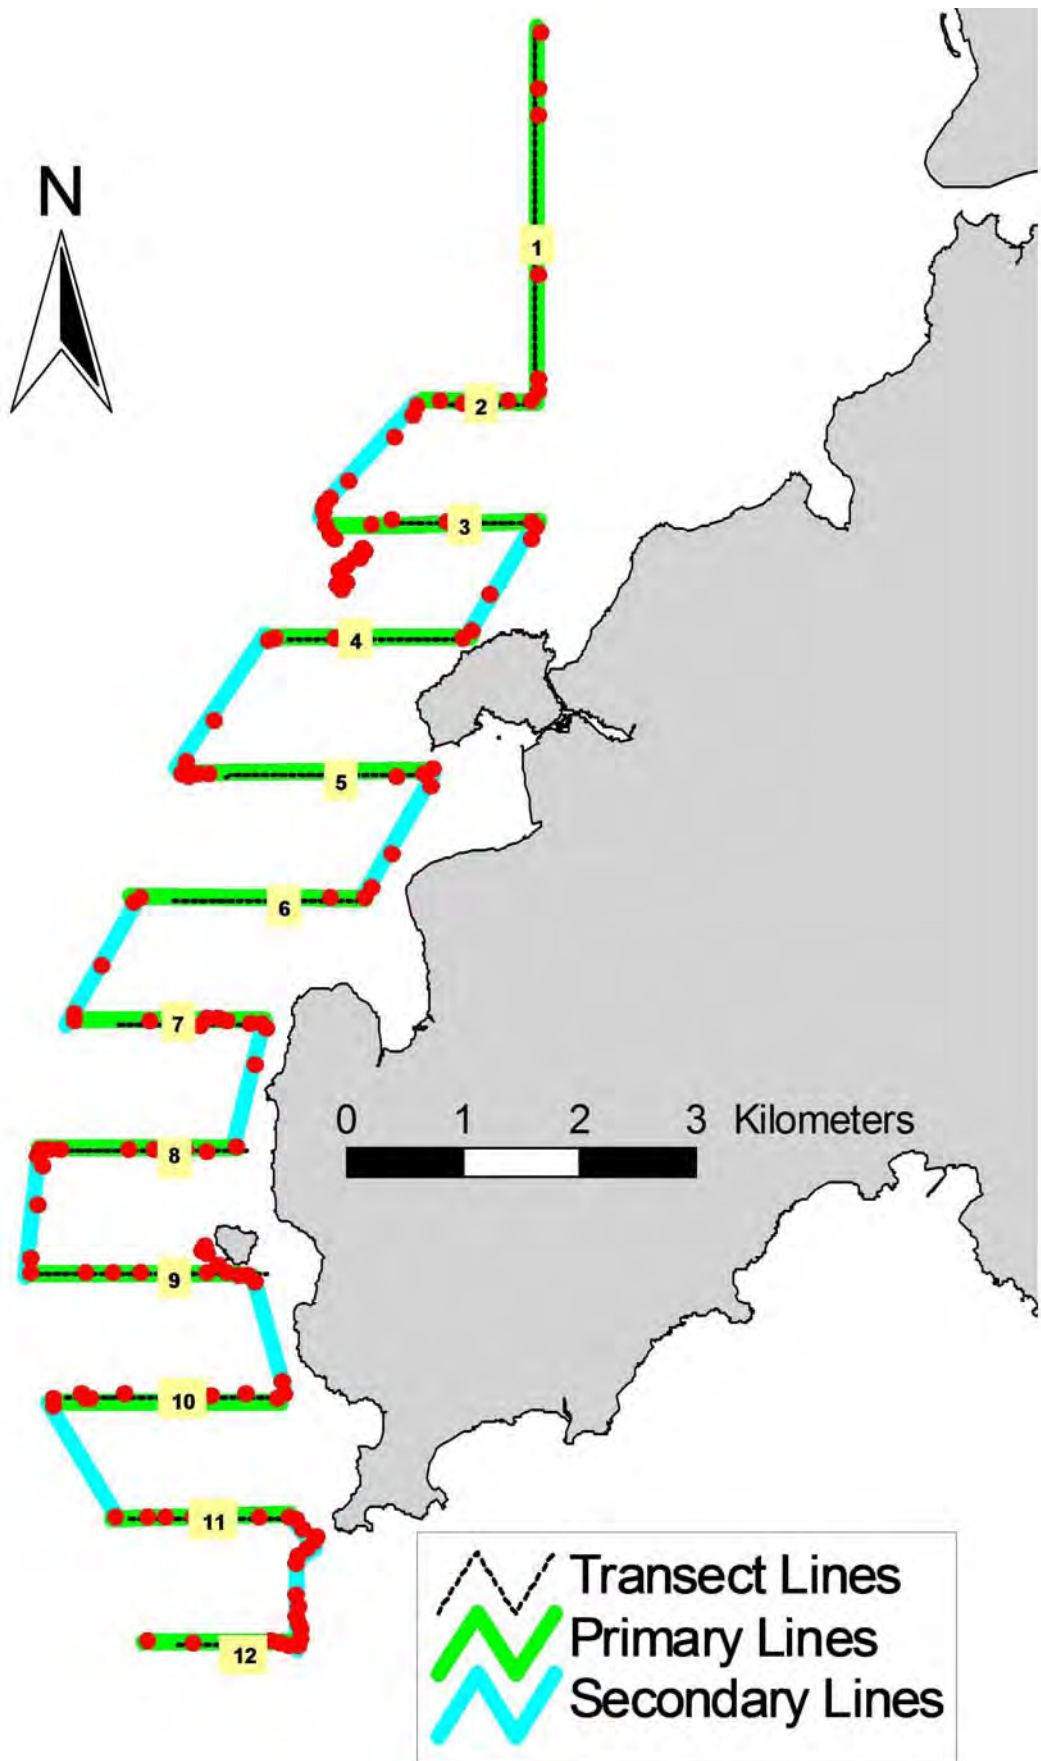
Figure 3. Survey Route on February 26th, 2014 (note: red dots represent the tracked positions of survey boat logged continuously by GPS throughout the course of the survey)

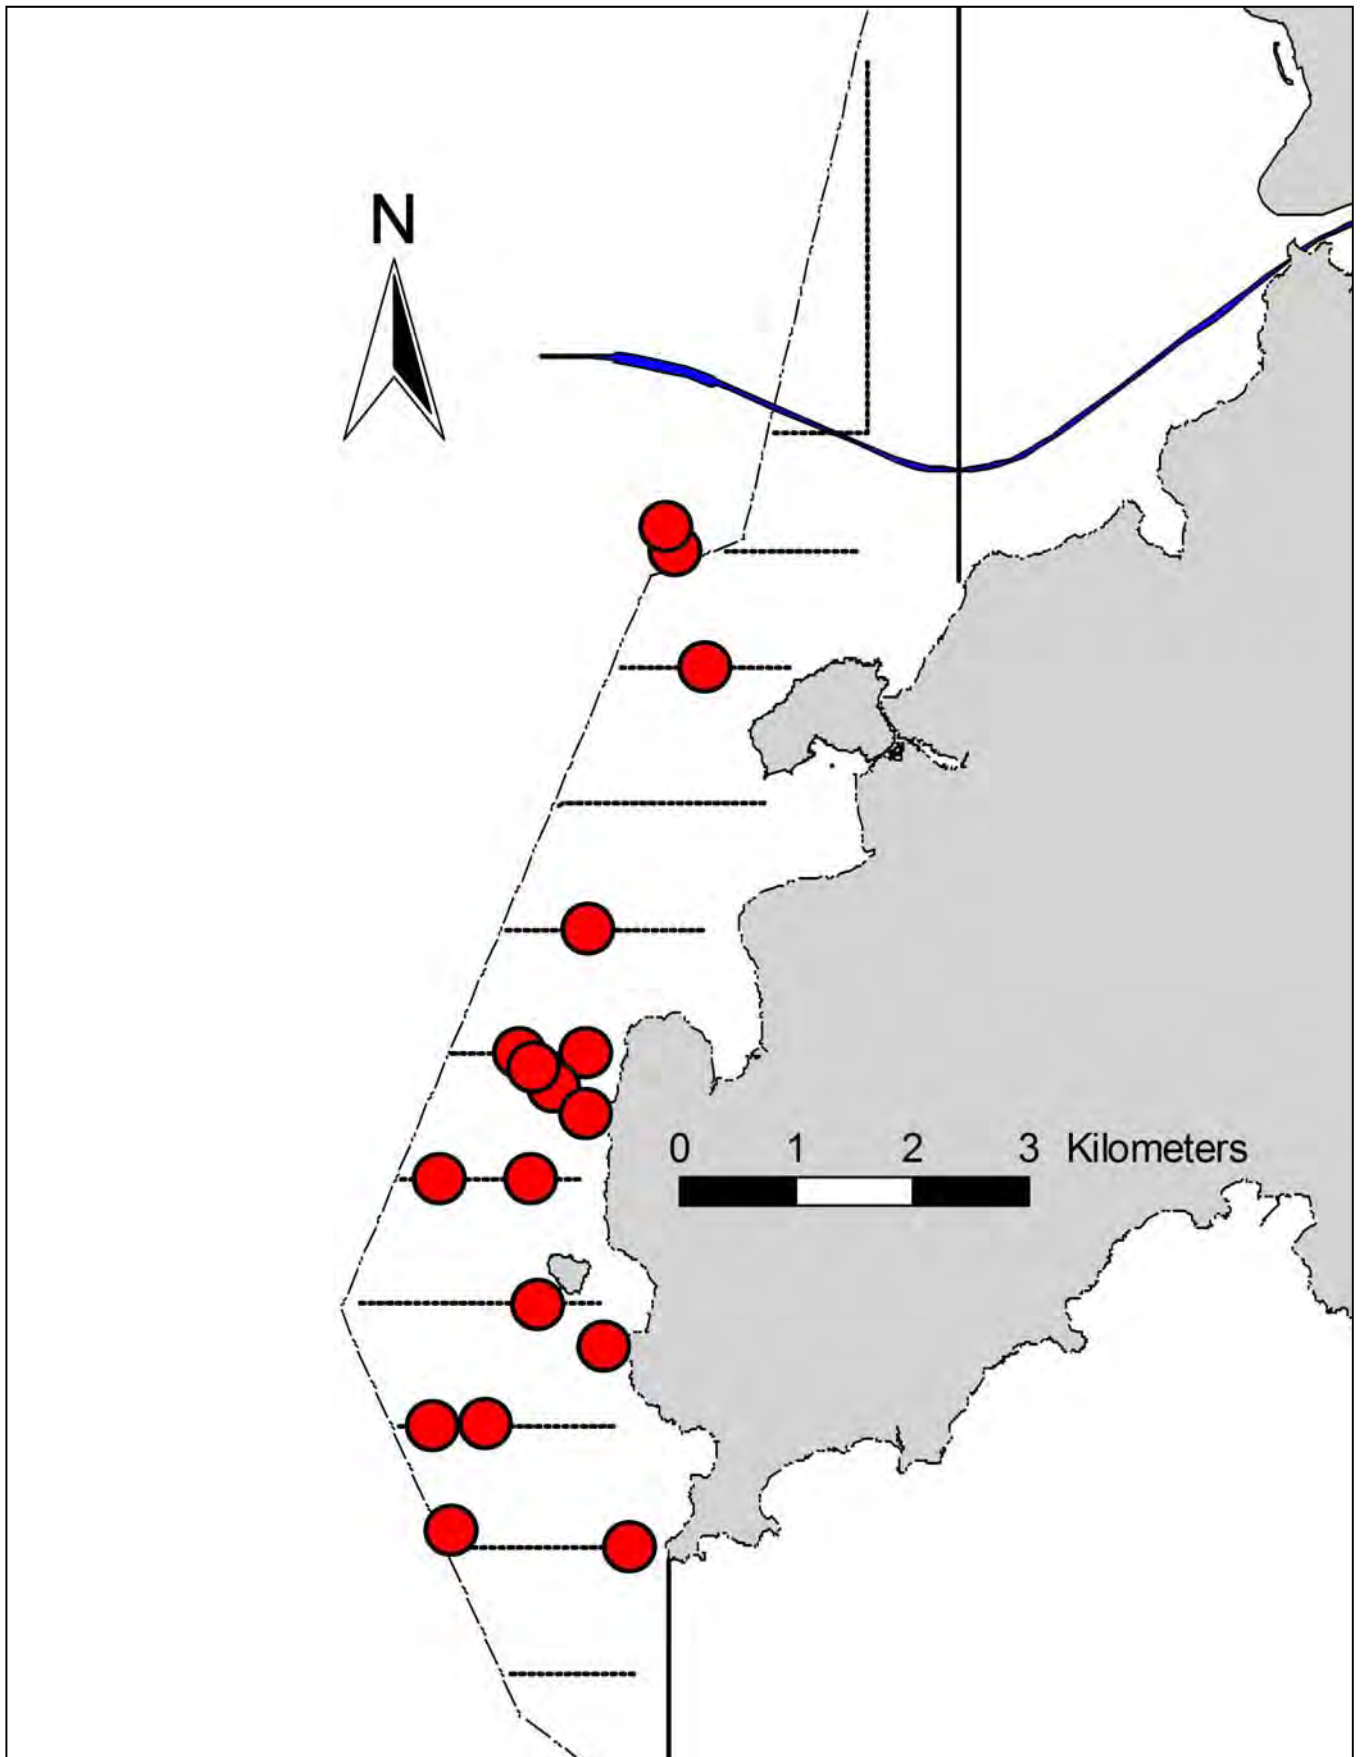
Figure 4. Distribution of Chinese White Dolphin Sighting during February 2014 HKLR09 Monitoring Surveys

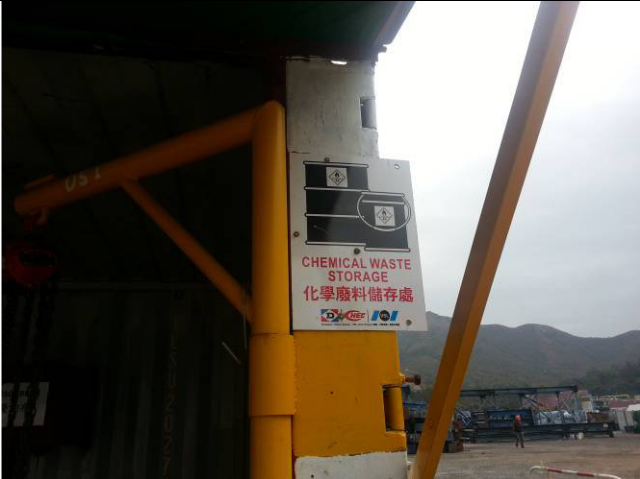
| | <p>Ref No: 140205-R01</p> <p>Impact: Waste / Chemical Management (F2i. & 2iii.)</p> <p>Details: To improve the chemical waste storage area at WA3 in accordance with code of practice on the Packaging, labeling and storage of chemical wastes.</p> |

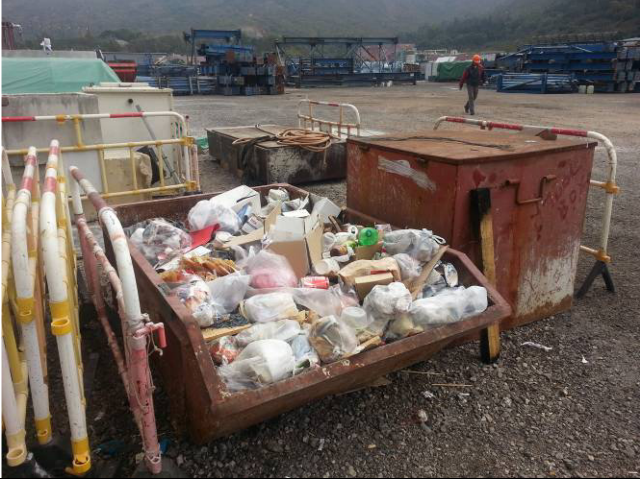
| | <p>Ref No: 140205-R02</p> <p>Impact: Air Quality(D7)</p> <p>Details: To cover the wastes skip at WA3.</p> |

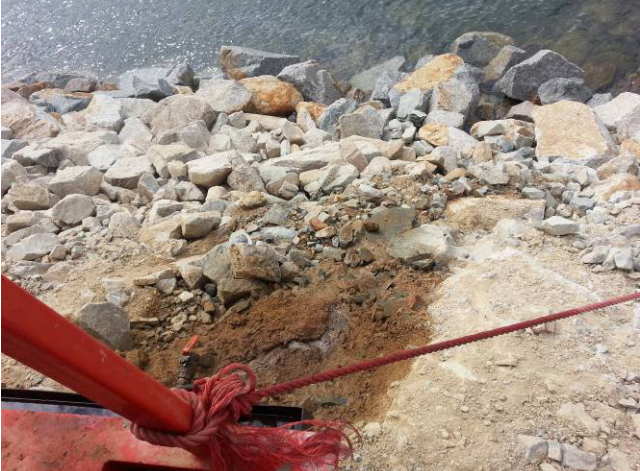
| | <p>Ref No: 140205-R03</p> <p>Impact: Waste / Chemical Management (F8)</p> <p>Details: Clear and avoid the oil leakage at P101.</p> |

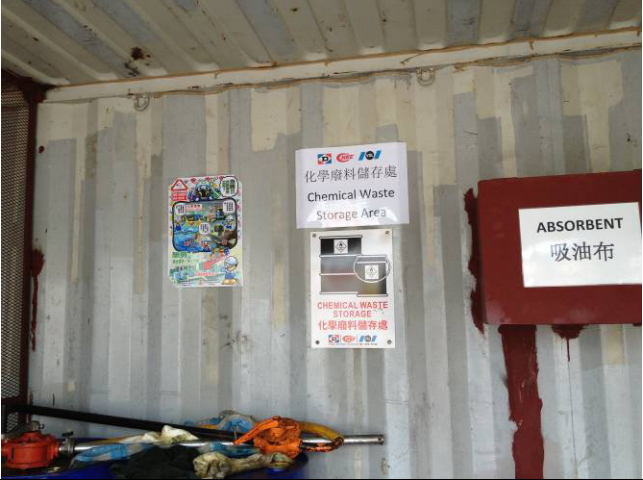
| The image shows the interior of a white metal container used for chemical waste storage. On the wall, there are several signs: a colorful warning sign on the left, a white sign with Chinese and English text '化學廢料儲存處 Chemical Waste Storage Area' in the center, and a red sign with white text 'ABSORBENT 吸油布' on the right. The floor is cluttered with various items, including what appears to be a blue container and some debris. | <p>Ref No: 140205-R01</p> <p>Impact: Waste / Chemical Management (F2i. & 2iii.)</p> <p>Details: To improve the chemical waste storage area at WA3 in accordance with code of practice on the Packaging, labeling and storage of chemical wastes.</p> <p>Follow Up: The chemical waste storage area at WA3 was improved in accordance with code of practice on the Packaging, labeling and storage of chemical wastes.</p> |

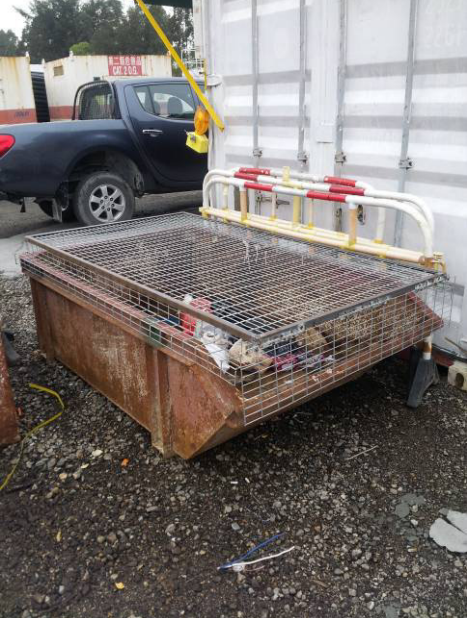
| The image shows a large, rectangular metal waste skip with a mesh top and a metal frame. It is situated outdoors on a gravel surface. In the background, a dark-colored pickup truck is parked, and a white container is visible. The skip appears to be used for collecting and transporting waste. | <p>Ref No: 140205-R02</p> <p>Impact: Air Quality(D7)</p> <p>Details: To cover the wastes skip at WA3.</p> <p>Follow Up: The accumulated wastes were cleared and the waste skip was covered.</p> |

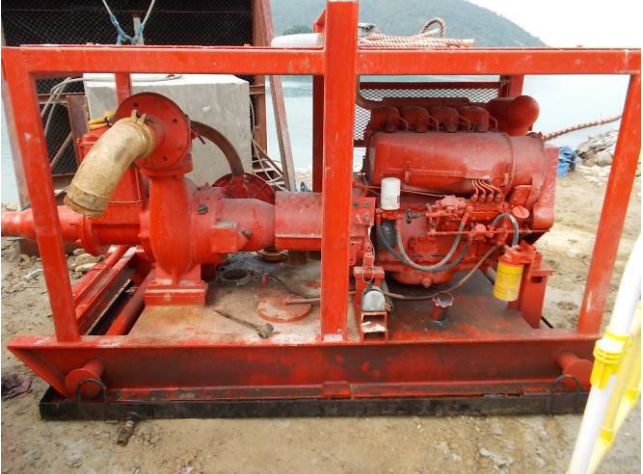
| The image shows a red industrial pump or engine mounted on a metal frame. It has various pipes, hoses, and a large cylindrical tank. The equipment is situated outdoors on a dirt or gravel surface. The red color is prominent, and the overall appearance is that of a heavy-duty piece of machinery. | <p>Ref No: 140205-R03</p> <p>Impact: Waste / Chemical Management (F8)</p> <p>Details: Clear and avoid the oil leakage at P101.</p> <p>Follow Up: No further oil leakage was observed.</p> |

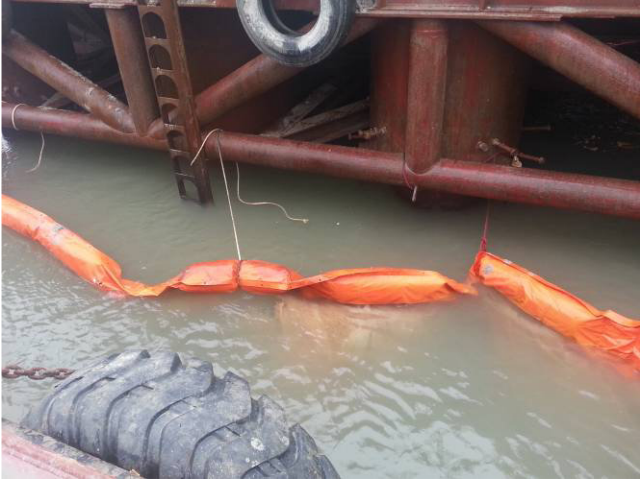
| | <p>Ref No: 140218-R01</p> <p>Impact: Water Quality (B25)</p> <p>Details: To repair the silt curtain at P36.</p> |

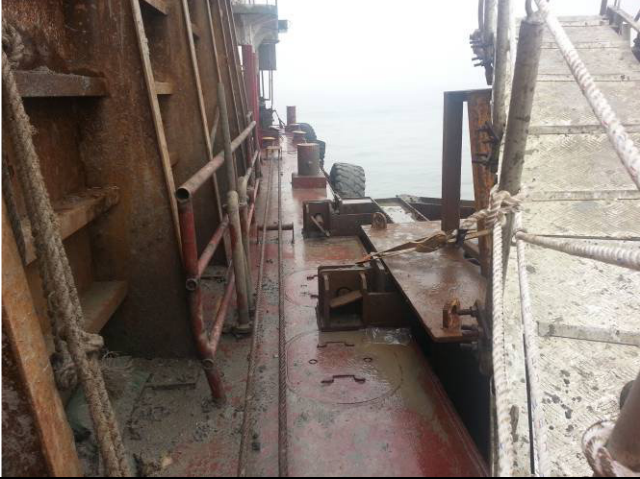
| | <p>Ref No: 140218-R02</p> <p>Impact: Water Quality (B20)</p> <p>Details: Provide sand bag bund at the barge to avoid leaking muddy water to the sea at P36.</p> |

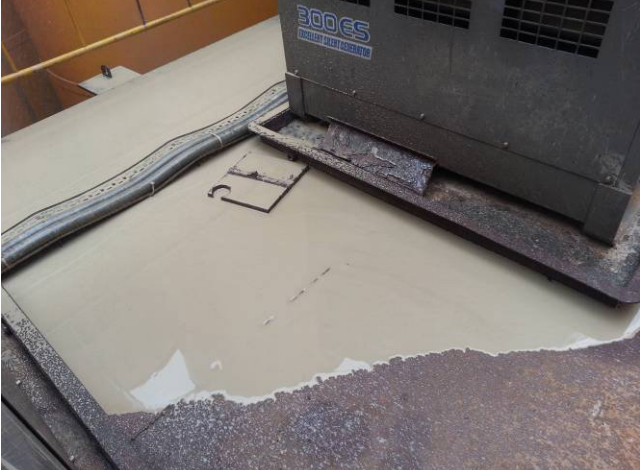
| | <p>Ref No: 140218-R03</p> <p>Impact: Water Quality (B22)</p> <p>Details: Clear the leakage of muddy water at near the silo at P36.</p> |

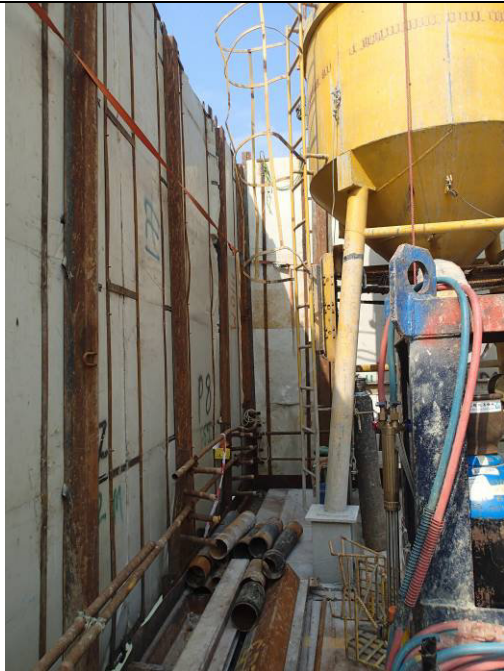
| | <p>Ref No: 140211-O01</p> <p>Impact: Noise (E7)</p> <p>Details: Part of the noise barrier was damaged at P18. The Contractor was reminded to repair it before the commencement of construction works during the restricted hours.</p> <p>Follow Up: The noise barrier was repaired.</p> |

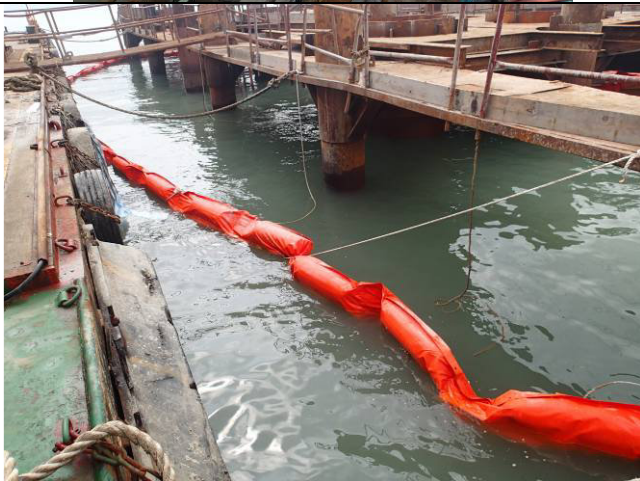
| | <p>Ref No: 140211-R02</p> <p>Impact: Water Quality(B21 & 25)</p> <p>Details: To repair the silt curtain and clear the polystyrene granule at P57.</p> <p>Follow Up: The silt curtain was repaired and the polystyrene granule was cleared.</p> |

| Parameters | Date | Observations and Recommendations | Follow-up |
|--|---|---|--|
| | 11/02/2014 | To repair the silt curtain and clear the polystyrene granule at P57. | Rectification/improvement was observed during the follow-up audit session on 18 February 2014. |

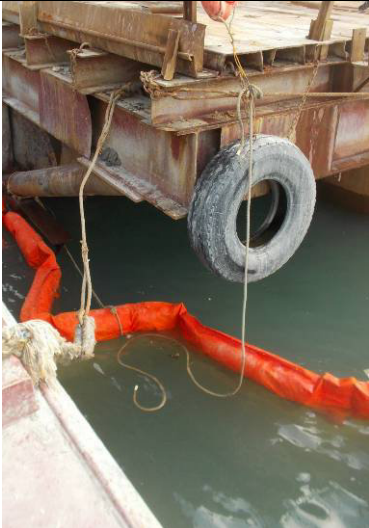
| | <p>Ref No: 140218-R01</p> <p>Impact: Water Quality (B25)</p> <p>Details: To repair the silt curtain at P36.</p> <p>Follow Up: The silt curtain was repaired.</p> |

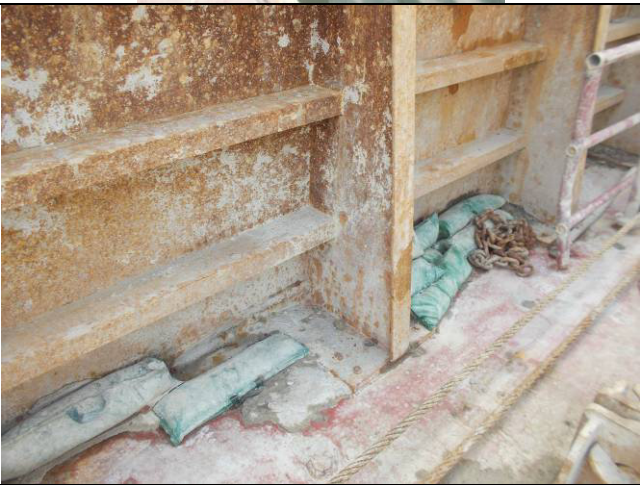
| | <p>Ref No: 140218-R02</p> <p>Impact: Water Quality (B20)</p> <p>Details: Provide sand bag bund at the barge to avoid leaking muddy water to the sea at P36.</p> <p>Follow Up: Sand bag bund was provided.</p> |

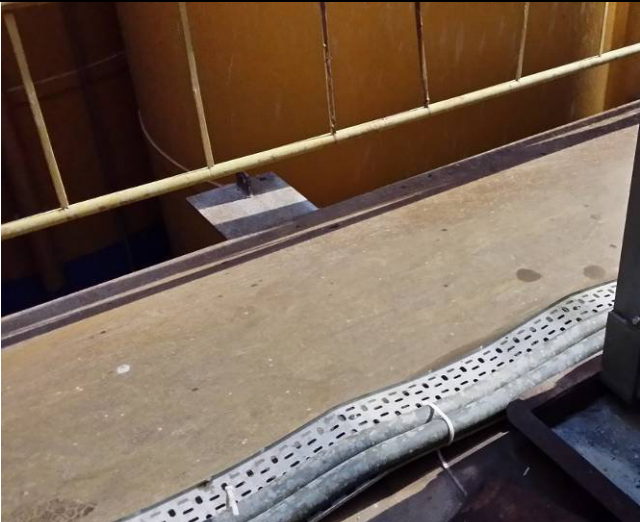
| | <p>Ref No: 140218-R03</p> <p>Impact: Water Quality (B22)</p> <p>Details: Clear the leakage of muddy water at near the silo at P36.</p> <p>Follow Up: Leakage of muddy water was cleared.</p> |
