HyD Contract No. HY/2011/09 Hong Kong-Zhuhai-Macao Bridge Hong Kong Link Road – Section between HKSAR Boundary and Scenic Hill Submission under Environmental Permit (EP-352/2009/C - Condition 4.4) Monthly EM&A Report – March 2014

Contract No. HY/2011/09 HZMB Hong Kong Link Road – Section between HKSAR Boundary and Scenic Hill Revised Monthly EM&A Report for March 2014 (EP-352/2009/C)

Title Contract HY/2011/09 Hong Kong-Zhuhai-Macao Bridge
Hong Kong Link Road-Section between
HKSAR Boundary and Scenic Hill
Graphical Presentation of Water Quality Monitoring
Results

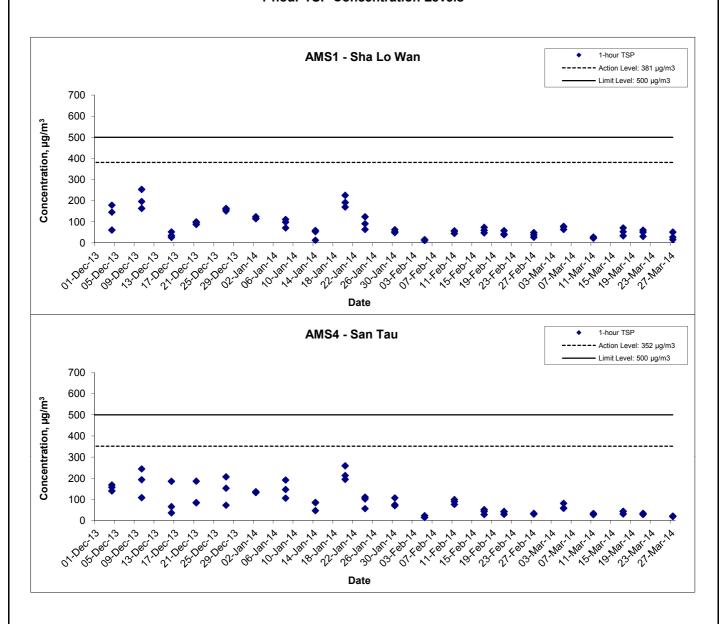
1-hour TSP Concentration Levels

Title Contract No. HY/2011/09
Hong Kong-Zhuhai-Macao Bridge Hong Kong Link Road –
Section between HKSAR Boundary and Scenic Hill
Graphical Presentation of 1-hour TSP Monitoring Results

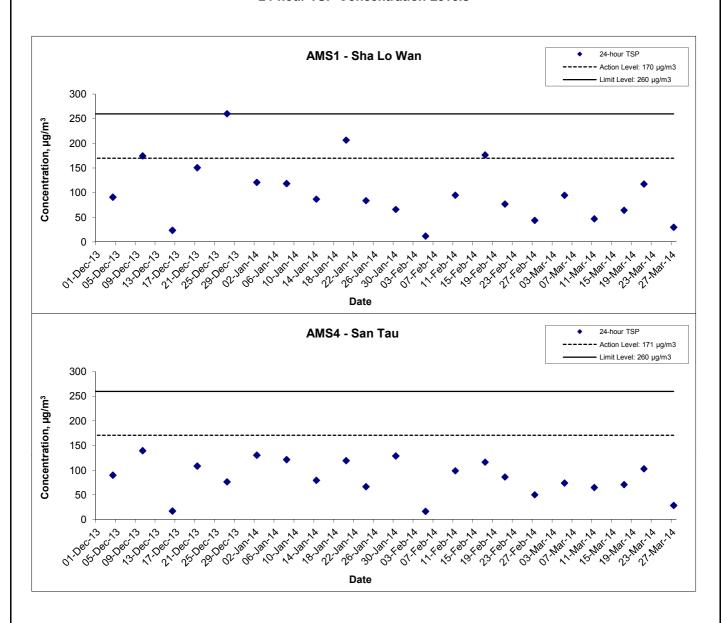
24-hour TSP Concentration Levels

Title Contract No. HY/2011/09
Hong Kong-Zhuhai-Macao Bridge Hong Kong Link Road –
Section between HKSAR Boundary and Scenic Hill
Graphical Presentation of 24-hour TSP Monitoring Results

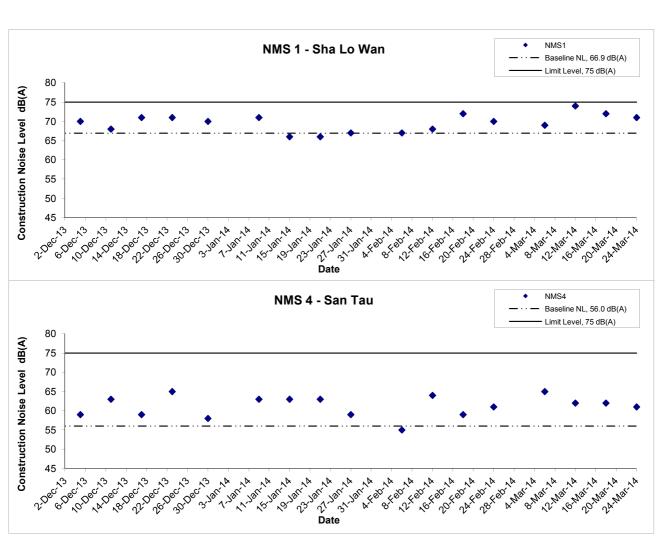
Noise Levels

Title Contract HY/2011/09 Hong Kong-Zhuhai-Macao Bridge
Hong Kong Link Road-Section between
HKSAR Boundary and Scenic Hill
Graphical Presentation of Construction Noise Monitoring
Results

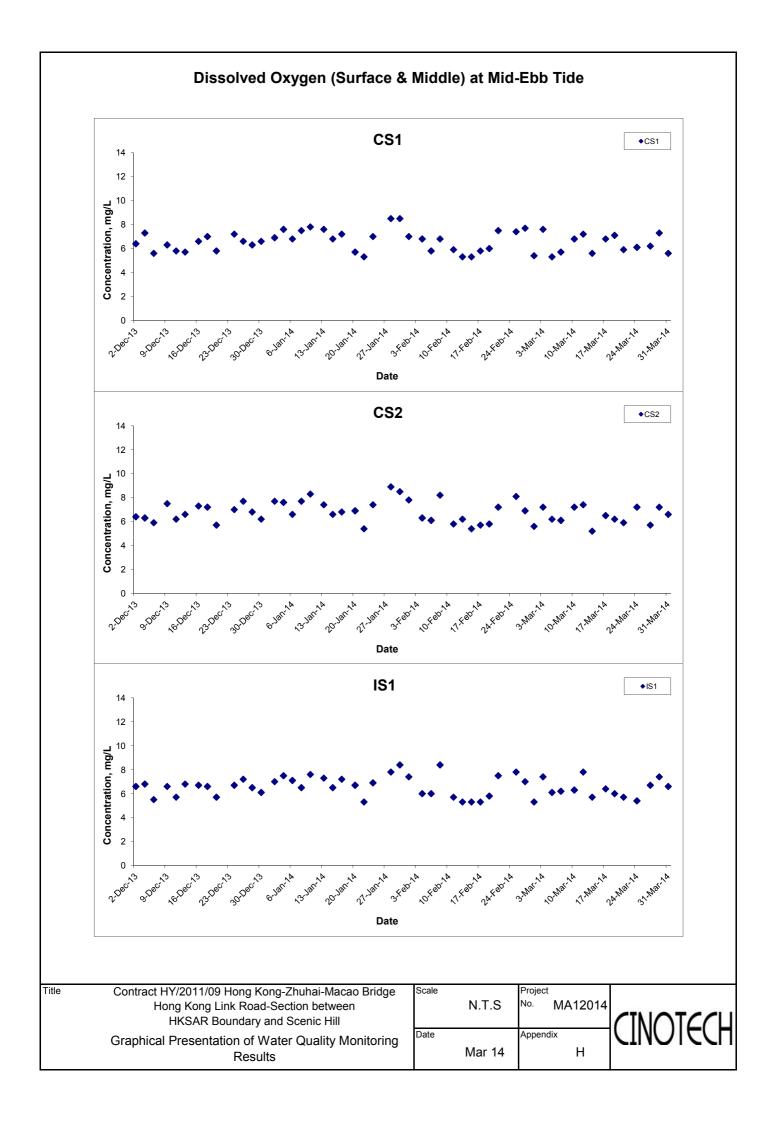
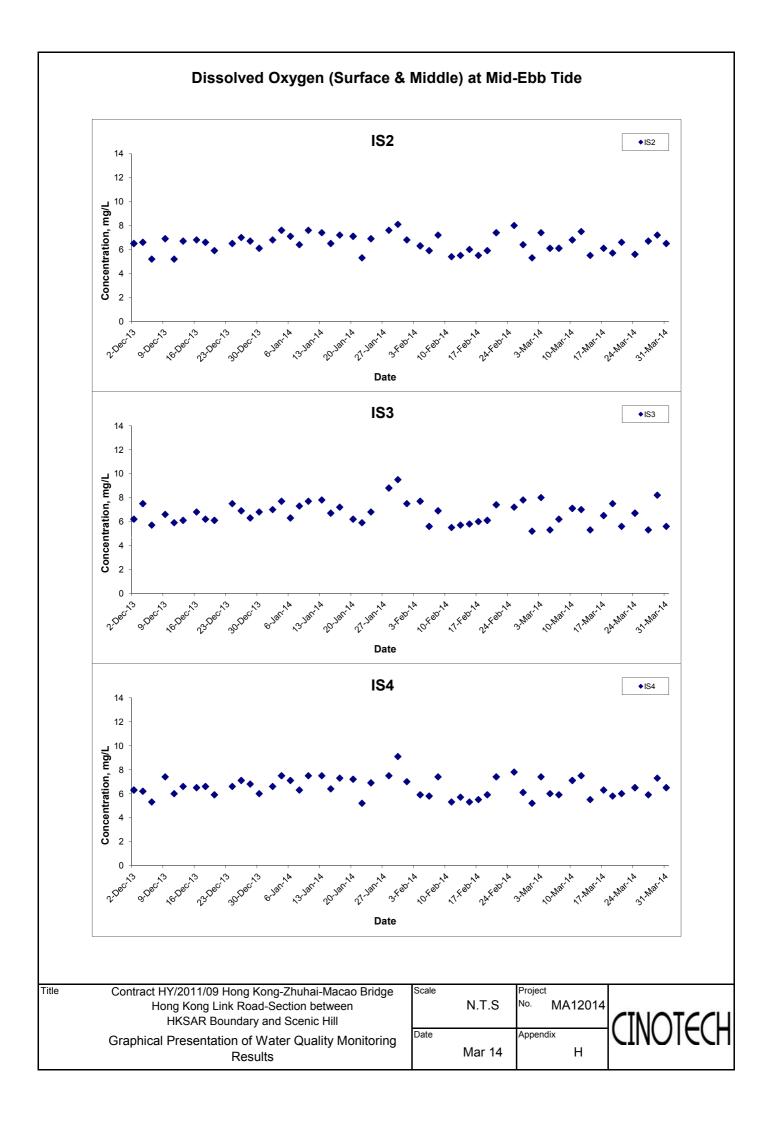
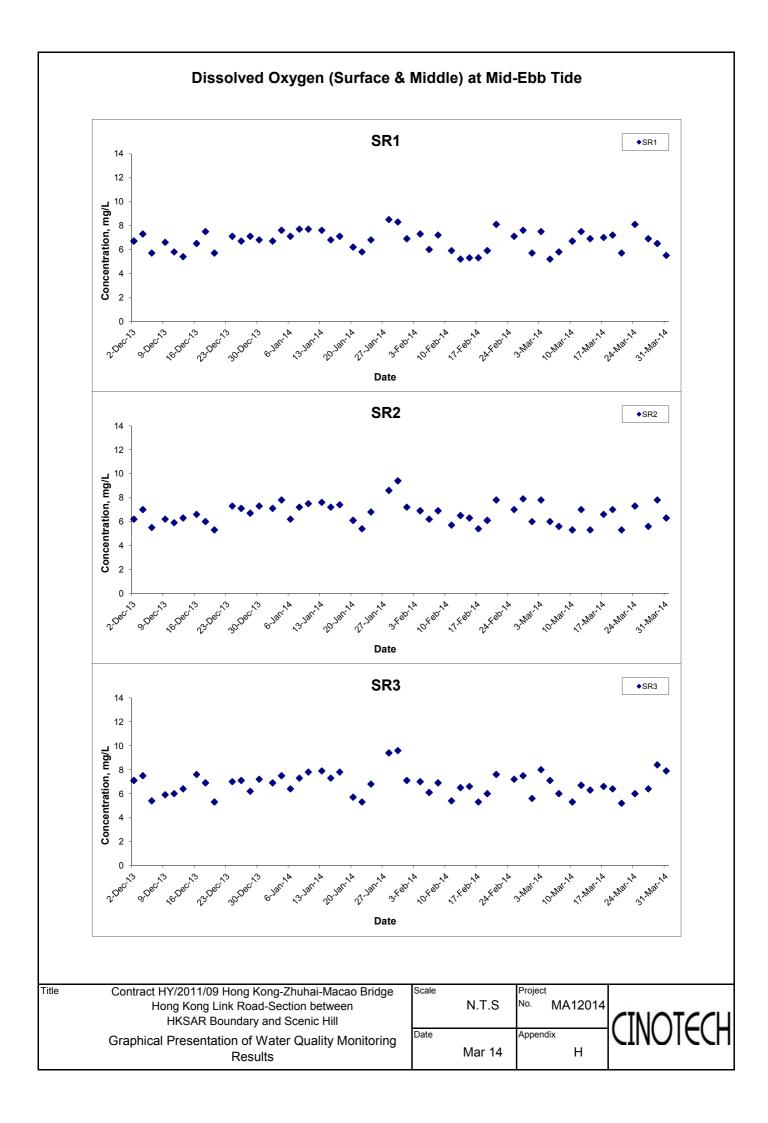
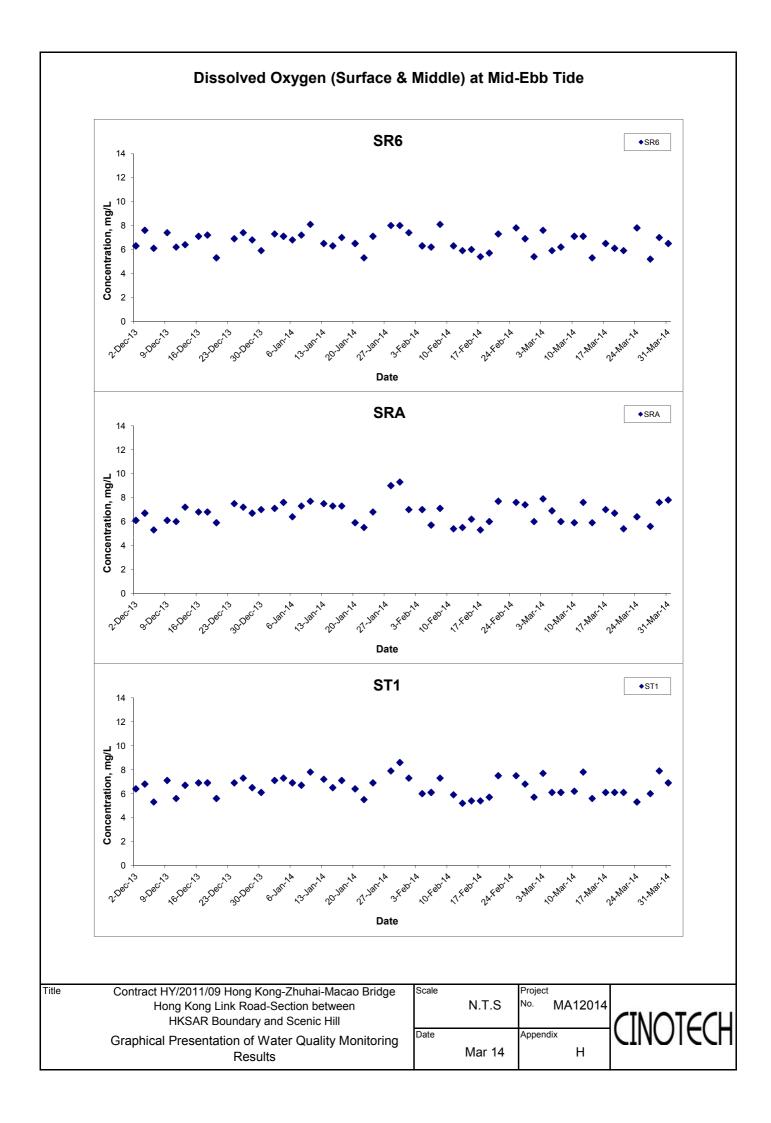
Dissolved Oxygen (Surface & Middle) at Mid-Ebb Tide

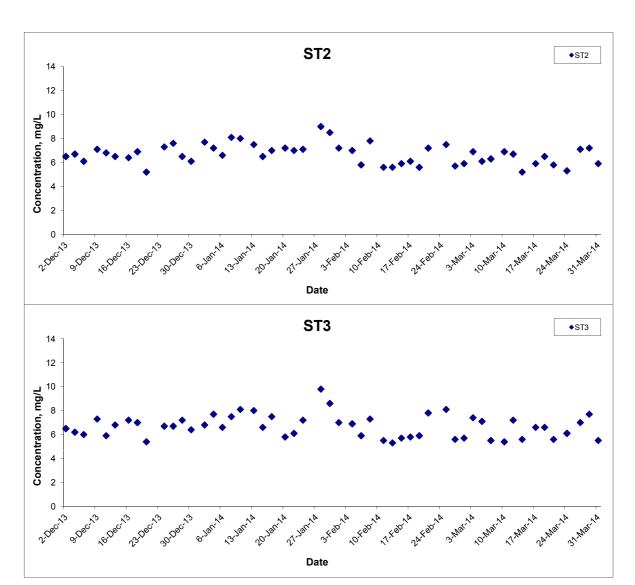
Dissolved Oxygen (Surface & Middle) at Mid-Flood Tide

Contract HY/2011/09 Hong Kong-Zhuhai-Macao Bridge
Hong Kong Link Road-Section between
HKSAR Boundary and Scenic Hill
Graphical Presentation of Water Quality Monitoring
Results

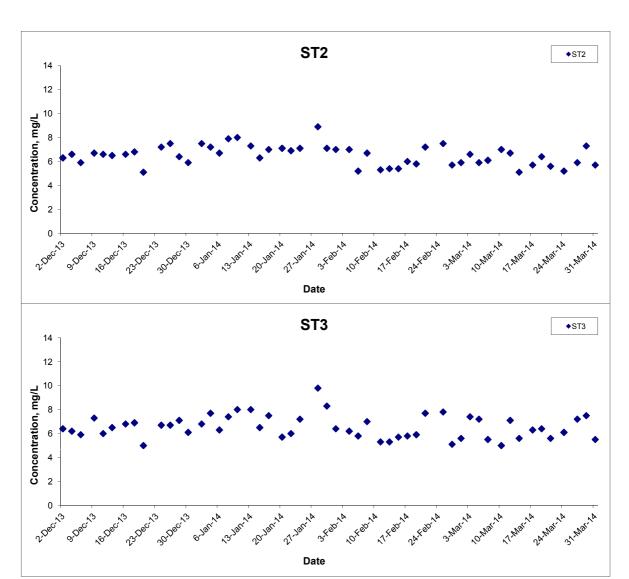
Dissolved Oxygen (Bottom) at Mid-Flood Tide

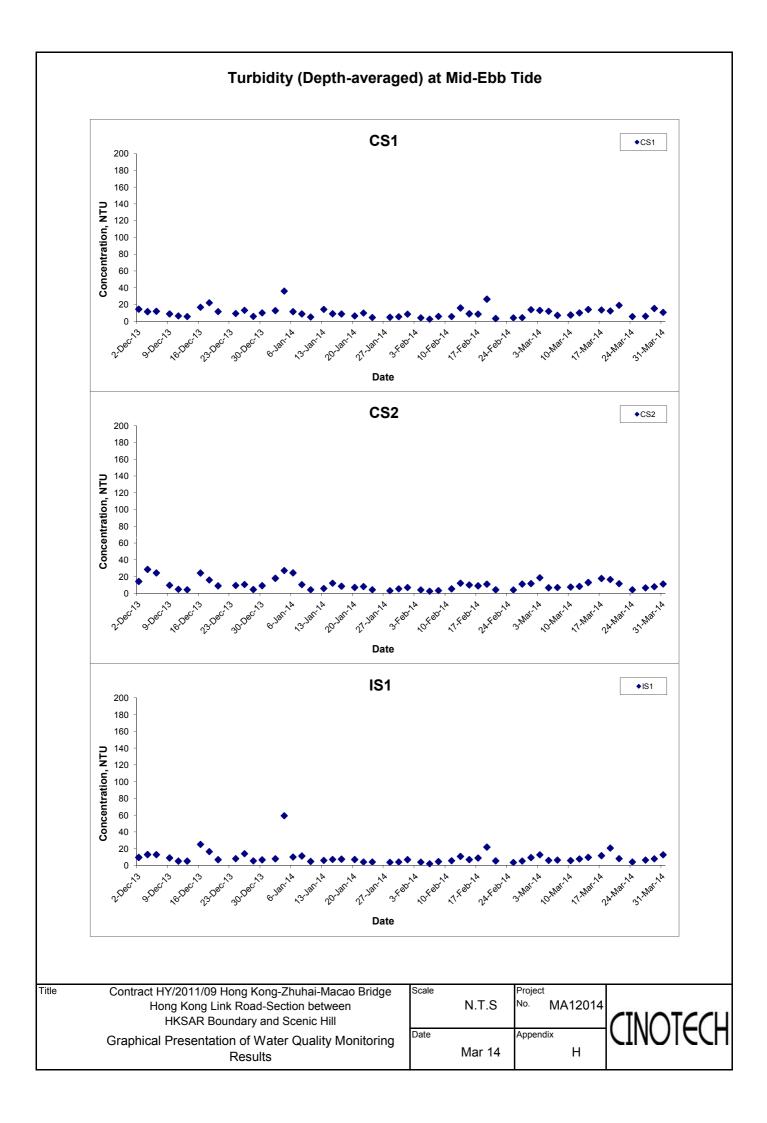
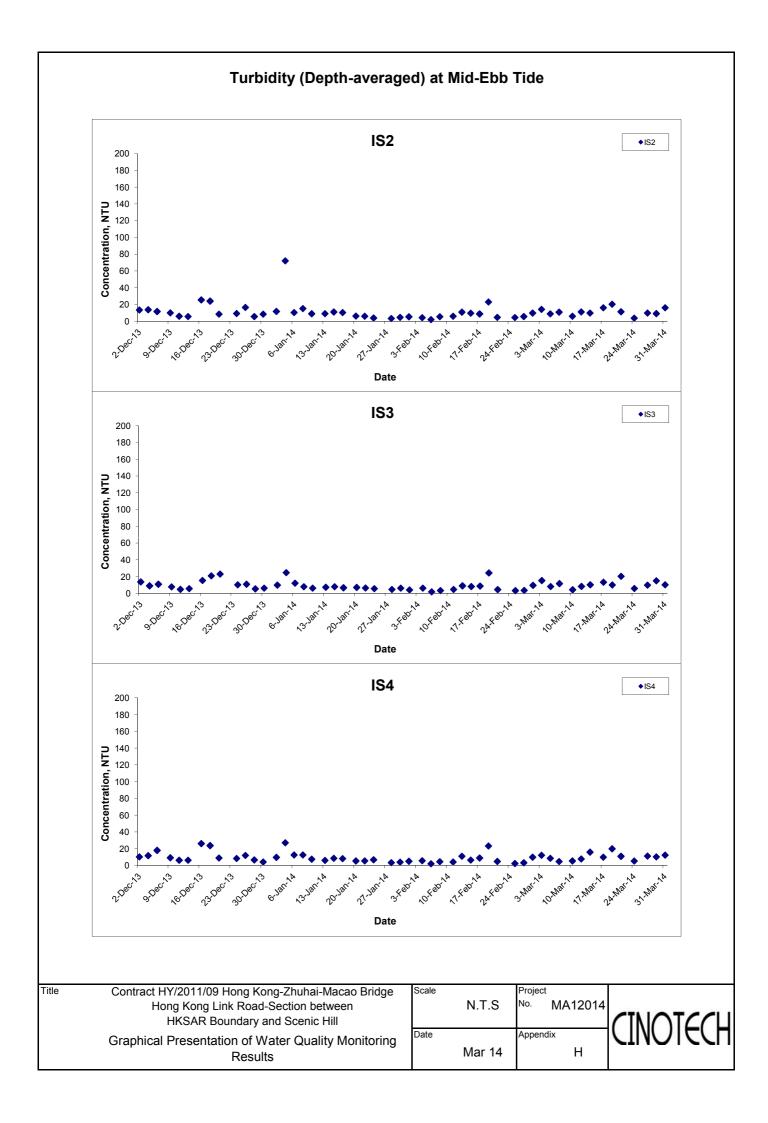
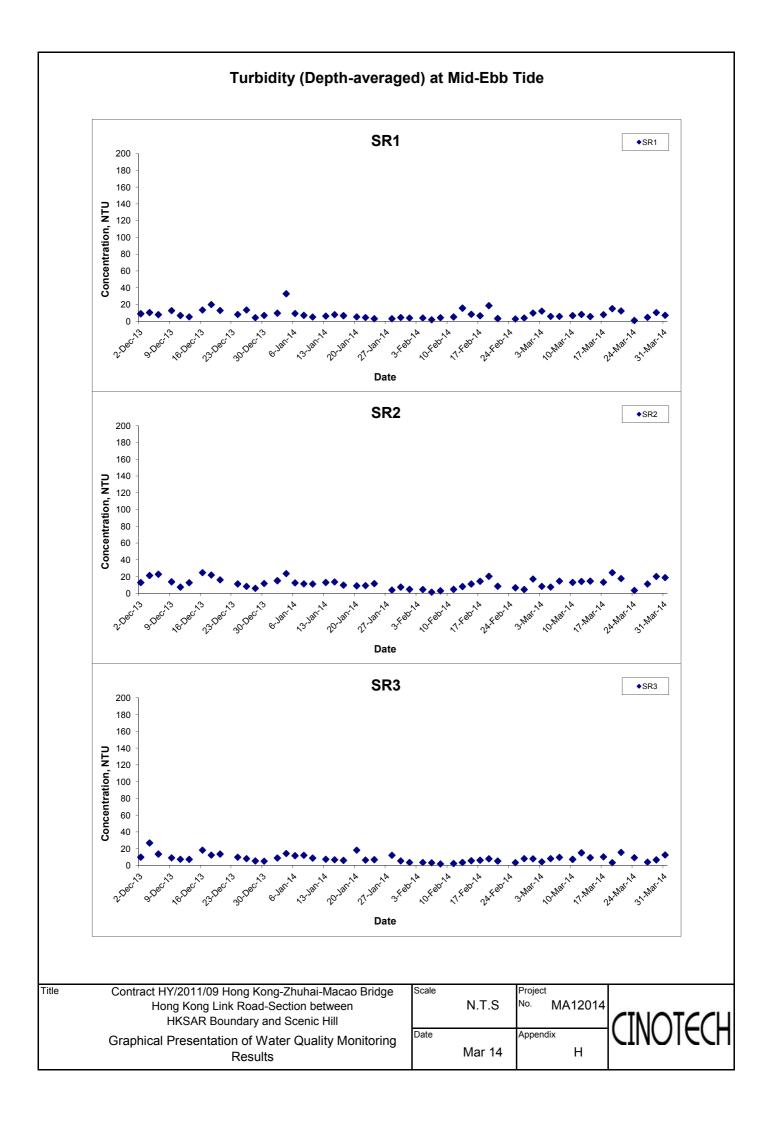
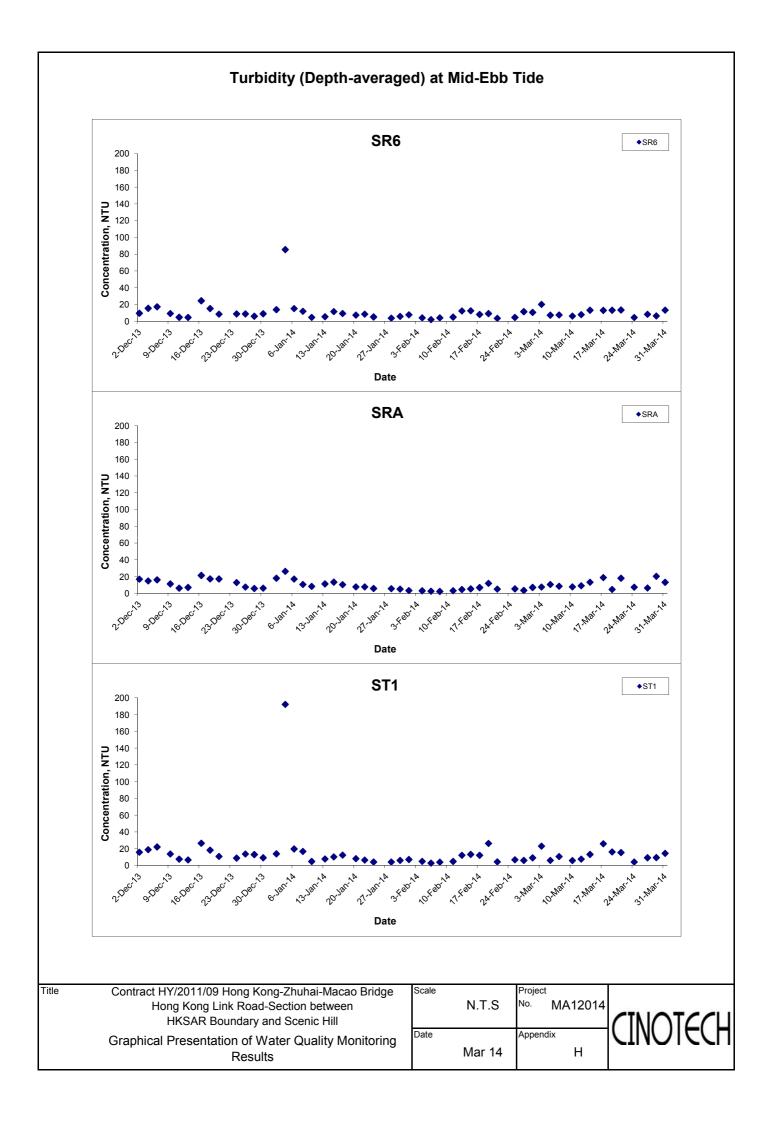
Turbidity (Depth-averaged) at Mid-Ebb Tide

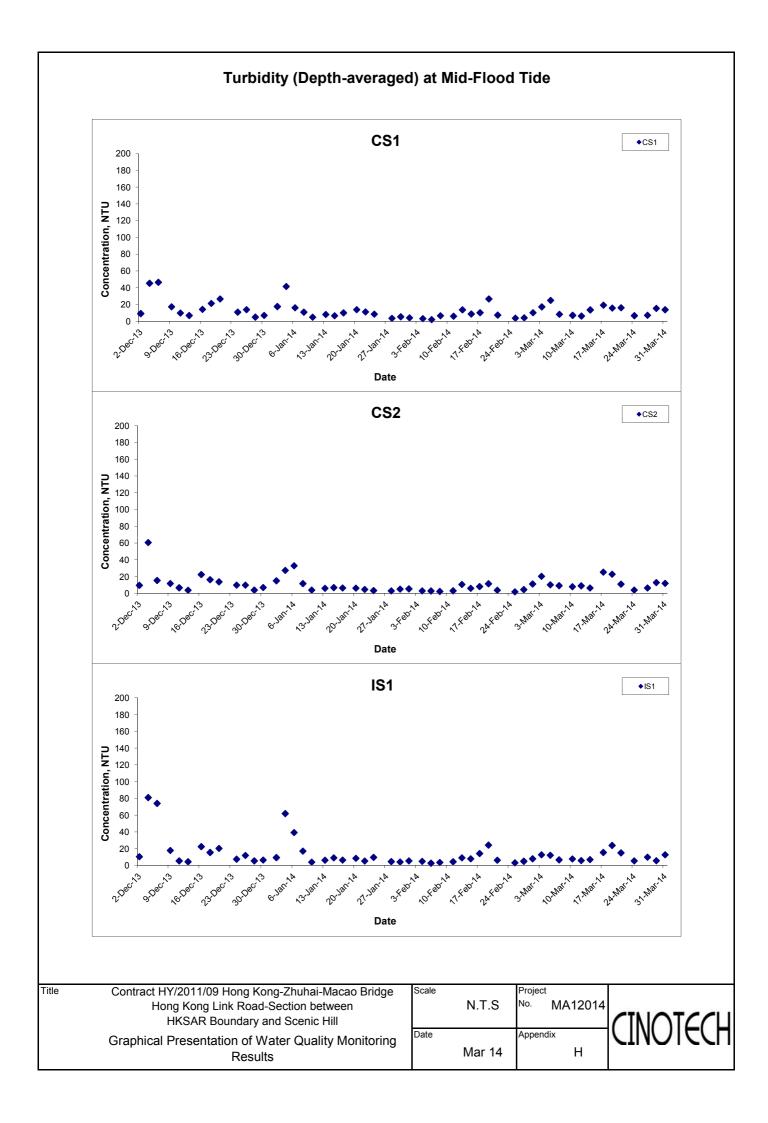
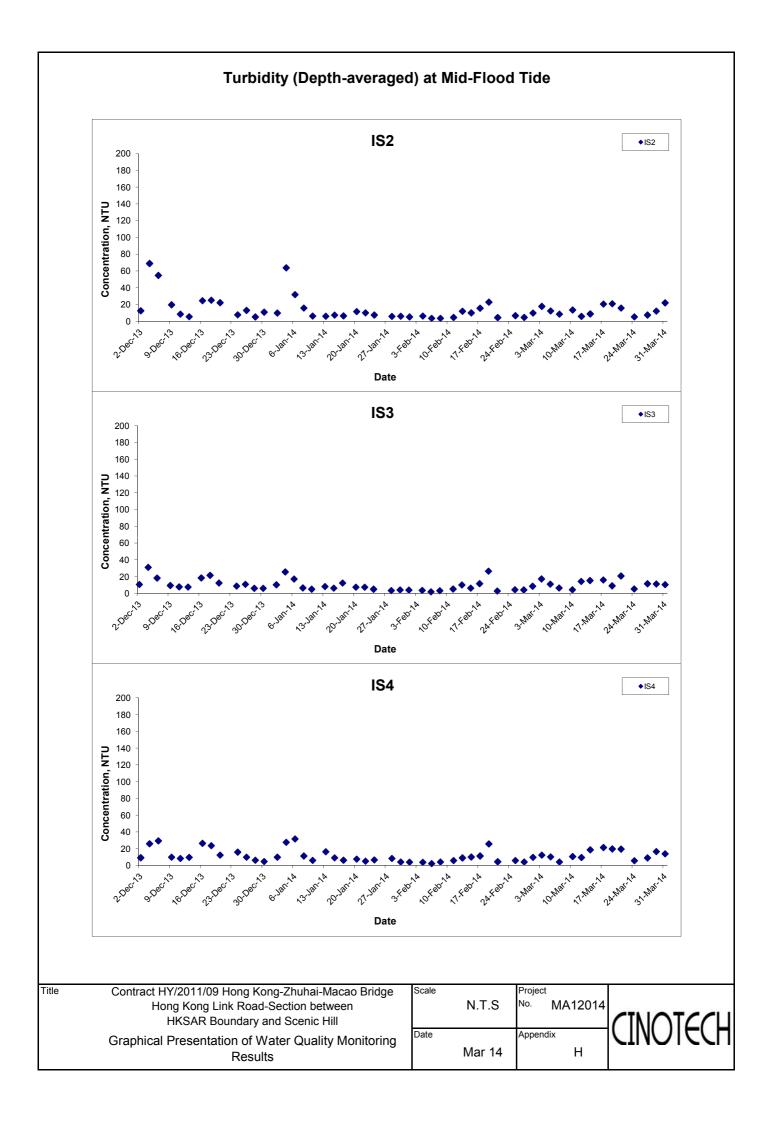
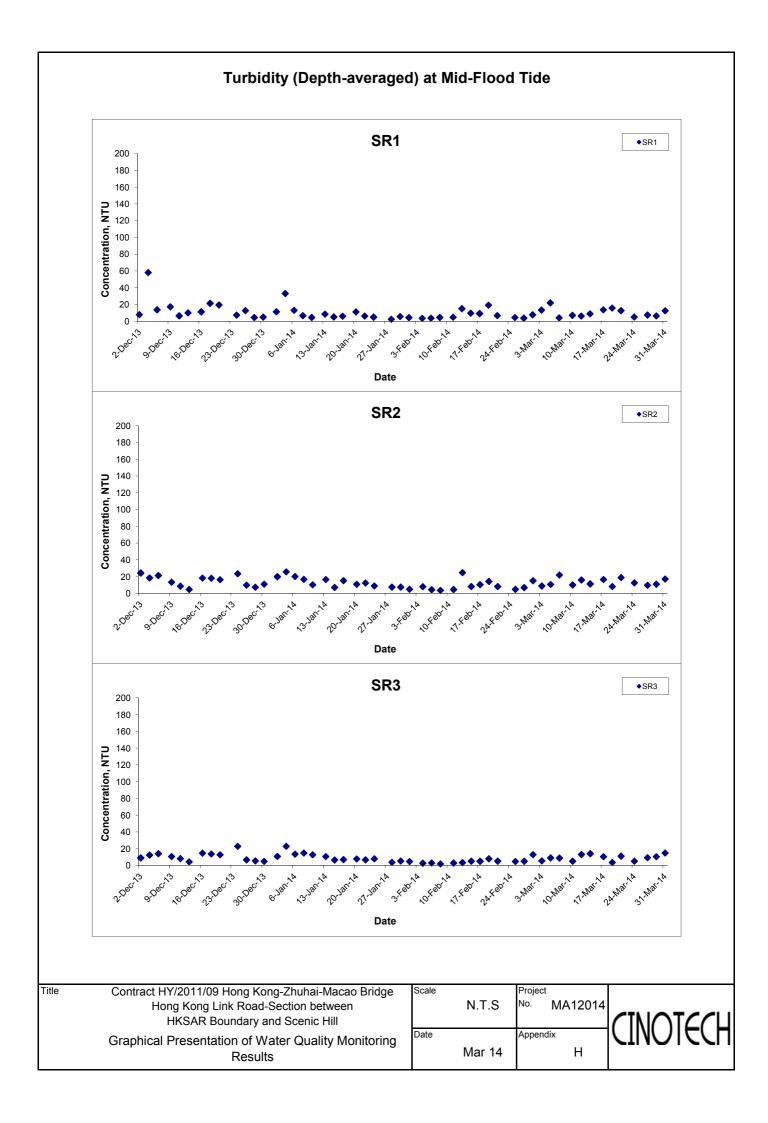
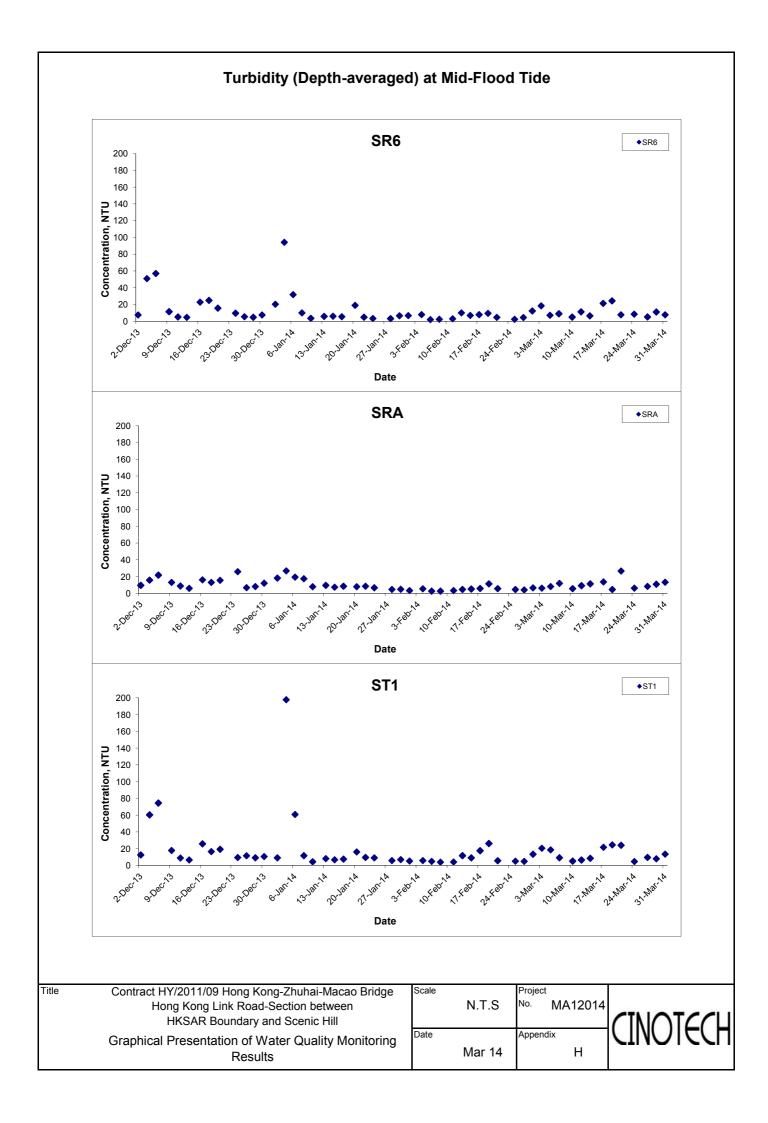
Turbidity (Depth-averaged) at Mid-Flood Tide

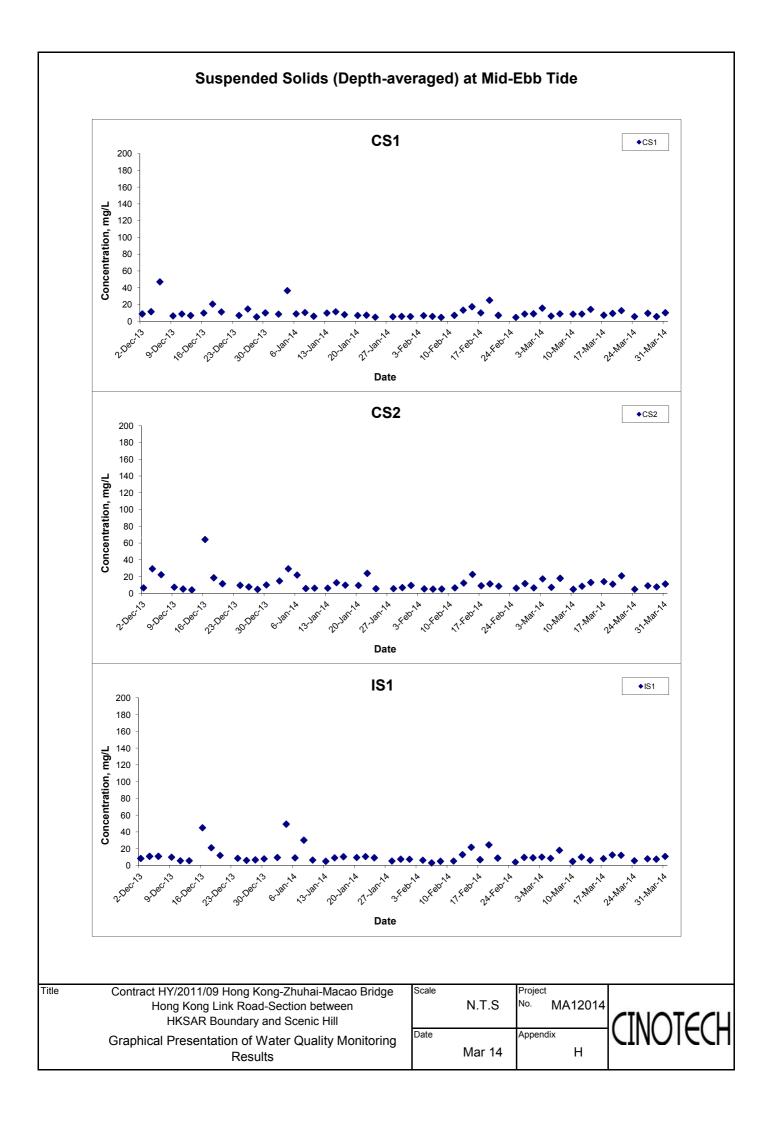
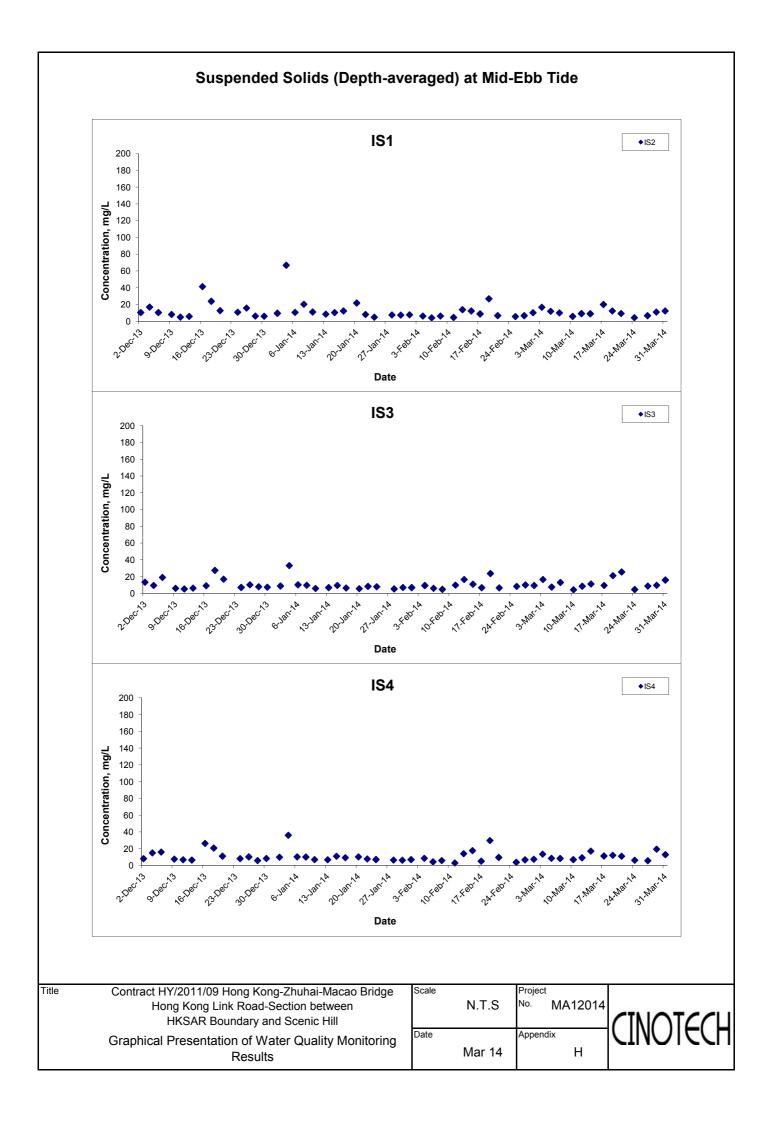
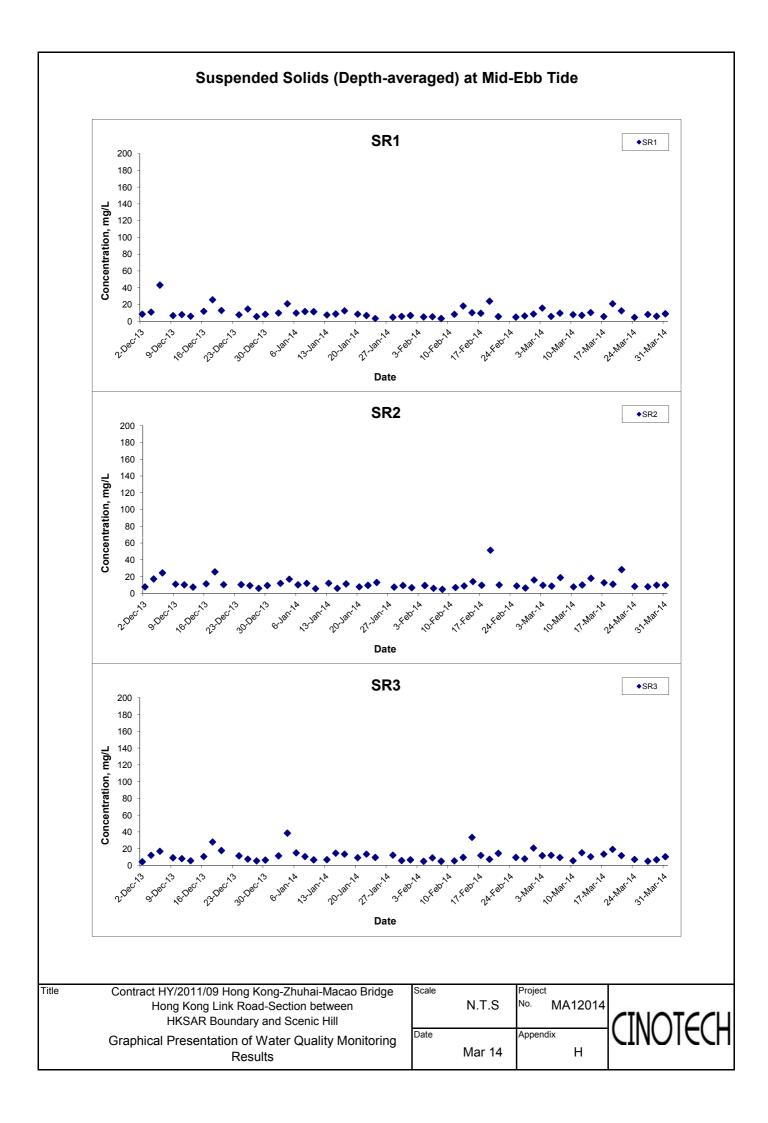
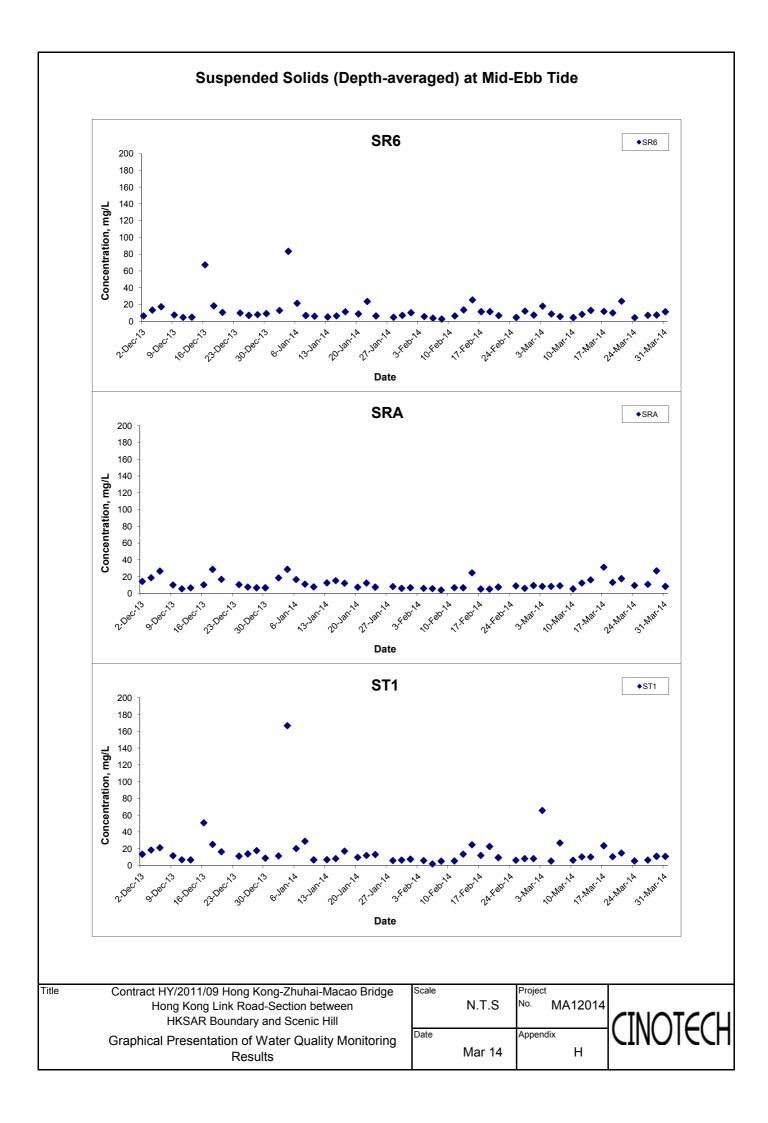
Suspended Solids (Depth-averaged) at Mid-Ebb Tide

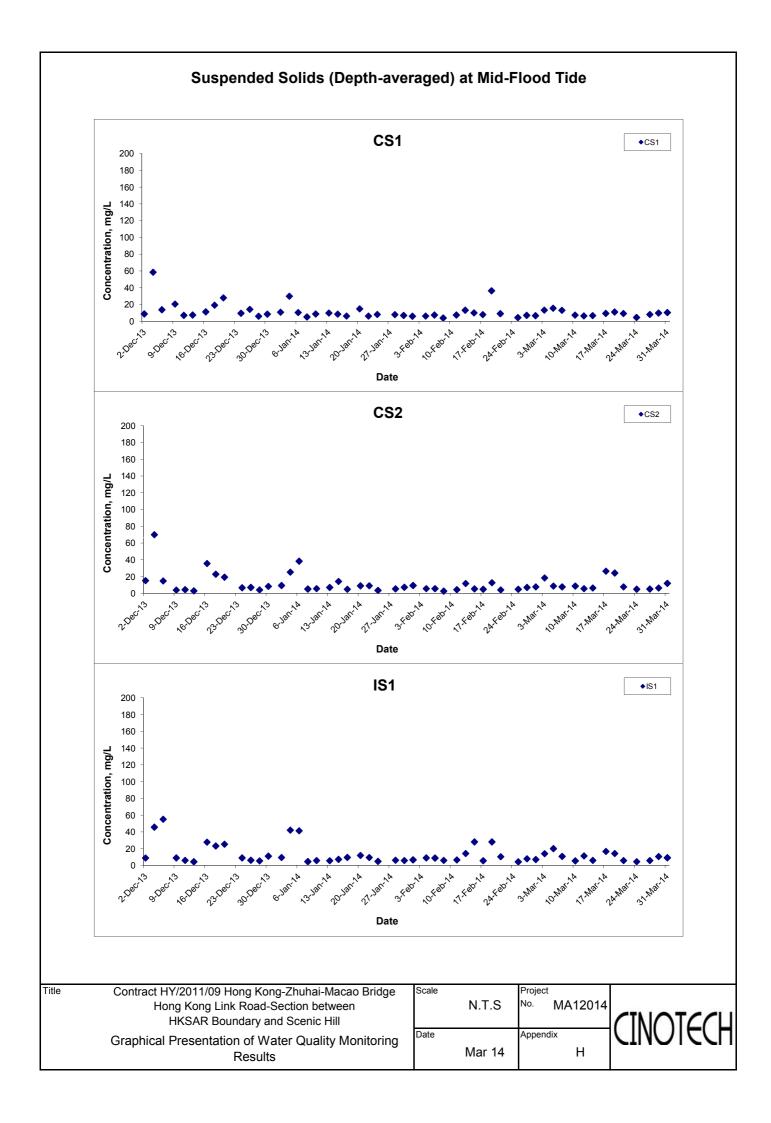
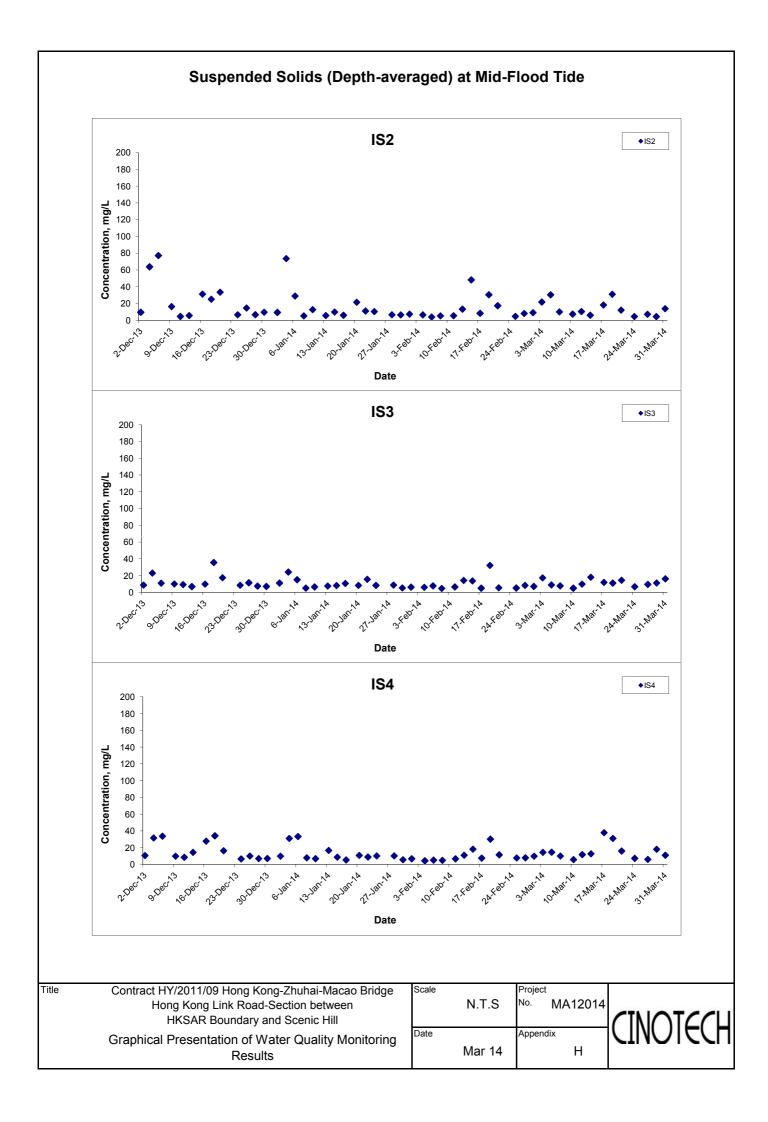
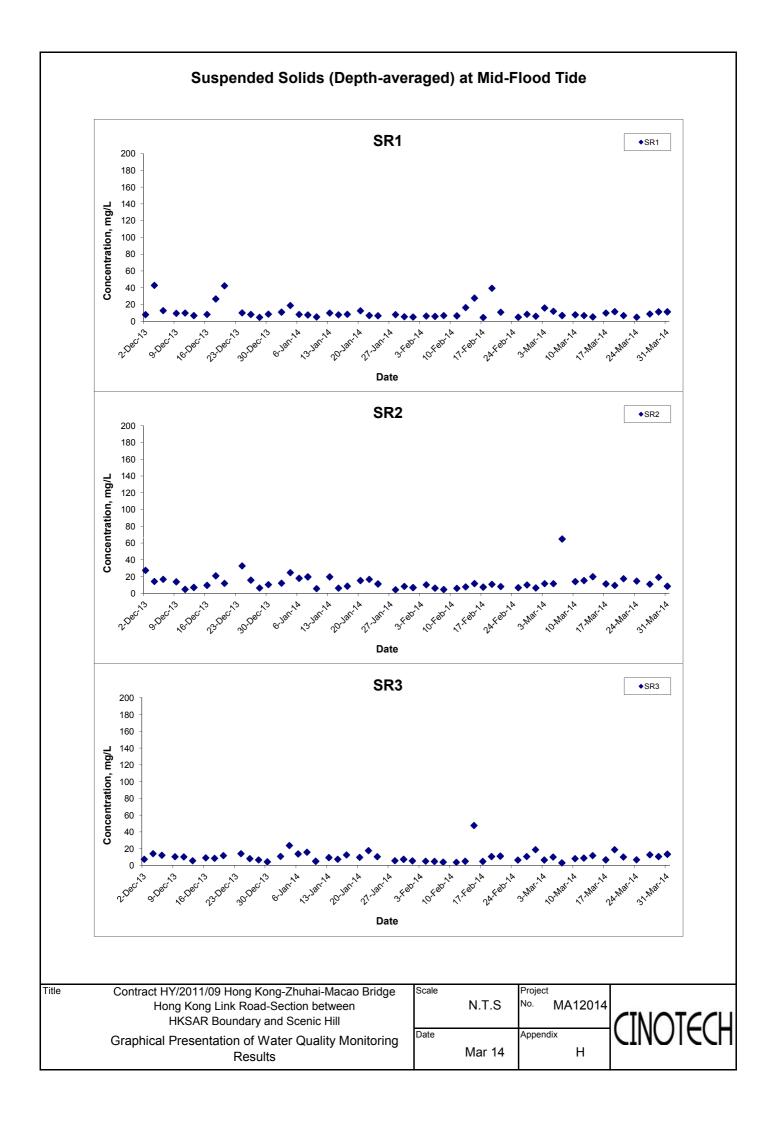
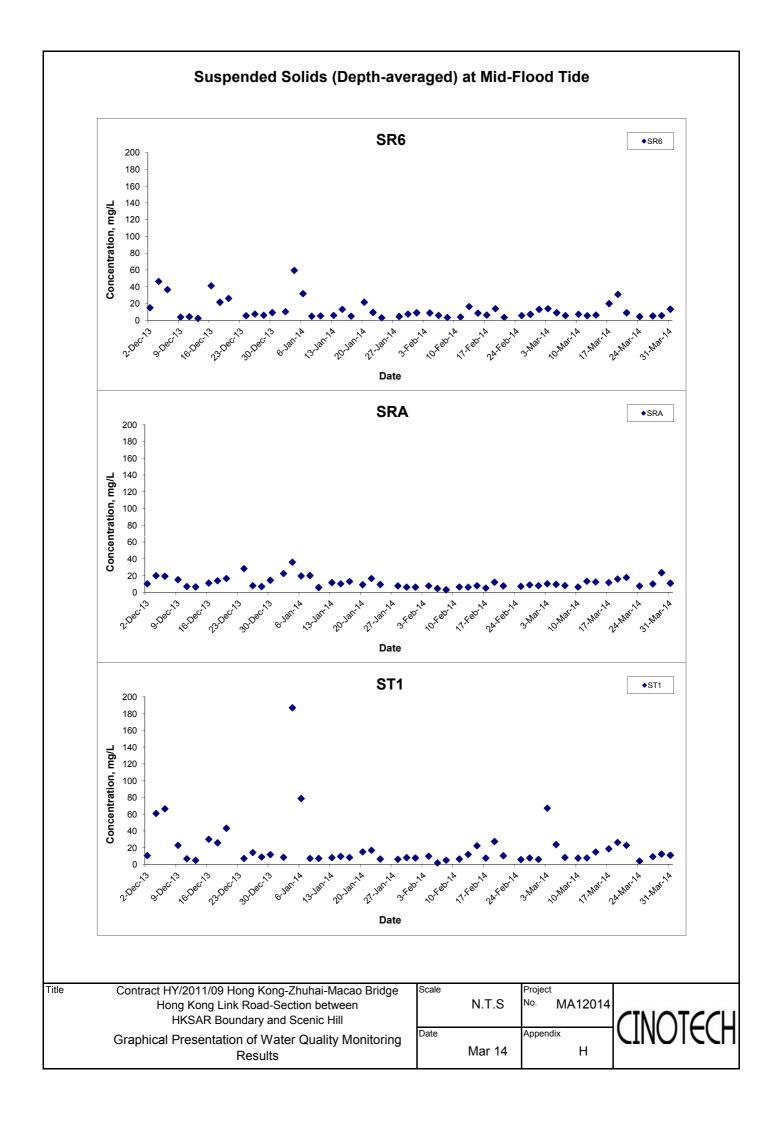
Suspended Solids (Depth-averaged) at Mid-Flood Tide

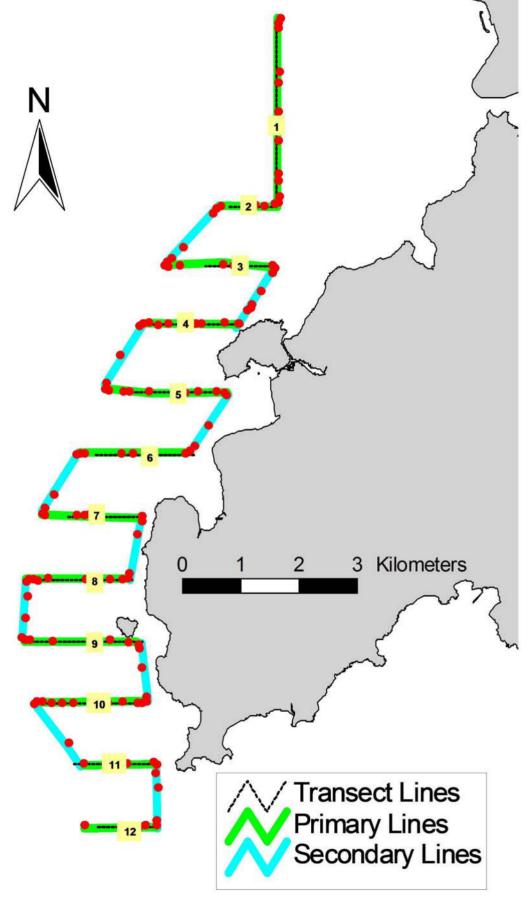
Figure 2. Survey Route on March 12th, 2014 (note: red dots represent the tracked positions of survey boat logged continuously by GPS throughout the course of the survey)

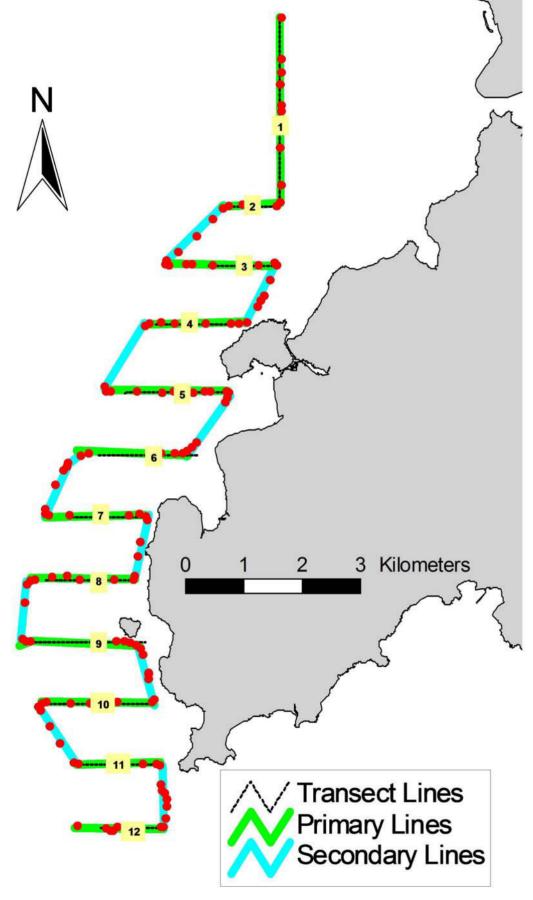
Figure 3. Survey Route on March 26th, 2014 (note: red dots represent the tracked positions of survey boat logged continuously by GPS throughout the course of the survey)

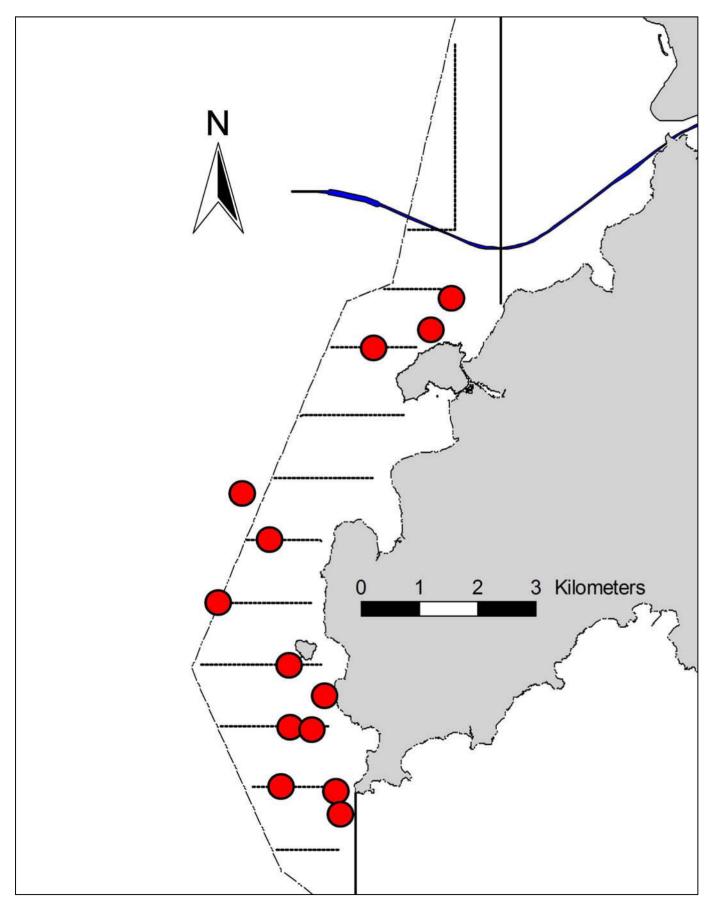
Figure 4. Distribution of Chinese White Dolphin Sighting during March 2014 HKLR09 Monitoring Surveys

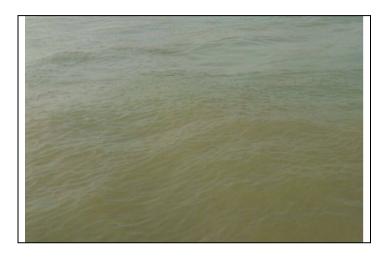
Table I – Photographic Records during Water Quality Monitoring on 3 March 2014

Part B – Conclusion: No direct evidence that the exceedances were due to the Contract, therefore the exceedances are considered due to the other external factors rather than the contract works.

Part C – Recommendation: As the excedences were not related to the contract works, no further action to be required.

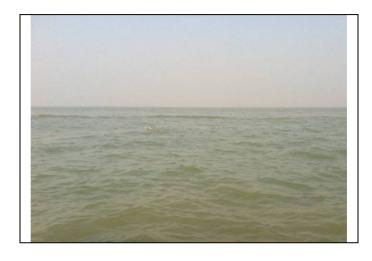
Table I – Photographic Records during Water Quality Monitoring on 5 March 2014

Part B – Conclusion: No direct evidence that the exceedances were due to the Contract, therefore the exceedances are considered due to the other external factors rather than the contract works.

Part C – Recommendation: As the excedances were not related to the contract works, no further action to be required.

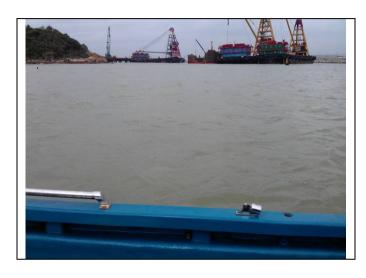
Table I – Photographic Records during Water Quality Monitoring on 7 March 2014

Part B – Conclusion: No direct evidence that the exceedances were due to the Contract, therefore the exceedances are considered due to the other external factors rather than the contract works.

Part C – Recommendation: As the excedances were not related to the contract works, no further action to be required.

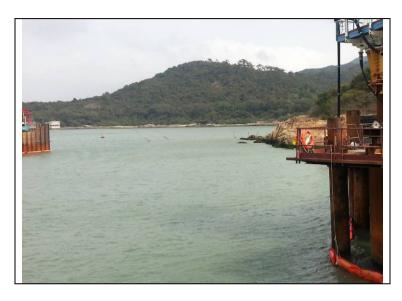
Table I – Photographic Records during Water Quality Monitoring on 17 March 2014

Part B – Conclusion: No direct evidence that the exceedances were due to the Contract, therefore the exceedances are considered due to the other external factors rather than the contract works.

Part C – Recommendation: As the exceedances were not related to the contract works, no further action to be required.

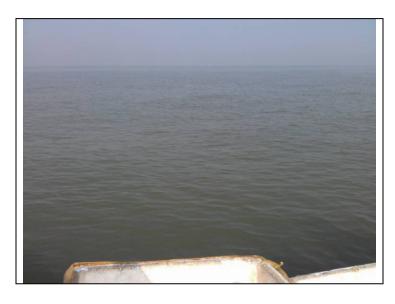
Table I – Photographic Records during Water Quality Monitoring on 19 March 2014

Part B – Conclusion: No direct evidence that the exceedances were due to the Contract, therefore the exceedances are considered due to the other external factors rather than the contract works.

Part C – Recommendation: As the excedences were not related to the contract works, no further action to be required.

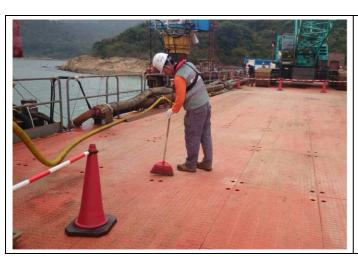
Ref No: 140228-R01

Rectification Actions taken by the Contractor for Environmental Deficiencies Identified during Previous Audit Session
