Contract No. HY/2011/09
Hong Kong-Zhuhai-Macao Bridge
Hong Kong Link Road – Section between HKSAR Boundary and Scenic Hill

Submission under Environmental Permit (EP-352/2009/C – Condition 4.4)
Monthly EM&A Report – June 2014

**Contract No. HY/2011/09 HZMB Hong Kong Link Road –
Section between HKSAR Boundary and Scenic Hill
Revised Monthly EM&A Report for June 2014 (EP-352/2009/C)**

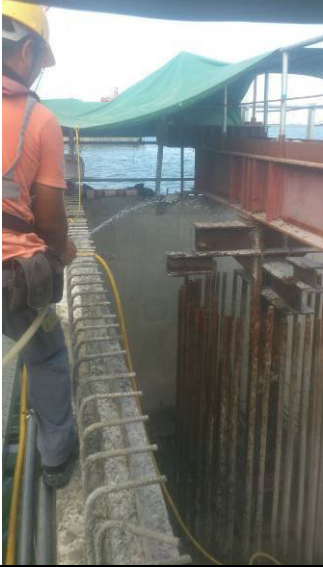
<p>Ref No: 140530-O01</p> <p>Impact: Air Quality (D13, 14, 15)</p> <p>Details: Dust generation was observed from the trimming works at P45. The Contractor was reminded to provide sufficient dust mitigation measures properly.</p> <p>Follow Up: Dust mitigation measures were provided.</p>

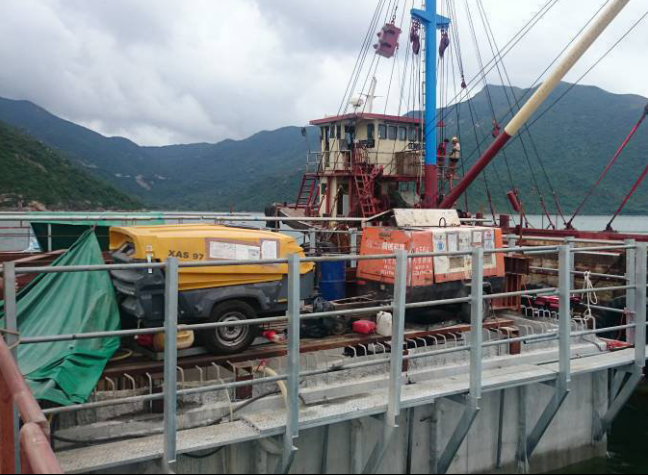
<p>Ref No: 140530-R02</p> <p>Impact: Noise (E9)</p> <p>Details: To close the panel of air compressor at P45.</p> <p>Follow Up: The panel of air compressor was closed.</p>

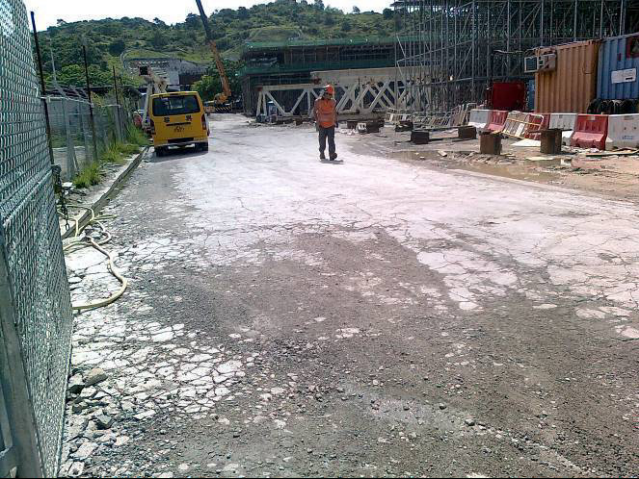
<p>Ref No: 140610-O01</p> <p>Impact: Water Quality (B9, B10i)</p> <p>Details: The wheel washing bay at Portion C was filled with soil. The Contractor was reminded to rectify it as soon as possible.</p> <p>Follow Up: According to the Contractor, the wheel washing bay is no longer used and the road at near the site exit is paved.</p>

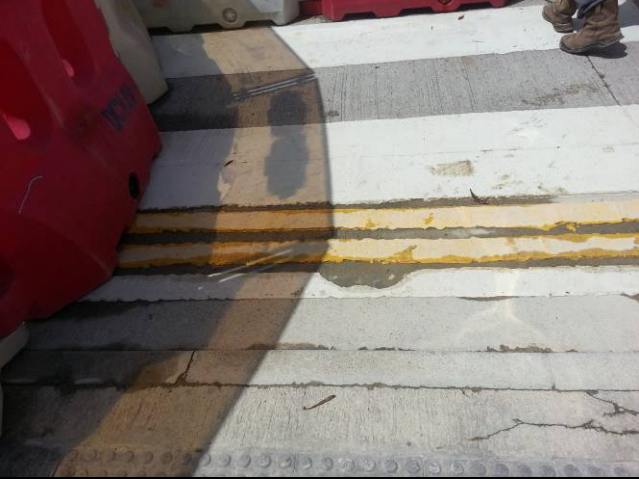
<p>Ref No: 140610-O02</p> <p>Impact: Water Quality (B3)</p> <p>Details: Muddy water was observed discharging to the public road at Portion C. The Contractor was reminded to direct the muddy water for treatment properly.</p> <p>Follow Up: No further muddy water was observed discharging to the public road.</p>
 	<p>Ref No: 140610-O03</p> <p>Impact: Water Quality (B1, B2i, B2ii, B10ii) Waste / Chemical Management (F6)</p> <p>Details: Muddy water due to the wheel washing was observed discharging to the public road, drain and gullies at S10 out. The Contractor was reminded to provide proper wheel washing bay and rectify the deficiency as soon as possible.</p> <p>Follow Up: No further muddy water was observed discharging to the public road, drain and gullies.</p>

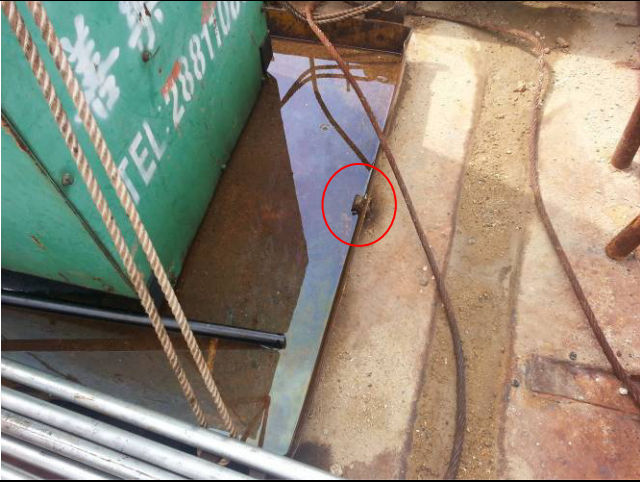
<p>Ref No: 140627-R04</p> <p>Impact: Waste / Chemical Management (F9)</p> <p>Details: To plug the drip tray for generator at P74.</p>
