Contract No. HY/2011/09
Hong Kong-Zhuhai-Macao Bridge
Hong Kong Link Road – Section between HKSAR Boundary and Scenic Hill

Submission under Environmental Permit (EP-352/2009/C – Condition 4.4)
Monthly EM&A Report – October 2014

**Contract No. HY/2011/09 HZMB Hong Kong Link Road –
Section between HKSAR Boundary and Scenic Hill
Revised Monthly EM&A Report for October 2014 (EP-352/2009/C)**

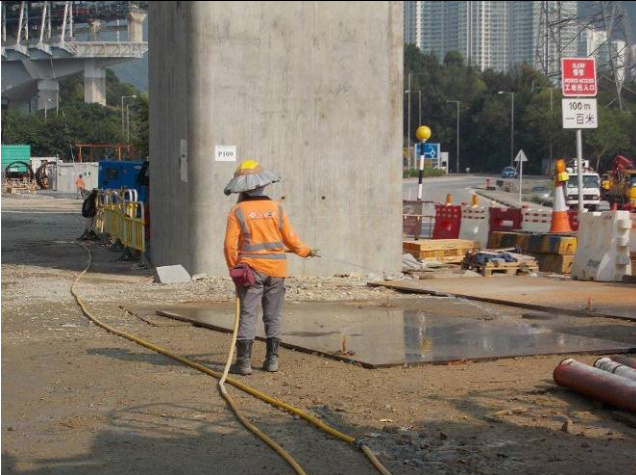
<p>Ref No: 141007-R04</p> <p>Impact: Air Quality (D5, 6, 8, 14)</p> <p>Details: Provide proper watering for the dry exposed area at Portion C.</p> <p>Follow Up: Proper watering was provided.</p>

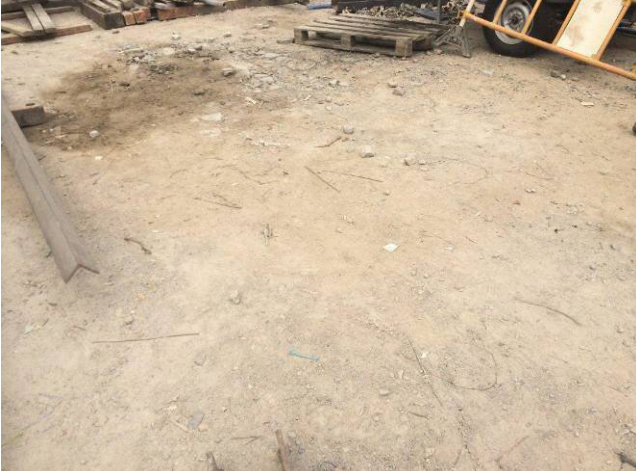
<p>Ref No: 141007-R05</p> <p>Impact: Waste / Chemical Management (F8)</p> <p>Details: Clear the oil leakage and painting materials at Portion C.</p> <p>Follow Up: The oil leakage and painting materials were cleared.</p>

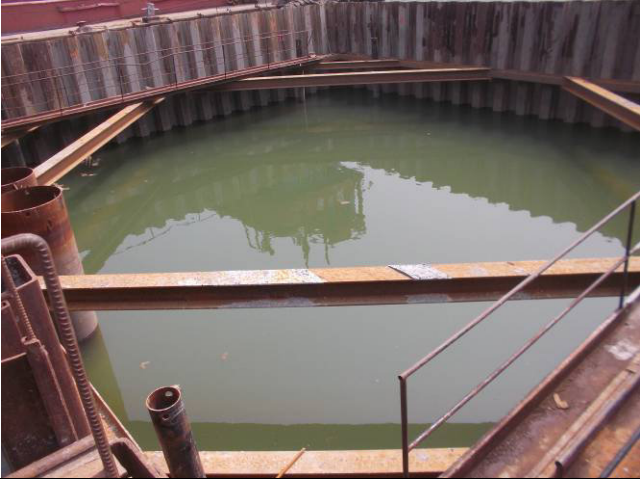
<p>Ref No: 141014-R01</p> <p>Impact: Water Quality (B21)</p> <p>Details: Clear the floating rubbish inside the cofferdam at P73.</p> <p>Follow Up: The floating rubbish was cleared.</p>

Parameters	Date	Observations and Recommendations	Follow-up
<i>Water Quality</i>	10/10/2014	Clear the floating rubbish inside the cofferdam at P73.	Rectification/improvement was observed during the follow-up audit session on 21 October 2014.
	10/10/2014	Properly maintain the silt curtain at P75 to avoid the gap.	Rectification/improvement was observed during the follow-up audit session on 21 October 2014.
	31/10/2014	Clear the broken sand bags at the barge at P27.	Rectification/improvement was observed during the follow-up audit session on 4 November 2014.
<i>Ecology</i>	21/10/2014	Clear the accumulated wastes at near the trees at near P93.	Rectification/improvement was observed during the follow-up audit session on 31 October 2014.
<i>Air Quality</i>	07/10/2014	Provide proper watering for the dry exposed area at Portion C.	Rectification/improvement was observed during the follow-up audit session on 10 October 2014.
