Dragages -China Harbour-VSL JV

Contract HY/2011/09
Hong Kong-Zhuhai-Macao Bridge
Hong Kong Link Road-Section between
HKSAR Boundary and Scenic Hill
Monthly EM&A Report
September 2013
(Version 3.0)

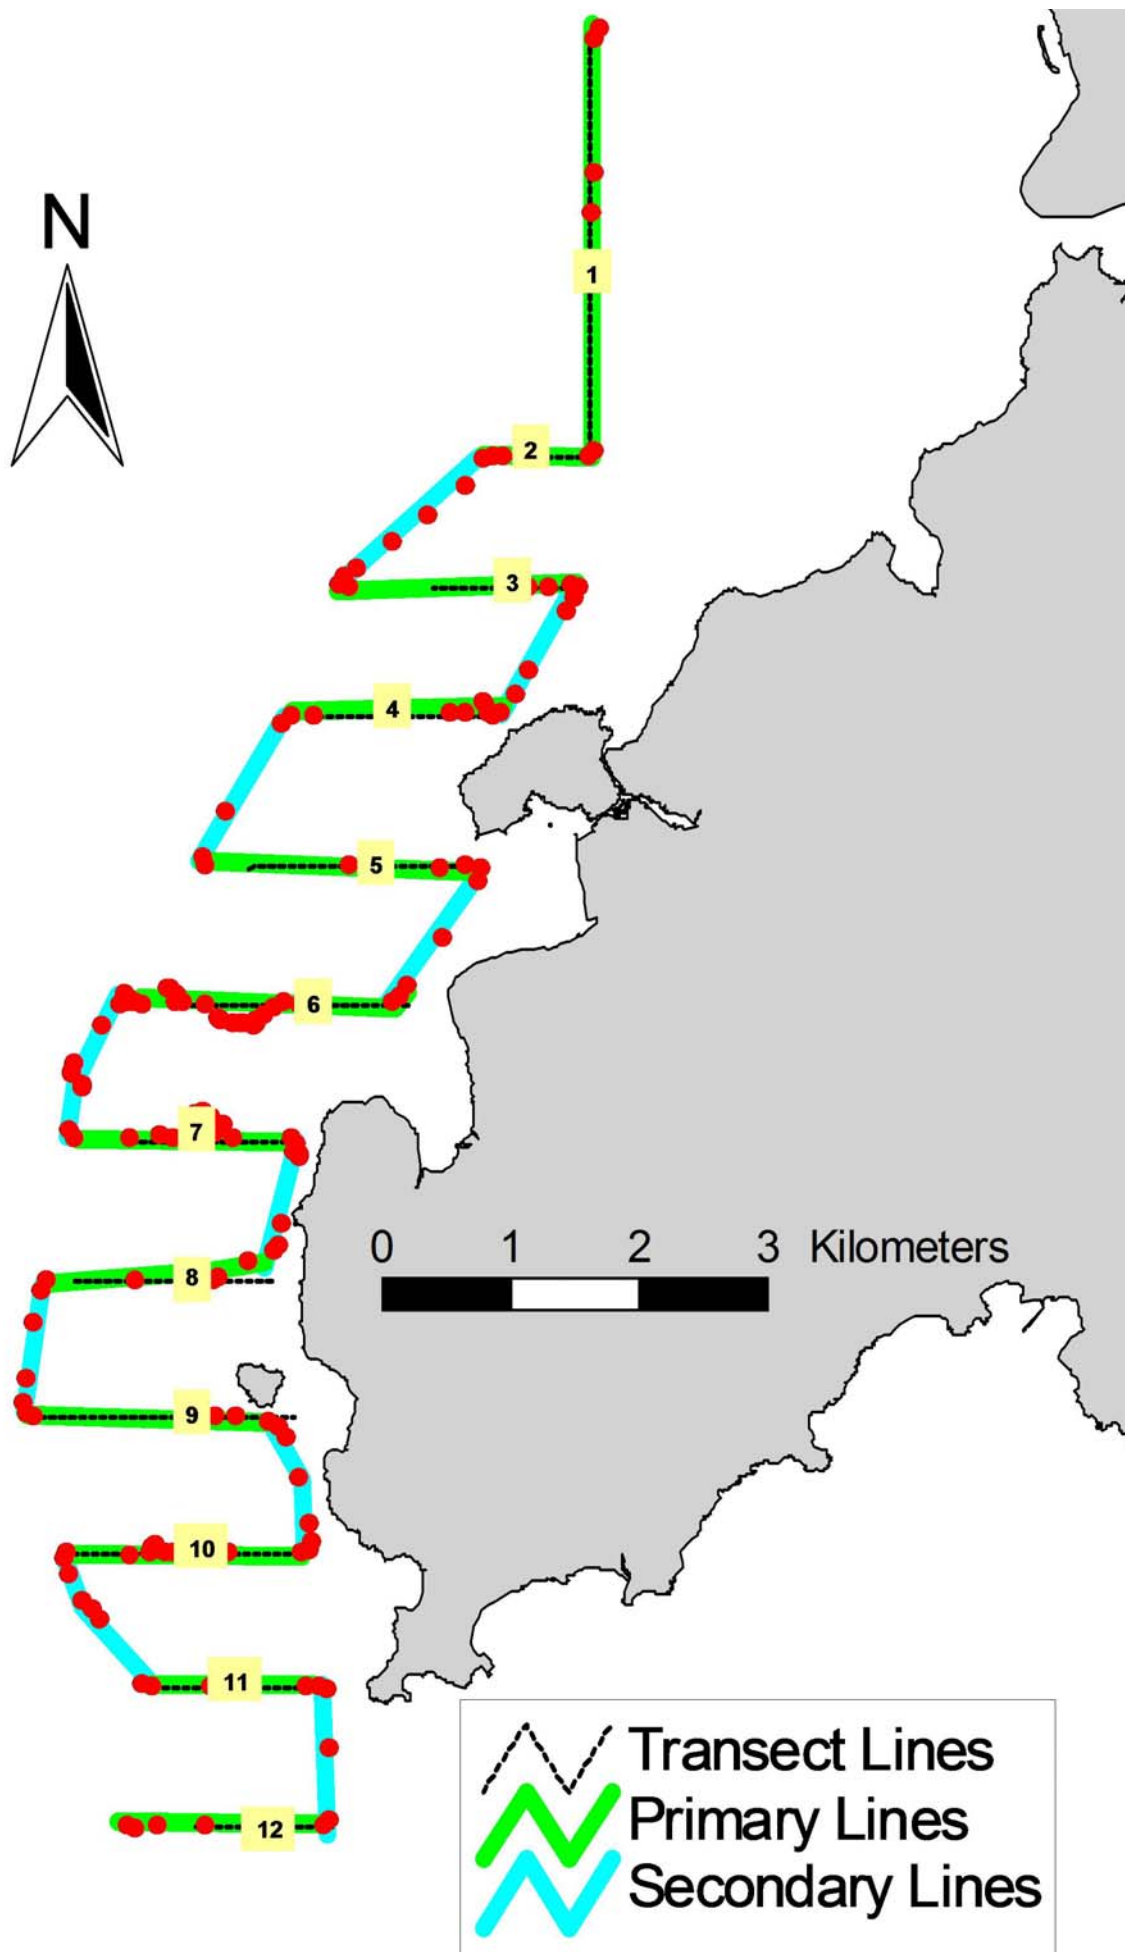
Figure 2. Survey Route on September 11th, 2013 (note: red dots represent the tracked positions of survey boat logged continuously by GPS throughout the course of the survey)

6.9 From these surveys, a total of 61.55 km of survey effort was collected, with 100.0% of the total survey effort being conducted under favourable weather conditions (i.e. Beaufort Sea State 3 or below with good visibility) Out of the 61.55 km of survey effort, the total survey effort conducted on primary lines (the vertical lines perpendicular to the coastlines) was 40.43 km.

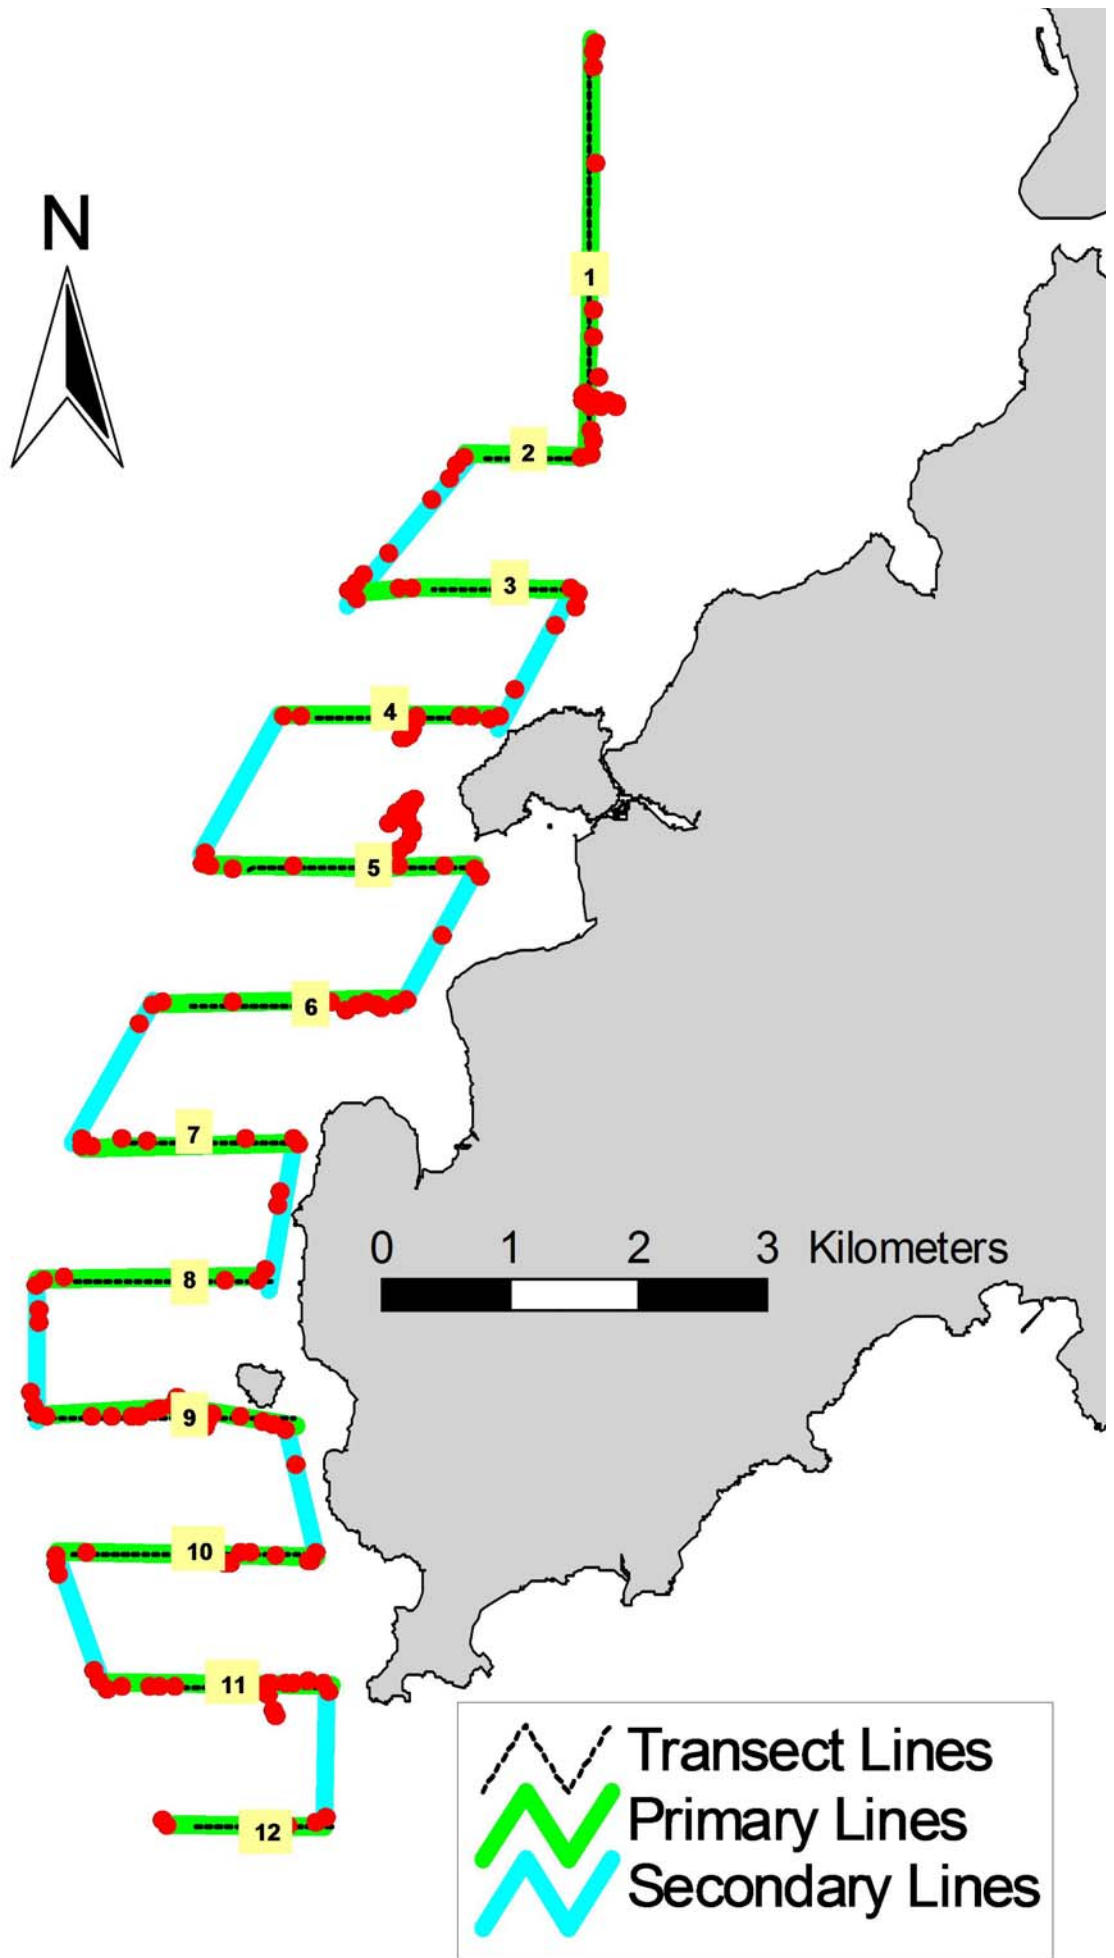
Figure 3. Survey Route on September 19th, 2013 (note: red dots represent the tracked positions of survey boat logged continuously by GPS throughout the course of the survey)

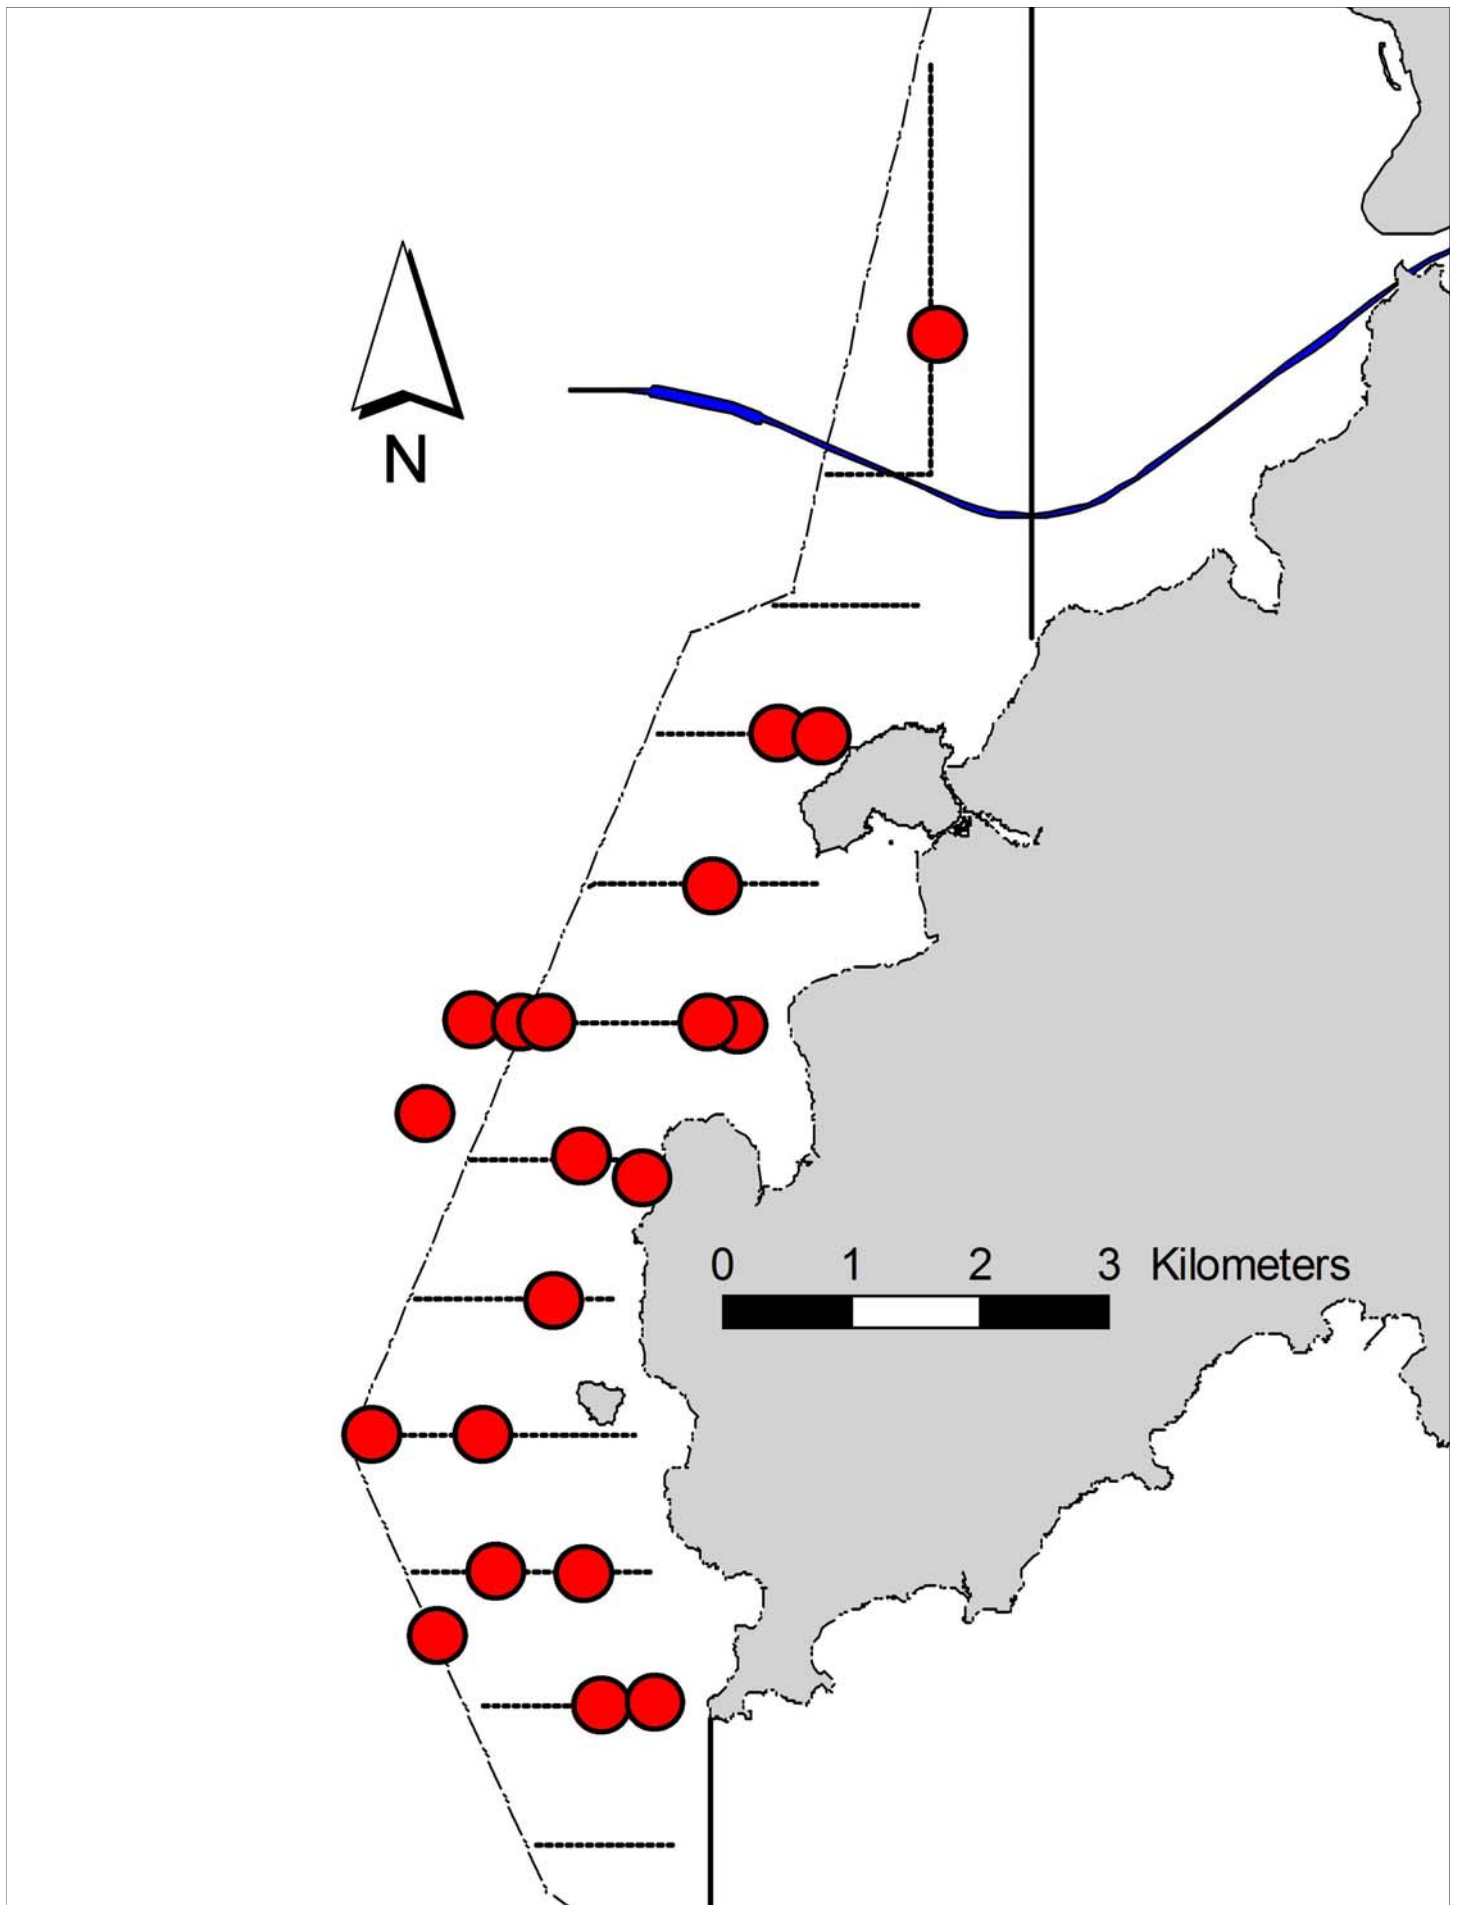
Figure 4. Distribution of Chinese White Dolphin Sighting during September 2013 HKLR09 Monitoring Surveys

- 6.13 No adverse impact on Chinese white dolphins was noticeable from general observations.
- 6.14 Evaluation of impacts on dolphins due to construction work will be conducted in the quarterly EM&A report.
- 6.15 Detailed monitoring methodology and results can be found in **Appendix I**.
