AGREEMENT NO. CE 45/2008 (CE)
LIANTANG/HEUNG YUEN WAI
BOUNDARY CONTROL POINT AND ASSOCIATED WORKS

MONTHLY ENVIRONMENTAL MONITORING AND AUDIT
REPORT (NO.4) – NOVEMBER 2013

PREPARED FOR
CIVIL ENGINEERING AND DEVELOPMENT DEPARTMENT
(CEDD)

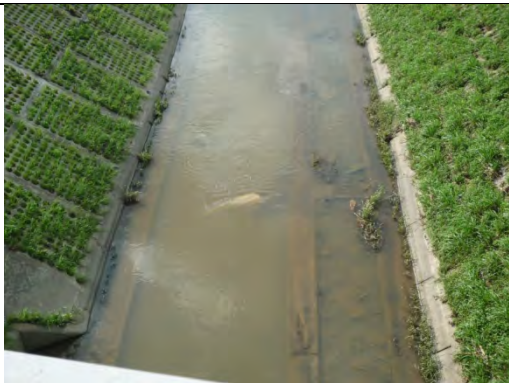
Location of WM4

6.2.3 Two (2) Limit Level exceedances including parameters of turbidity and SS were recorded at water samples collected from WM4 on 25 November 2013. NOEs were issued to relevant parties upon confirmation of the results. The investigation for the cause of exceedance was completed and the result is presented as follow:
