Ref No.: 100440EN150601

Contract No. EP/SP/58/08
Sludge Treatment Facilities
Environmental Monitoring and Audit Report
For
May 2015

1. Executive Summary

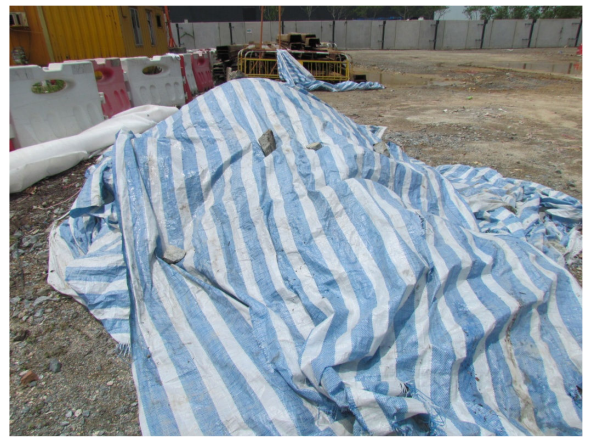
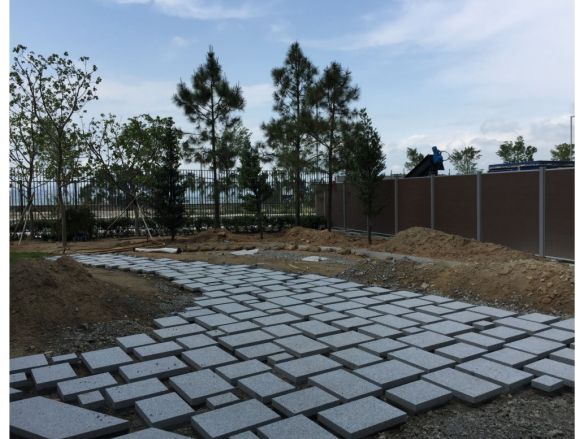
1. Photographic Record of the PFA Treatment

<p>Capping of the PFA is established to prevent spreading in air.</p>	<p>Suitable topsoil has been imported to the site for softscape planting.</p>

Topsoil found within the project site is PFA. Suitable topsoil already imported for planting. All PFA excavated during the tree felling works has been retained in the site confinement. The PFA has been under dehydration and concealed properly to prevent spreading in the air. Backfill of PFA to its original location inside site area is under progress.

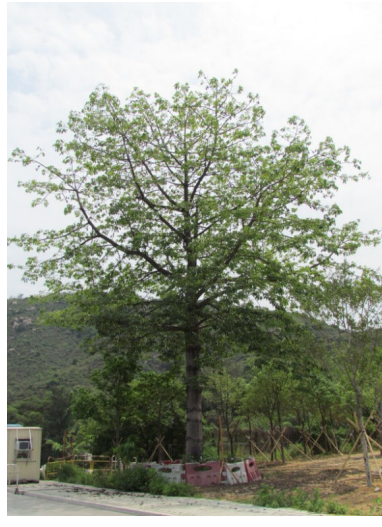
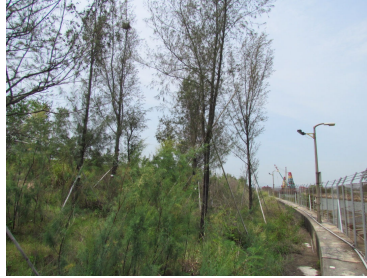
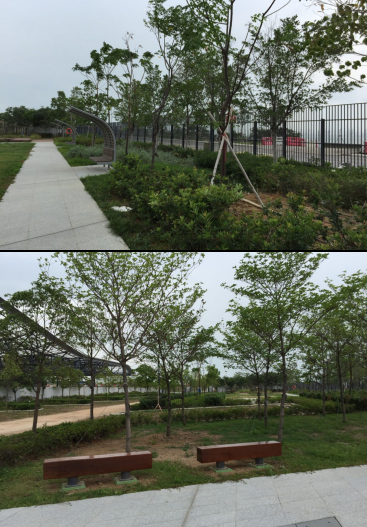
2. Photographic Record of Protection to the Fell / Retained Trees	3. Photographic Record of the Original Transplant Trees Location	4. Photographic Record of the Compensatory Tree Locations

<p>T758 is confirmed to be retained on site. Proper tree protection should be applied to protect T758.</p>	<p>Total 13 nos. of transplant trees have been transplanted back to the site in August and September 2013. There have 2 transplant trees found dead in March 2014. Status of the other transplant trees is under close monitoring.</p>	<p>Second batch of compensatory trees has finished.</p>

The Tree felling work approved under the Phase 1 and 2 tree felling application has been completed. Proper procedures of tree felling have been observed. The tree felling works should not cause damages to the existing trees on site. T758 has been confirmed to be retained on site. Proper tree protection should be set up for T758.

- CM3** – Trees unavoidably affected by the works should be transplanted where practical. Total 13 nos. of transplant trees have been transplanted back to the site in August and September 2013. There have 2 more transplant trees found dead in the March 2014. Compensatory trees will be proposed in the revised compensatory planting proposal in compensation for the loss of the 2 trees. Status of the other transplant trees is under close monitoring.

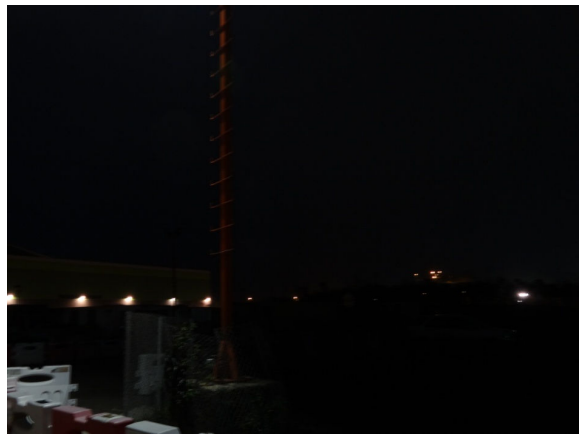
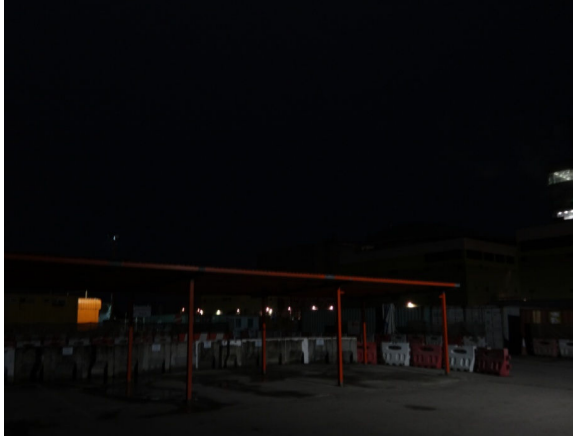
5. Photographic Record of the Night-Time Working

<p>The lighting during night-time working is confined within the working area within the site boundary. Periphery area and the sensitive receivers are not affected by the lighting during night-time working.</p>	<p>The lighting during night-time working is confined within the working area within the site boundary. Periphery area and the sensitive receivers are not affected by the lighting during night-time working.</p>

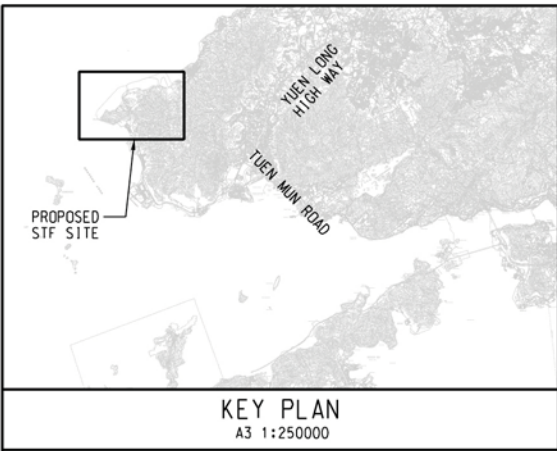
Figure 3.1

Site Layout Plan

The Contractor, VW-VES (HK) Limited, has been awarded a contract by the Environmental Protection Department of the Government of the Hong Kong Special Administrative Region for the Sludge Treatment Facilities. The location of the site is shown in Figure 3.1.
