**Contract No. DC/2009/24
HATS Stage 2A – Upgrading of
Preliminary Treatment Works at
Sandy Bay, Cyberport,
Wah Fu, Aberdeen and Ap Lei Chau**

**Monthly Environmental
Monitoring and Audit Report
May 2015**

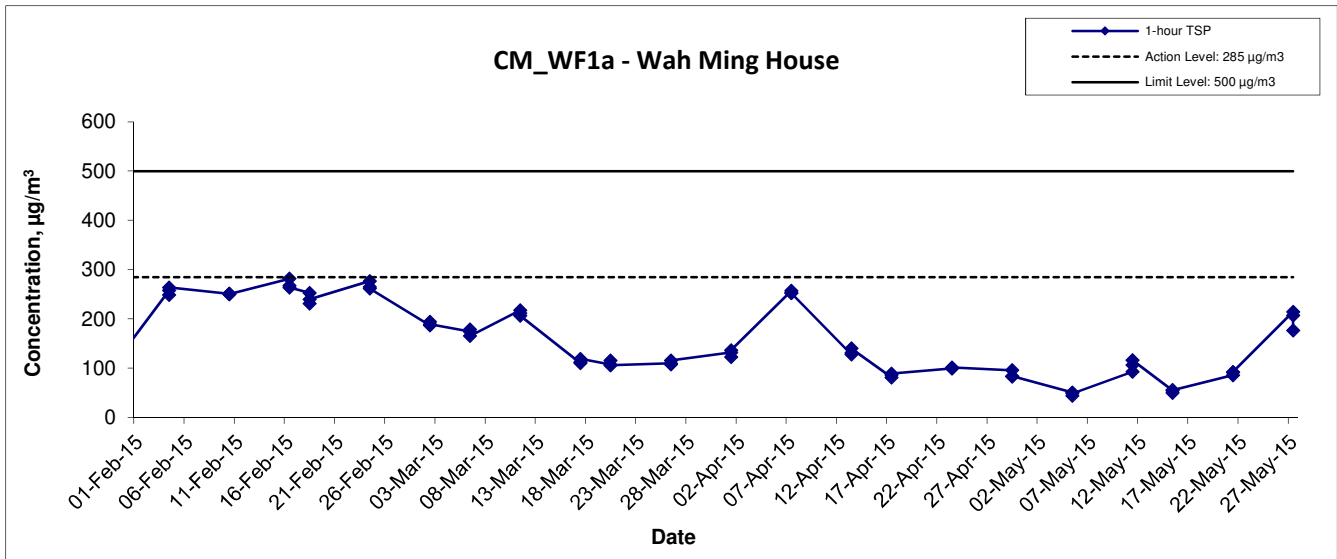
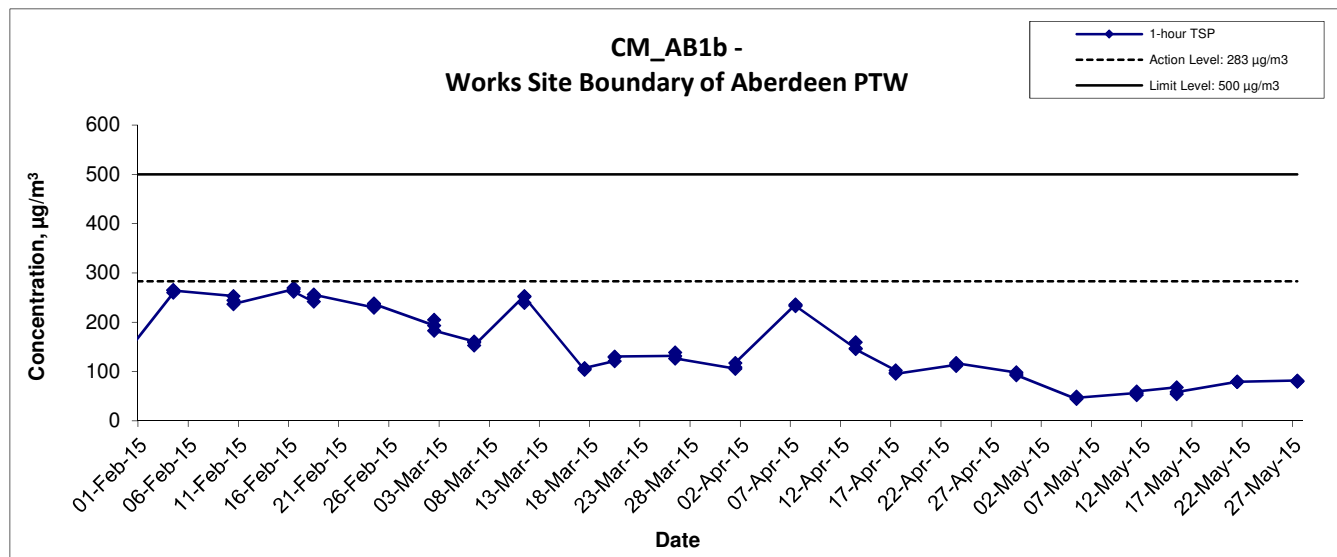
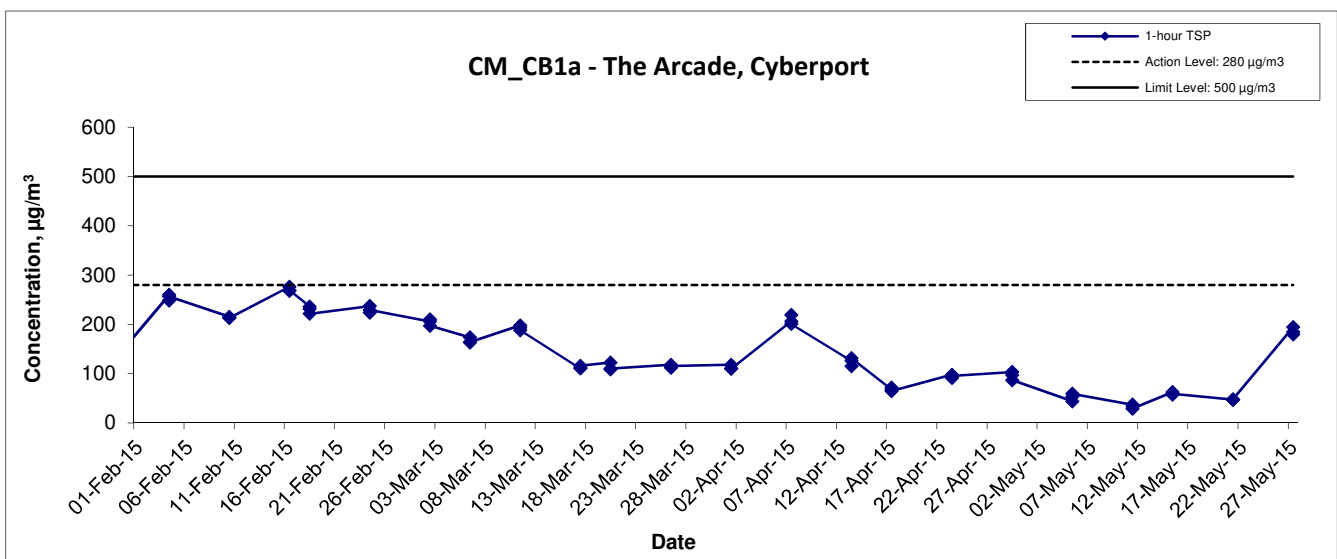
1-hr TSP Concentration Levels

Title Contract No. DC/2009/24 HATS 2A – Upgrading of Preliminary Treatment Works at Sandy Bay, Cyberport, Wah Fu, Aberdeen and Ap Lei Chau Graphical Presentation of 1-hour TSP Monitoring Results	Scale N.T.S	Project No. MA11060	
	Date May 15	Appendix E

- 2.24 The detailed monitoring data and graphical presentations of 1-hour and 24-hour TSP monitoring results could be referred to **Appendix E**.
- 2.25 All 1-hour TSP monitoring was conducted as scheduled in the reporting month. No Action/Limit Level exceedance was recorded. Summary of exceedance is presented in **Appendix G**.
- 2.26 The 24-hour TSP monitoring result of CM_CB1a recorded on 26 May 2015, which was found invalid due to the interruption of power supply of High Volume Sampler at CM_CB1a. No Action/Limit Level exceedance was recorded. Summary of exceedance is presented in **Appendix G**.
- 2.27 The identified dust sources at the monitoring stations were mainly from operation of excavator, mobile crane, dump truck, backhoe loader, road traffic, sea traffic.

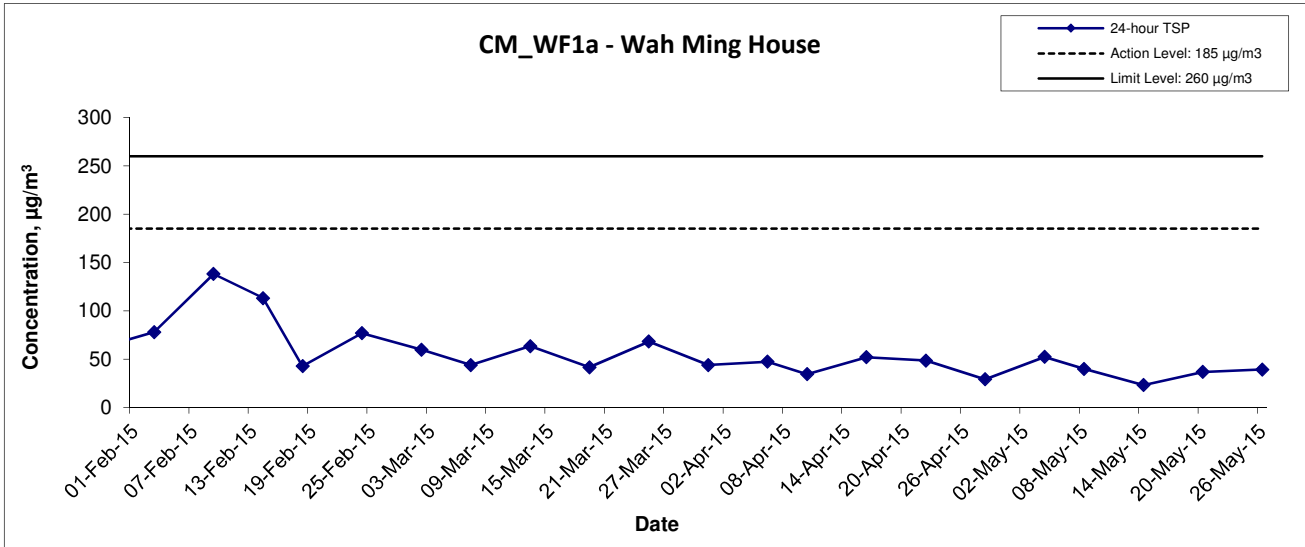
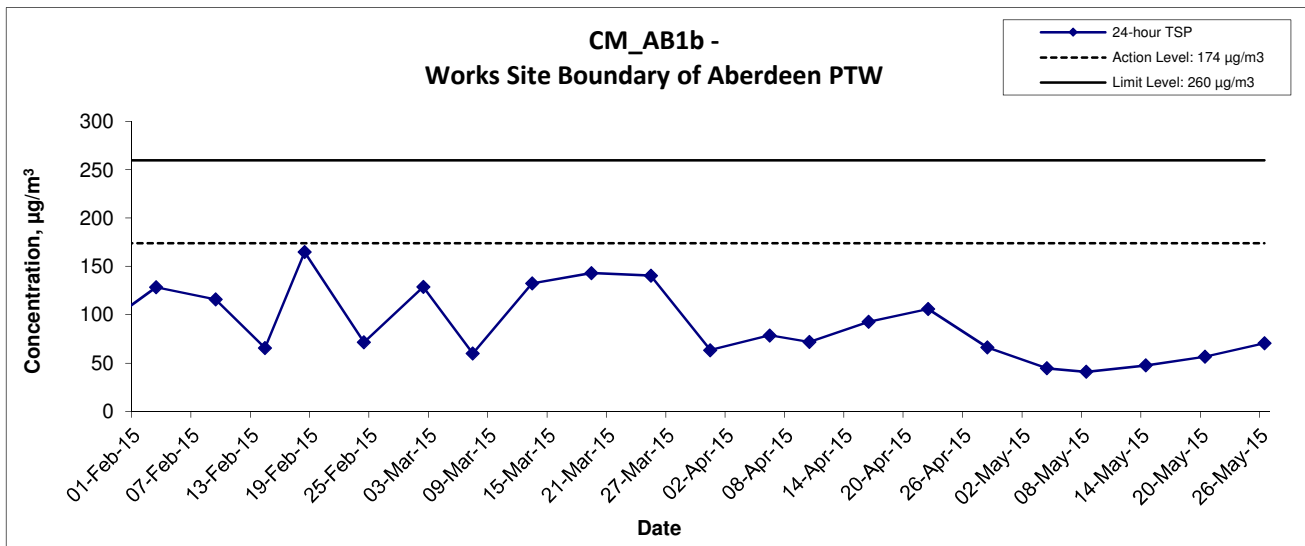
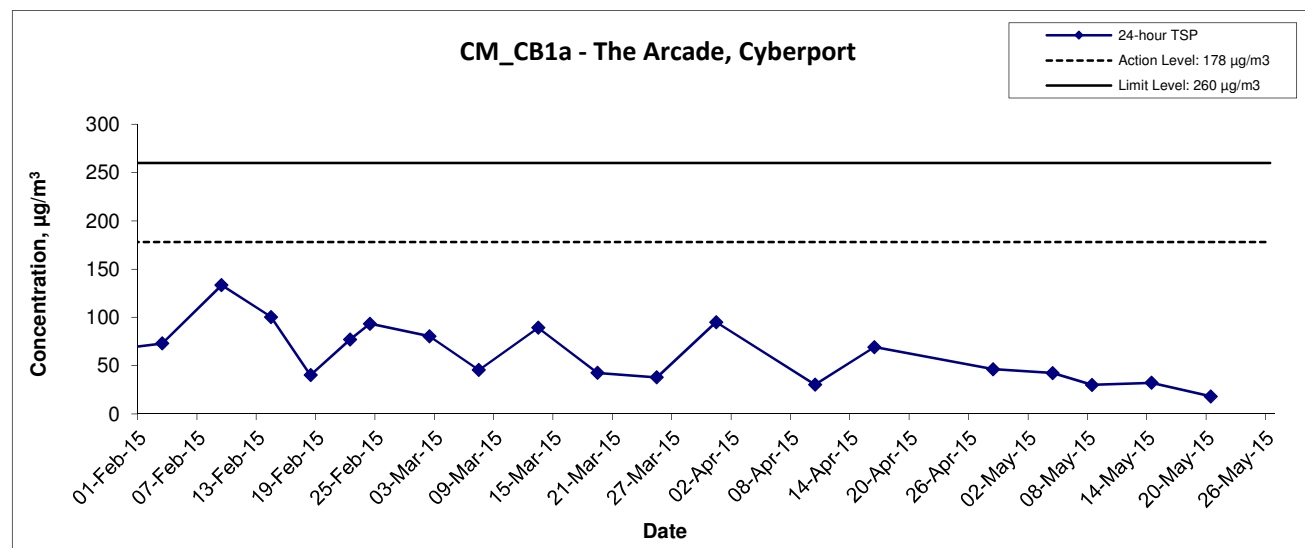
24-hr TSP Concentration Levels

Remark: 24-hour TSP value recorded on 26 May 2015 was found invalid due to the interruption of power supply of High Volume Sampler at CM_CB1a.

Title Contract No. DC/2009/24 HATS 2A – Upgrading of Preliminary Treatment Works at Sandy Bay, Cyberport, Wah Fu, Aberdeen and Ap Lei Chau Graphical Presentation of 24-hour TSP Monitoring Results	Scale N.T.S	Project No. MA11060	
	Date May 15	Appendix E

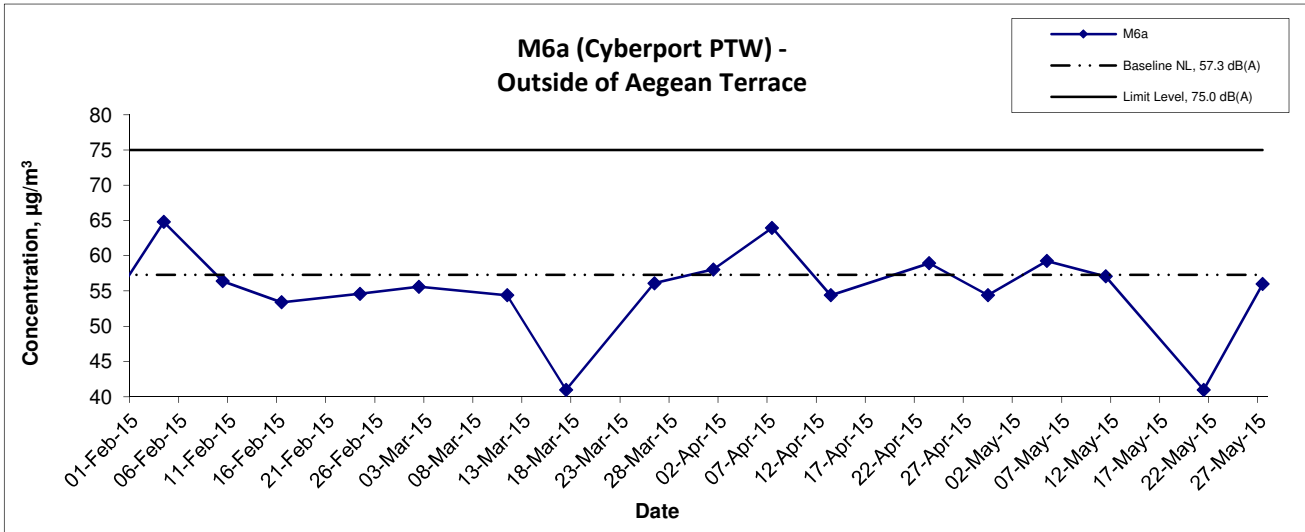
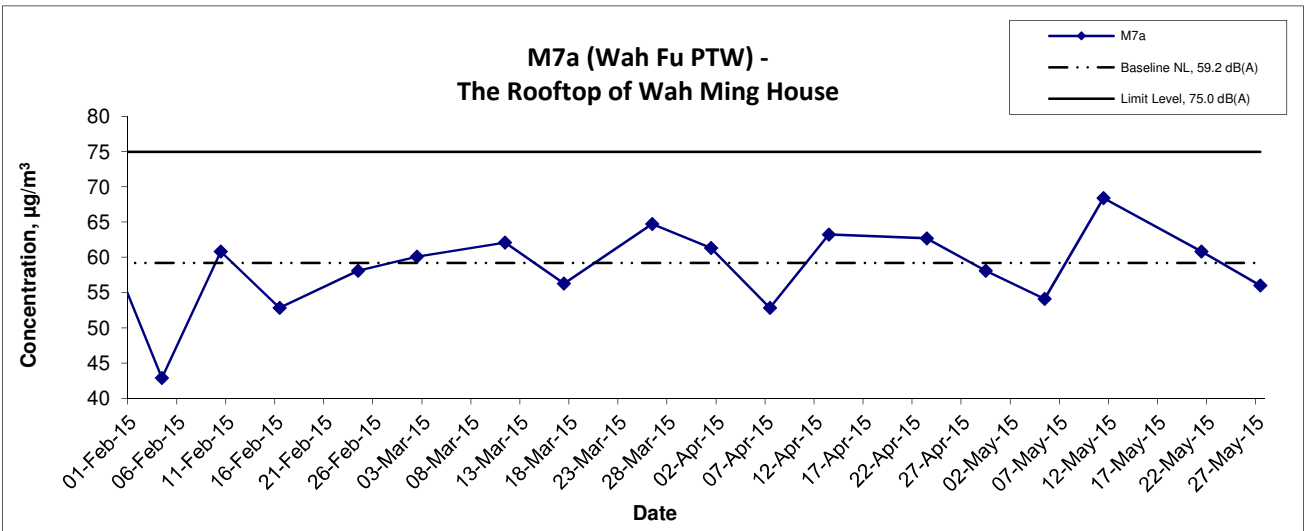
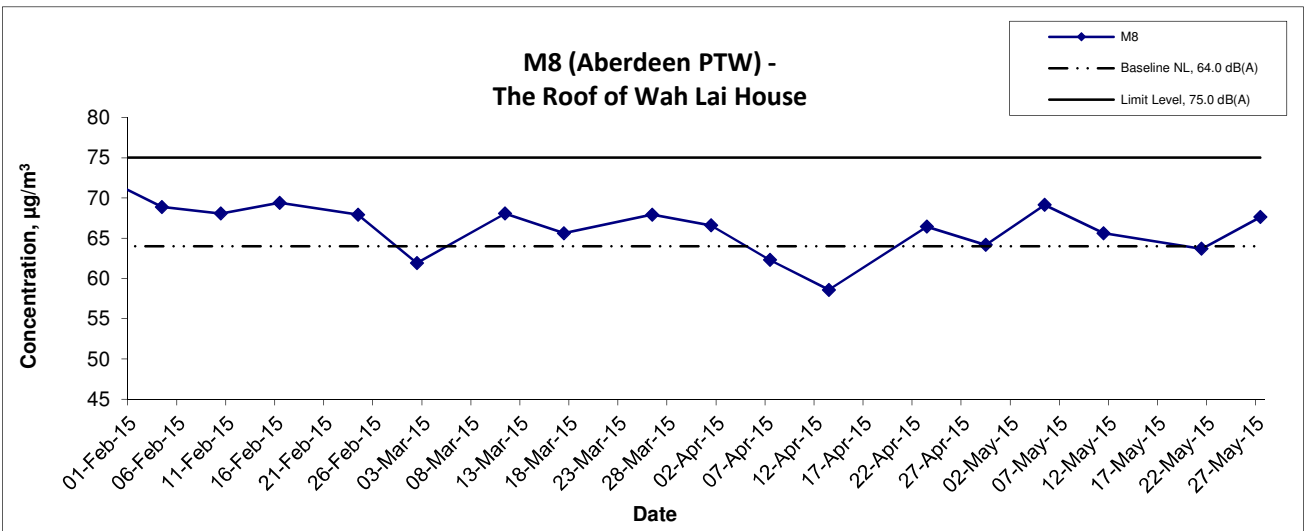
Noise Levels

Title Contract No. DC/2009/24 HATS 2A – Upgrading of Preliminary Treatment Works at Sandy Bay, Cyberport, Wah Fu, Abredeen and Ap Lei Chau Graphical Presentation of Noise Monitoring Result	Scale N.T.S Date May 15	Project No. MA11060 Appendix F	
-------------------------------------------------------------------------------------------------------------------------------------------------------------------------------------------------------	----------------------------------	-----------------------------------------	--

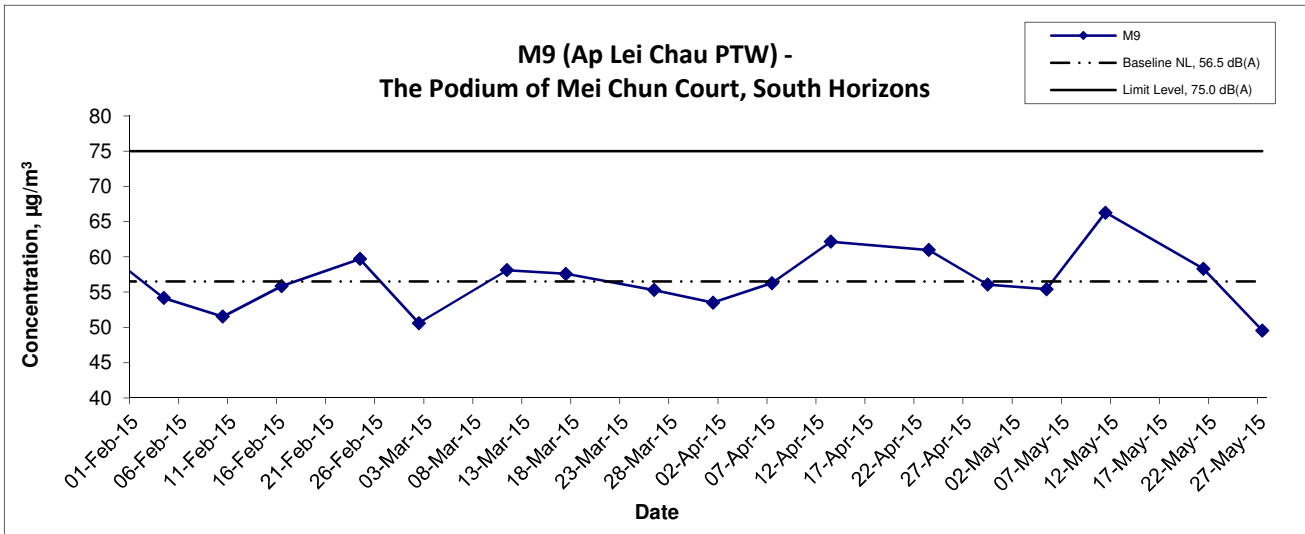
Noise Levels

Title Contract No. DC/2009/24 HATS 2A – Upgrading of Preliminary Treatment Works at Sandy Bay, Cyberport, Wah Fu, Abredeen and Ap Lei Chau Graphical Presentation of Noise Monitoring Result	Scale N.T.S	Project No. MA11060	CINOTECH
	Date May 15	Appendix F
