# Leader and JEC Joint Venture

**Contract No. DC/2009/24  
HATS Stage 2A – Upgrading of  
Preliminary Treatment Works at  
Sandy Bay, Cyberport,  
Wah Fu, Aberdeen and Ap Lei Chau**

**Monthly Environmental  
Monitoring and Audit Report  
July 2015**

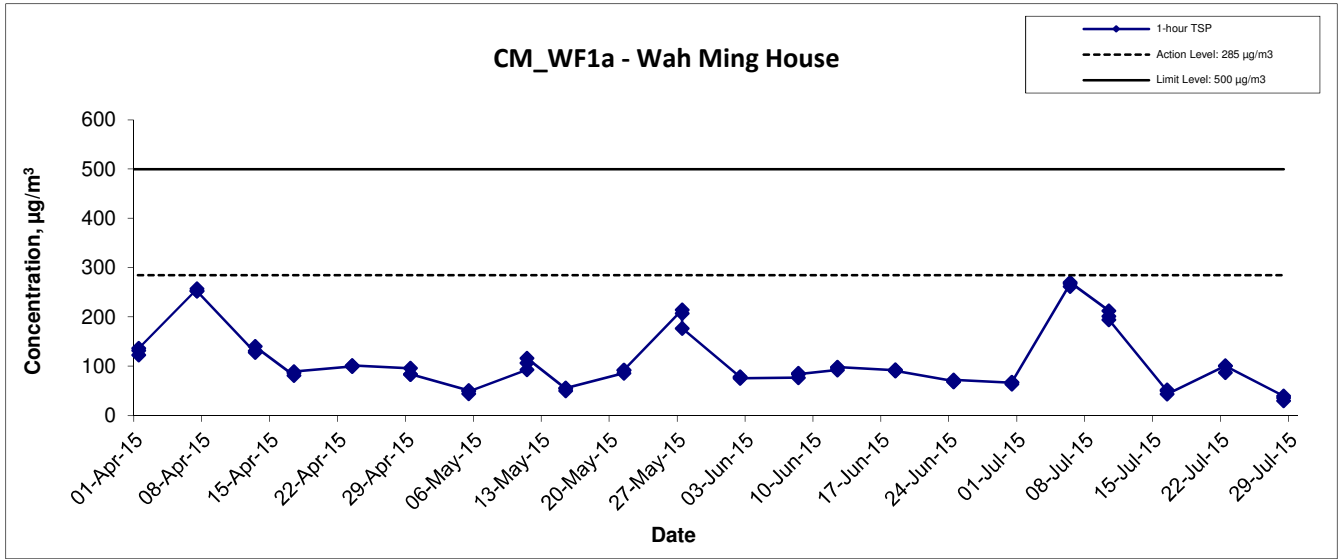
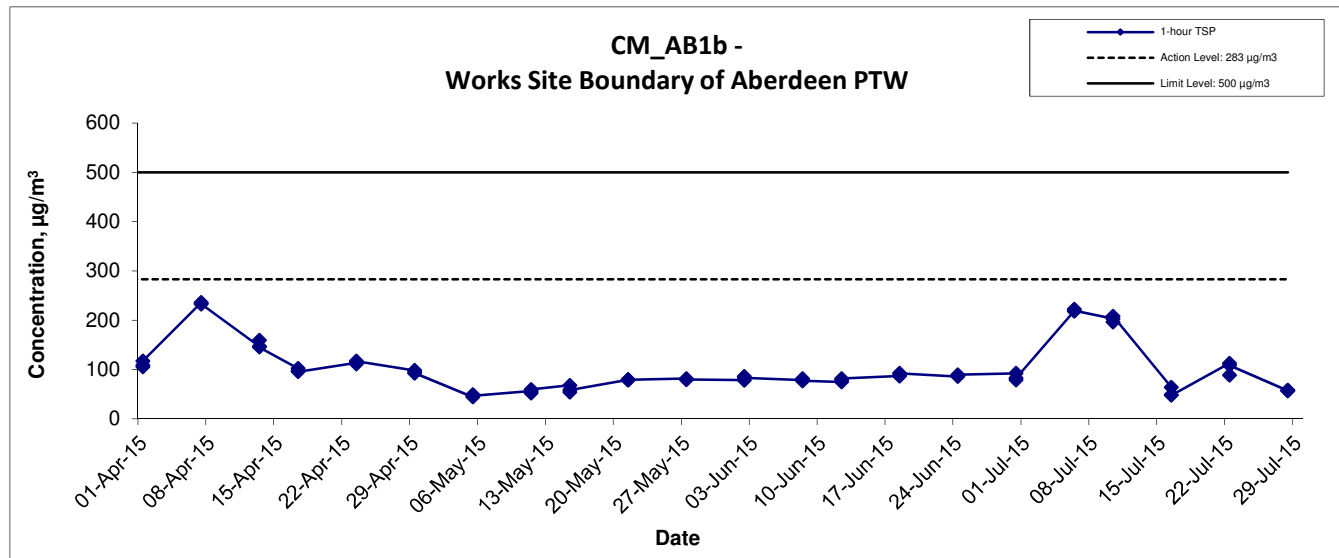
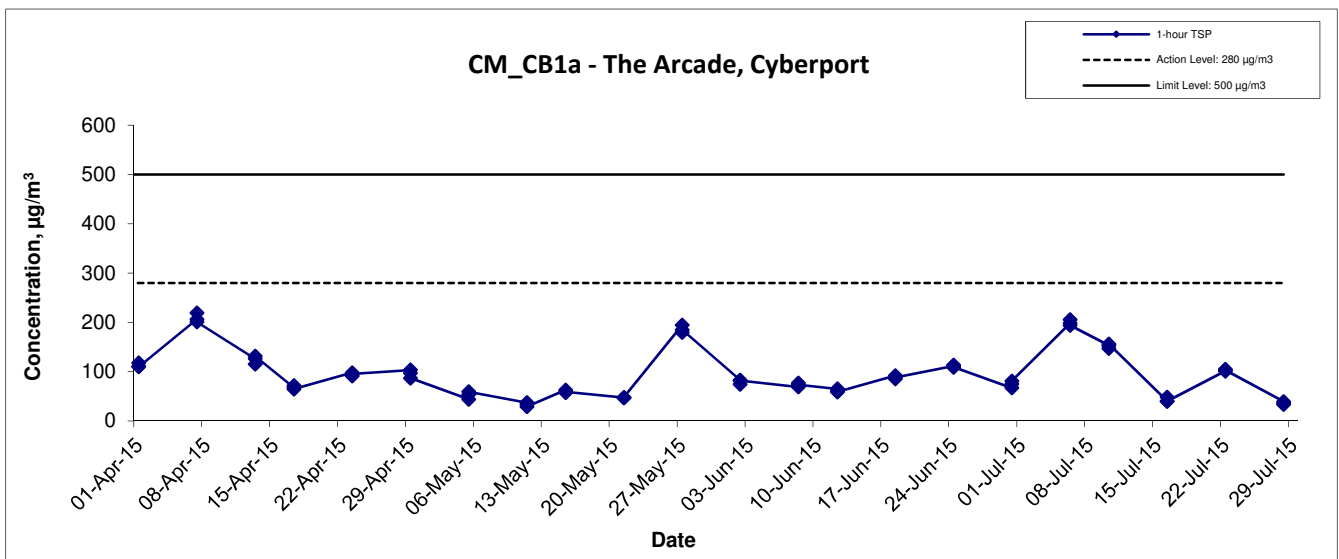
Title Contract No. DC/2009/24 HATS 2A – Upgrading of Preliminary Treatment Works at Sandy Bay, Cyberport, Wah Fu, Aberdeen and Ap Lei Chau Graphical Presentation of 1-hour TSP Monitoring Results	Scale N.T.S	Project No. MA11060	
	Date Jul 15	Appendix E

### 1-hr TSP Concentration Levels

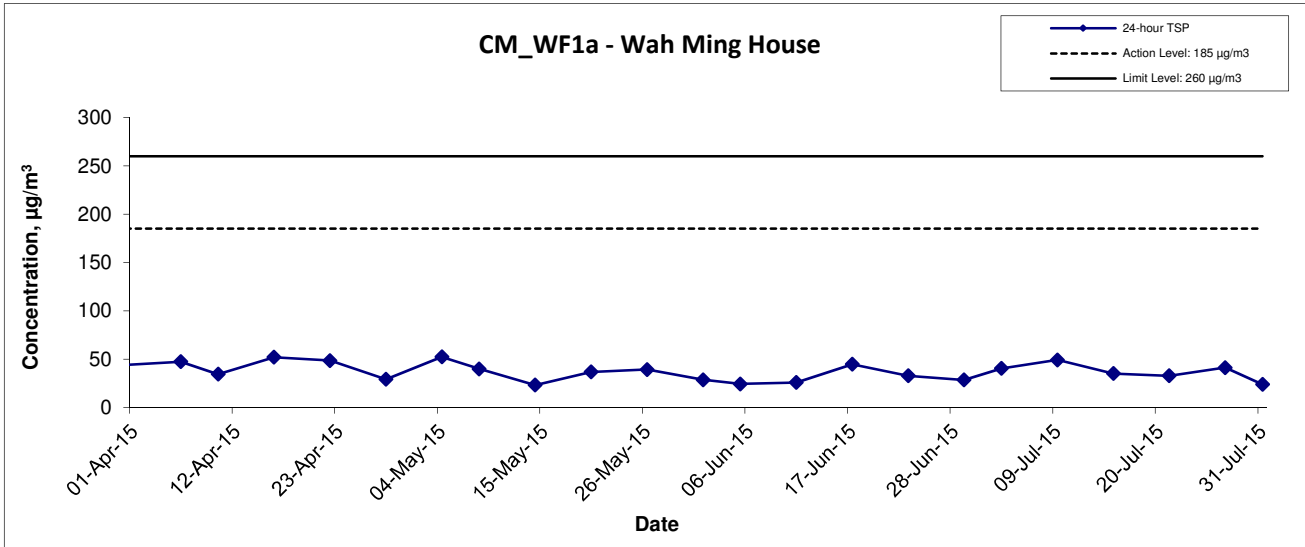
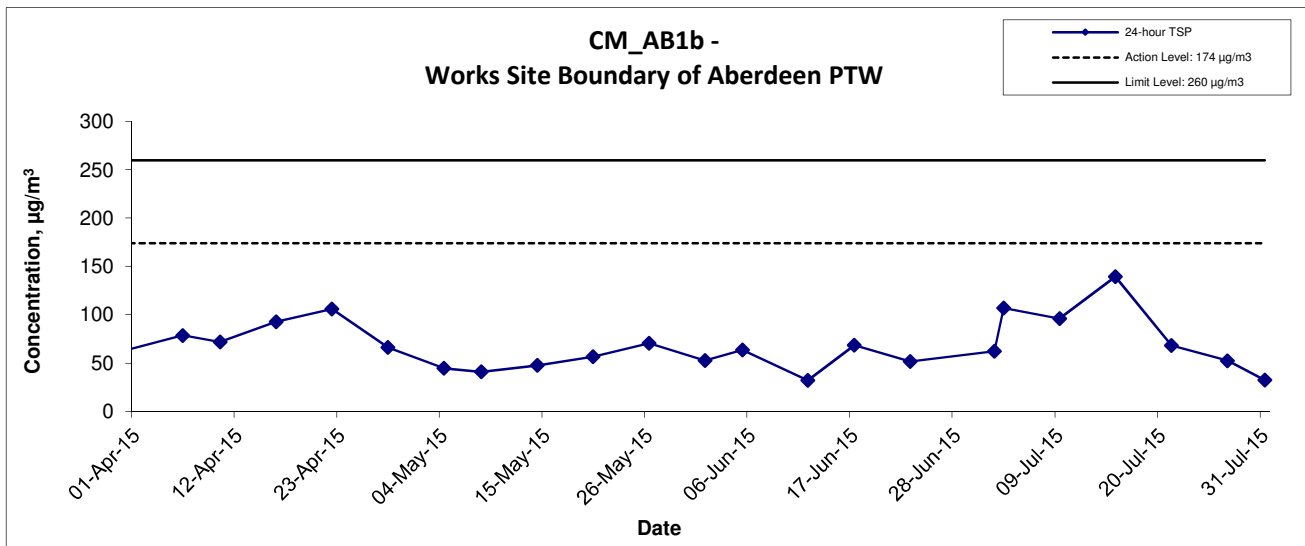
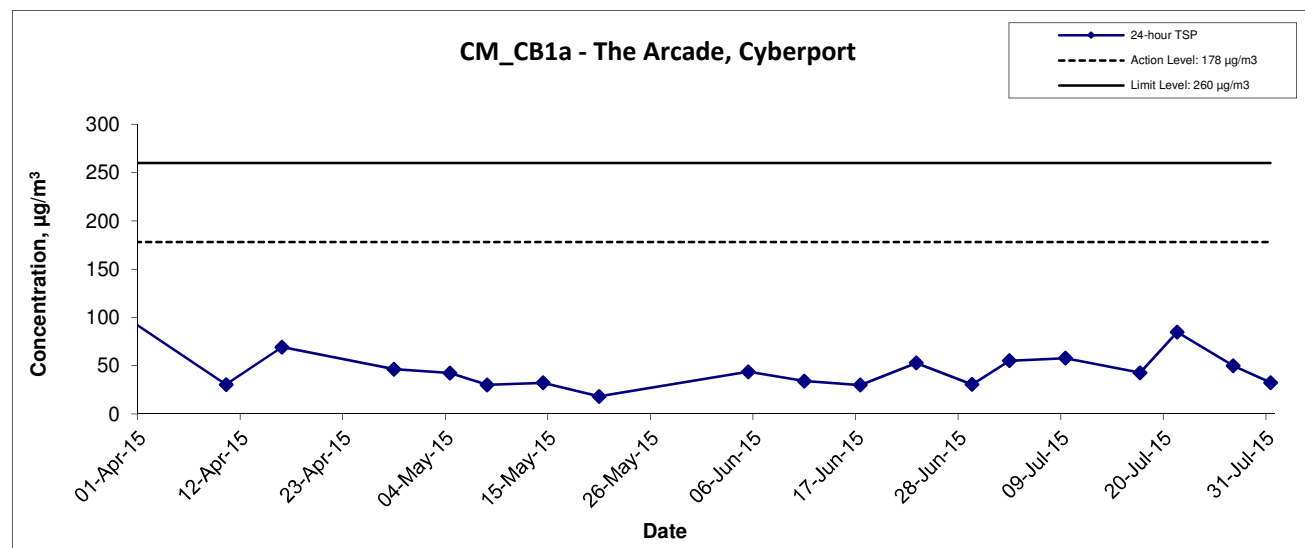
Title Contract No. DC/2009/24 HATS 2A – Upgrading of Preliminary Treatment Works at Sandy Bay, Cyberport, Wah Fu, Aberdeen and Ap Lei Chau Graphical Presentation of 24-hour TSP Monitoring Results	Scale N.T.S	Project No. MA11060	
	Date Jul 15	Appendix E

### 24-hr TSP Concentration Levels

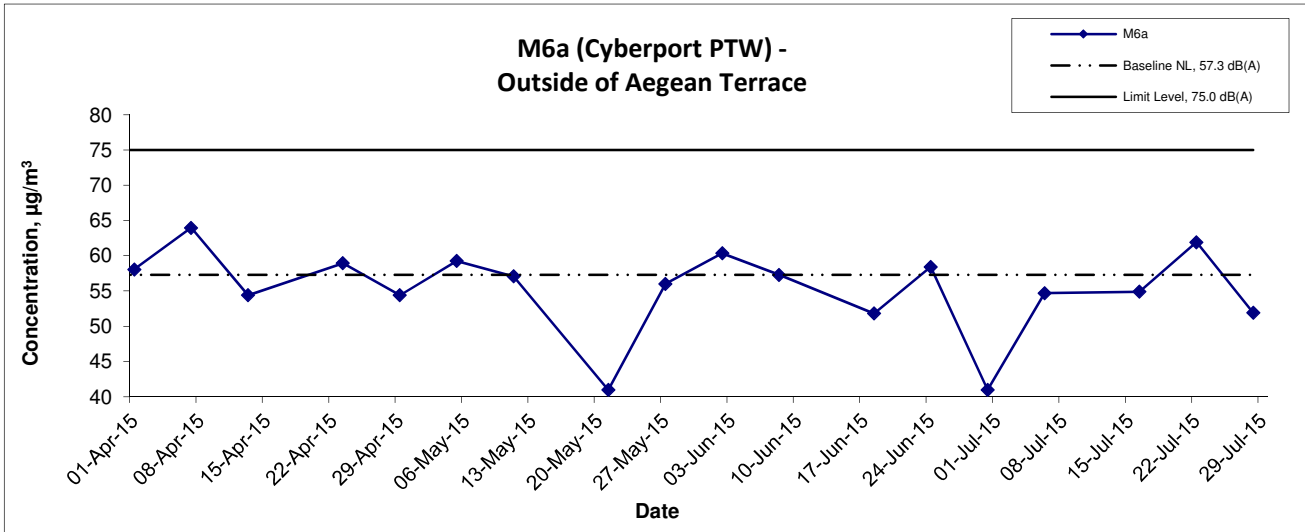
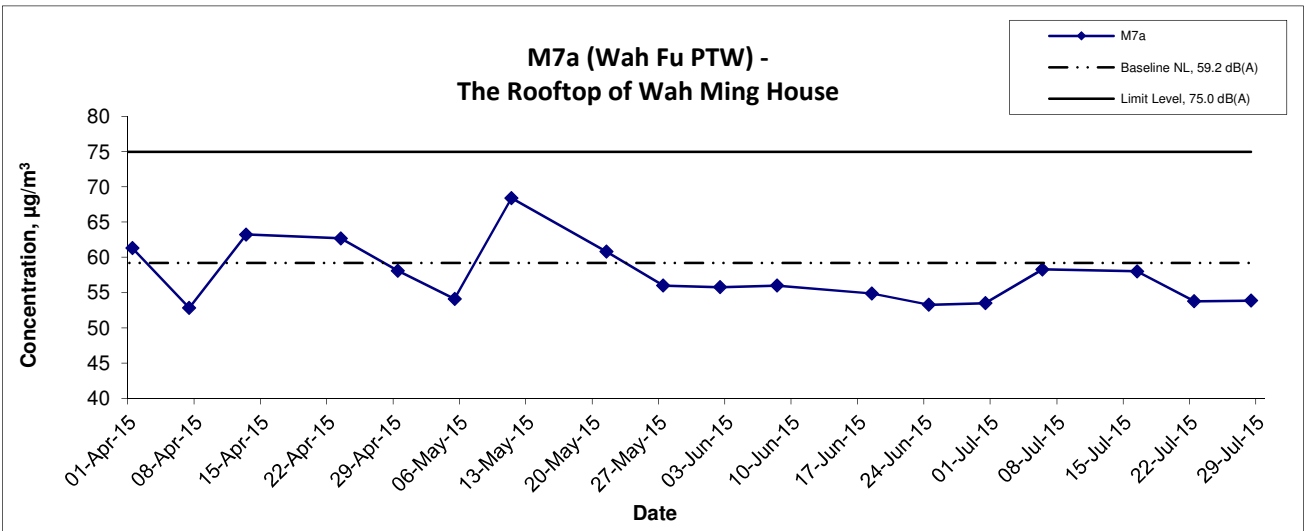
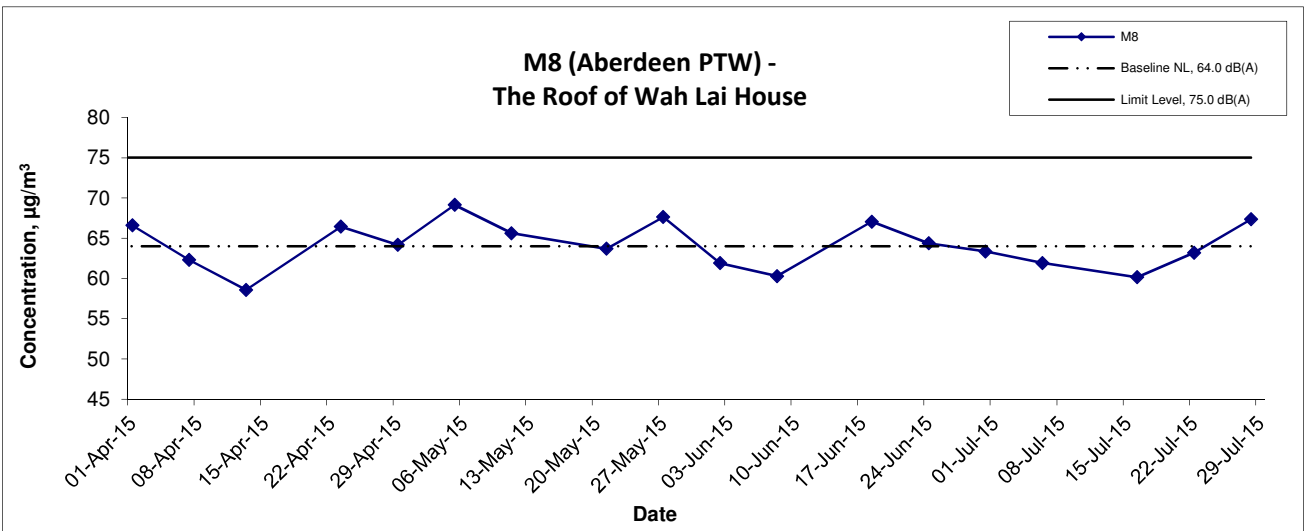
Title Contract No. DC/2009/24 HATS 2A – Upgrading of Preliminary Treatment Works at Sandy Bay, Cyberport, Wah Fu, Abredeen and Ap Lei Chau Graphical Presentation of Noise Monitoring Result	Scale N.T.S	Project No. MA11060	
Date Jul 15	Appendix F

## Noise Levels

(0700-1900 hrs on Normal Weekdays)

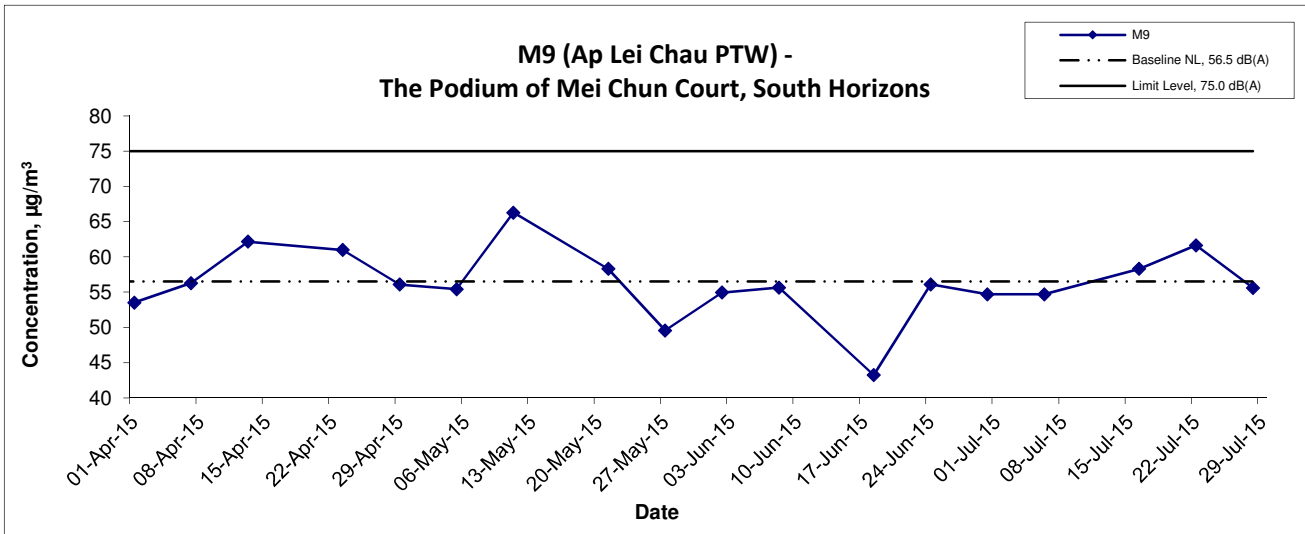
Title Contract No. DC/2009/24 HATS 2A – Upgrading of Preliminary Treatment Works at Sandy Bay, Cyberport, Wah Fu, Abredeen and Ap Lei Chau Graphical Presentation of Noise Monitoring Result	Scale N.T.S	Project No. MA11060	<b>CINOTECH</b>
	Date Jul 15	Appendix F

## Noise Levels

**(0700-1900 hrs on Normal Weekdays)**
