**Harbour Area Treatment Scheme Stage 2A  
Contract No. DC/2009/10, DC/2009/17  
and DC/2009/18**

**Consolidated Monthly Environmental  
Monitoring and Audit Report  
March 2016**

**Submission of Monthly EM&A Consolidated Report for Stonecutters Island Sewage  
Treatment Works for March 2016 (Issue No. 76) Version 1.0**

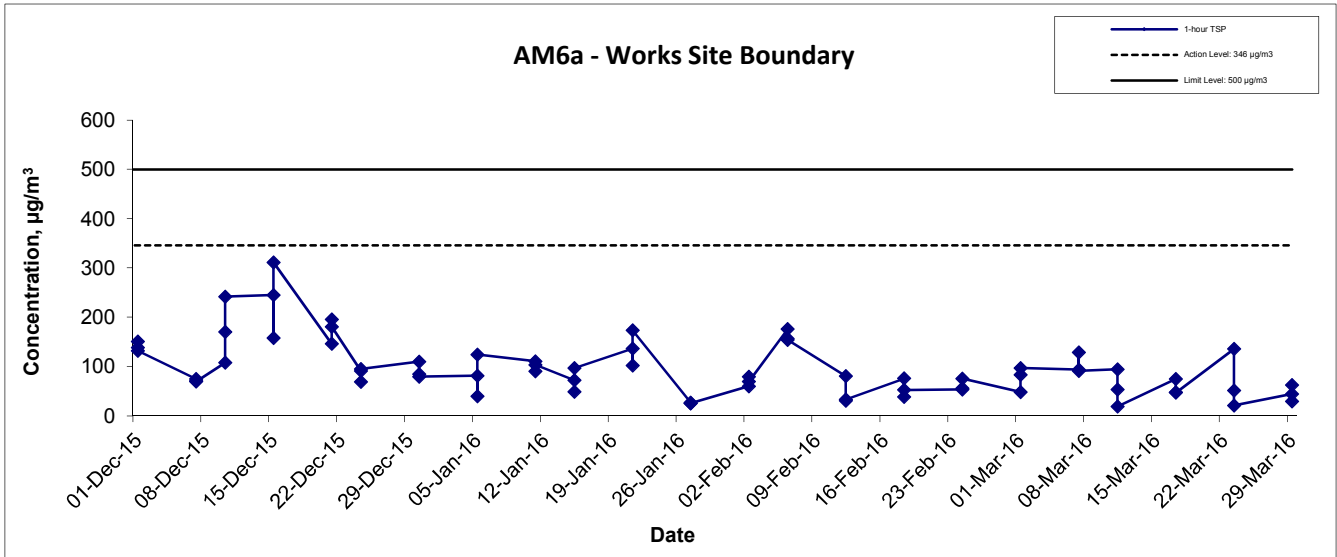
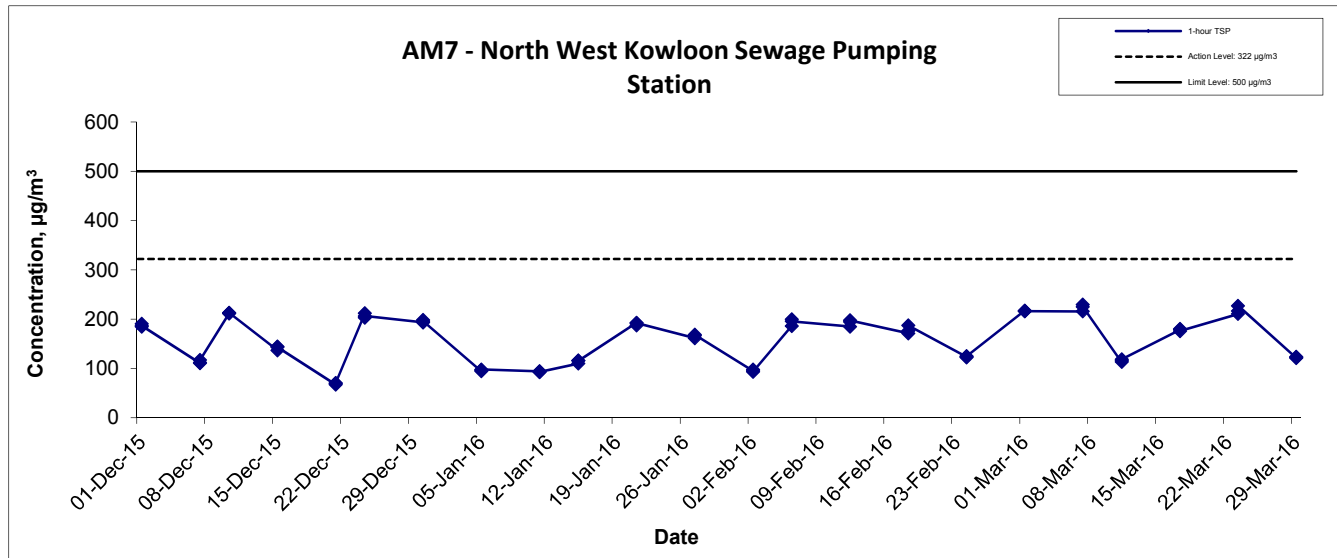
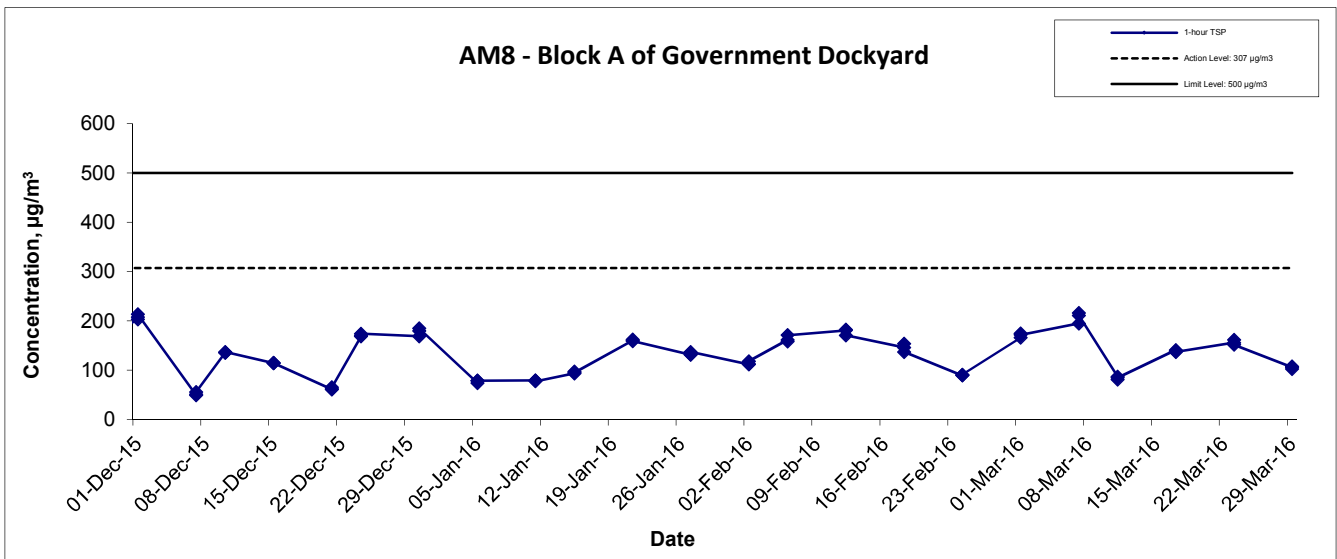
### 1-hr TSP Concentration Levels

Title Contract No. DC/2009/10 HATS 2A – Upgrading Works at SCISTW– Main Pumping Station, Sedimentation Tanks and Ancillary Graphical Presentation of 1-hour TSP Monitoring Results	Scale N.T.S	Project No. MA11007	<b>CINOTECH</b>
	Date Mar 16	Appendix D

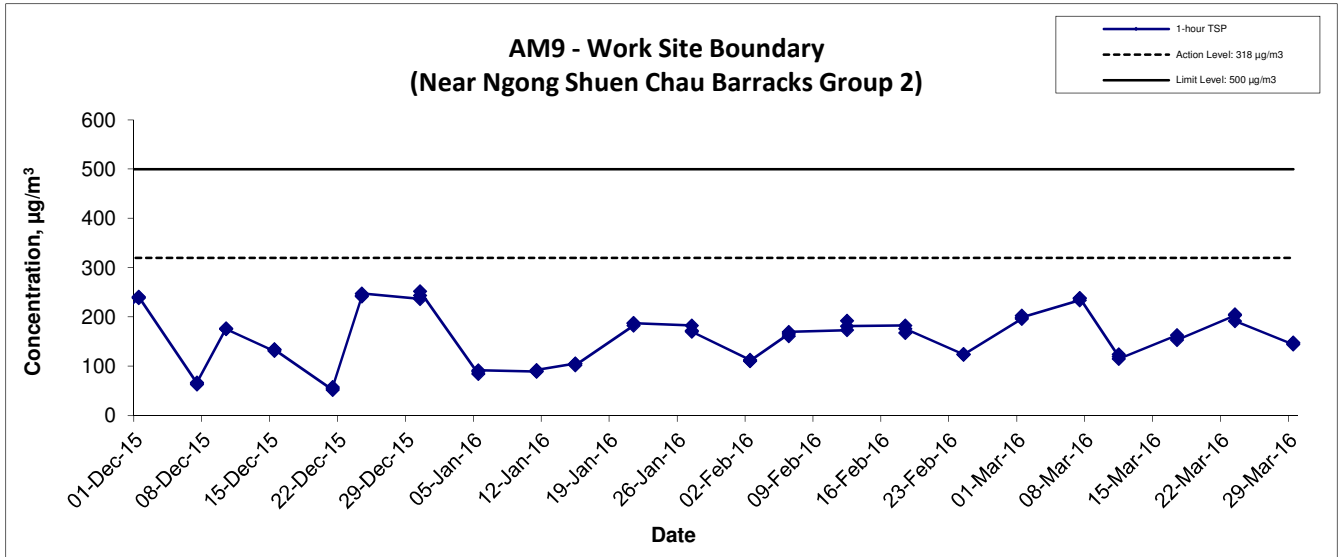
### 1-hr TSP Concentration Levels

Title Contract No. DC/2009/18 HATS 2A – Upgrading Works at SCISTW– Effluent Tunnel and Disinfection Facilities Graphical Presentation of 1-hour TSP Monitoring Results	Scale N.T.S	Project No. MA11043	<b>CINOTECH</b>
	Date Mar 16	Appendix D

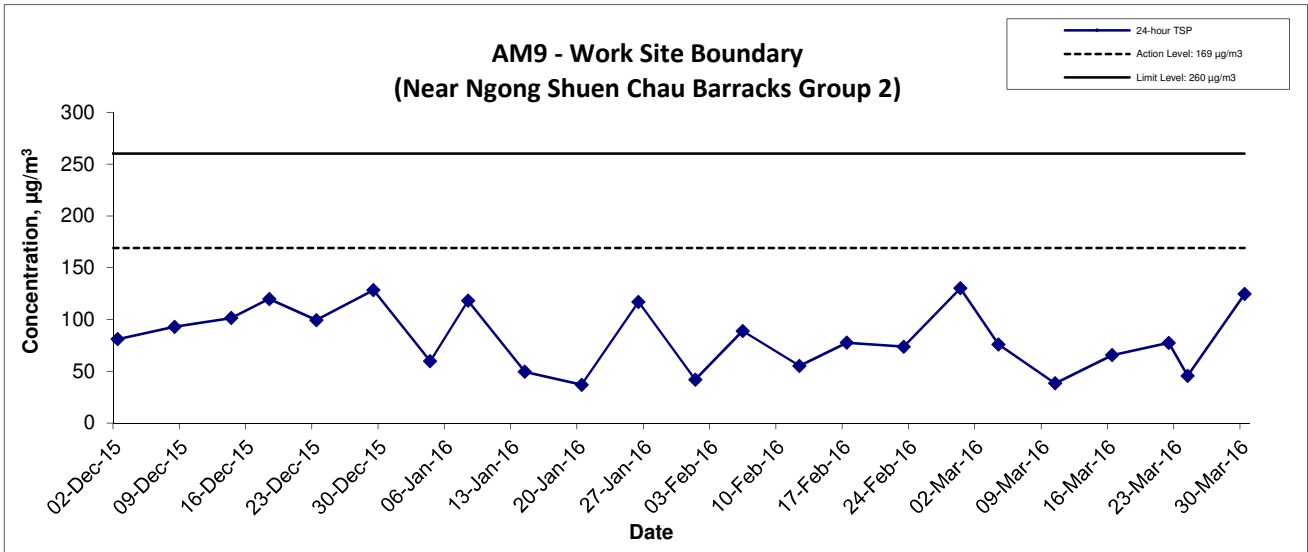
### 24-hr TSP Concentration Levels

Title Contract No. DC/2009/18 HATS 2A – Upgrading Works at SCISTW– Effluent Tunnel and Disinfection Facilities Graphical Presentation of 24-hour TSP Monitoring Results	Scale N.T.S	Project No. MA11043	
	Date Mar 16	Appendix D

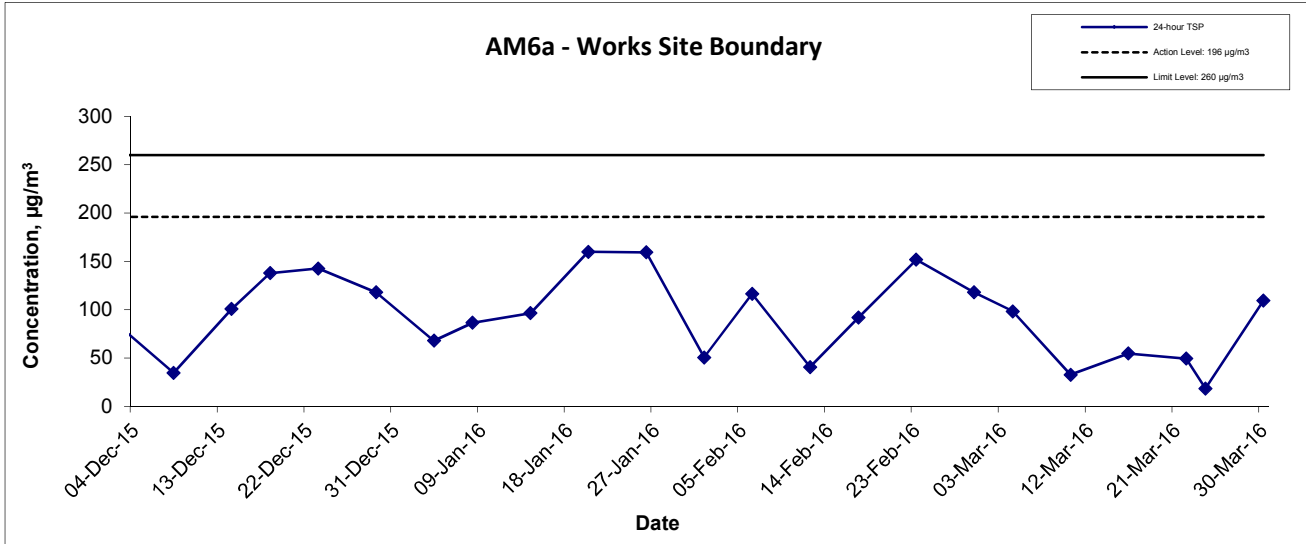
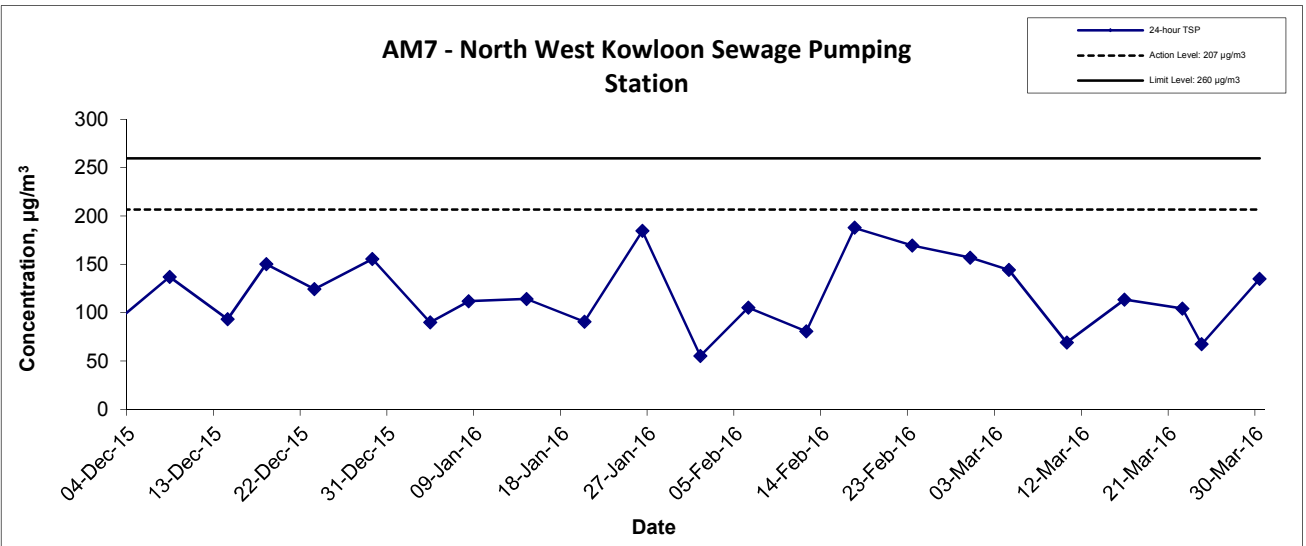
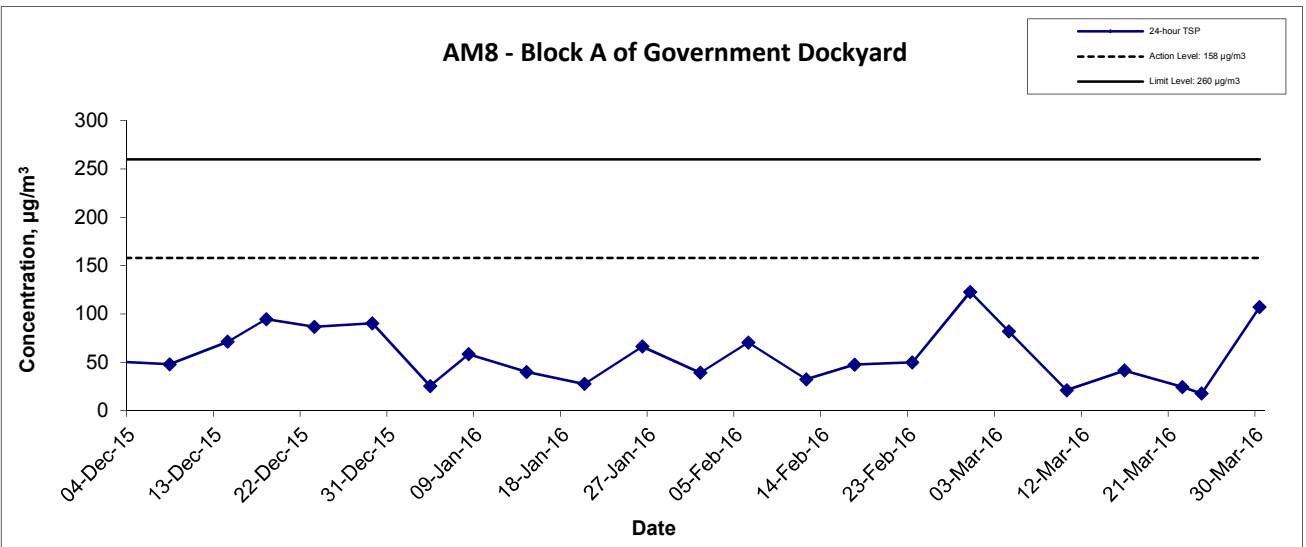
### 24-hr TSP Concentration Levels

Title Contract No. DC/2009/10  
 HATS 2A – Upgrading Works at SCISTW–  
 Main Pumping Station, Sedimentation Tanks and Ancillary  
 Graphical Presentation of 24-hour TSP Monitoring Results

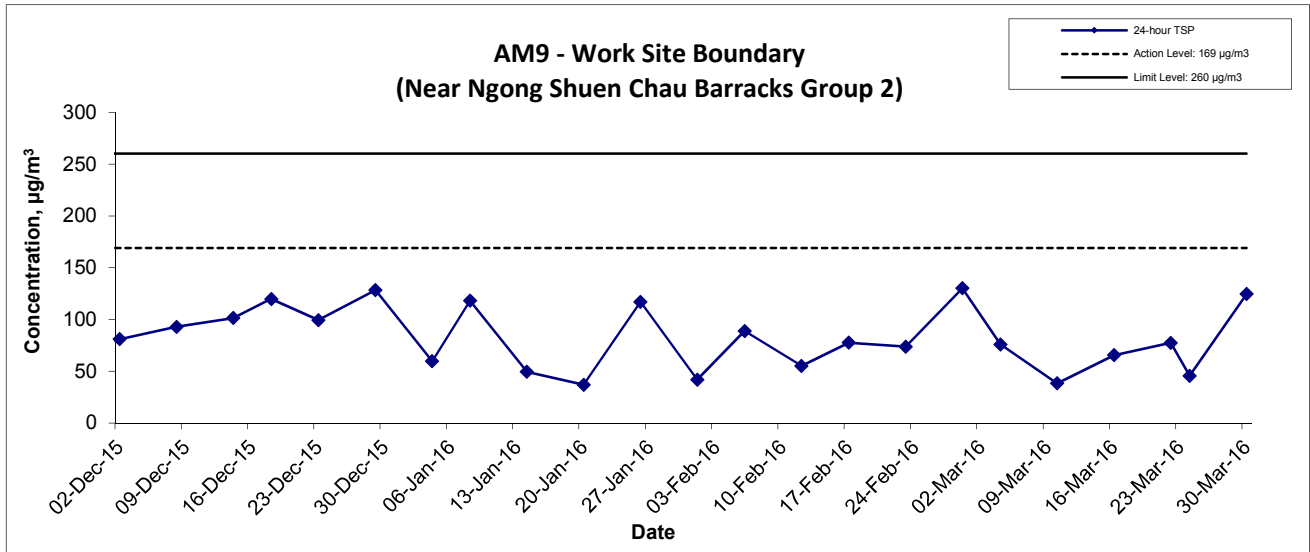
### 24-hr TSP Concentration Levels

Title Contract No. DC/2009/18 HATS 2A – Upgrading Works at SCISTW– Effluent Tunnel and Disinfection Facilities Graphical Presentation of 24-hour TSP Monitoring Results	Scale N.T.S	Project No. MA11043	
	Date Mar 16	Appendix D

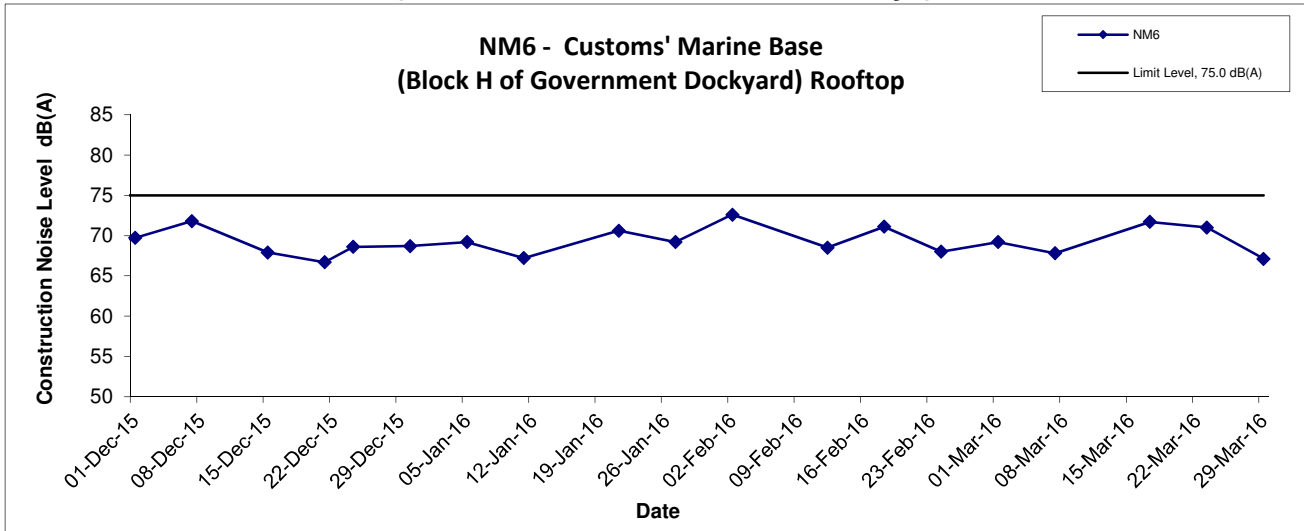
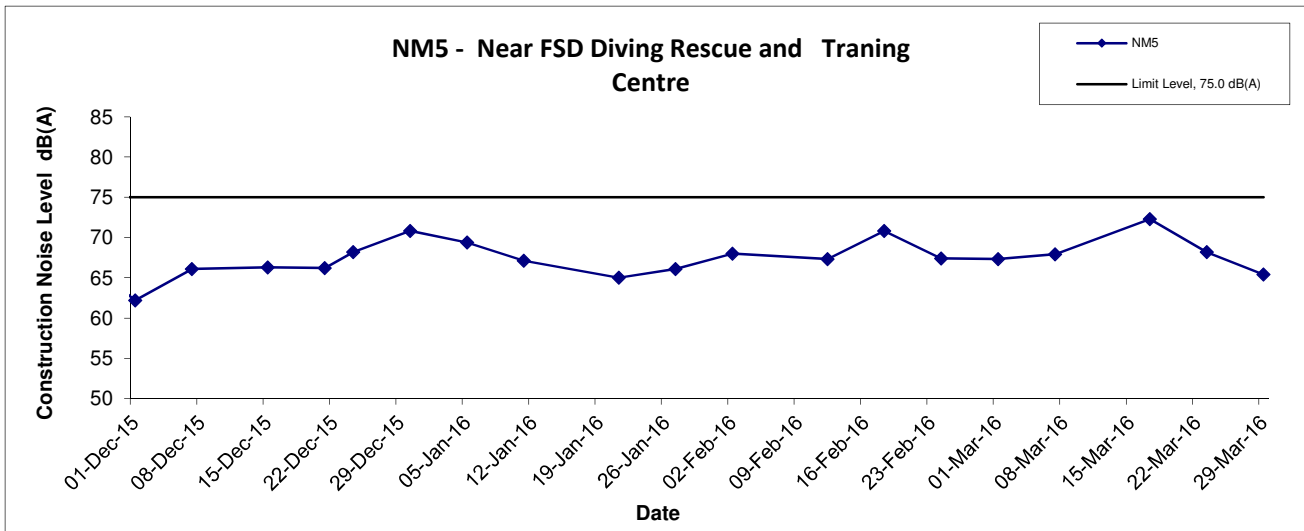
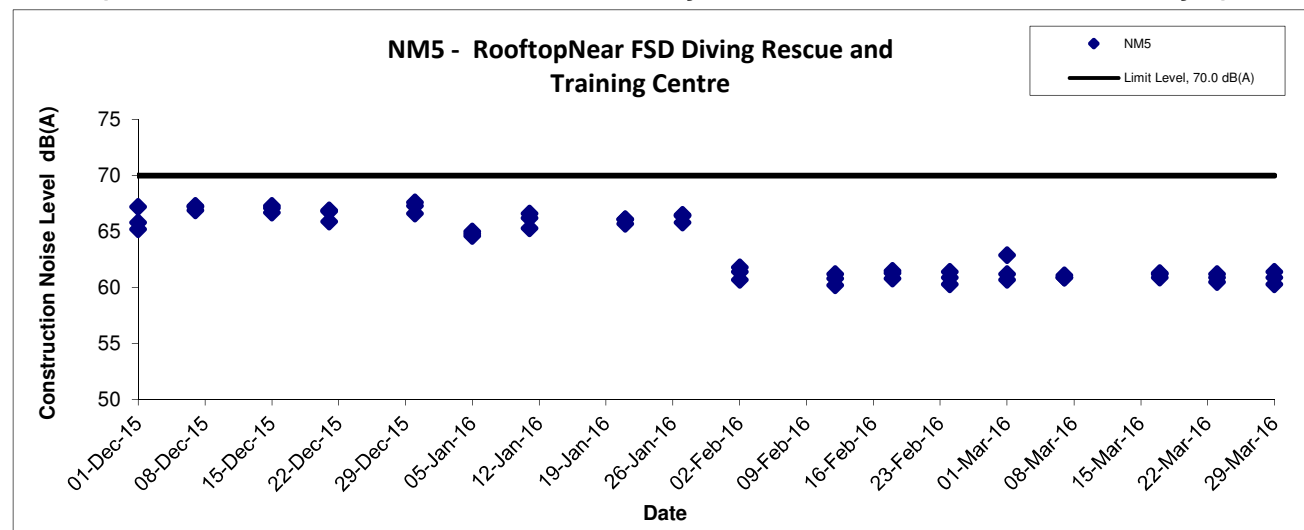
## Noise Levels

Title Contract No. DC/2009/10 HATS 2A – Upgrading Works at SCISTW– Main Pumping Station, Sedimentation Tanks and Ancillary Graphical Presentation of Noise Monitoring Result	Scale N.T.S	Project No. MA11007	
	Date Mar 16	Appendix E

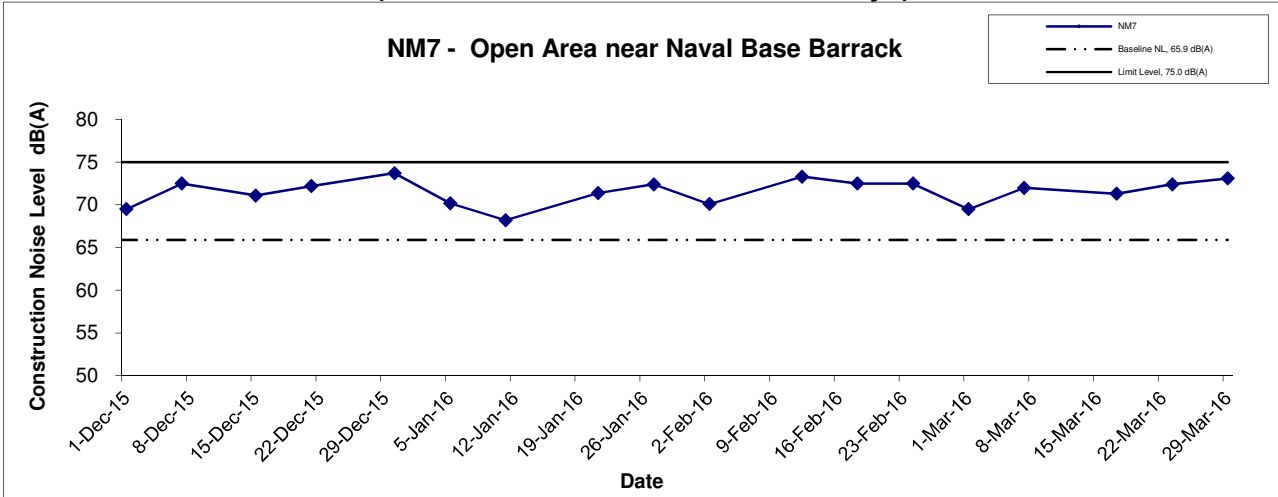
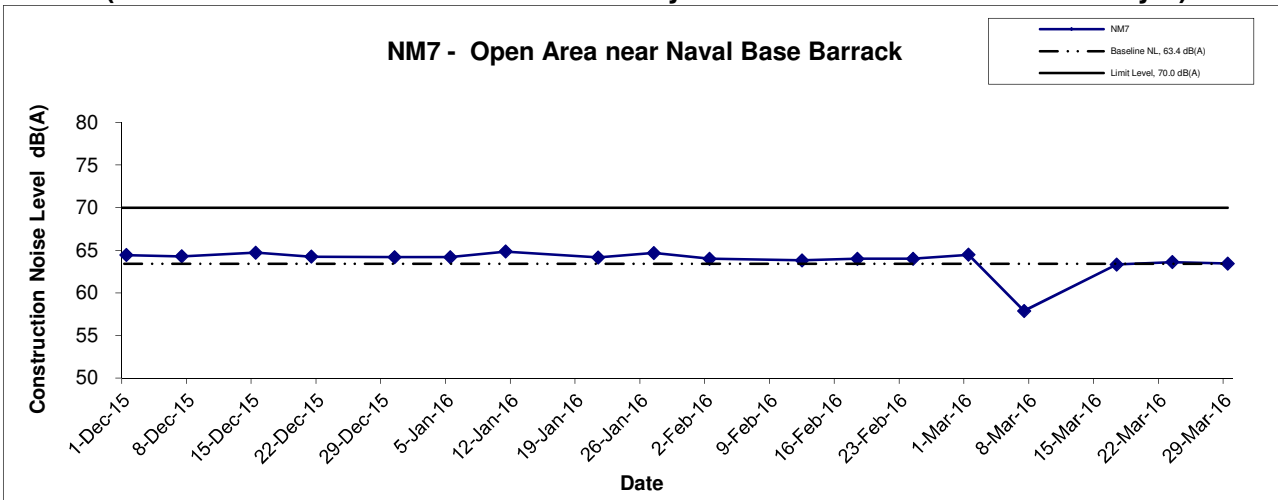
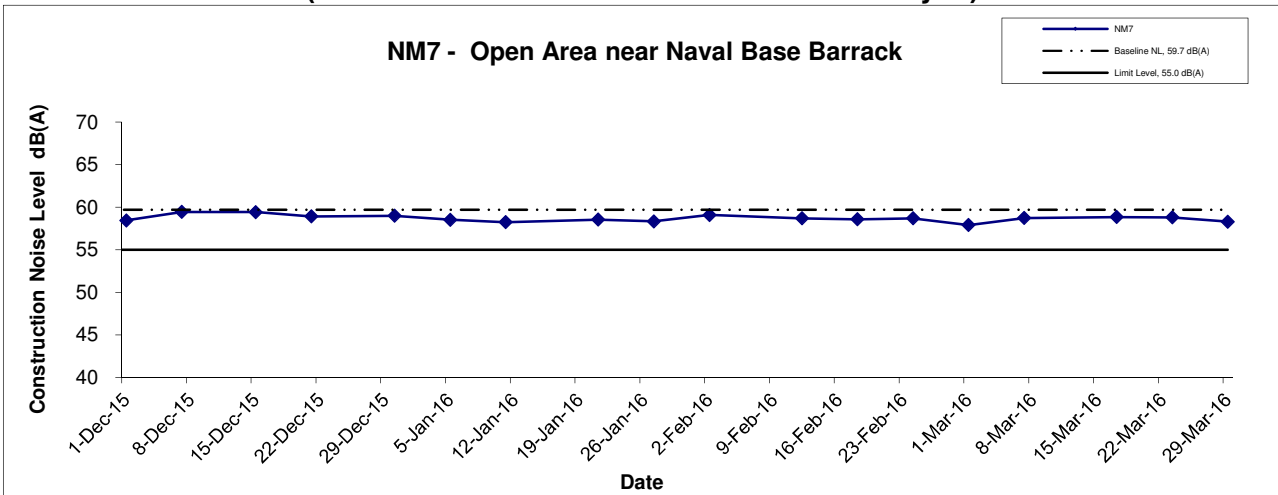
## Noise Levels

Title Contract No. DC/2009/18 HATS 2A – Upgrading Works at SCISTW– Effluent Tunnel and Disinfection Facilities Graphical Presentation of Noise Monitoring Result (NM7)	Scale N.T.S	Project No. MA11043	
	Date Mar 16	Appendix E
