**Contract No. DC/2009/24
HATS Stage 2A – Upgrading of
Preliminary Treatment Works at
Sandy Bay, Cyberport,
Wah Fu, Aberdeen and Ap Lei Chau**

**Monthly Environmental
Monitoring and Audit Report
April 2017**

Condition 4.4 – Monthly EM&A Report for April 2017 (no. 64) Version 1.0

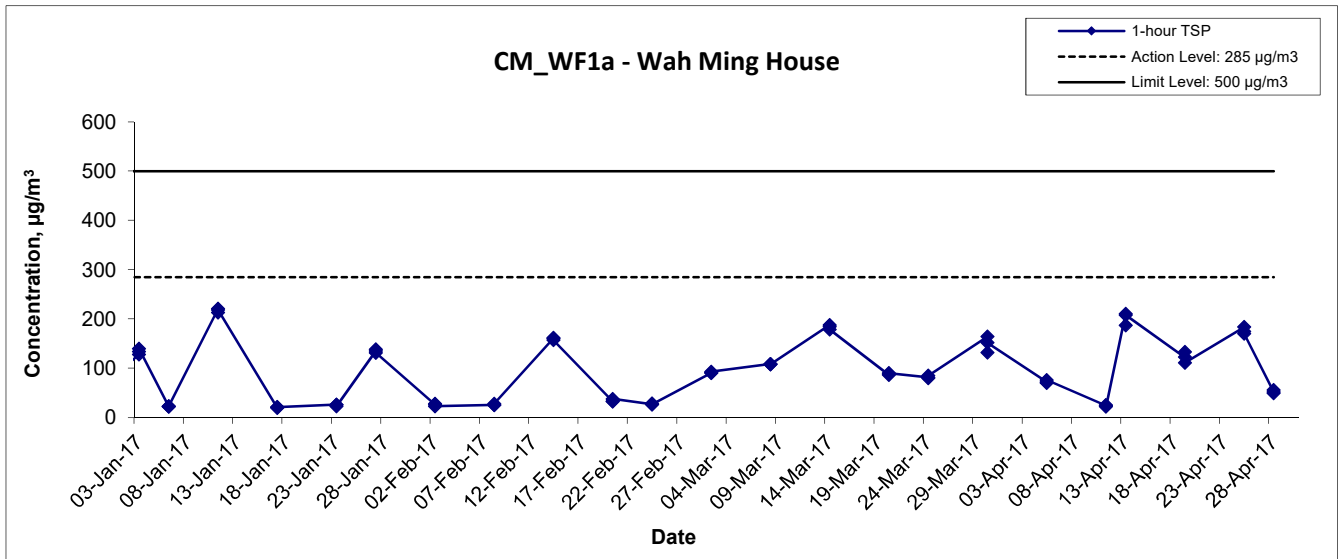
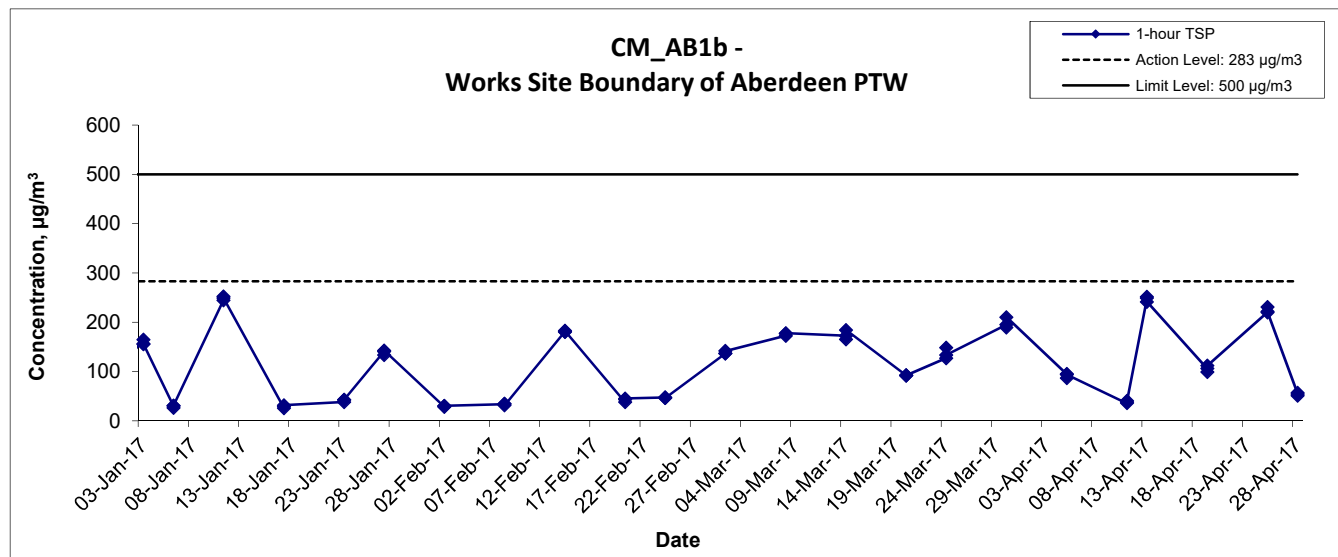
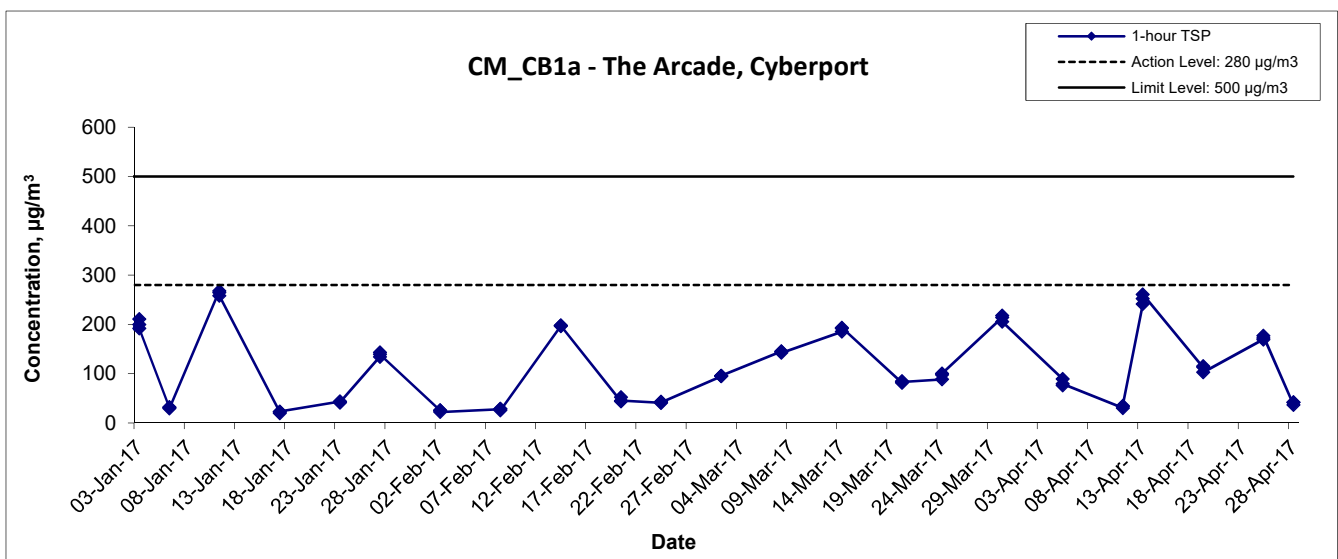
Title Contract No. DC/2009/24 HATS 2A – Upgrading of Preliminary Treatment Works at Sandy Bay, Cyberport, Wah Fu, Aberdeen and Ap Lei Chau Graphical Presentation of 1-hour TSP Monitoring Results	Scale N.T.S	Project No. MA11060	
	Date Apr 17	Appendix E

Location CM_CB1a - The Arcade, Cyberport			
Date	Time	Weather	Particulate Concentration ($\mu\text{g}/\text{m}^3$)
5-Apr-17	13:00	Sunny	89.3
5-Apr-17	14:00	Sunny	76.4
5-Apr-17	15:00	Sunny	79.4
11-Apr-17	13:00	Cloudy	30.1
11-Apr-17	14:00	Cloudy	33.6
11-Apr-17	15:00	Cloudy	34.8
13-Apr-17	9:00	Cloudy	241.4
13-Apr-17	10:00	Cloudy	251.9
13-Apr-17	11:00	Cloudy	260.8
19-Apr-17	13:00	Sunny	112.9
19-Apr-17	14:00	Sunny	115.4
19-Apr-17	15:00	Sunny	102.7
25-Apr-17	8:30	Fine	169.3
25-Apr-17	9:30	Fine	172.6
25-Apr-17	10:30	Fine	177.1
28-Apr-17	9:00	Cloudy	36.9
28-Apr-17	10:00	Cloudy	41.5
28-Apr-17	11:00	Cloudy	41.5
		Average	114.9
		Maximum	260.8
		Minimum	30.1

1-hr TSP Concentration Levels

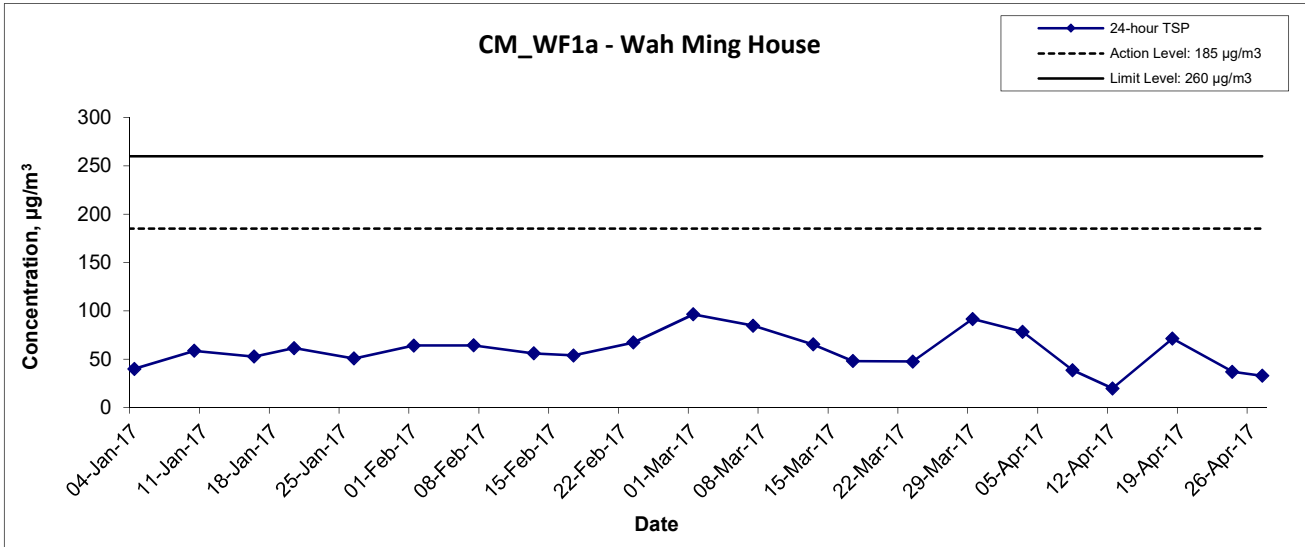
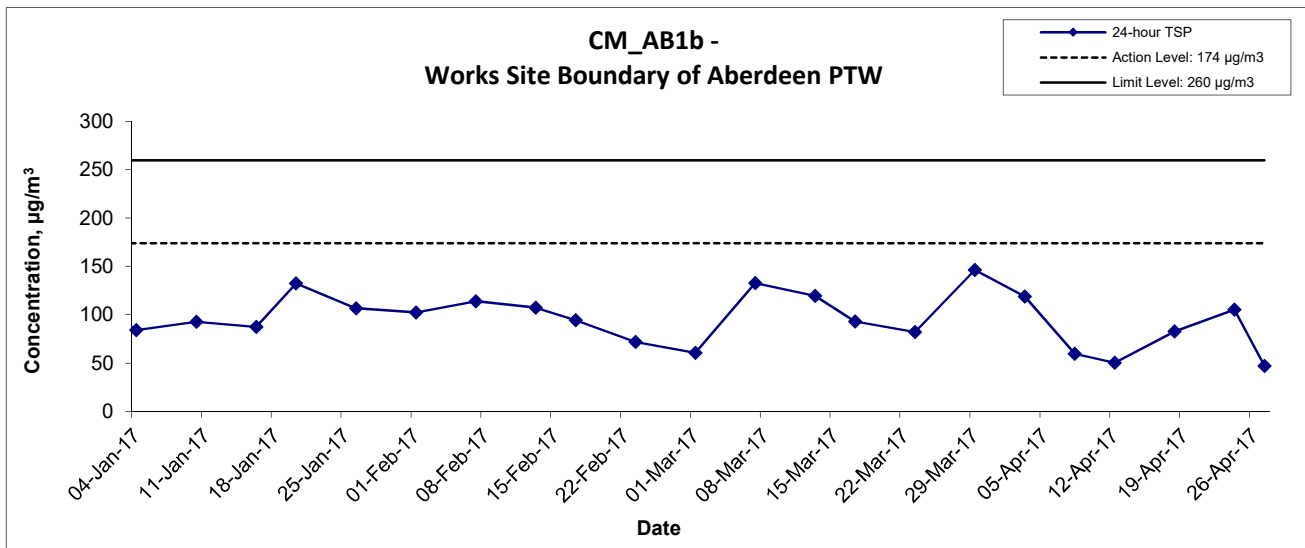
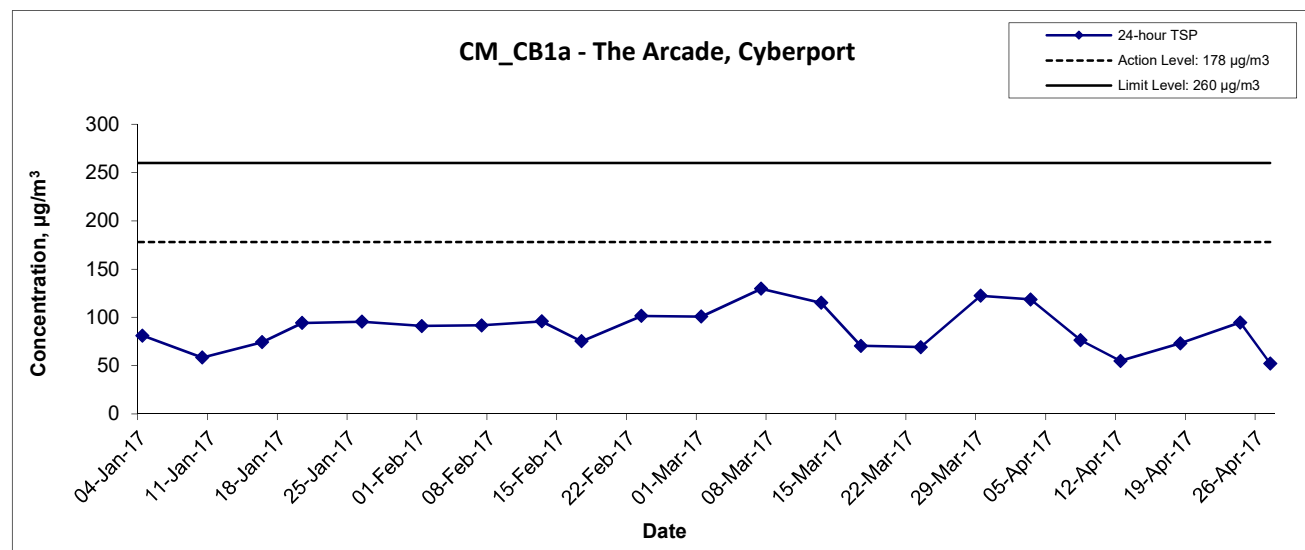
Title Contract No. DC/2009/24 HATS 2A – Upgrading of Preliminary Treatment Works at Sandy Bay, Cyberport, Wah Fu, Aberdeen and Ap Lei Chau Graphical Presentation of 24-hour TSP Monitoring Results	Scale N.T.S	Project No. MA11060	
	Date Apr 17	Appendix E

Min	52.2		
												Max	118.7		
												Average	78.4

24-hr TSP Concentration Levels

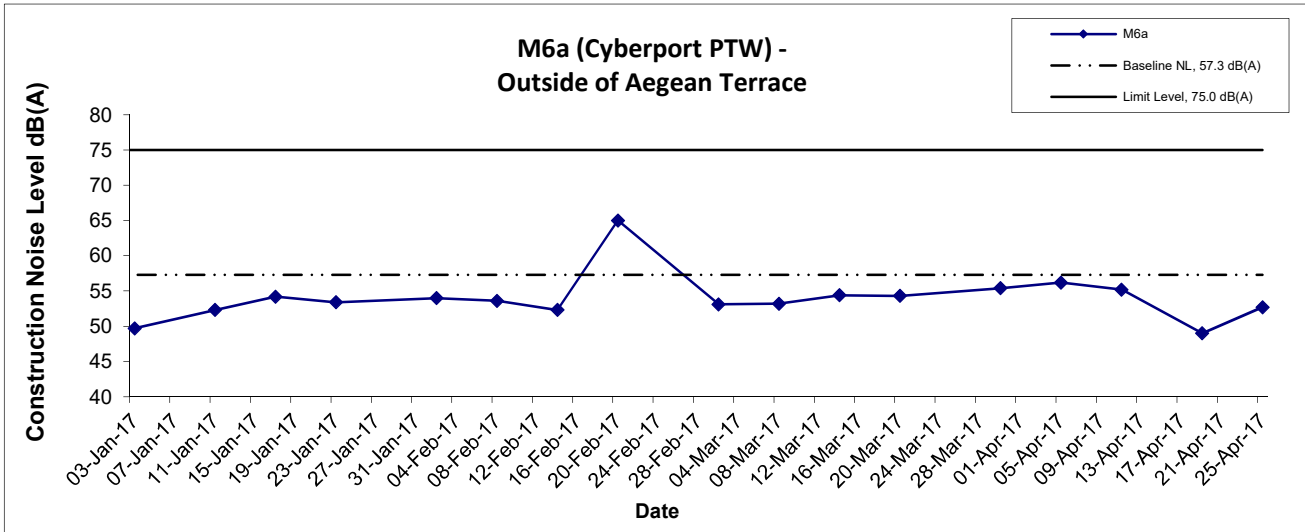
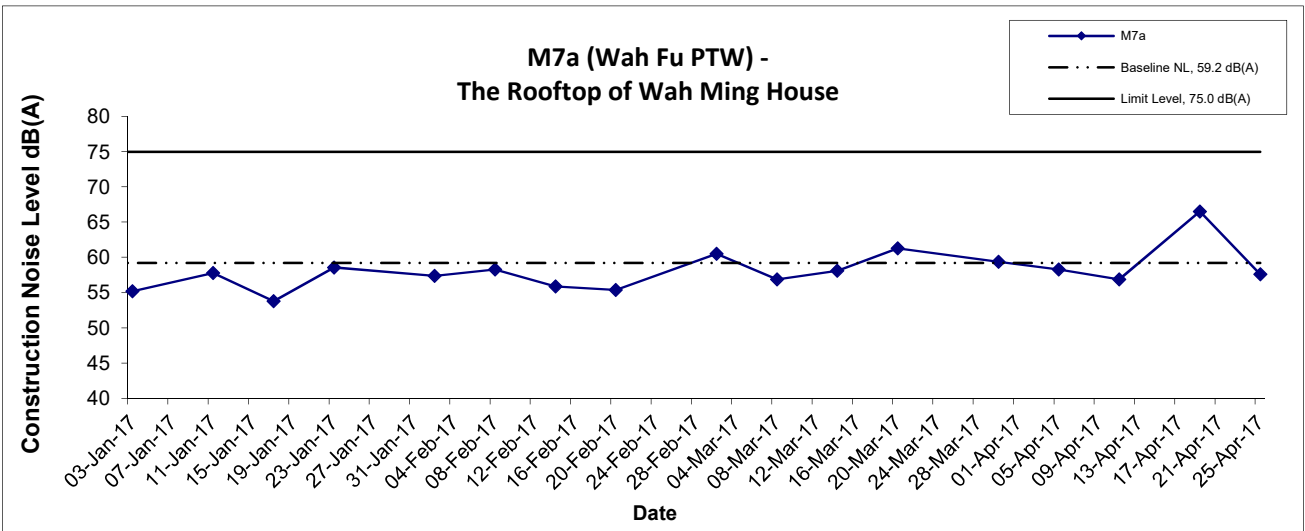
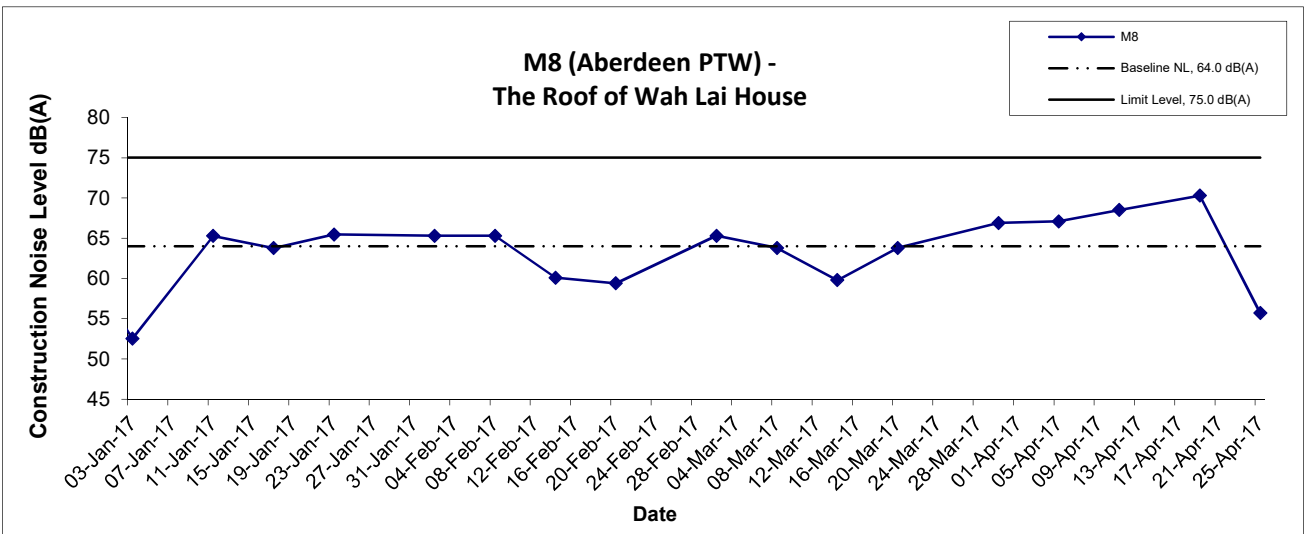
Title Contract No. DC/2009/24 HATS 2A – Upgrading of Preliminary Treatment Works at Sandy Bay, Cyberport, Wah Fu, Abredeen and Ap Lei Chau Graphical Presentation of Noise Monitoring Result	Scale N.T.S Date Apr 17	Project No. MA11060 Appendix F	
---	----------------------------------	---	--

Noise Levels

(0700-1900 hrs on Normal Weekdays)

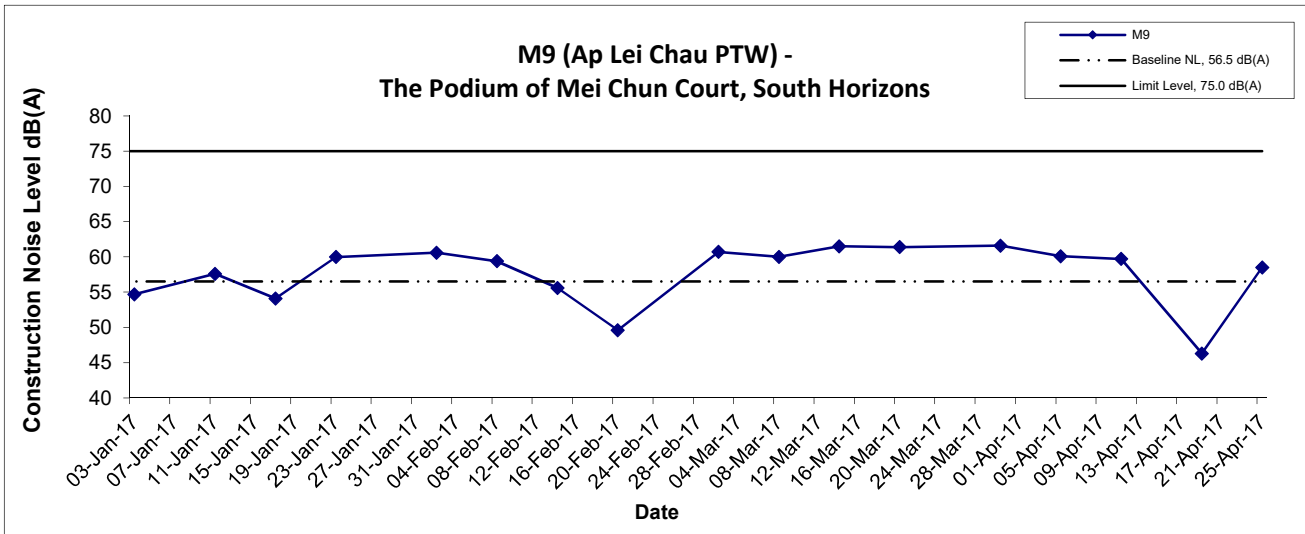
Title Contract No. DC/2009/24 HATS 2A – Upgrading of Preliminary Treatment Works at Sandy Bay, Cyberport, Wah Fu, Abredeen and Ap Lei Chau Graphical Presentation of Noise Monitoring Result	Scale N.T.S	Project No. MA11060	
	Date Apr 17	Appendix F

Noise Levels

(0700-1900 hrs on Normal Weekdays)
