**Harbour Area Treatment Scheme Stage 2A
Contract No. DC/2009/10 and
DC/2009/17**

**Consolidated Monthly Environmental
Monitoring and Audit Report
June 2018**

**Submission of Monthly EM&A Consolidated Report for Stonecutters Island
Sewage Treatment Works for June 2018 (Issue No. 103)**

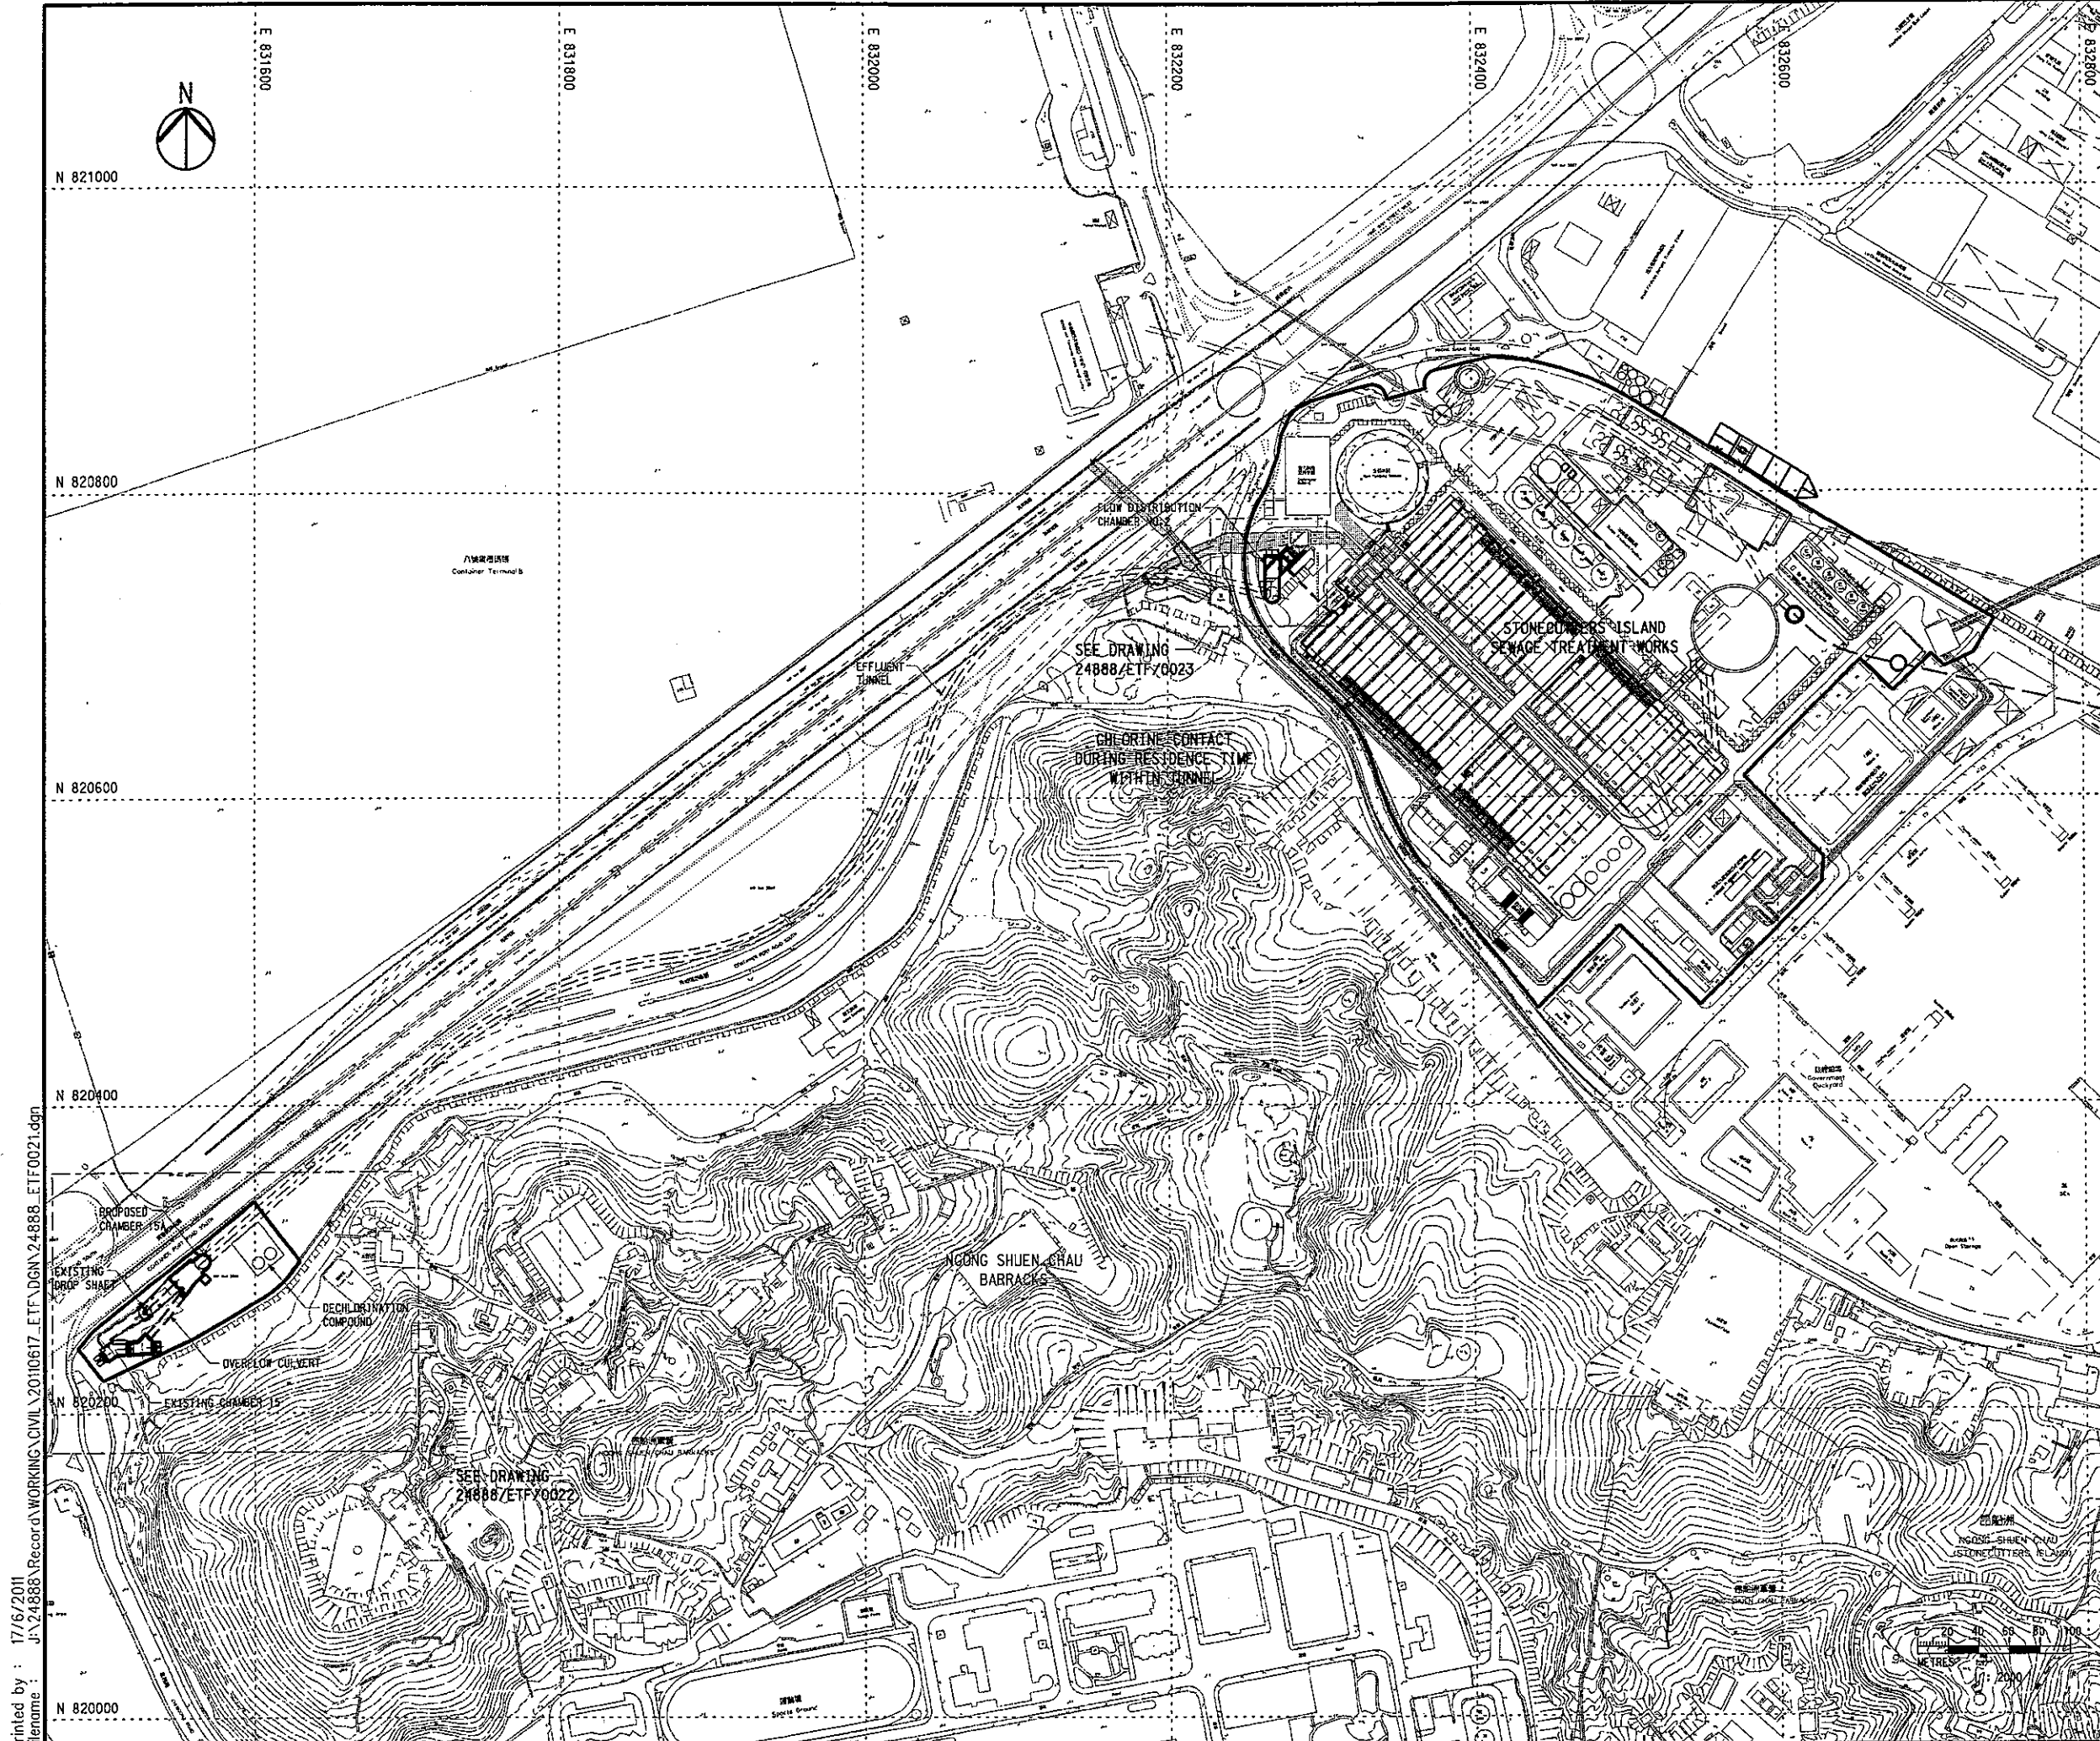
Figures 1-3	General Location Plan of the Project and Location of Air Quality and Noise Monitoring Stations
-------------	------------------------------------------------------------------------------------------------
