Contract No. DC/2009/10 HATS Stage 2A – Upgrading Works at Stonecutters Island Sewage Treatment Works - Main Pumping Station, Sedimentation Tanks and Ancillary Facilities

Monthly Environmental
Monitoring and Audit Report
April 2019

(Version 1.0)

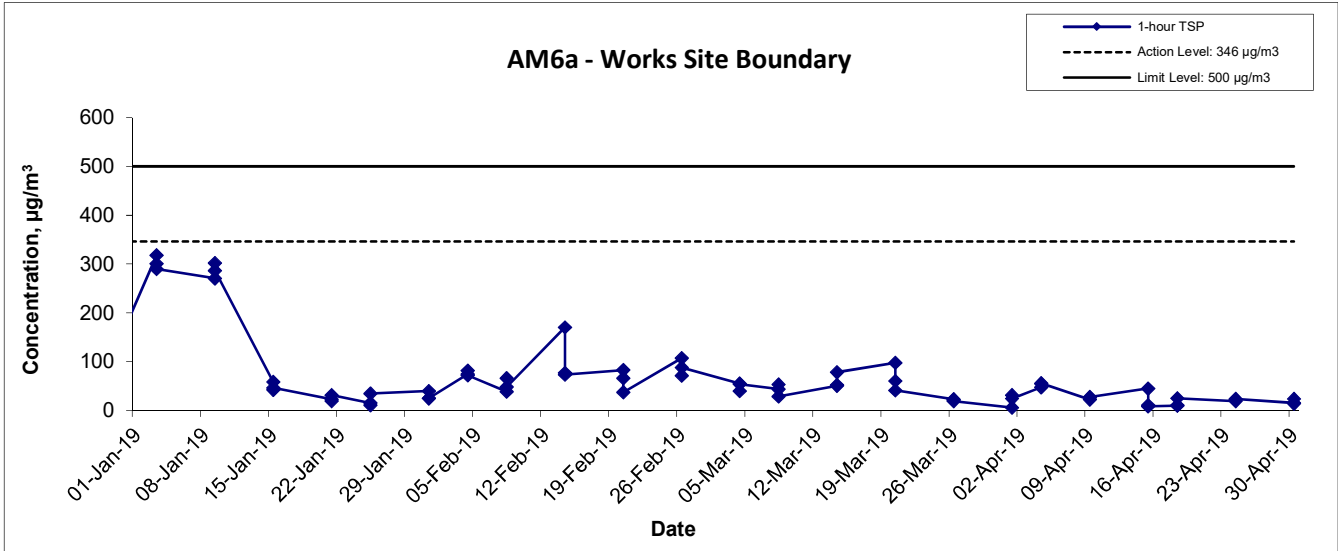
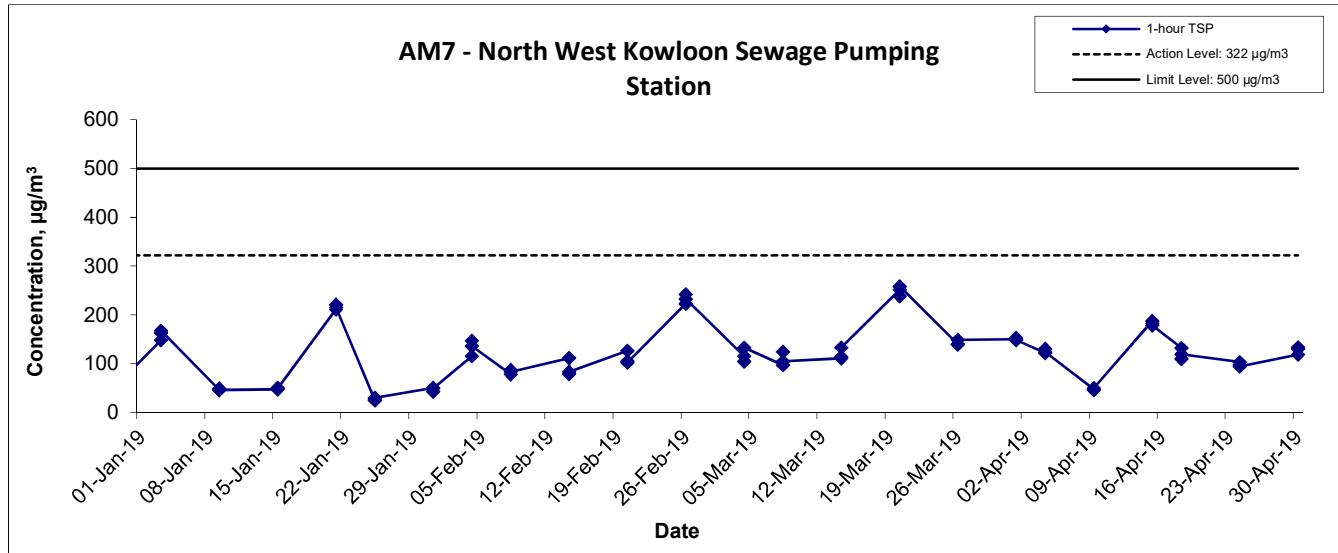
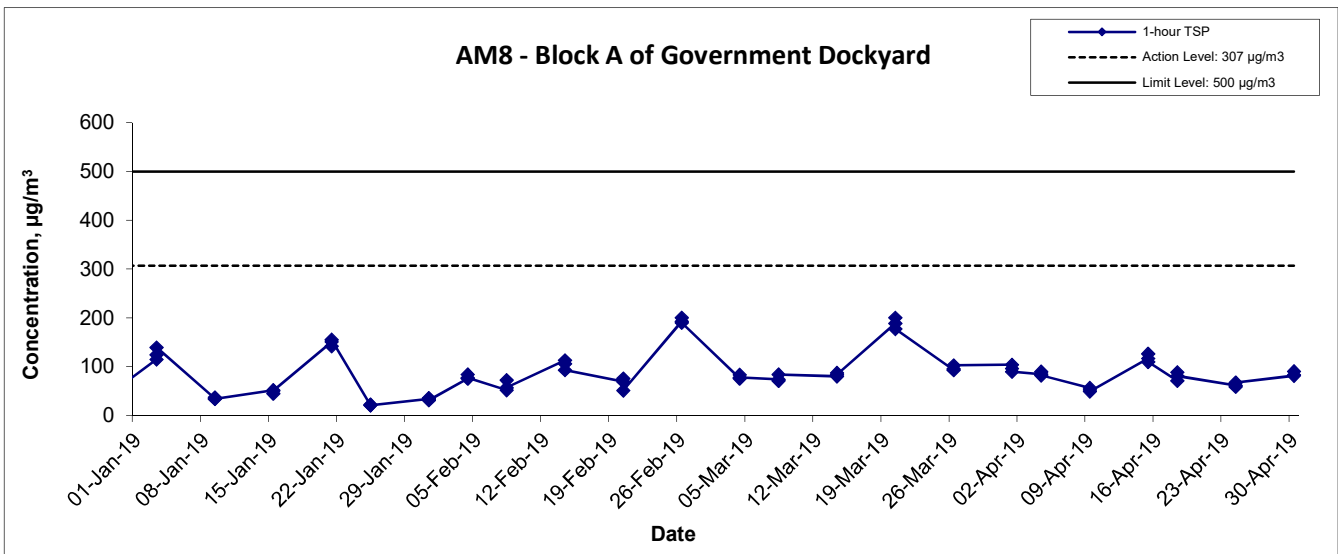
1-hr TSP Concentration Levels

Title	Contract No. DC/2009/10		Scale	Project No. MA11007	
	HATS 2A – Upgrading Works at SCISTW– Main Pumping Station, Sedimentation Tanks and Ancillary			N.T.S	
Graphical Presentation of 1-hour TSP Monitoring Results	Date		Appendix

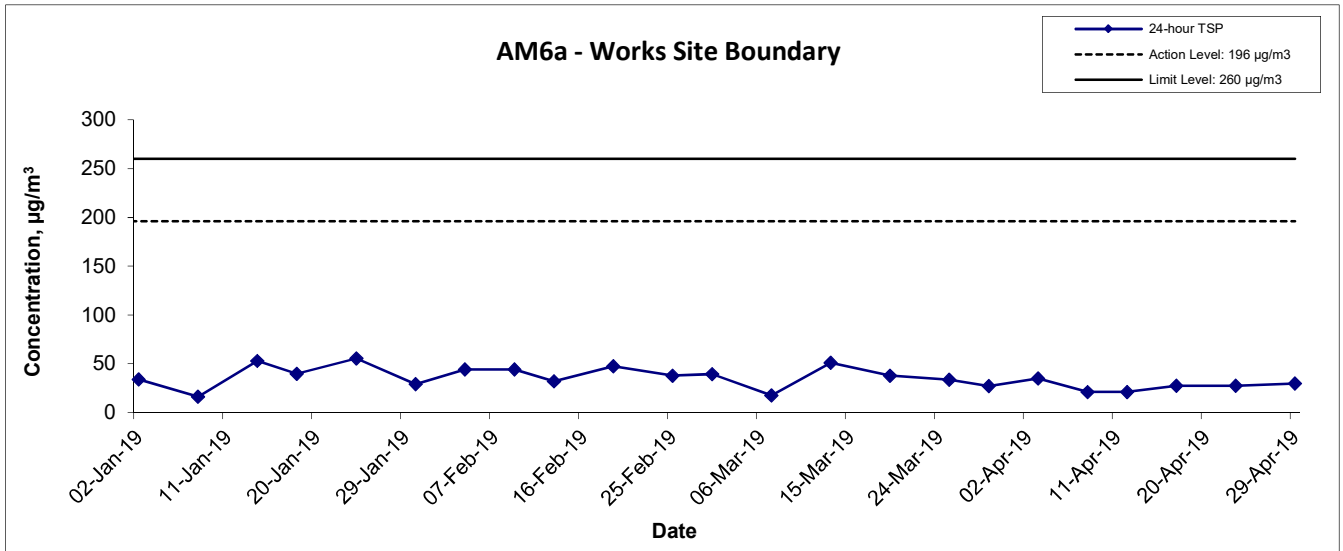
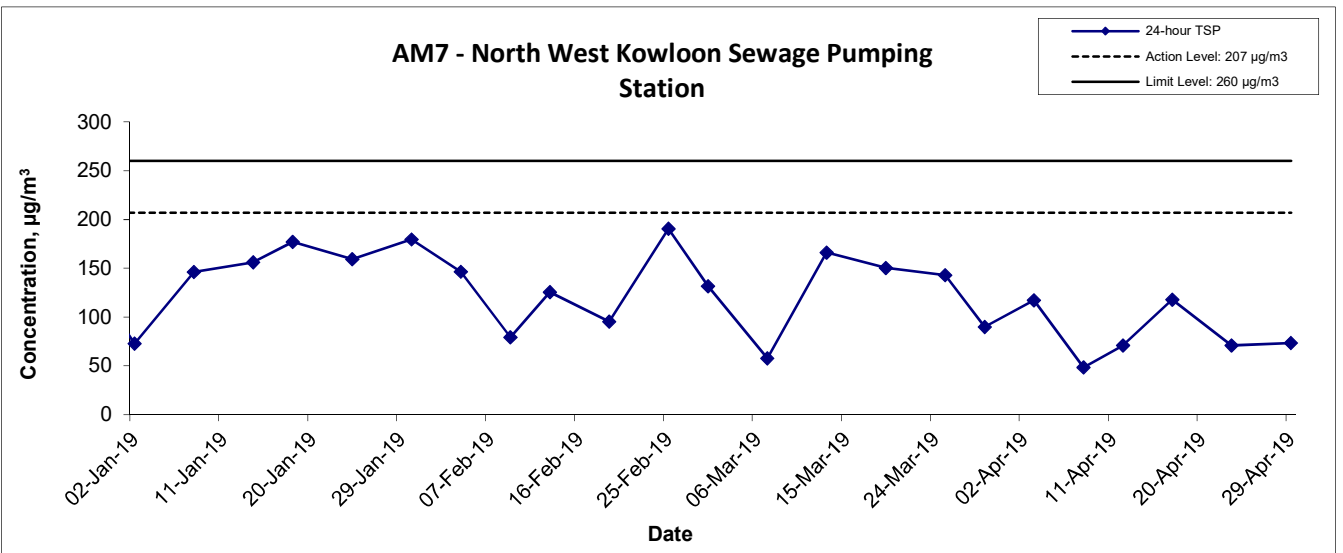
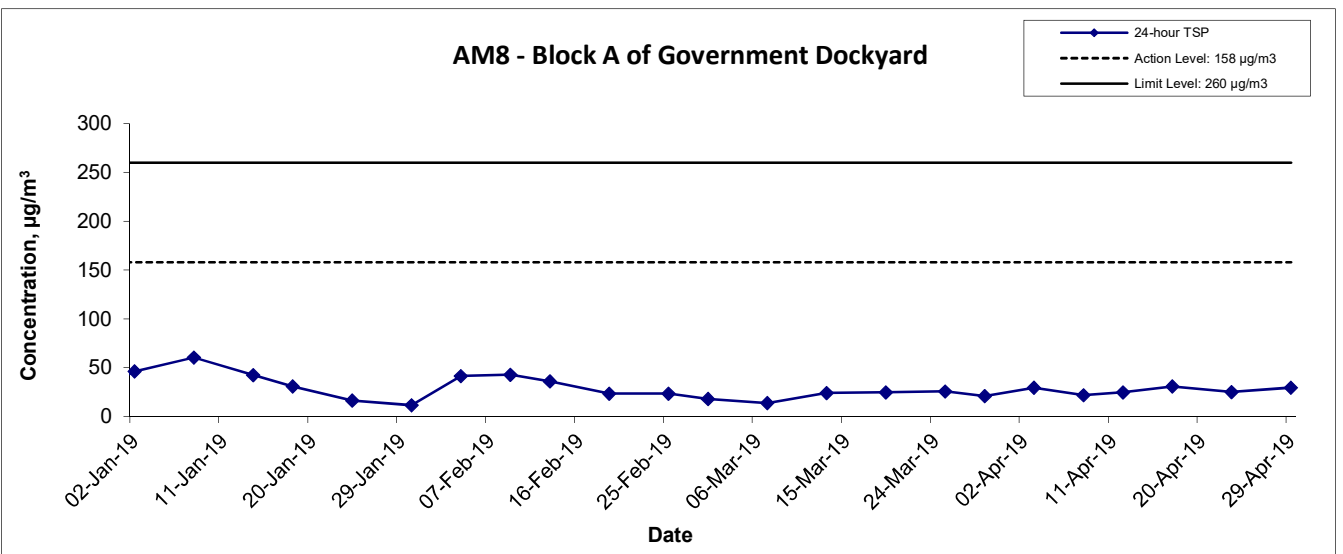
24-hr TSP Concentration Levels

Title	Contract No. DC/2009/10	Scale	Project	
	HATS 2A – Upgrading Works at SCISTW– Main Pumping Station, Sedimentation Tanks and Ancillary	N.T.S	No. MA11007	
Graphical Presentation of 24-hour TSP Monitoring Results		Date	Appendix	
		Apr 19	D

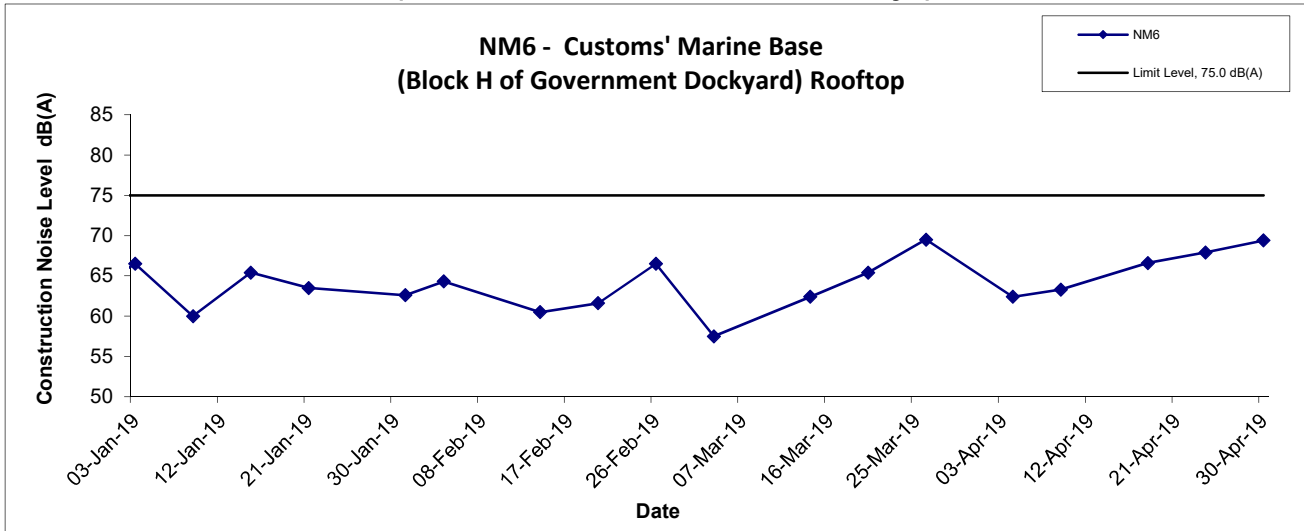
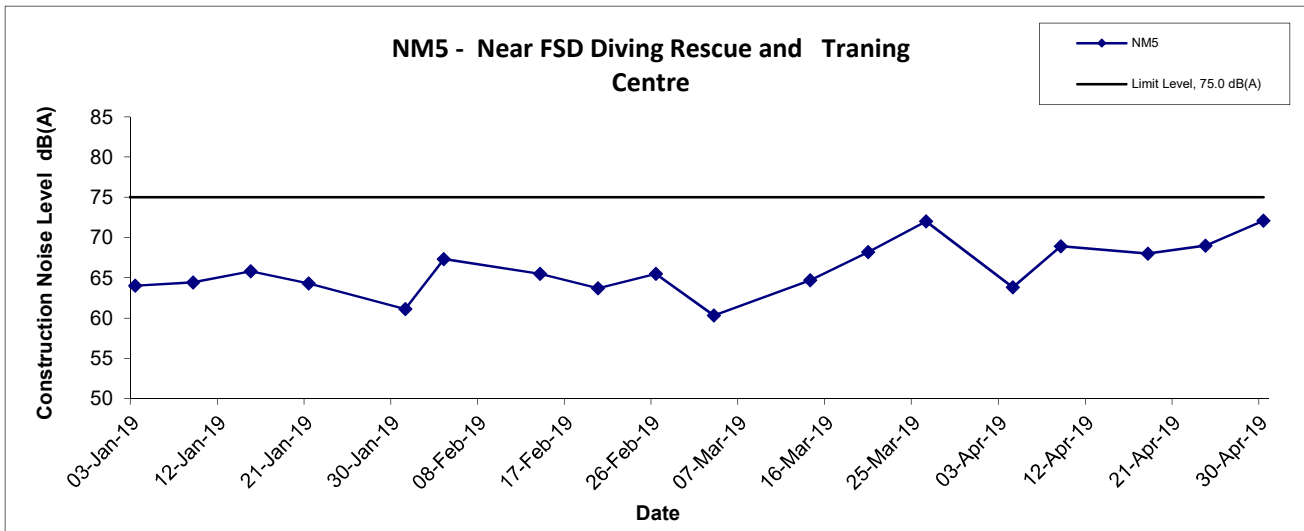
Noise Levels

(0700-1900 hrs on Normal Weekdays)

Title Contract No. DC/2009/10 HATS 2A – Upgrading Works at SCISTW– Main Pumping Station, Sedimentation Tanks and Ancillary Graphical Presentation of Noise Monitoring Result	Scale	N.T.S	Project No.	MA11007
	Date	Apr 19	Appendix	E
