**Contract No. DE/2018/17
Enhancement of Deodourisation System
at Stonecutters Island Sewage
Treatment Works**

**Monthly Environmental
Monitoring and Audit Report
January 2022**

(Version 1.0)

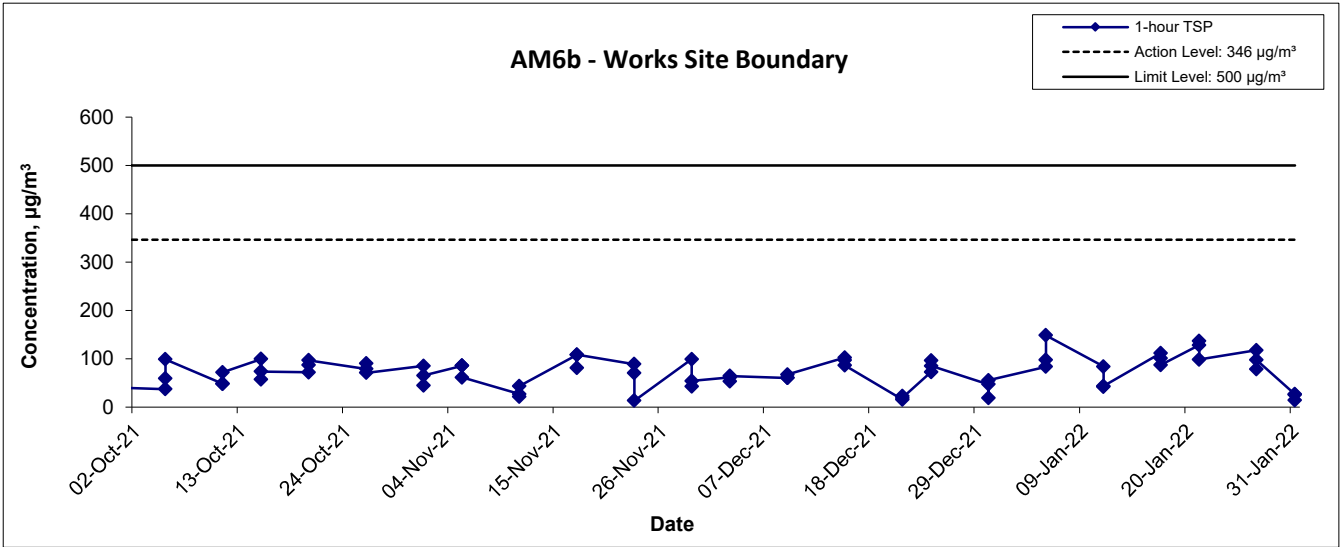
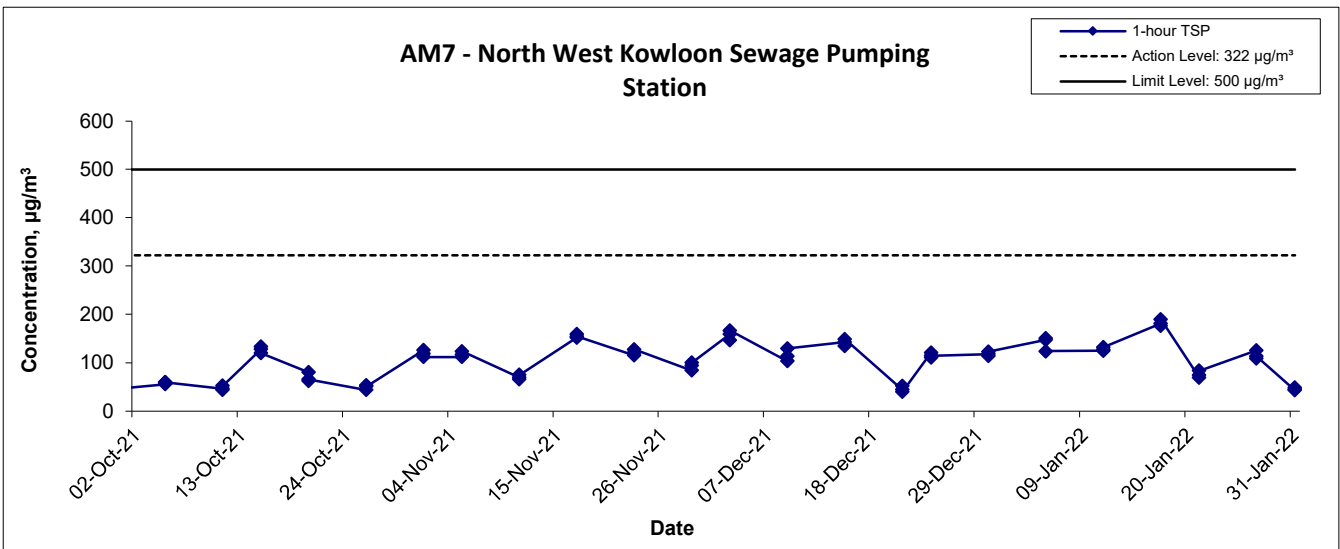
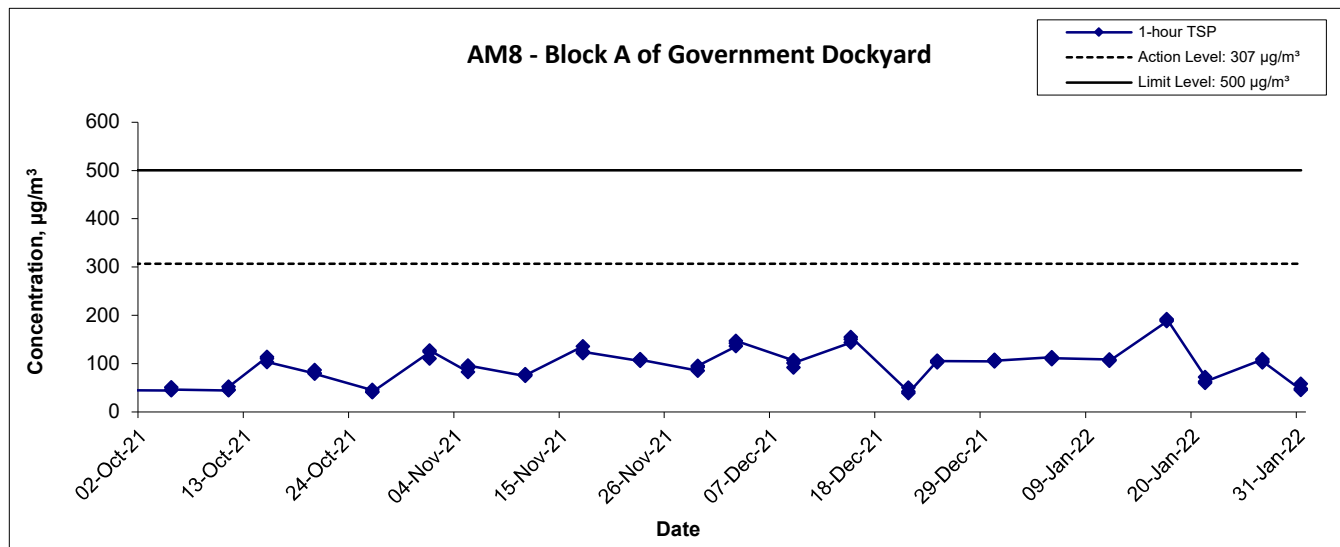
1-hr TSP Concentration Levels

Title Contract No. DE/2018/17 Enhancement of Deodourisation System at Stonecutters Island Sewage Treatment Works Graphical Presentation of 1-hour TSP Monitoring Results	Scale N.T.S	Project No. WMA19011	
	Date Jan 22	Appendix D

5. All 1-hour TSP monitoring was conducted as scheduled in the reporting month. No Action/Limit Level exceedance was recorded.

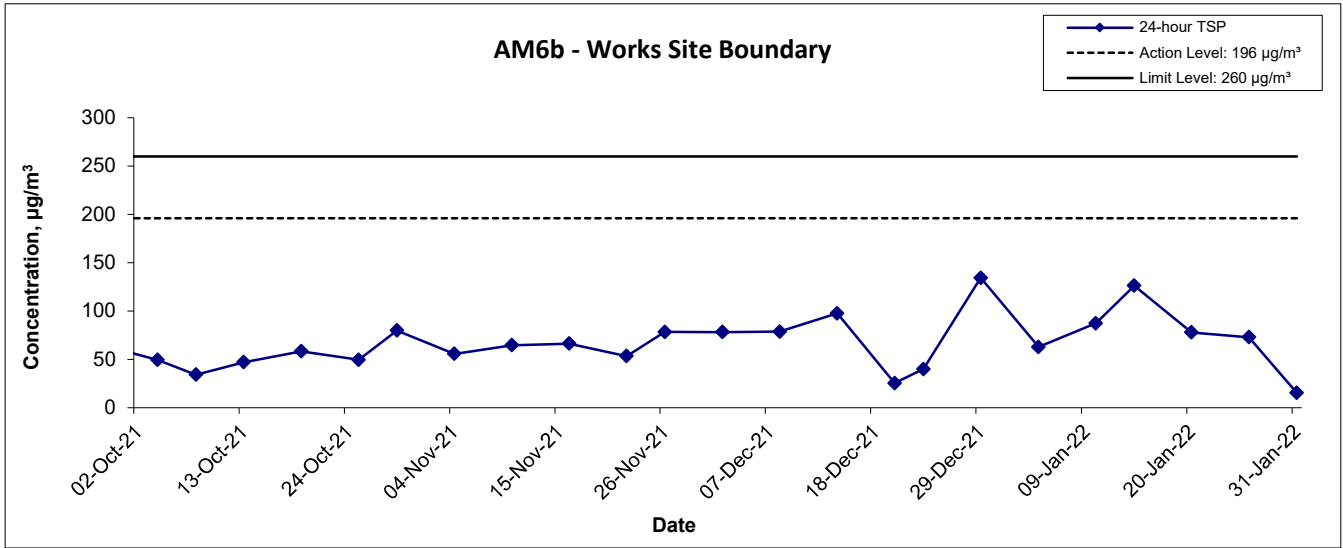
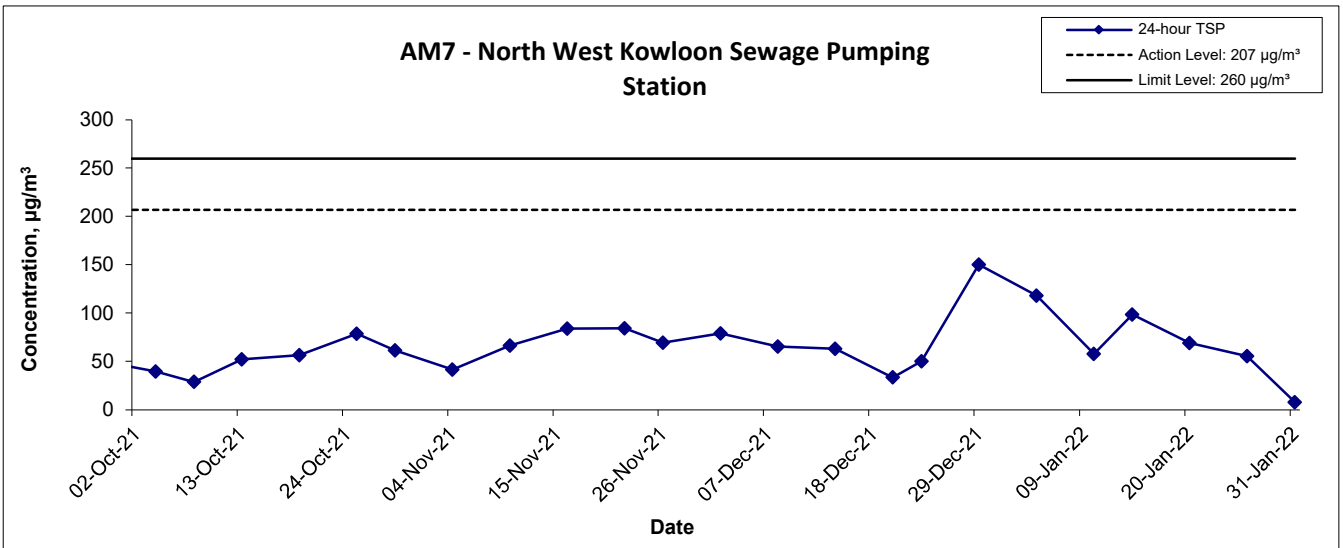
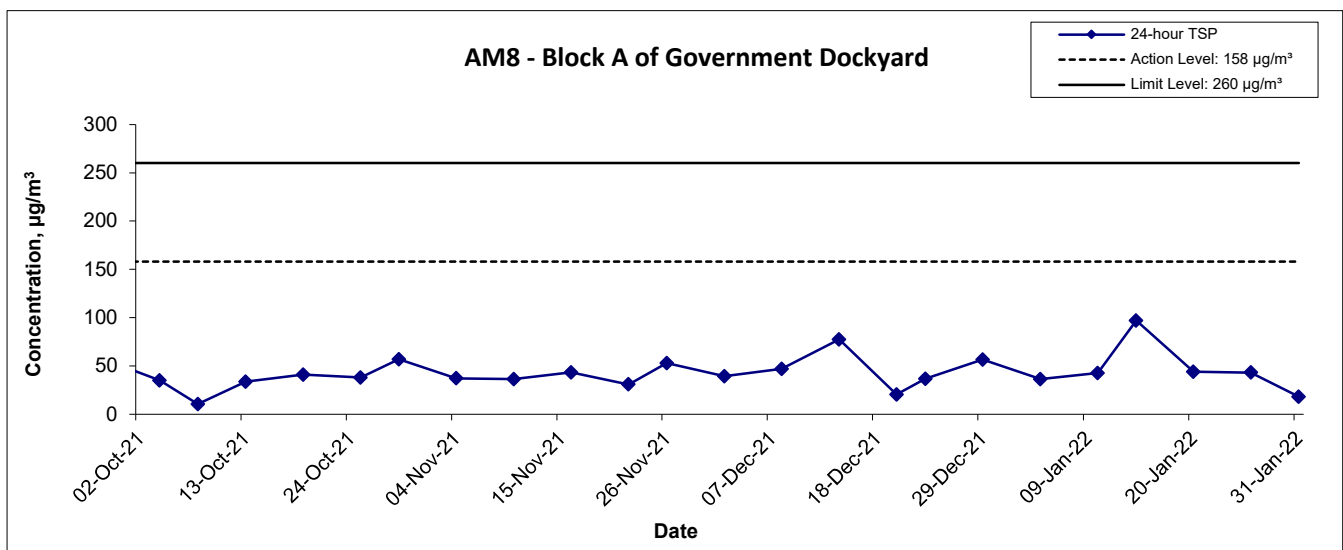
24-hr TSP Concentration Levels

Title Contract No. DE/2018/17 Enhancement of Deodourisation System at Stonecutters Island Sewage Treatment Works Graphical Presentation of 24-hour TSP Monitoring Results	Scale N.T.S	Project No. WMA19011

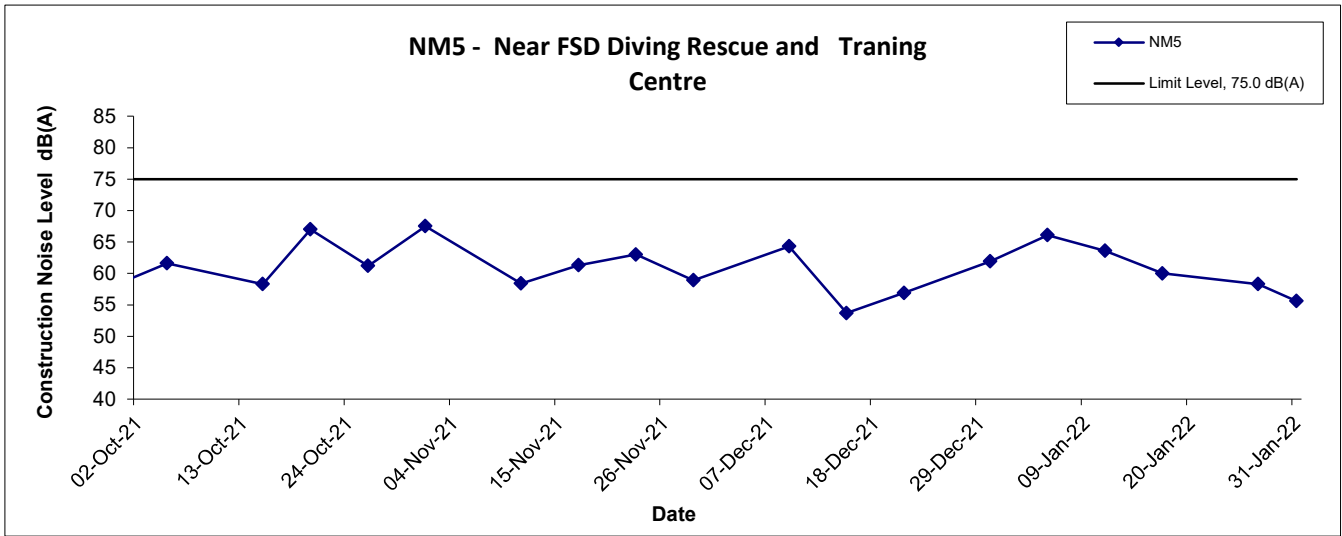
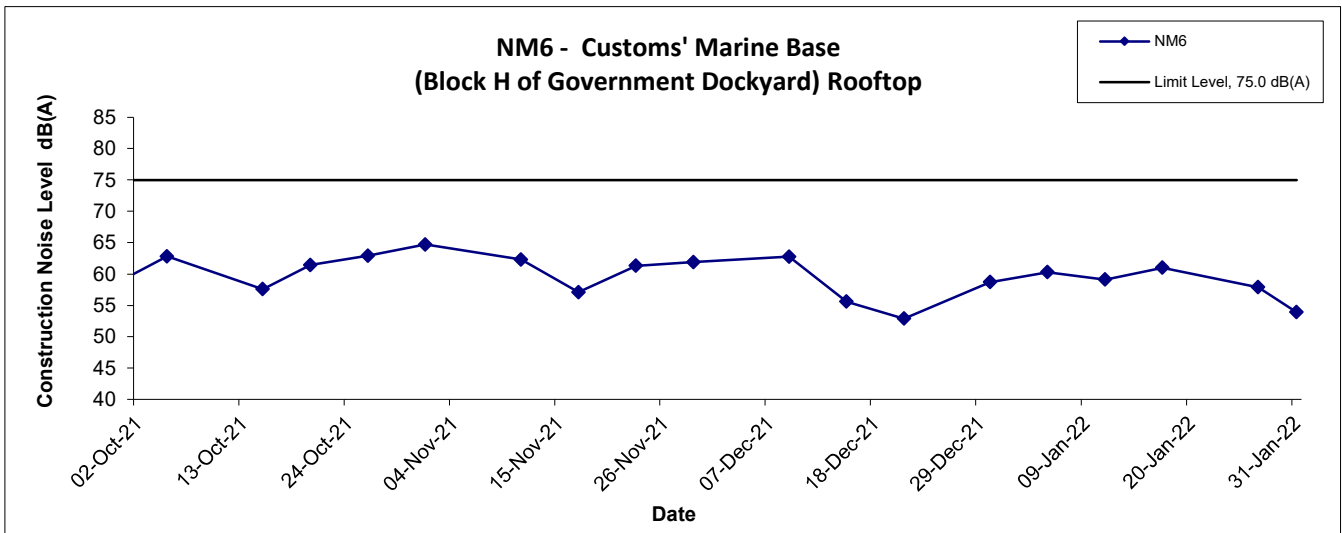
Noise Levels

(0700-1900 hrs on Normal Weekdays)

Title Contract No. DE/2018/17 Enhancement of Deodourisation System at Stonecutters Island Sewage Treatment Works Graphical Presentation of Noise Monitoring Result	Scale N.T.S	Project No. WMA19011	consulting . testing . research
	Date Jan 22	Appendix E
