Contract No. HY/2011/03

**Hong Kong-Zhuhai-Macao Bridge Hong Kong Link Road
Section between Scenic Hill and Hong Kong Boundary Crossing
Facilities**

Monthly EM&A Report No.63 (December 2017)

15 January 2018

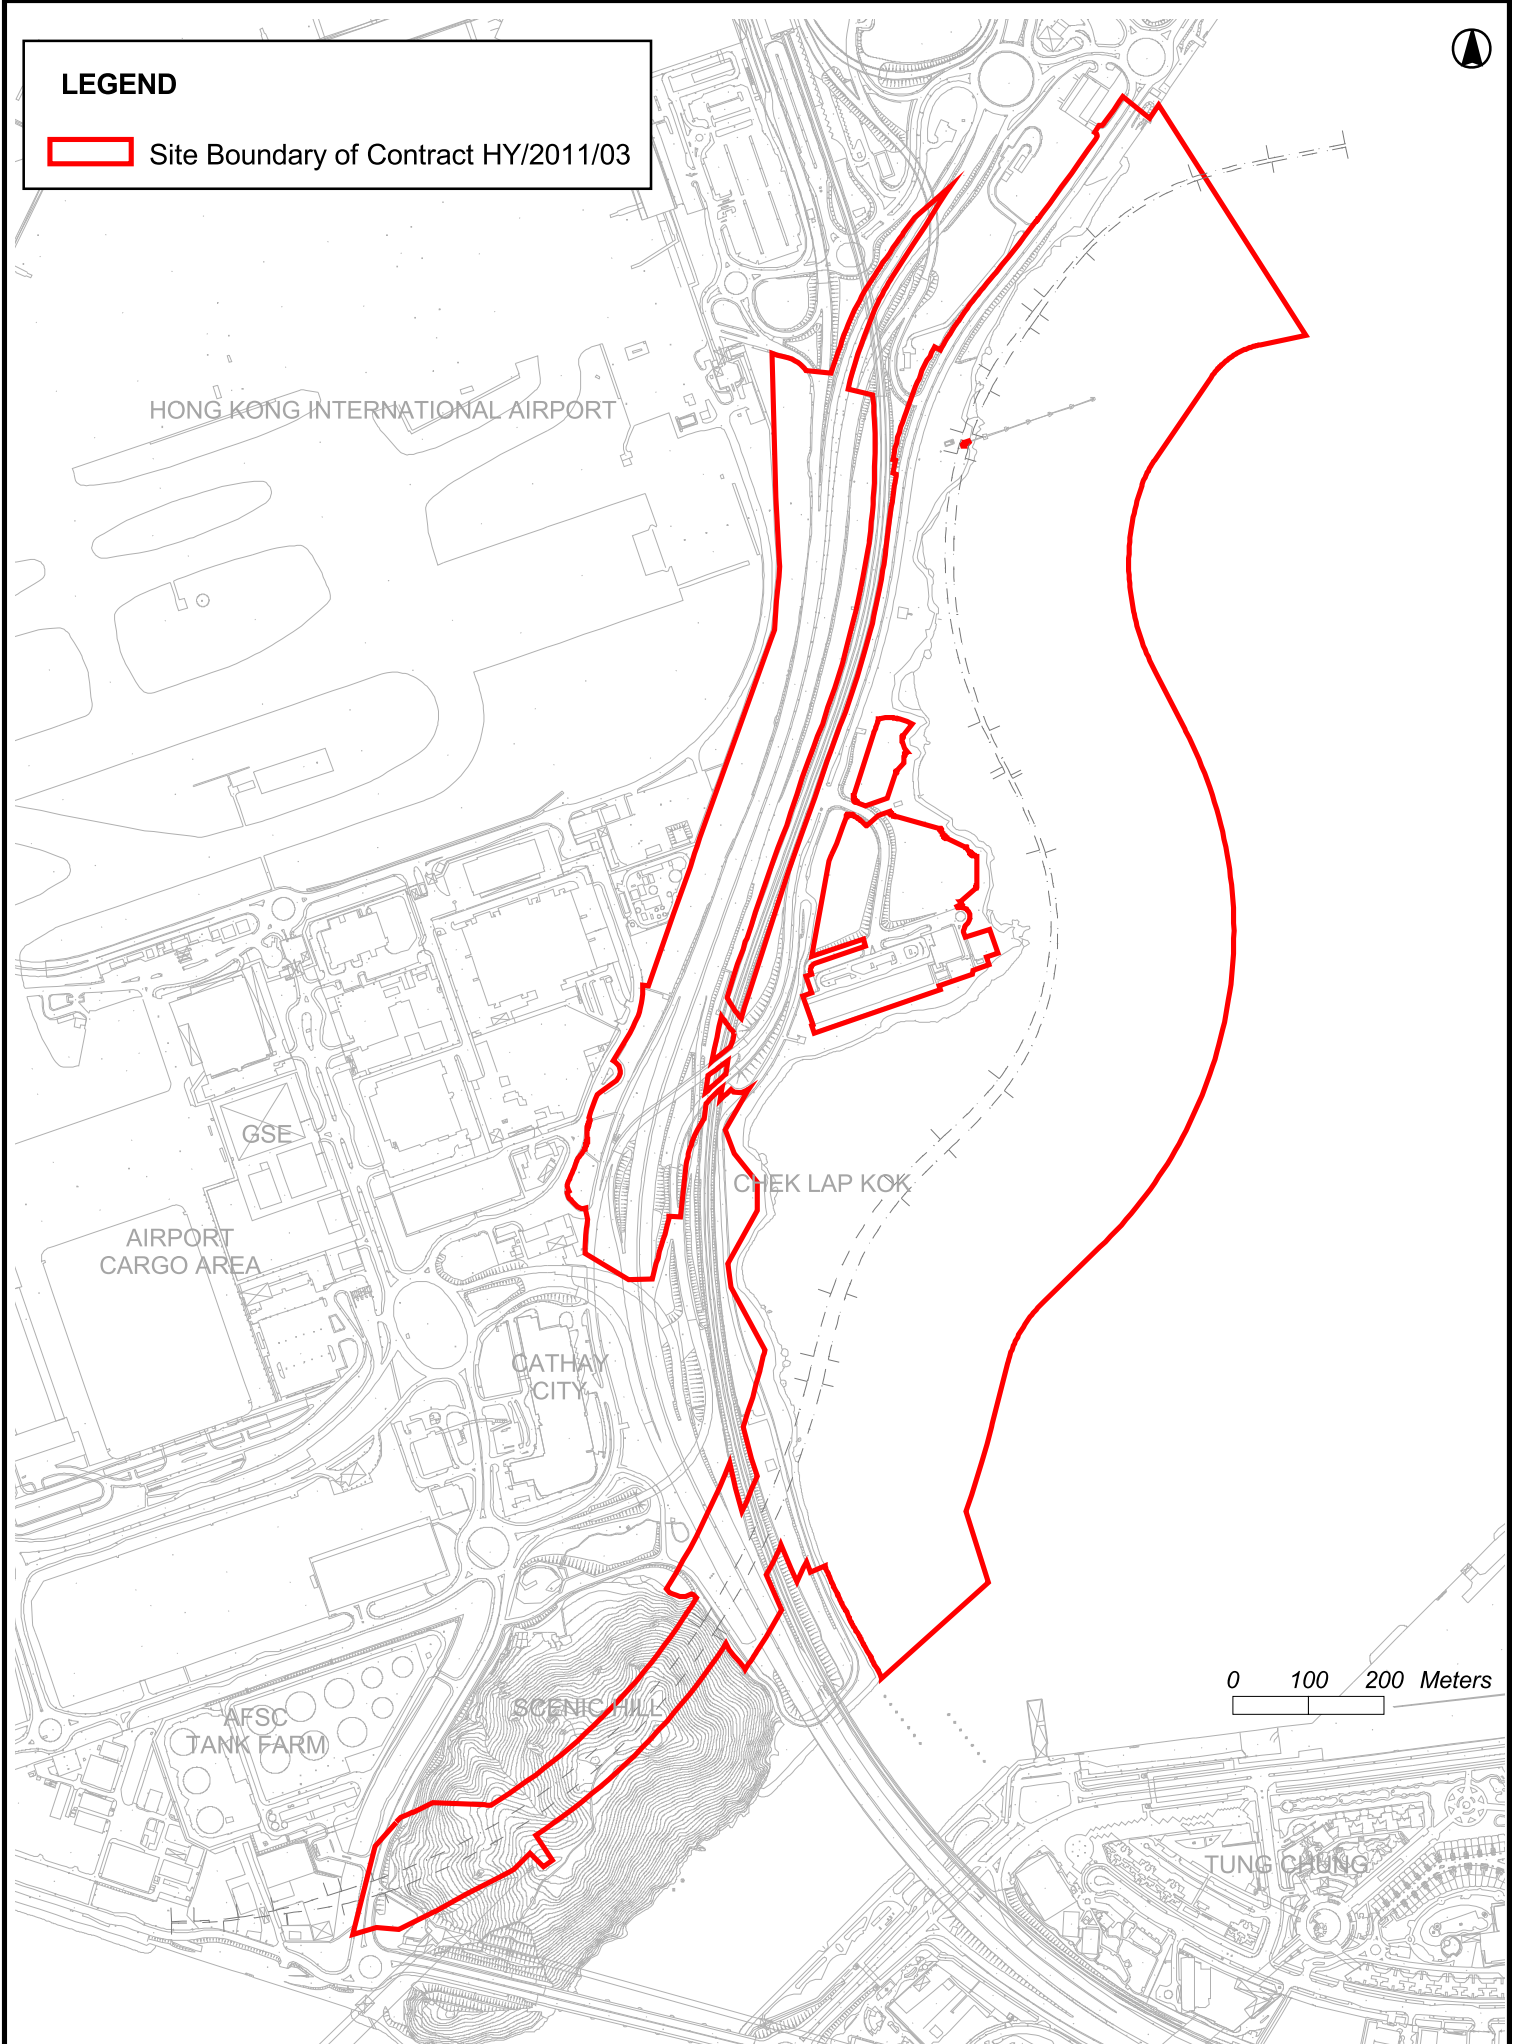
Figure 1.1 Location of the Site

Site Boundary of Contract HY/2011/03

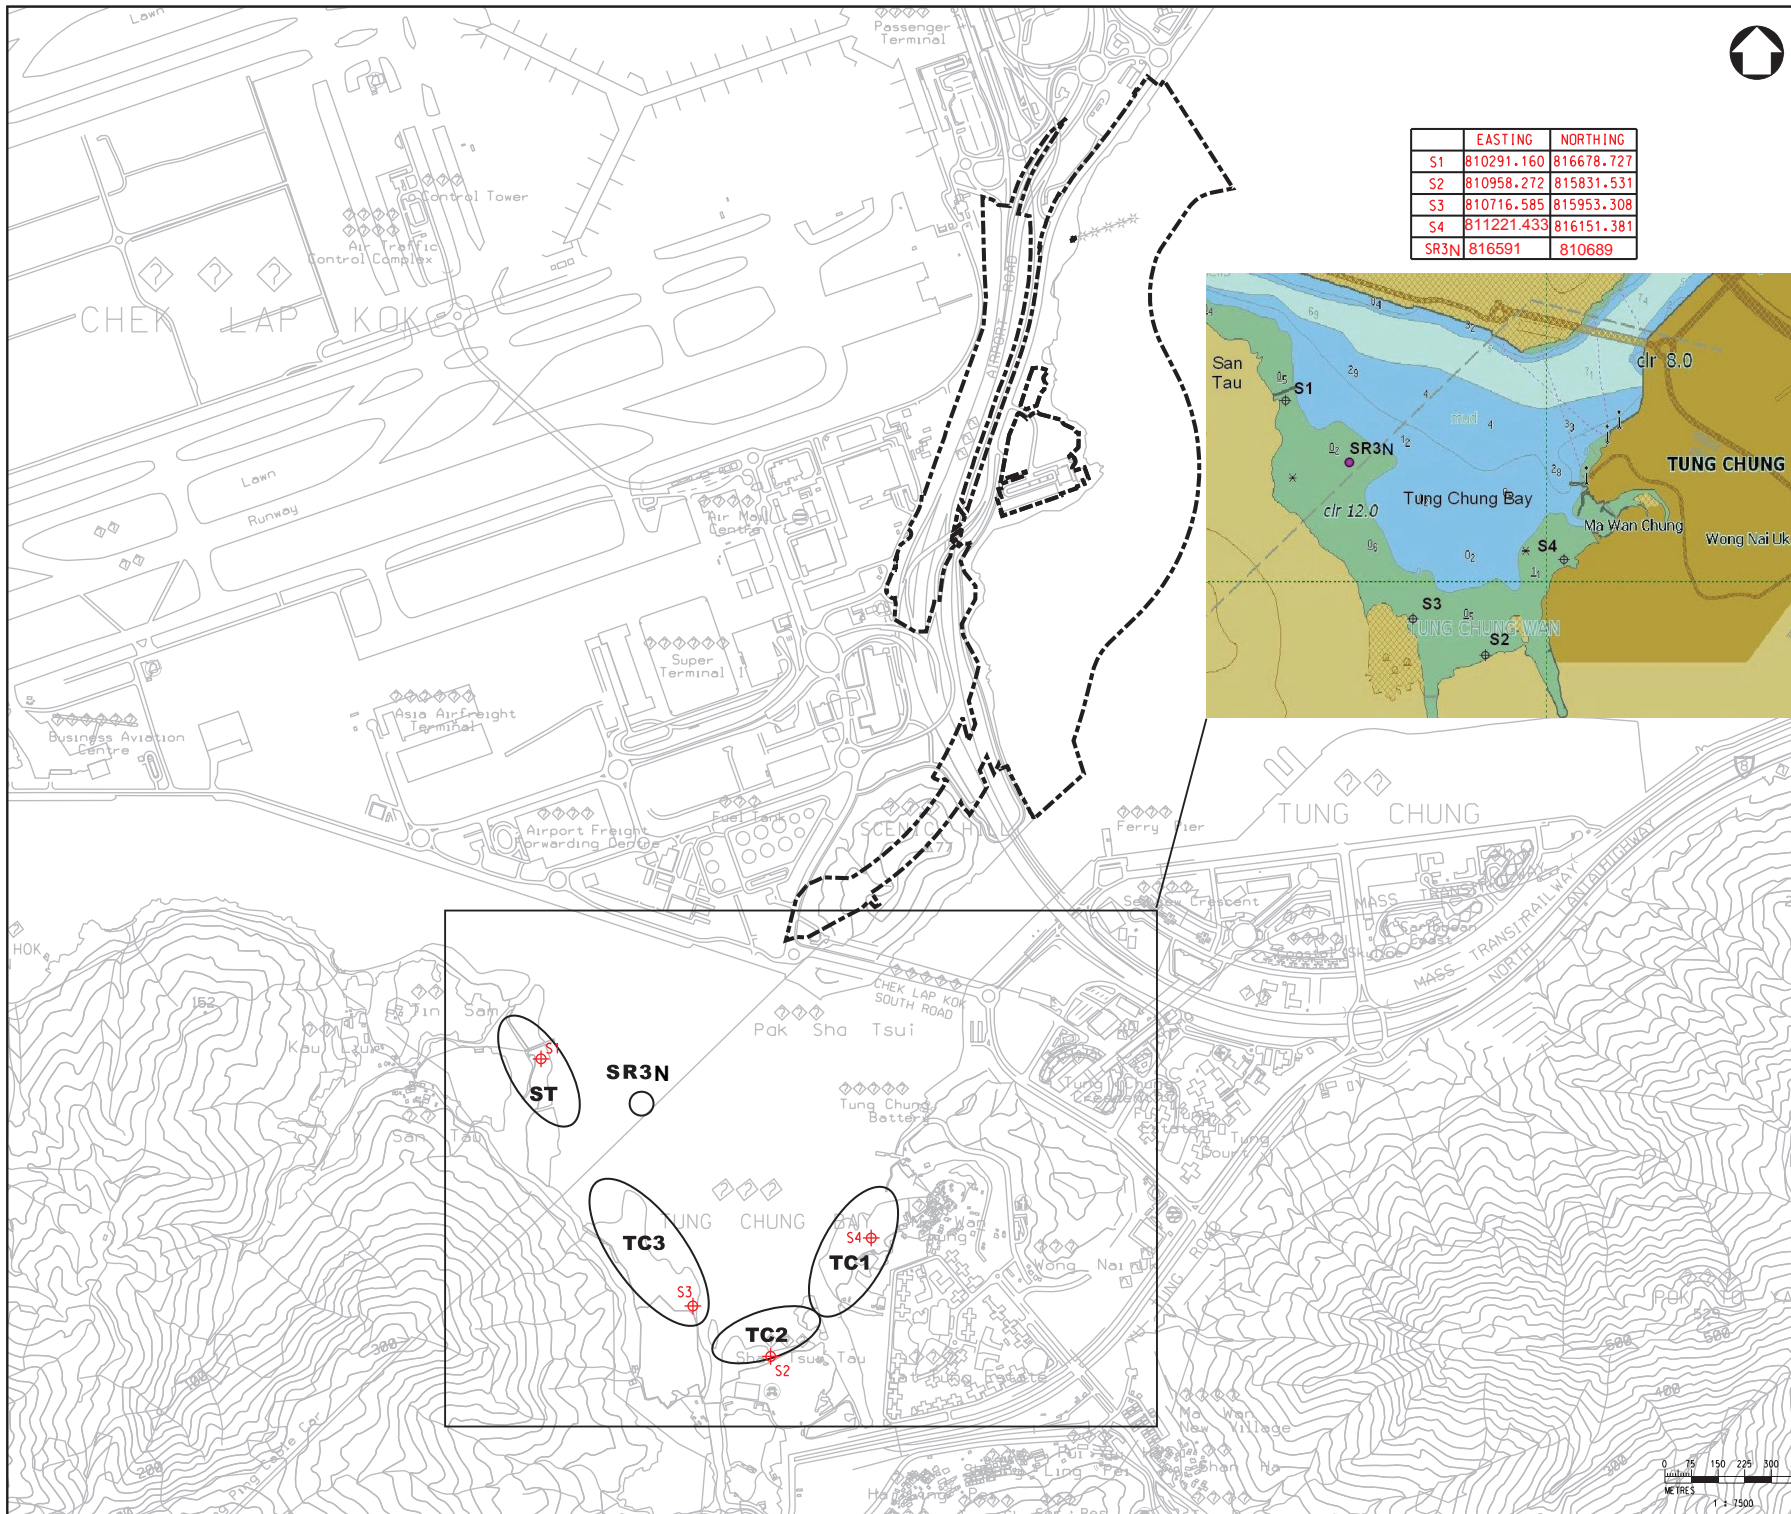
- 6.1.4 Four monitoring stations were established based on the site conditions for the sedimentation monitoring and are shown in **Figure 6.1**.

EASTING	NORTHING
S1	810291.160	816678.727
S2	810958.272	815831.531
S3	810716.585	815953.308
S4	811221.433	816151.381
SR3N	816591	810689

Monitoring Station	Comparison of measurement			Remarks and Recommendation
	Easting (m)	Northing (m)	Surface Level (mPD)	
S1	0.002	0.017	0.167	Level continuously increased
S2	-0.019	-0.028	0.122	Level continuously increased
S3	-0.021	0.021	0.138	Level continuously increased
S4	0.002	-0.042	0.168	Level continuously increased

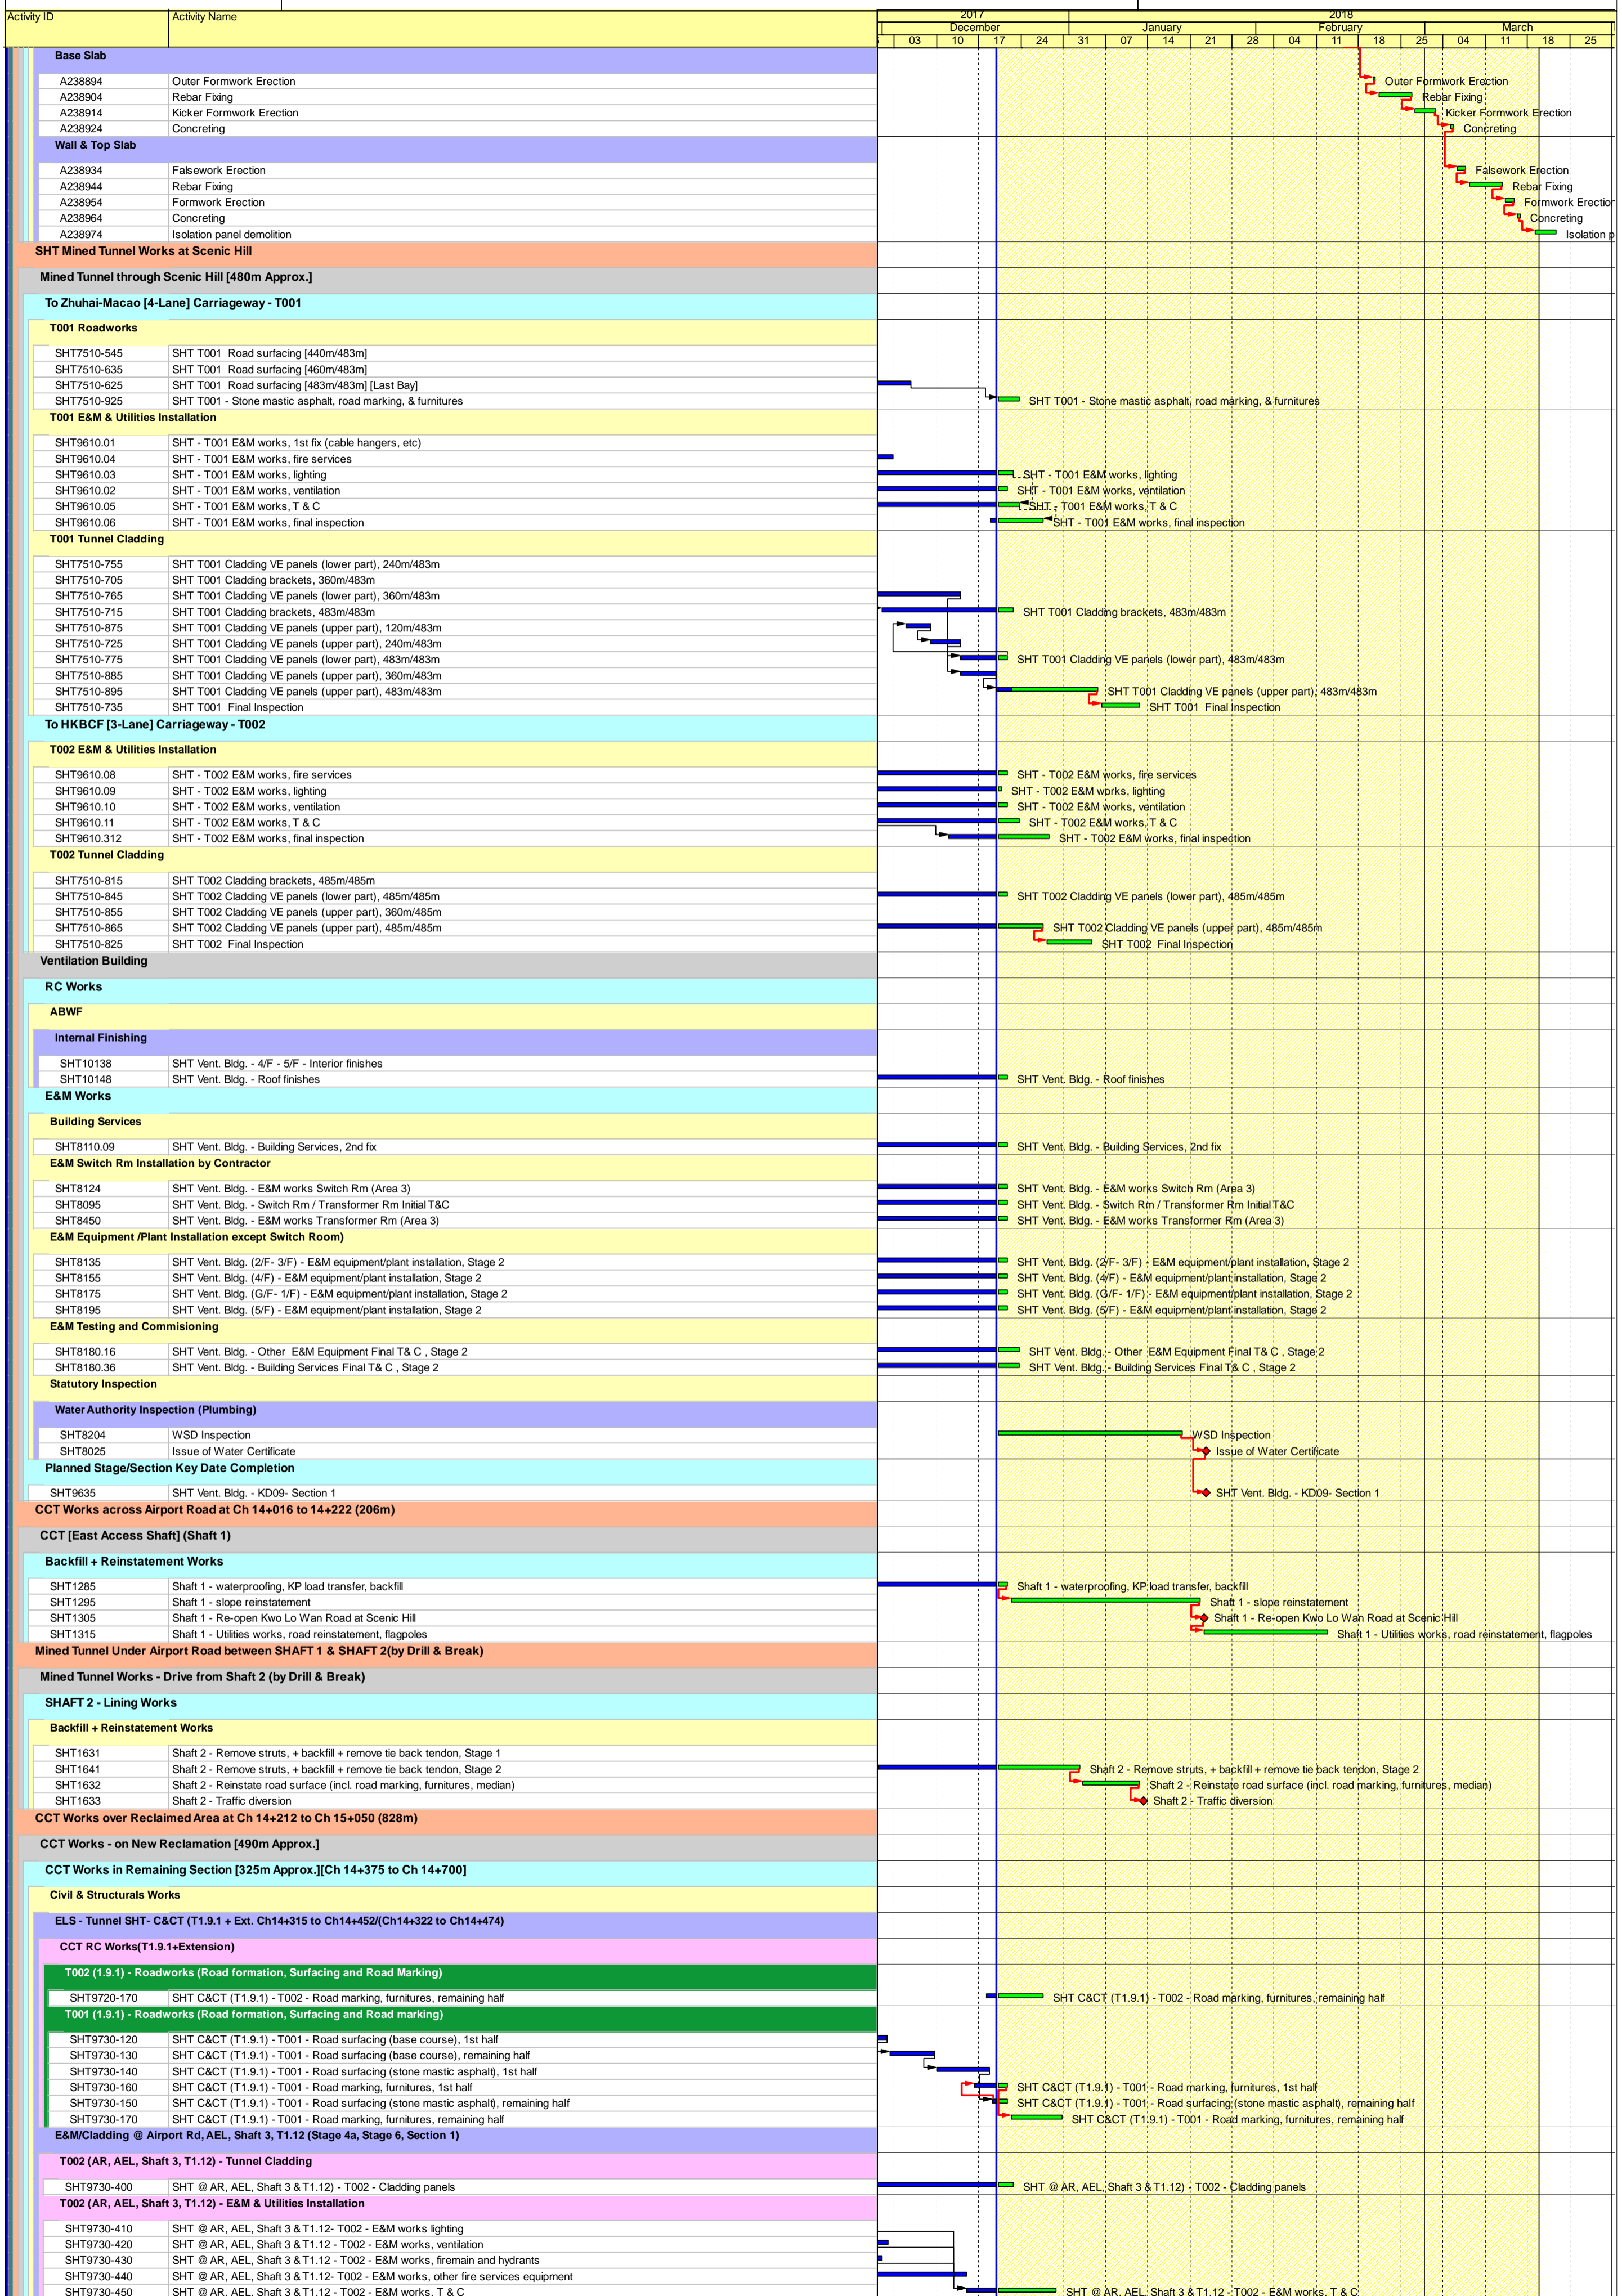
Activity ID	Activity Name	2017				2018									
		03	10	17	24	31	07	14	21	28	04	11	18	25	
WORKS IN NORTH AREA - CH 15+500 to CH 16+223 (HKLR AT GRADE & ROADWORKS)															
Reclamation SWCH 1+400 to SWCH 1+830 (incl. Approach Lights Area, 430m Approx.)															
Reclamation SWCH 1+400 to SWCH 1+590 (incl. PR09 Temp. Diversion Area)															
Reclamation SWCH 1+400 to 1+500 (PR09 Temp. Diversion)															
Toe Loading Platform (for Seawall & Reclamation)															
SWTL -120	North Area(except Portion C&D)s - Toe Loading Platform, 1st Stage (Ch. 1+600 to 1+750)														
SWTL -220	North Area(except Portion C&D)s - Toe Loading Platform, 2nd Stage (Ch. 1+600 to 1+750)														
Reclamation SWCH 1+500 to 1+590 (Except PR09 Temp. Diversion Area)															
RSC1070-105	North Area(except Portion C&D) - Remove toe loading (sub-zone 10-1, except PR9 Temp. diversion)

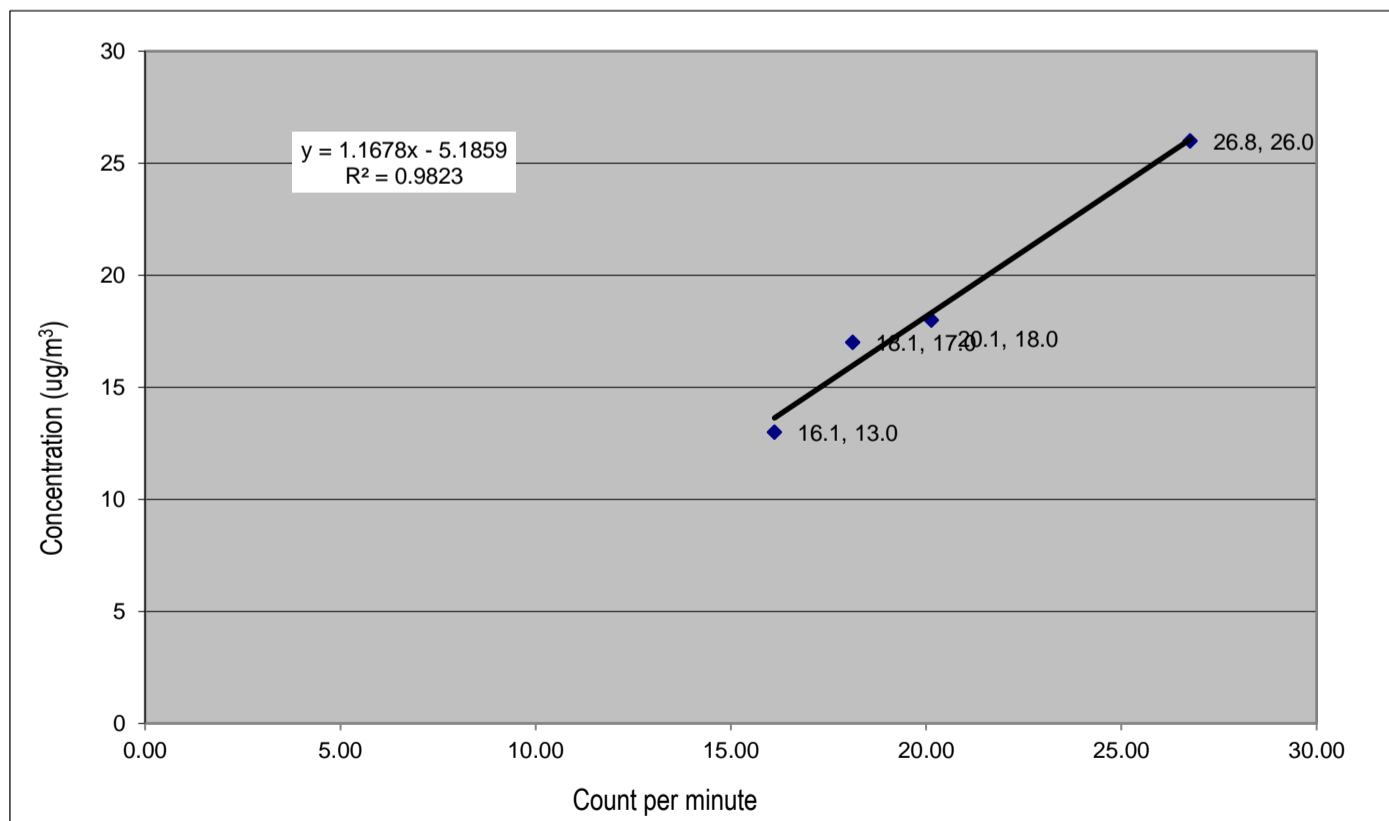
Slope (K-factor): 1.1678 Intercept,b: -5.186
 Correlation coefficient (R): 0.9911

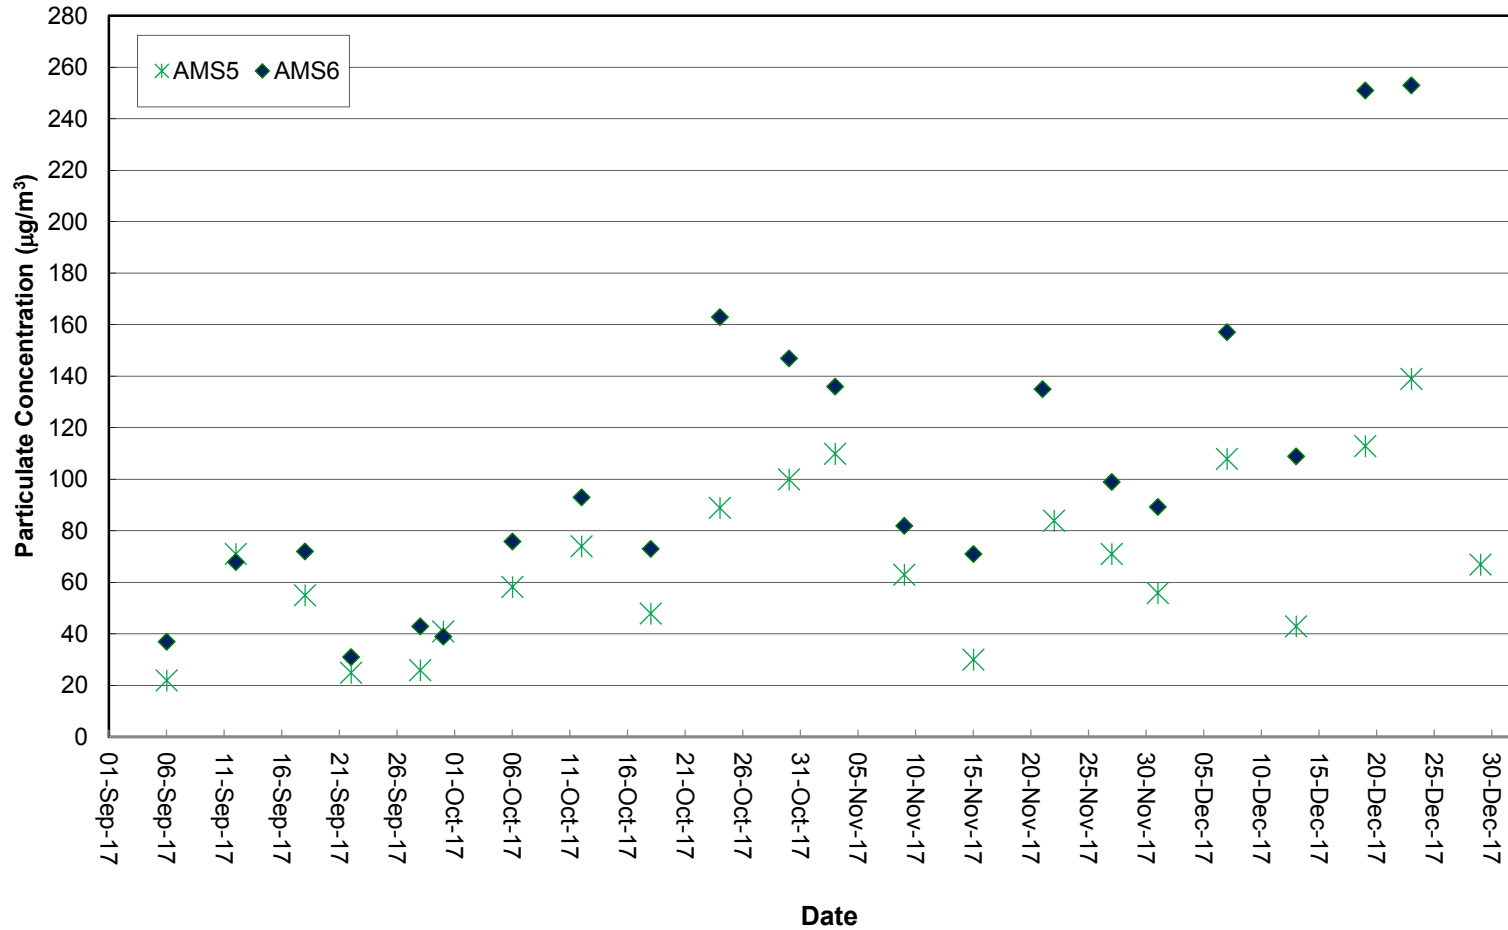
Graphical Plot of 24-hour TSP at AMS5 and AMS6

The monitoring time for 24-hr TSP monitoring on 29 December 2017 at AMS6 (Dragonair Building) was discovered less than 24 hours due to power interruption. The 24-hr TSP monitoring result obtained at AMS6 on 29 December 2017 was considered invalid. Due to power failure and malfunction of HVS from 29 December 2017 to 3 January 2018, 24-hr TSP monitoring could not be conducted at such period. Competent people were arranged to check the power supply and repair HVS on 3 and 4 January 2018 respectively. 24-hr TSP monitoring at AMS6 has been resumed on 4 January 2018.

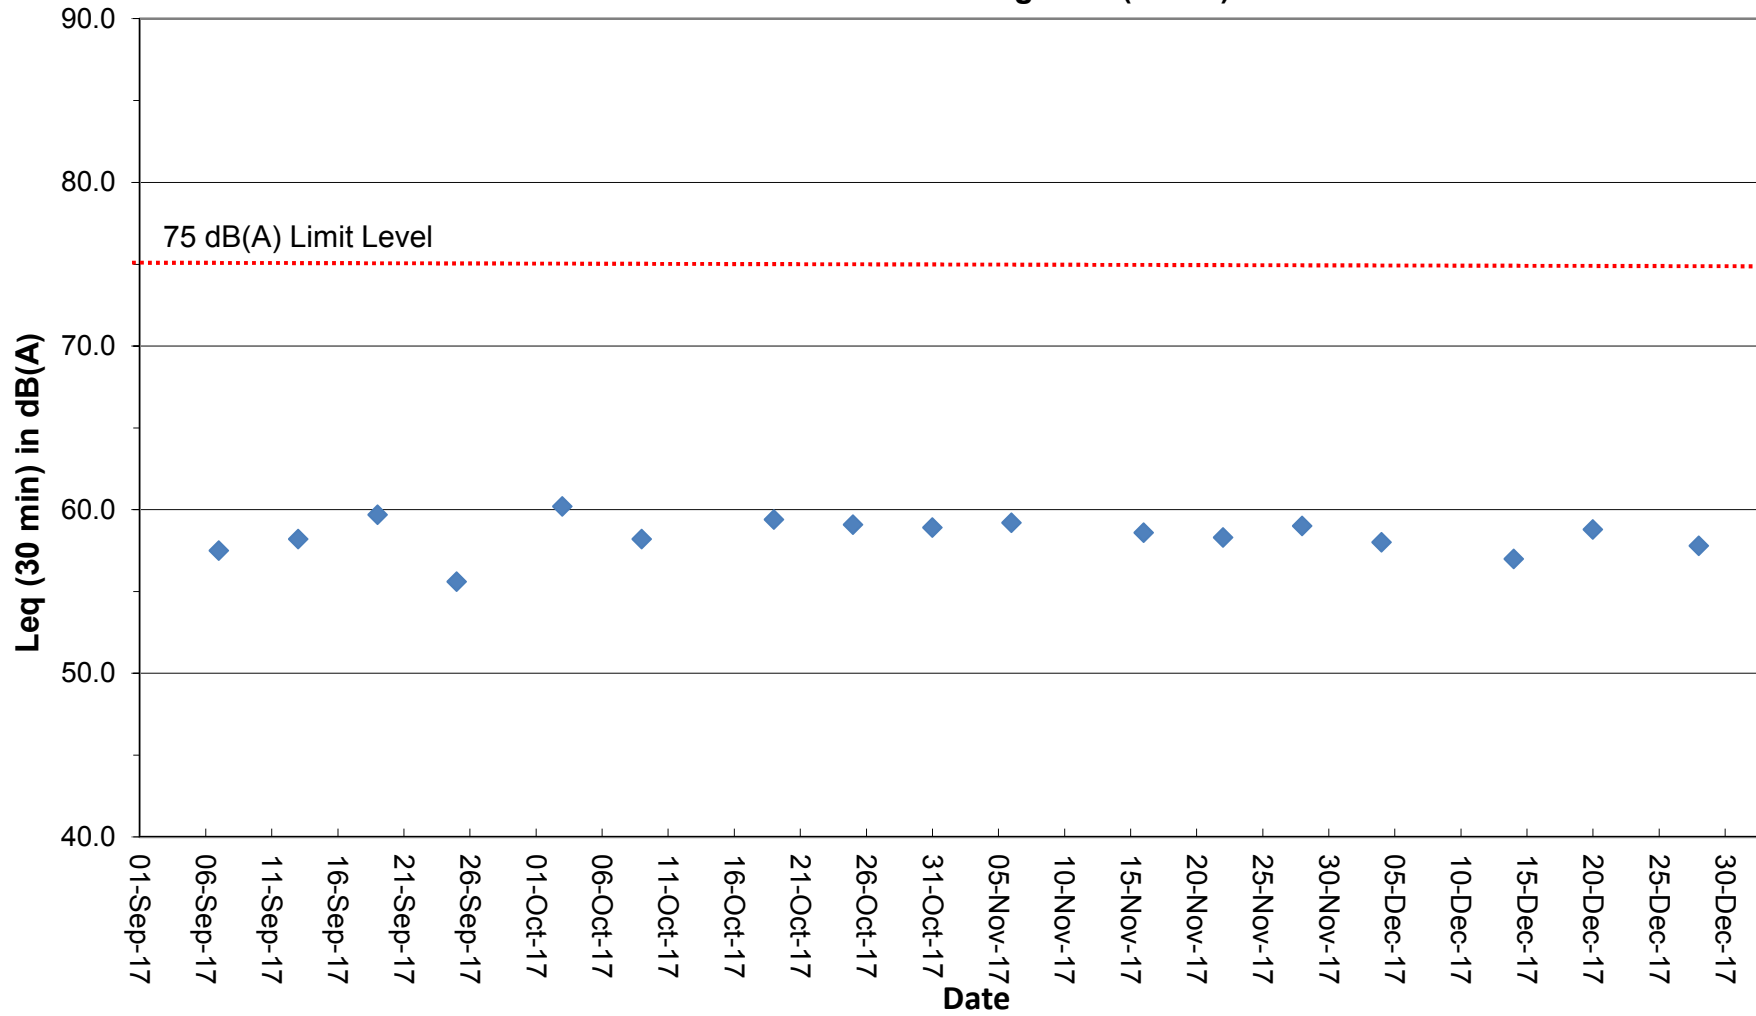
Continuous Noise Monitoring Data (NMS5)

(1) A facade correction of +3 dB(A) was applied to the measured noise level.

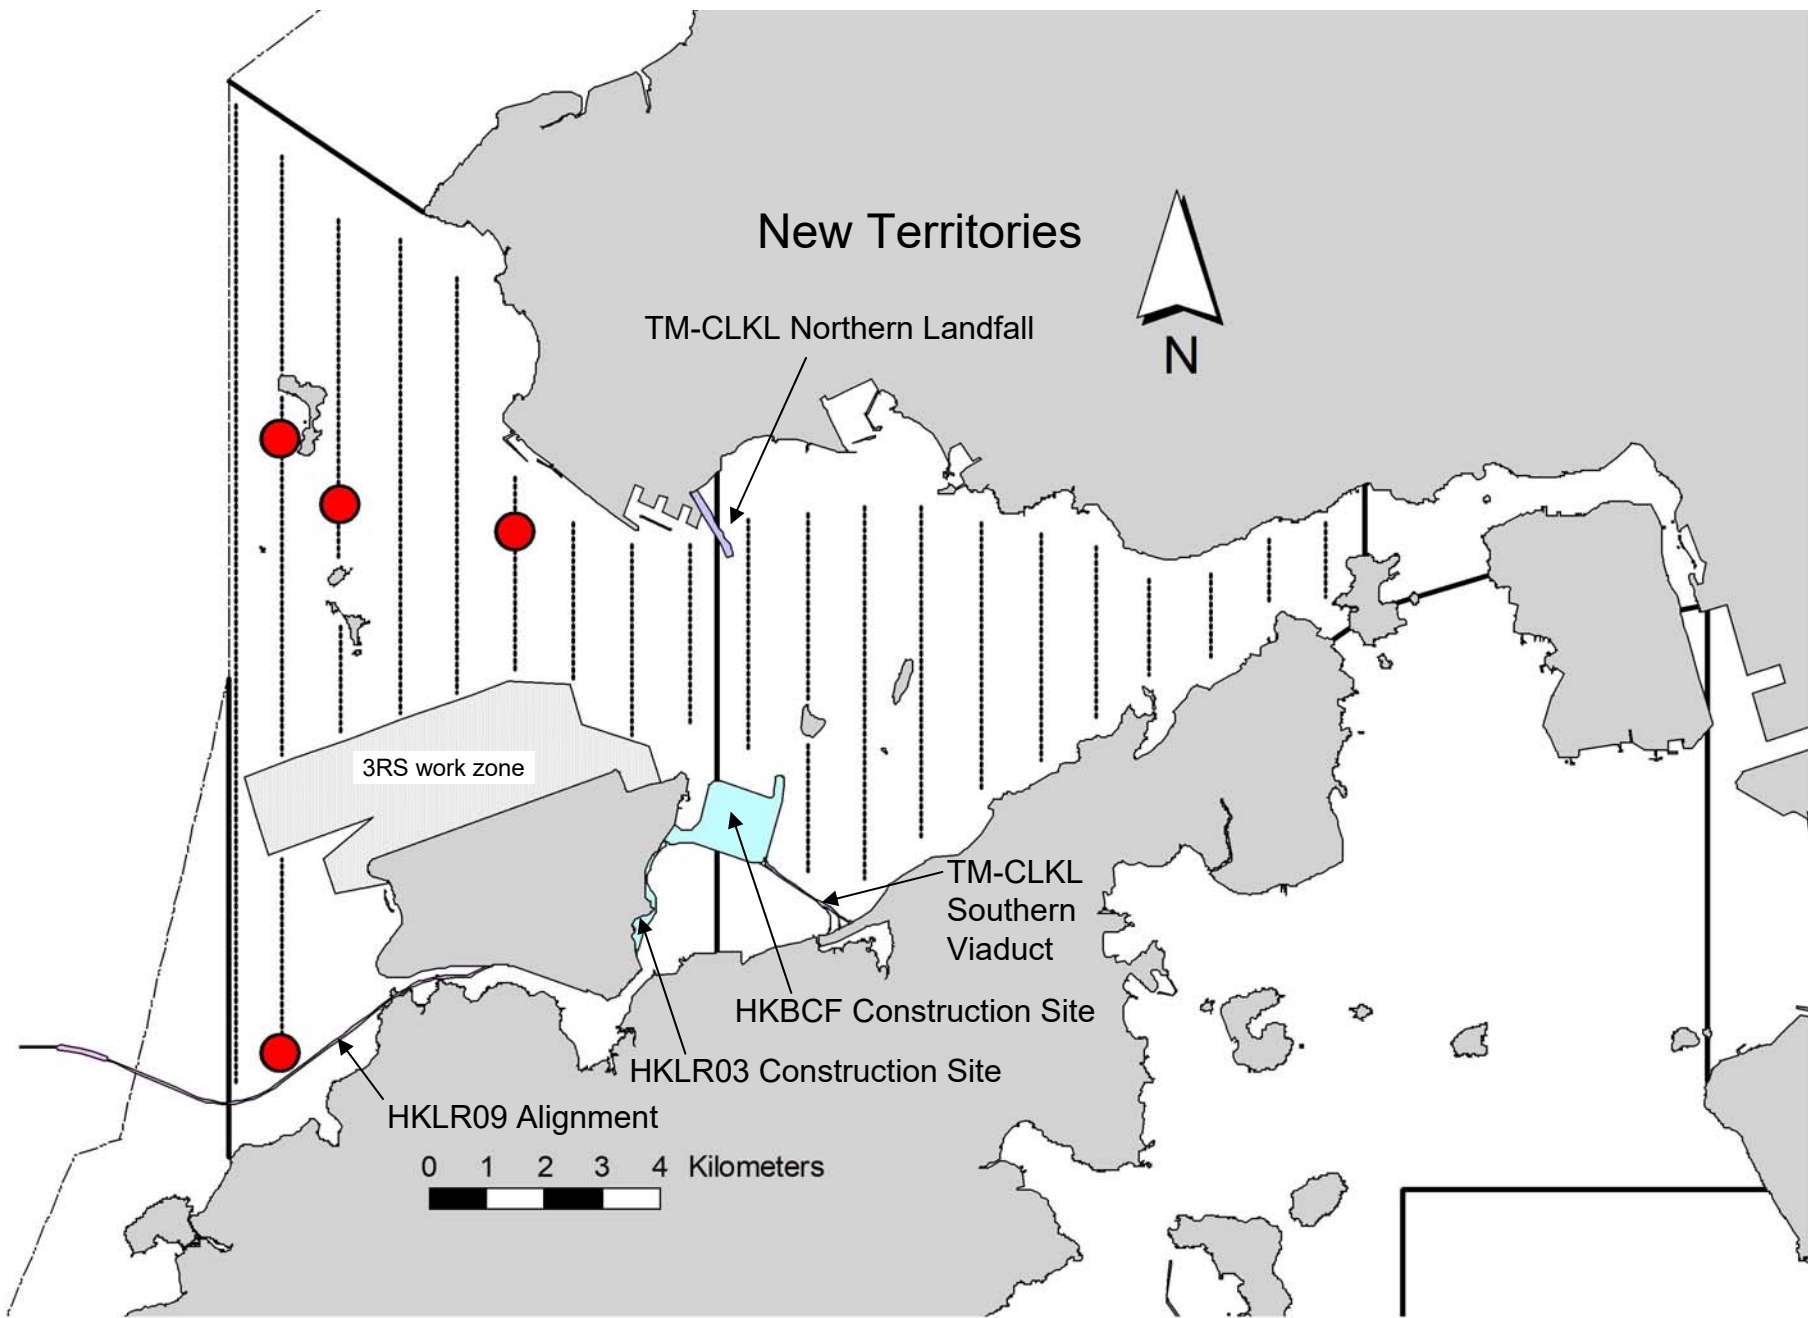
Figure 6. Distribution of Chinese White Dolphin Sightings during December 2017 HKLR03 Monitoring Surveys

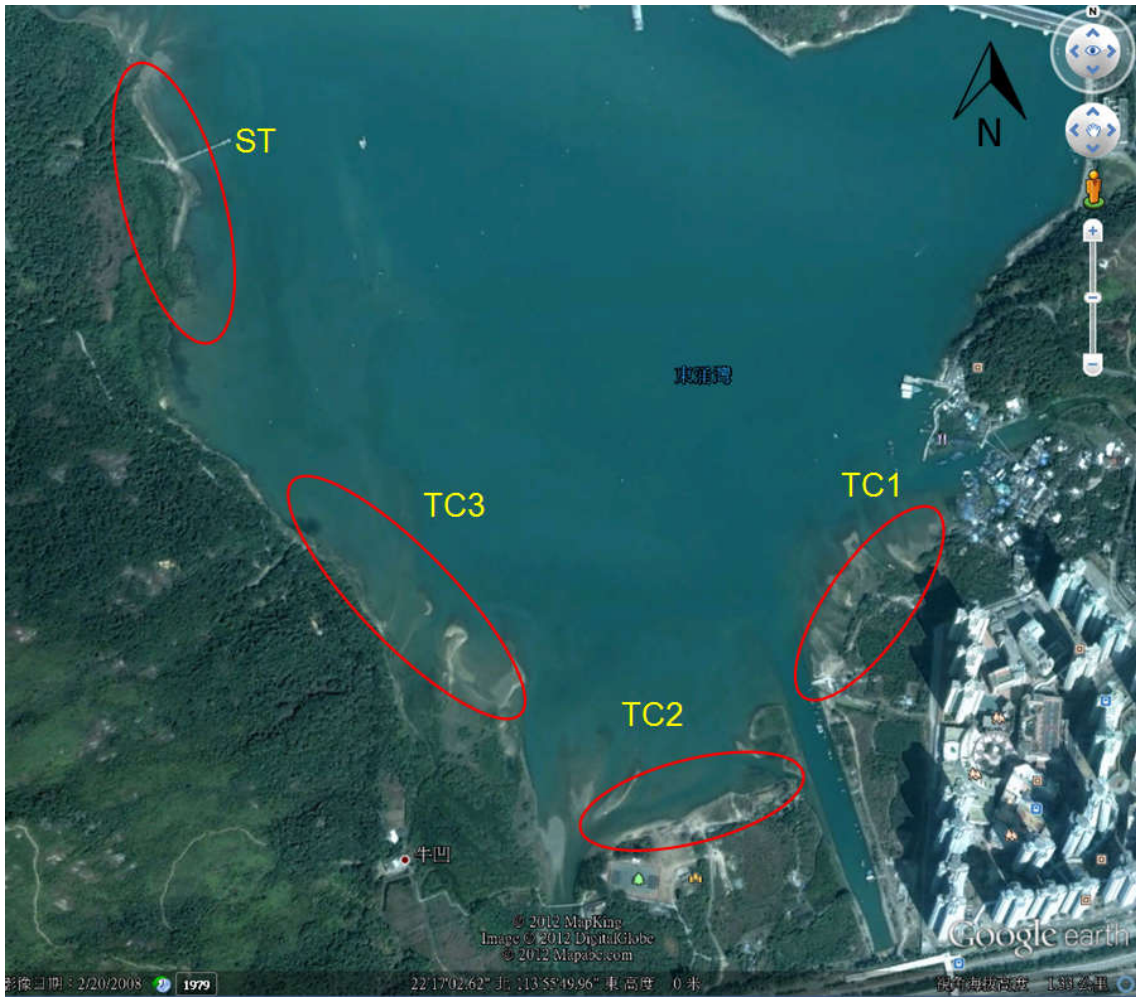
Figure 2.1. Locations of sampling zones. The study site was divided into three sampling zones (TC1, TC2, TC3) in Tung Chung Bay and one zone in San Tau (ST) (map generated from Google Map).

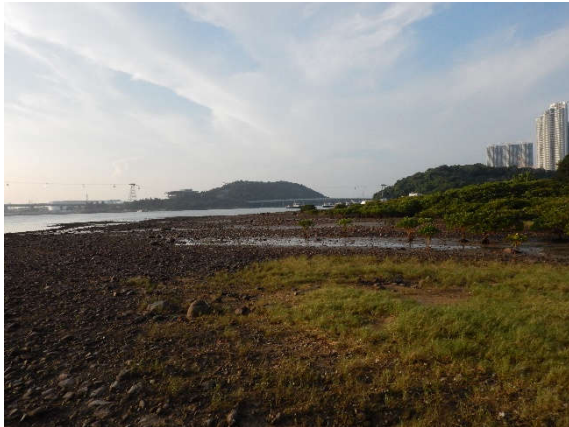
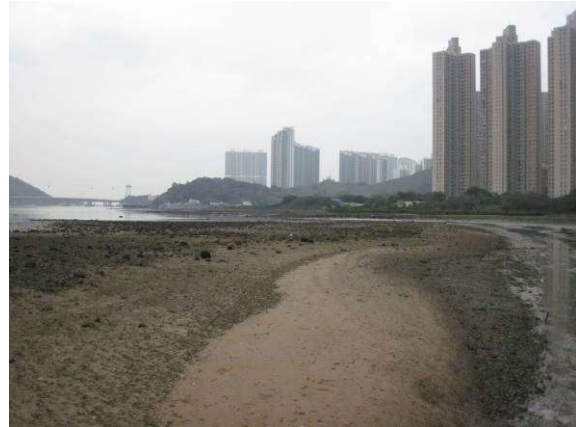
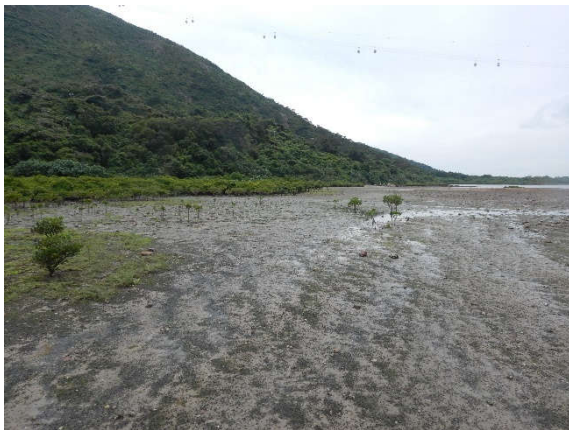
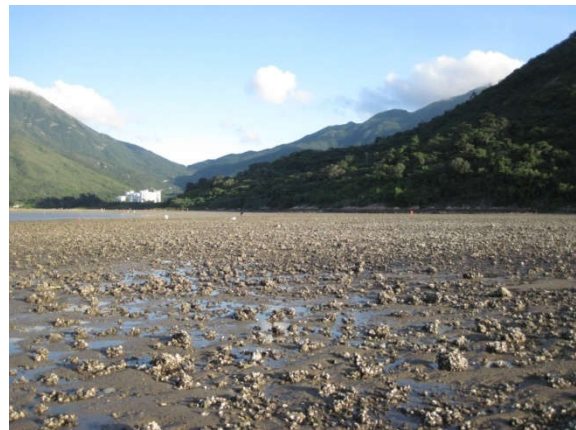
Figure 2.2. *Photographic record of the environment in every sampling zone.*

TC1

TC2

TC3

ST

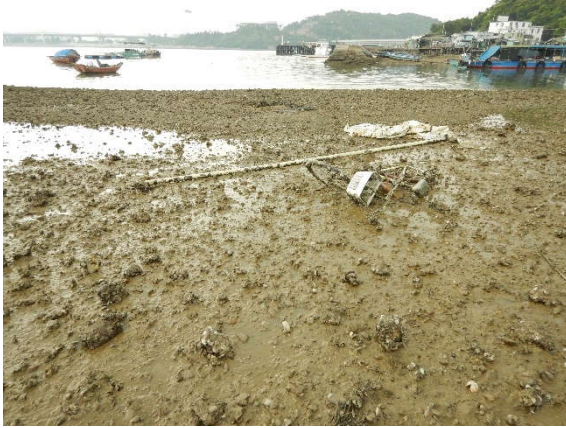
TC1

- 6.3.2 Since the field survey of Jun. 2016, increasing number of trashes and even big trashes (**Figure 2.3 of Appendix I**) were found in every sampling zone. It raised a concern about the solid waste dumping and current-driven waste issues in Tung Chung Wan. Respective measures (e.g. manual clean-up) should be implemented by responsible units.

broken bike and plastic waste

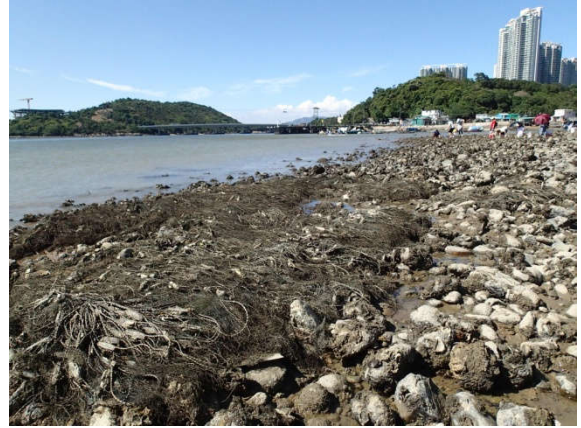
trash gill net

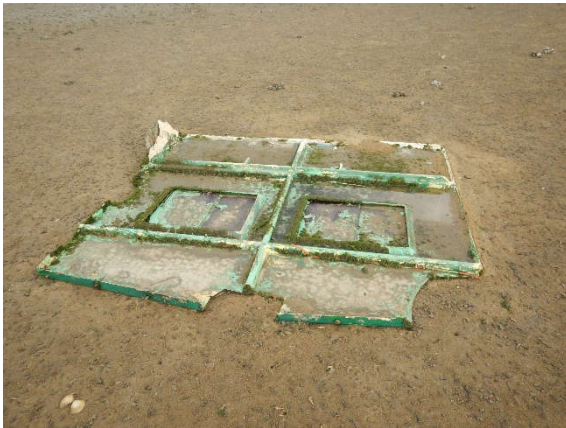
TC3

boat wreckage

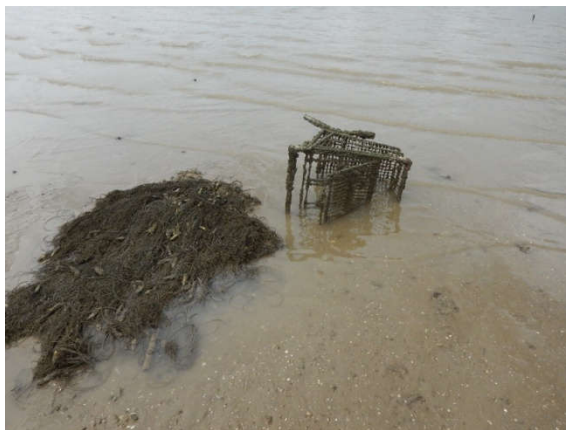
ST

trash gill net and hand trolley

Figure 2.3. Examples of photographic record of the big trashes found on the mudflat.

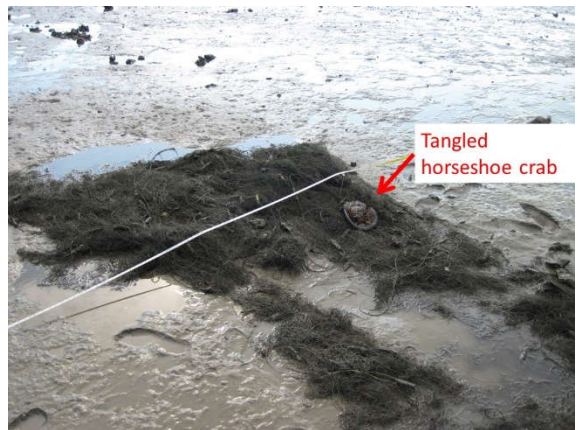
a tangled horseshoe crab on a trash net

(record in Jun. 2017)

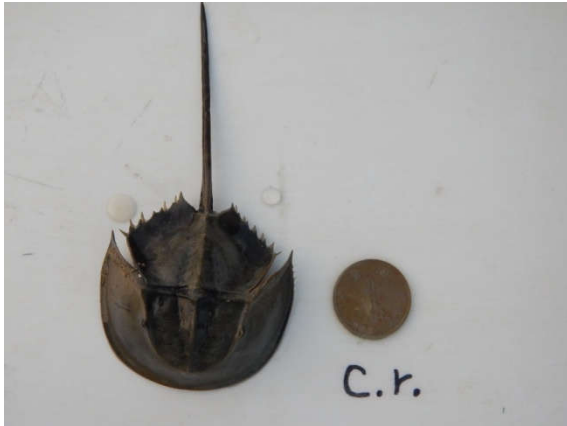
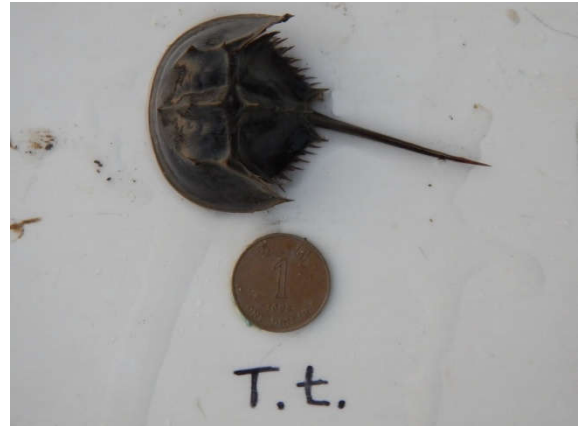
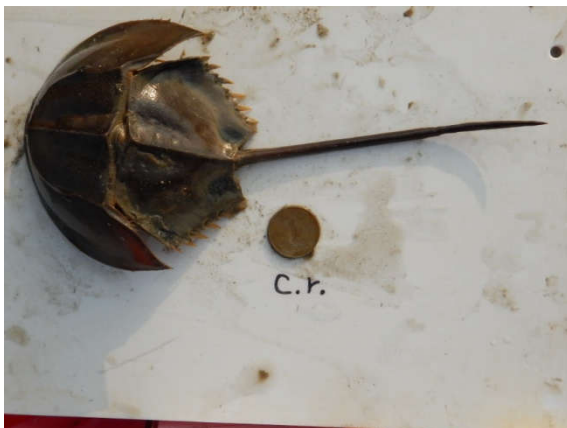
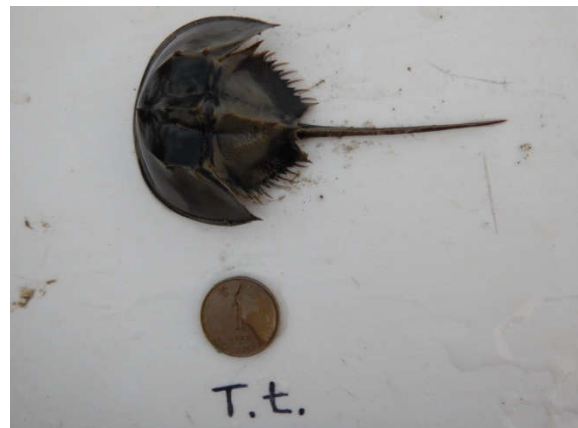
Figure 3.1. Examples of photographic records of horseshoe crab (Dec. 2017)

Carcinoscorpius rotundicauda

Tachypleus tridentatus

- 6.5.1 In the present survey, two species of horseshoe crab *Carcinoscorpius rotundicauda* (total 8 ind.) and *Tachypleus tridentatus* (total 3 ind.) were recorded. The recorded individuals were scattered along the shoreline from TC3 to ST on similar substratum (fine sand or soft mud, slightly submerged). No grouping was observed. Photo records were shown in **Figure 3.1 of Appendix I** while the complete survey records were listed in **Annex II of Appendix I**.
