Contract No. HY/2011/03

**Hong Kong-Zhuhai-Macao Bridge Hong Kong Link Road
Section between Scenic Hill and Hong Kong Boundary Crossing
Facilities**

Monthly EM&A Report No.63 (December 2017)

15 January 2018

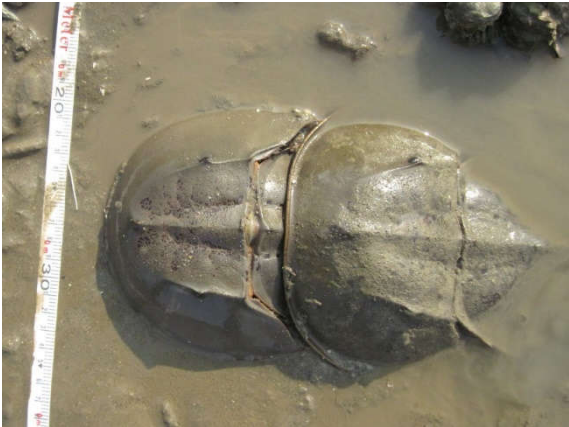
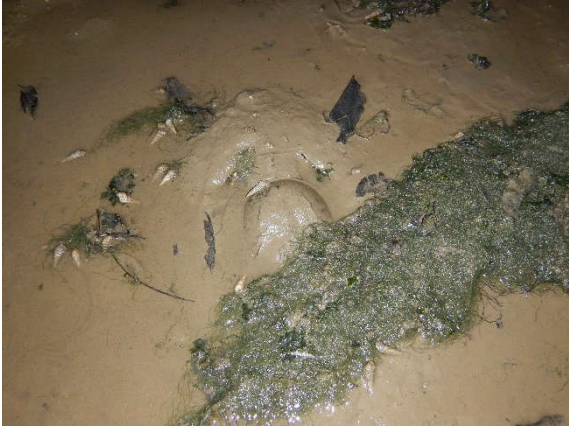
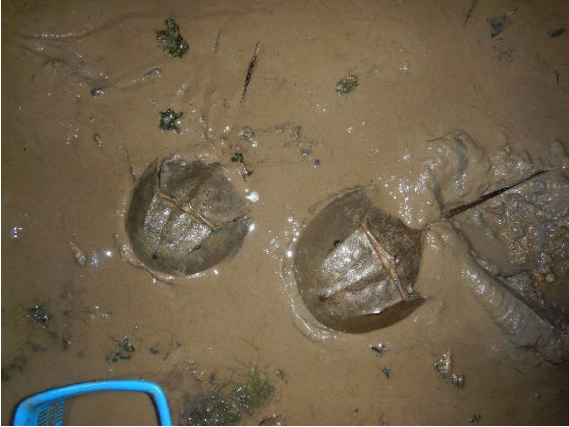
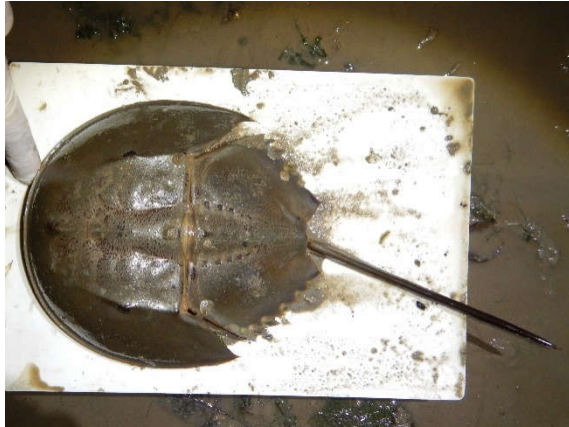
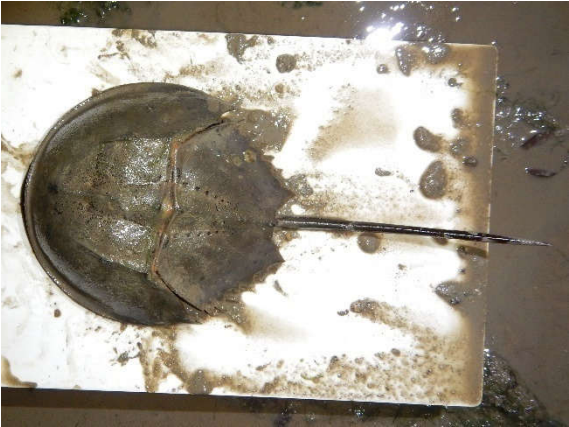
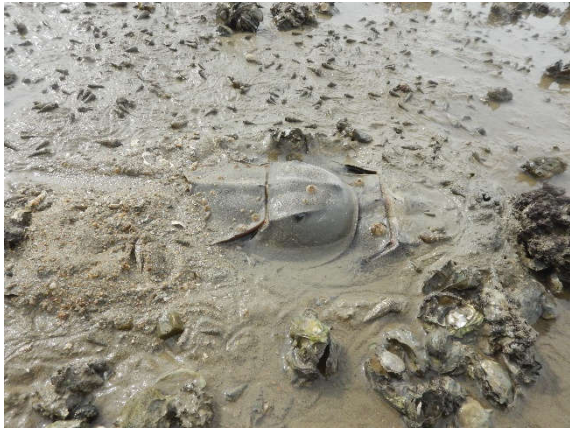
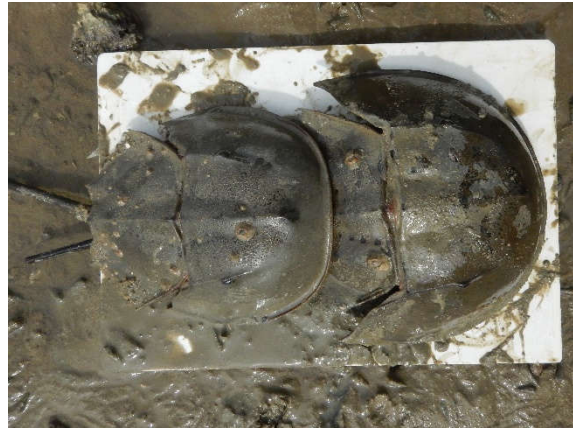
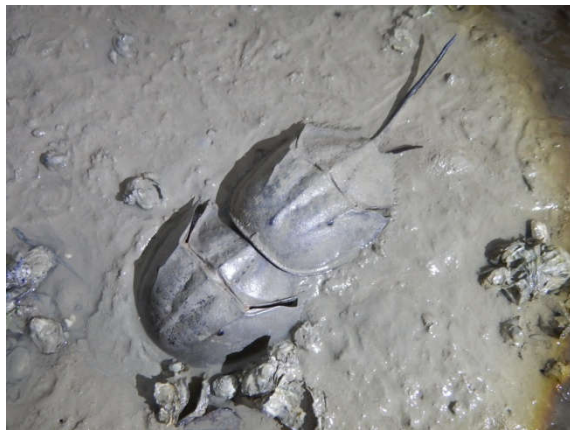
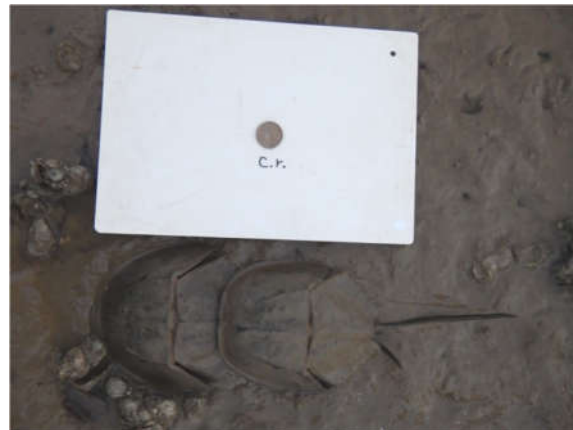
Figure 3.2. Photographic records of mating pair of *Carcinoscorpius rotundicauda*

Mar. 2015 - ST

Jun. 2017 – TC2

Female

Male

Jun. 2017 - TC3

Dec. 2017 - TC3

- 6.5.4 In the previous survey of Mar. 2015, there was one important finding that a mating pair of *Carcinoscorpius rotundicauda* was found in ST (prosomal width: male 155.1 mm, female 138.2 mm) (**Figure 3.2 of Appendix I**). It indicated the importance of ST as a breeding ground of horseshoe crab. In Jun. 2017, mating pairs of *Carcinoscorpius rotundicauda* were also found in TC2 (male 175.27 mm, female 143.51 mm) and TC3 (male 182.08 mm, female 145.63 mm) (**Figure 3.2 of Appendix I**). In Dec. 2017 (present survey), one mating pair was of *Carcinoscorpius rotundicauda* was found in TC3 (male 127.80 mm, female 144.61 mm) (**Figure 3.2 of Appendix I**). These mating pairs indicated that breeding of horseshoe crab could be

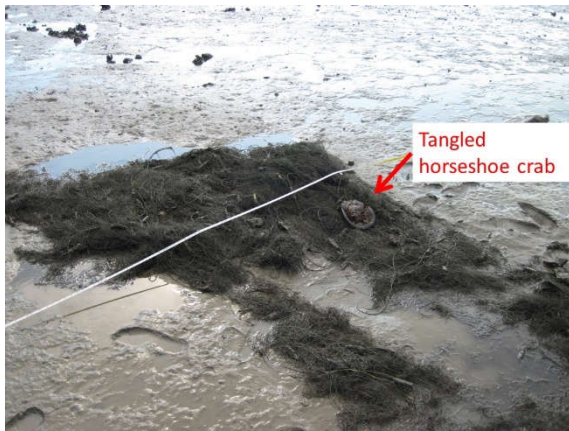
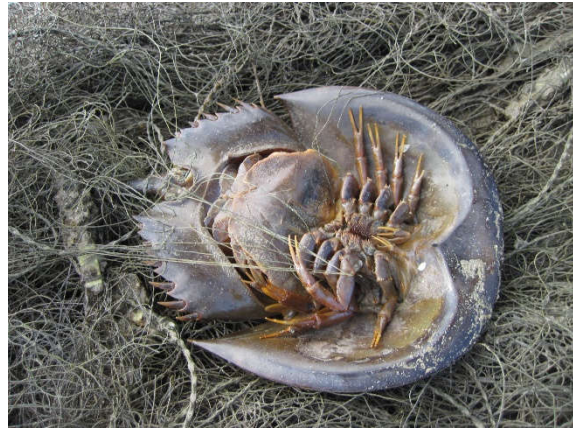
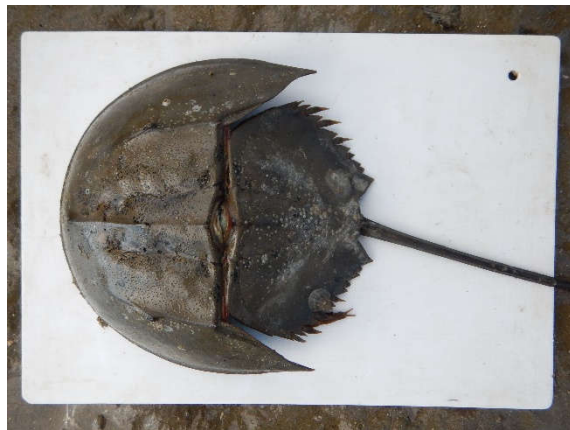
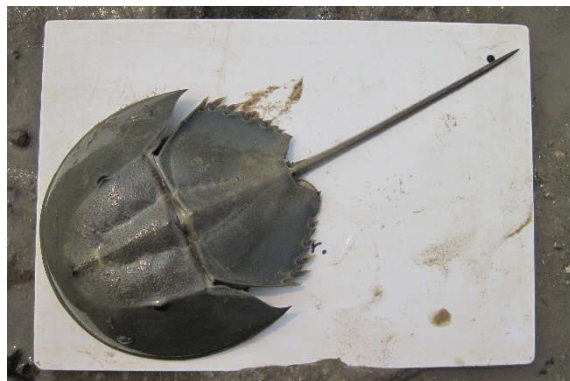
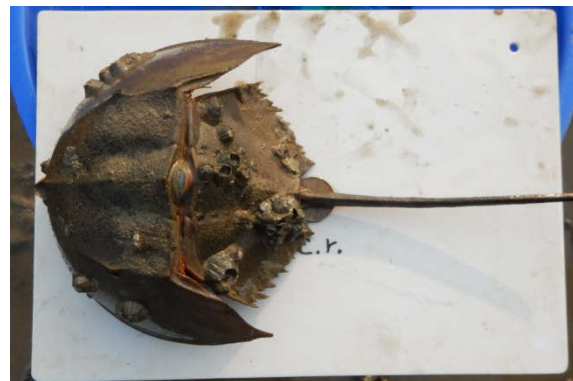
Figure 3.3. *Photographic records of large individuals (>100 mm) of *Carcinoscorpius rotundicauda* whose records were excluded from data analysis.*

Jun. 2017

Sep. 2017

Dec. 2017

- 6.5.5 In the previous surveys (Jun. 2016, Jun. 2017, Sep. 2017) present survey (Dec. 2017), there were occasional records of large individuals of *Carcinoscorpius rotundicauda* (prosomal width ranged 114.45- 178.67 mm, either single or in pair) in ST (**Figure 3.3 of Appendix I**). Based on their sizes, it indicated that individuals of prosomal width larger than 100 mm would progress its nursery stage from intertidal habitat to sub-tidal habitat of Tung Chung Wan. These large individuals might move onto intertidal shore occasionally during high tide for foraging and breeding. Because they should be inhabiting sub-tidal habitat most of the time. Their records were excluded from the data analysis to avoid mixing up with juvenile population living on intertidal habitat.

6.5.12 Throughout the monitoring period, the search record of horseshoe crab declined obviously during dry season especially December (**Figures 3.3 and 3.4 of Appendix I**). In Dec. 2012, 4 individuals of *Carcinoscorpius rotundicauda* and 12 individuals of *Tachypleus tridentatus* were found only. In Dec. 2013, no individual of horseshoe crab was found. In Dec. 2014, 2 individuals of *Carcinoscorpius rotundicauda* and 8 individuals of *Tachypleus tridentatus* were found only. In Dec. 2015, 2 individuals of *Carcinoscorpius rotundicauda*, 6 individuals of *Tachypleus tridentatus* and one newly hatched, unidentified individual were found only. The horseshoe crabs were inactive and burrowed in the sediments during cold weather (<15 °C). Similar results of low search record in dry season were reported in a previous territory-wide survey of horseshoe crab. For example, the search records in Tung Chung Wan were 0.17 ind. hr⁻¹ person⁻¹ and 0.00 ind. hr⁻¹ person⁻¹ in wet season and dry season respectively (details see Li, 2008). Relatively the search records were much higher in Dec. 2016. There were totally 70 individuals of *Carcinoscorpius rotundicauda* and 24 individuals of *Tachypleus tridentatus* in TC3 and ST. Because the survey was arranged in early December while the weather was warm with sunlight (~22 °C during dawn according to Hong Kong Observatory database, Chek Lap Kok station on 5 Dec). In contrast, there was no search record in TC1 and TC2 because the survey was conducted in mid December with colder and cloudy weather (~20 °C during dawn on 19 Dec). The horseshoe crab activity would decrease gradually with the colder climate. In Dec. 2017 (present survey), the weather was cold (13-15 °C during dawn) that very few individuals of both species could be found as mentioned above.

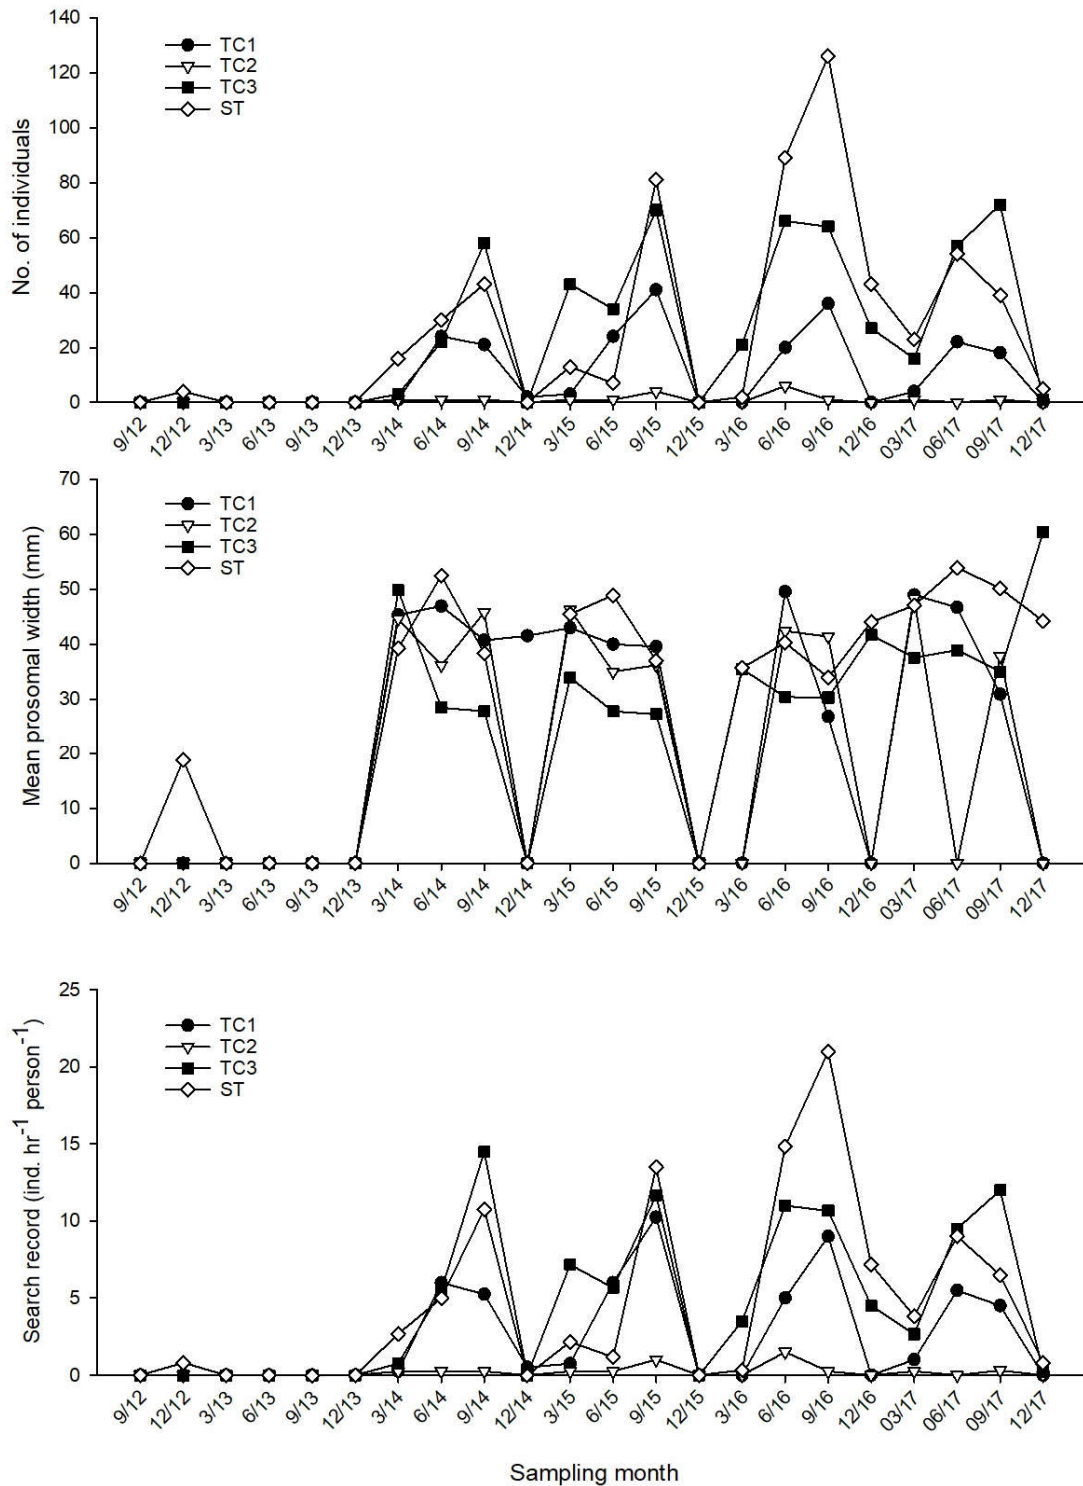
Figure 3.4. Changes of number of individuals, mean prosomal width and search record of horseshoe crab *Carcinoscorpius rotundicauda* in every sampling zone along the sampling months

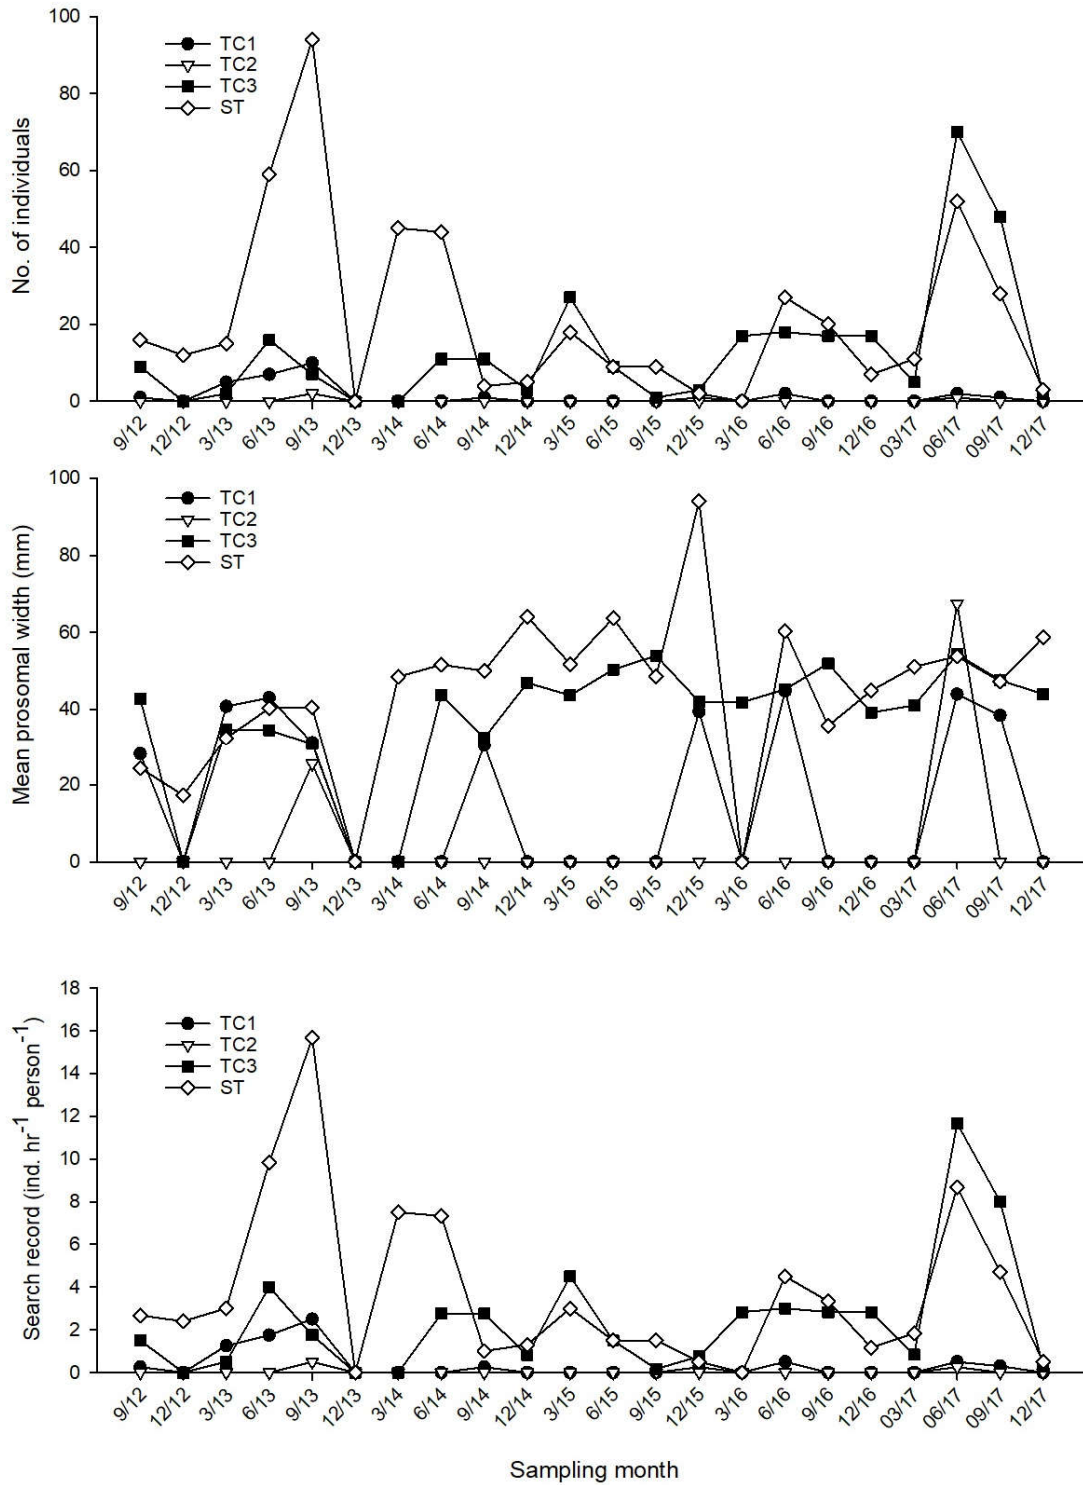
Figure 3.5. Changes of number of individuals, mean prosomal width and search record of horseshoe crab *Tachypleus tridentatus* in every sampling zone along the sampling months

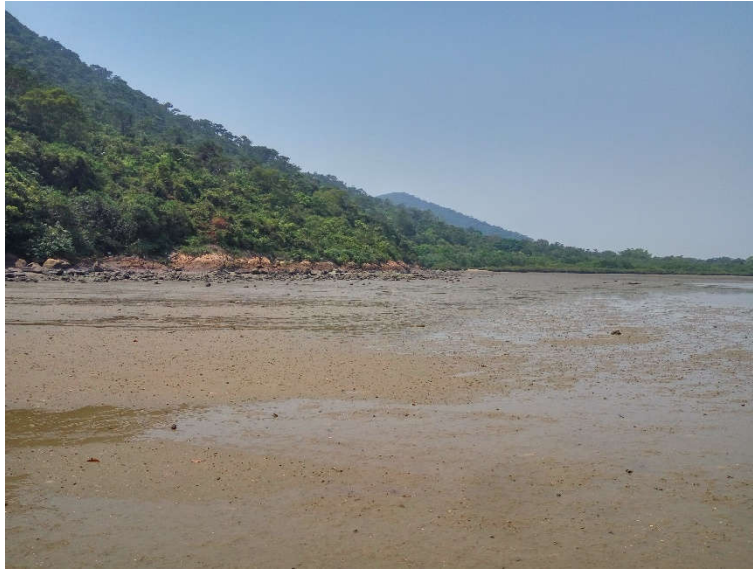
Re-exposed mudflat area between TC3 and ST where used to be an extensive patch of *Halophila ovalis* (photo taken in Sep. 2017)

Figure 3.8. Seagrass disappearance in areas between TC3 and ST

- 6.5.22 From Sep. to Dec. 2017 (present survey), no seagrass bed was recorded in Tung Chung Wan. Extensive area of mudflat, where used to be covered by seagrass beds, re-exposed along TC3 and ST (**Figure 3.8 of Appendix I**). In the previous survey of Jun. 2017, two species of seagrass *Halophila ovalis* and *Zostera japonica* were recorded in TC3 and ST (**Figure 3.9 of Appendix I**). There was still extensive seagrass area (~17046.5 m²) of *Halophila ovalis* along the mudflat between TC3 and ST at 0.5-2.0 m above C.D.. Another seagrass species *Zostera japonica*, which was much lower in vegetation area (~105.4 m²), was co-existing with few patches of *Halophila ovalis* nearby the mangrove strand. The disappearance of seagrass beds would be discussed in later paragraphs.

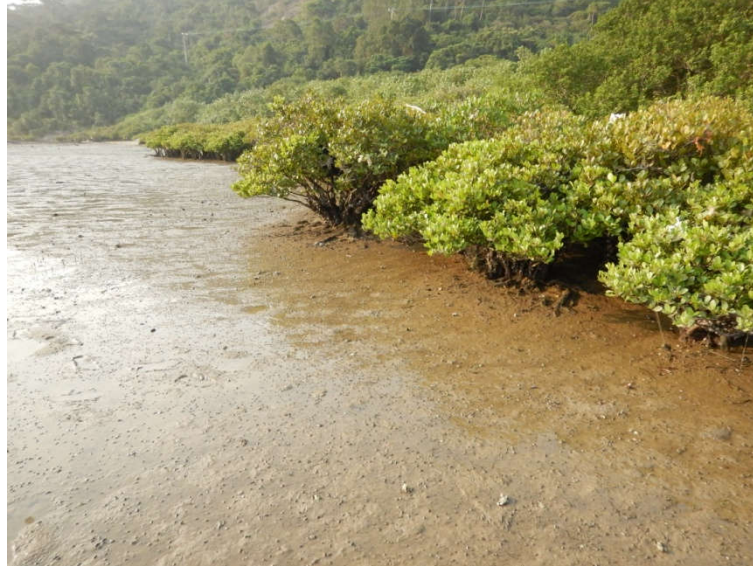
Re-exposed mudflat area in ST where used to be co-existing patches of *Halophila ovalis* and *Zostera japonica* (photo taken in Dec. 2017)

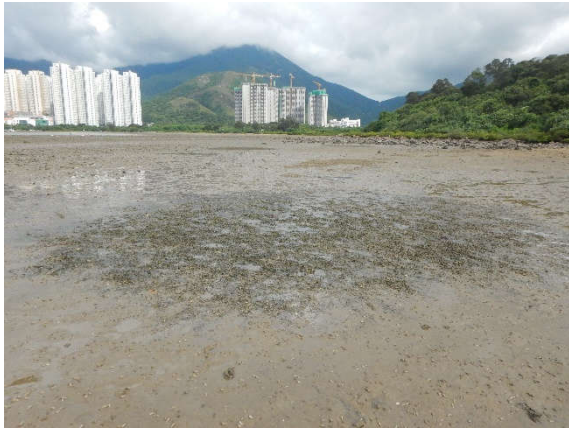
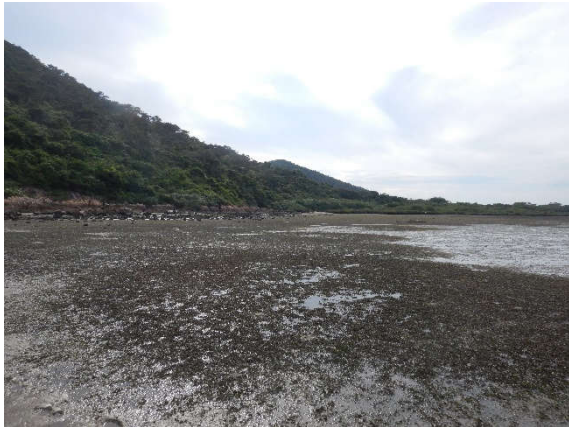
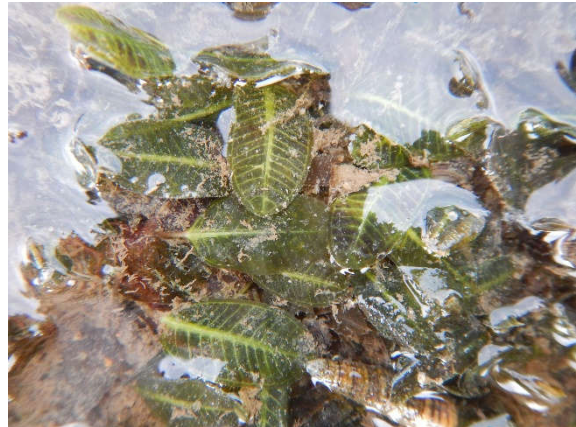
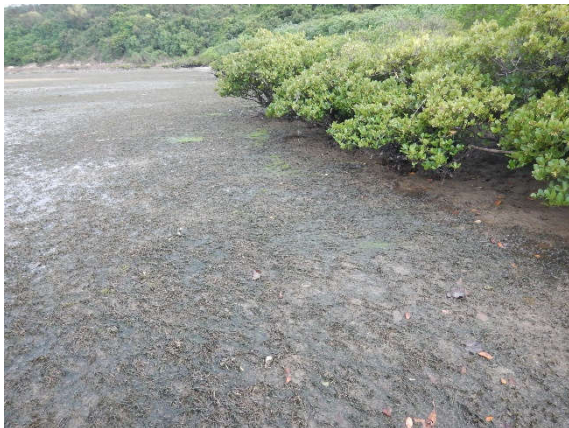
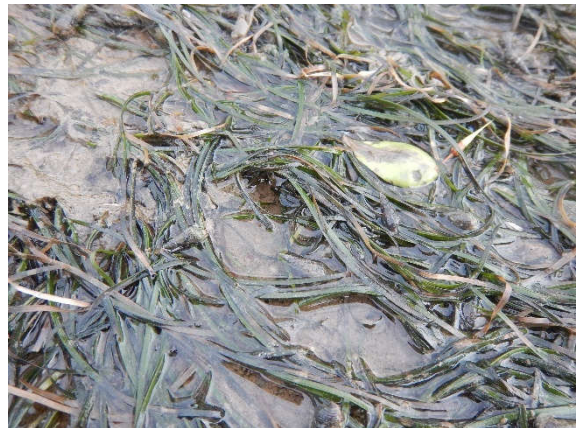
Figure 3.9. Examples of photographic records of seagrass beds (record in Jun. 2017)

TC3 *Halophila ovalis*

ST *Halophila ovalis*

ST *Zostera japonica*

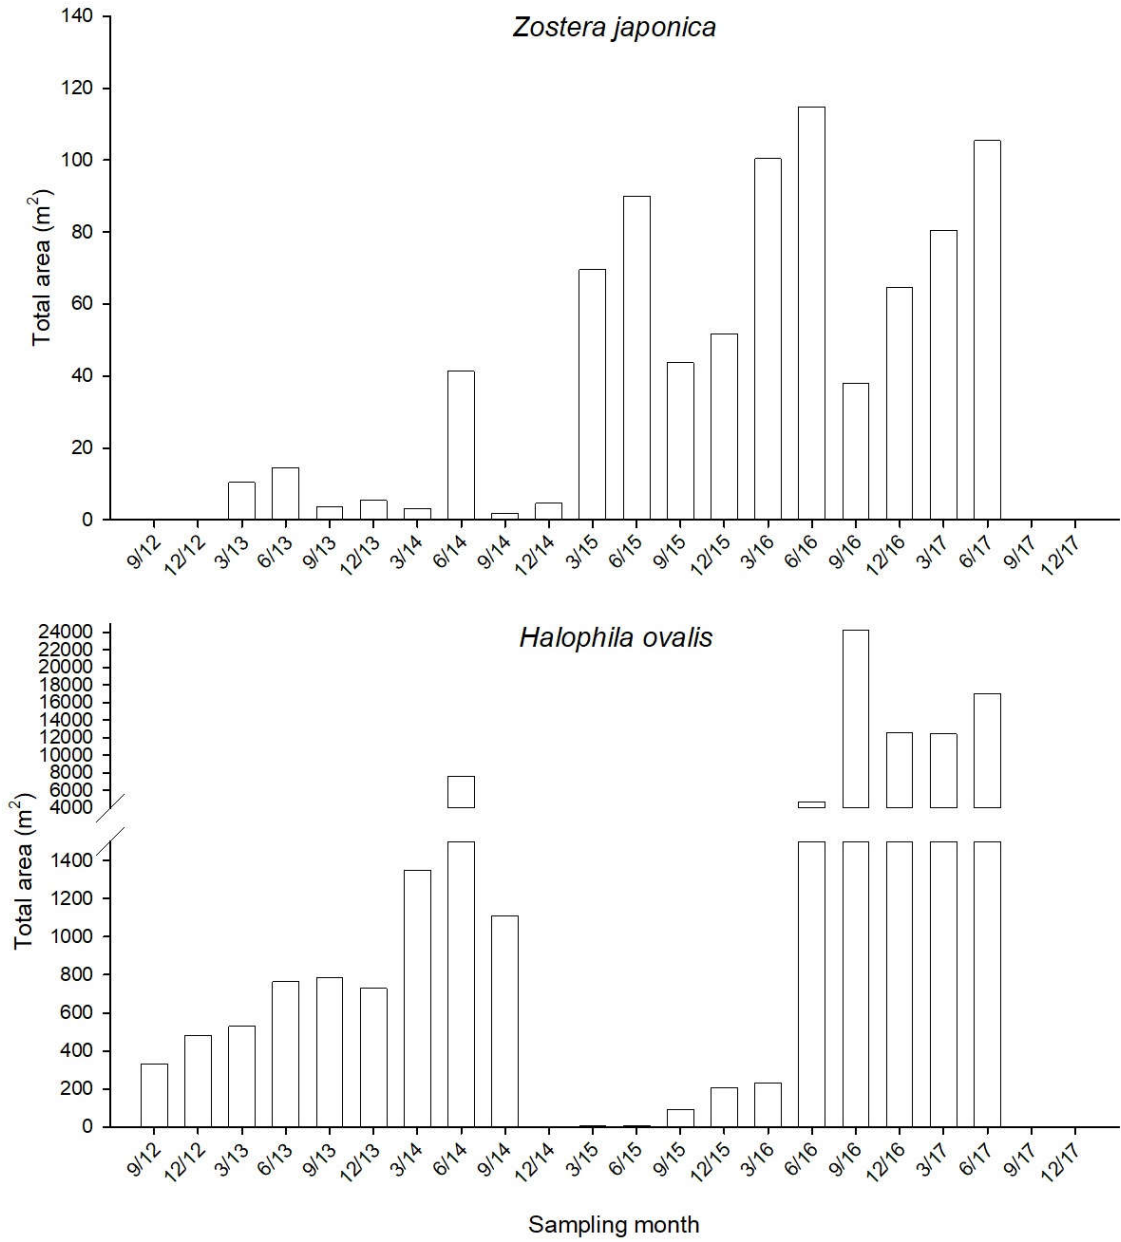
Figure 3.10. Temporal changes of estimated total area of seagrass beds in ST

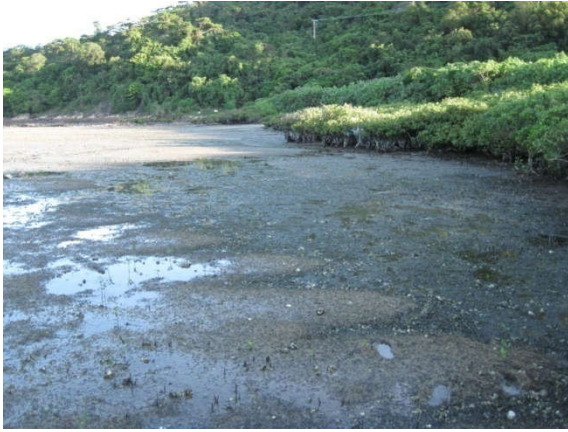
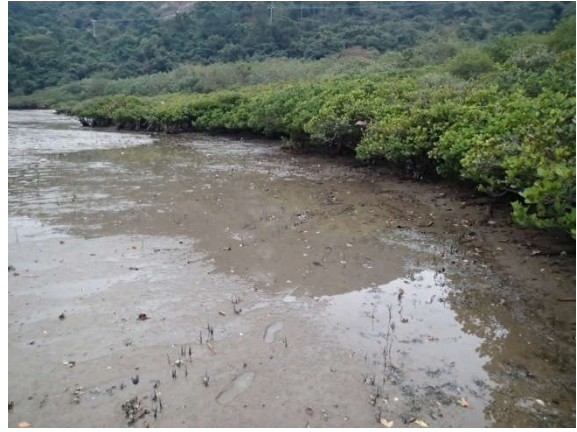
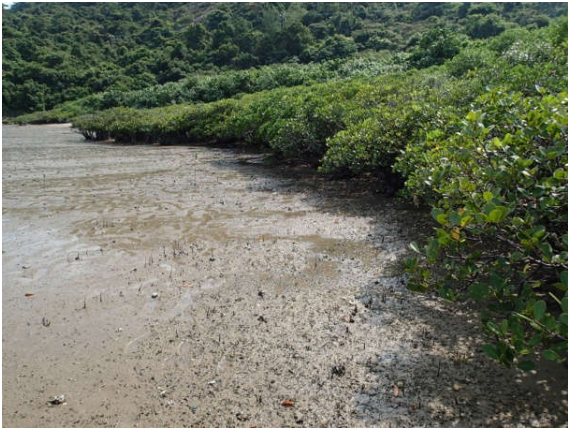
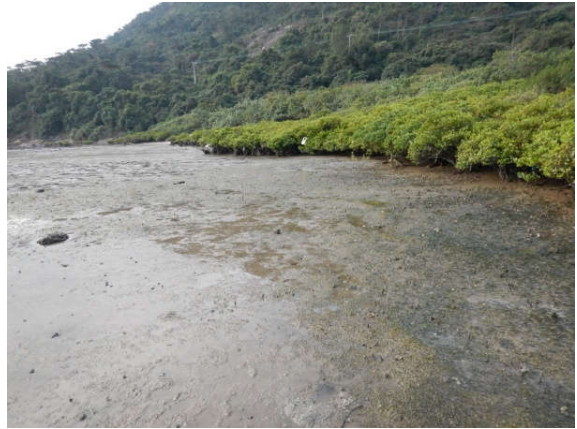
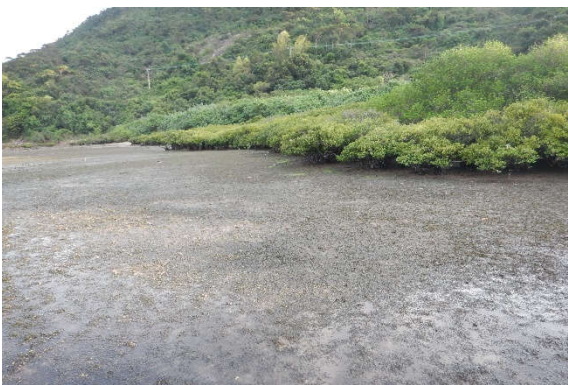
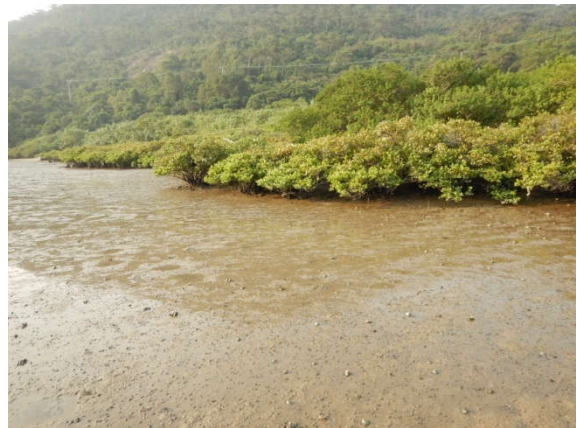
Figure 3.11. Comparison of pictures taken in different sampling months shows the disappearance, recolonization of seagrass beds and disappearance again

Jun. 2014

Dec. 2014 (no seagrass)

Sep. 2015

Sep. 2016

Jun. 2017

Sep. - Dec. 2017 (no seagrass)

- 6.5.26 In Dec. 2014, all the seagrass patches of *Halophila ovalis* disappeared in ST. **Figure 3.10 of Appendix I** shows the difference of the original seagrass beds area nearby the mangrove vegetation at high tidal level between Jun. 2014 and Dec. 2014. Such rapid loss would not be seasonal phenomenon because the seagrass beds at higher tidal level (2.0 m above C.D.) were present and normal in December 2012 and 2013. According to Fong (1998), similar incident had occurred in ST in the past. The original seagrass area had declined significantly during the commencement of the construction and reclamation works for the international airport at Chek Lap Kok in 1992. The seagrass almost disappeared in 1995 and recovered gradually after the completion of reclamation works. Moreover, incident of rapid loss of seagrass area was also recorded in another intertidal mudflat in Lai Chi Wo in 1998 with unknown reason. Hence *Halophila ovalis* was regarded as a short-lived and *r*-strategy seagrass that could colonize areas in short period but disappears quickly under unfavourable conditions (Fong, 1998).

- 6.5.31 **Figure 3.10 of Appendix I** shows the recolonization of seagrass bed area in ST from Dec. 2014 to Jun. 2017. From Mar. to Jun. 2015, 2-3 small patches of *Halophila ovalis* were newly found coinhabiting with another seagrass species *Zostera japonica*. But its total patch area was still very low relative to the previous records. The recolonization rate was low while cold weather and insufficient sunlight were possible factors between Dec. 2014 and Mar. 2015. Moreover, it would need to compete with seagrass *Zostera japonica* for substratum and nutrient. Since *Zostera japonica* had extended and had covered the original seagrass bed of *Halophila ovalis* at certain degree. From Jun. 2015 to Mar. 2016, the total seagrass area of *Halophila ovalis* had increased rapidly from 6.8 m² to 230.63 m². It had recolonized its original patch locations and covered *Zostera japonica*. In Jun. 2016, the total seagrass area increased sharply to 4707.3 m². Similar to the previous records of Mar to Jun. 2014, the original patch area increased further to a horizontally long strand. Another large seagrass beds colonized the lower tidal zone (1.0-1.5 m above C.D.). In Sep. 2016, this patch extended much and covered significant soft mud area of ST, resulting in sharp increase of total area (24245 m²). It indicated the second extensive colonization of this *r*-strategy seagrass. In Dec. 2016, this extensive seagrass patch decreased in size and had separated into few, undistinguishable patches. Moreover, the horizontal strand nearby the mangrove vegetation decreased in size (Fig. 3.10). The total seagrass bed decreased to 12550 m². From Mar. to Jun. 2017, the seagrass bed area remained generally stable (12438-17046.5 m²) but the vegetation coverage fluctuated (20-50% in Mar. 2017 to 80-100% in Jun. 2017).

- 6.5.32 In Jun 2017, the whole seagrass bed of *Halophila ovalis* disappeared again along the shore of TC3 and ST (**Figure 3.10 of Appendix I**). It was similar to the case between Sep. and Dec. 2014. As mentioned, strong water current (e.g. cyclone) or deteriorated water quality (e.g. high turbidity) were the possible causes.

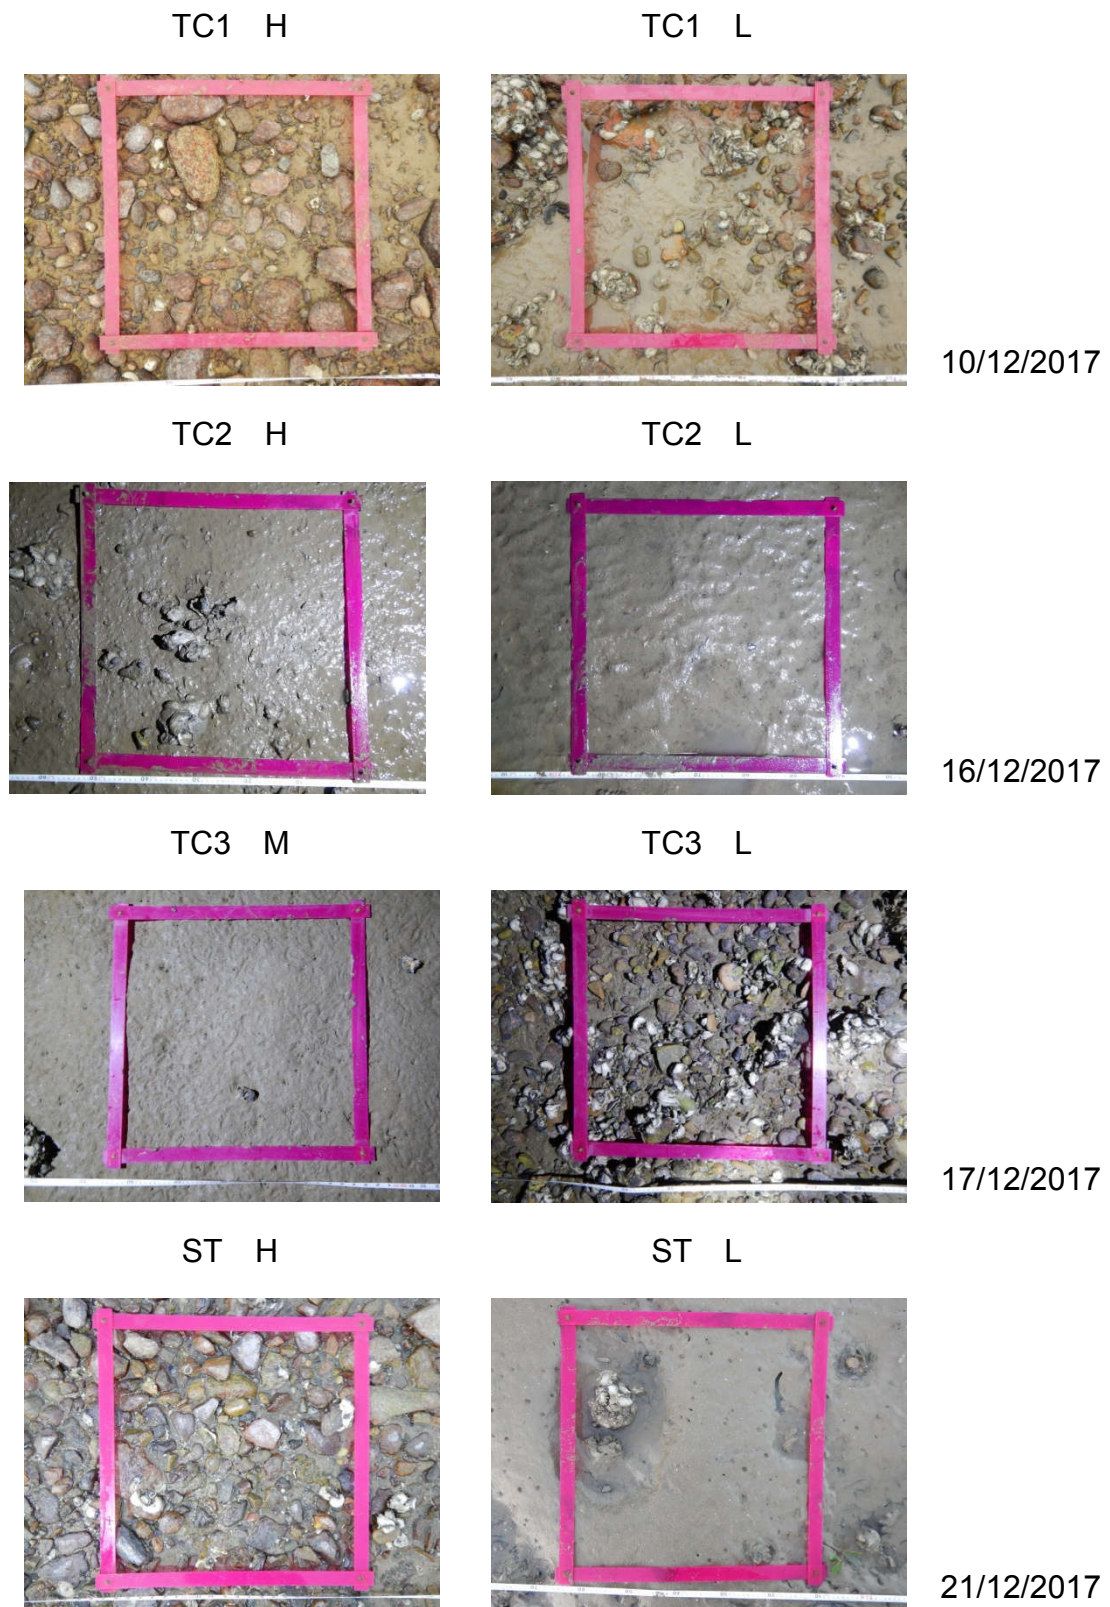
Figure 3.12. *Examples of photographic records of quadrat for intertidal soft shore community survey (H: 2.0 m above C.D.; M: 1.5 m above C.D.; L: 1.0 m above C.D.)*

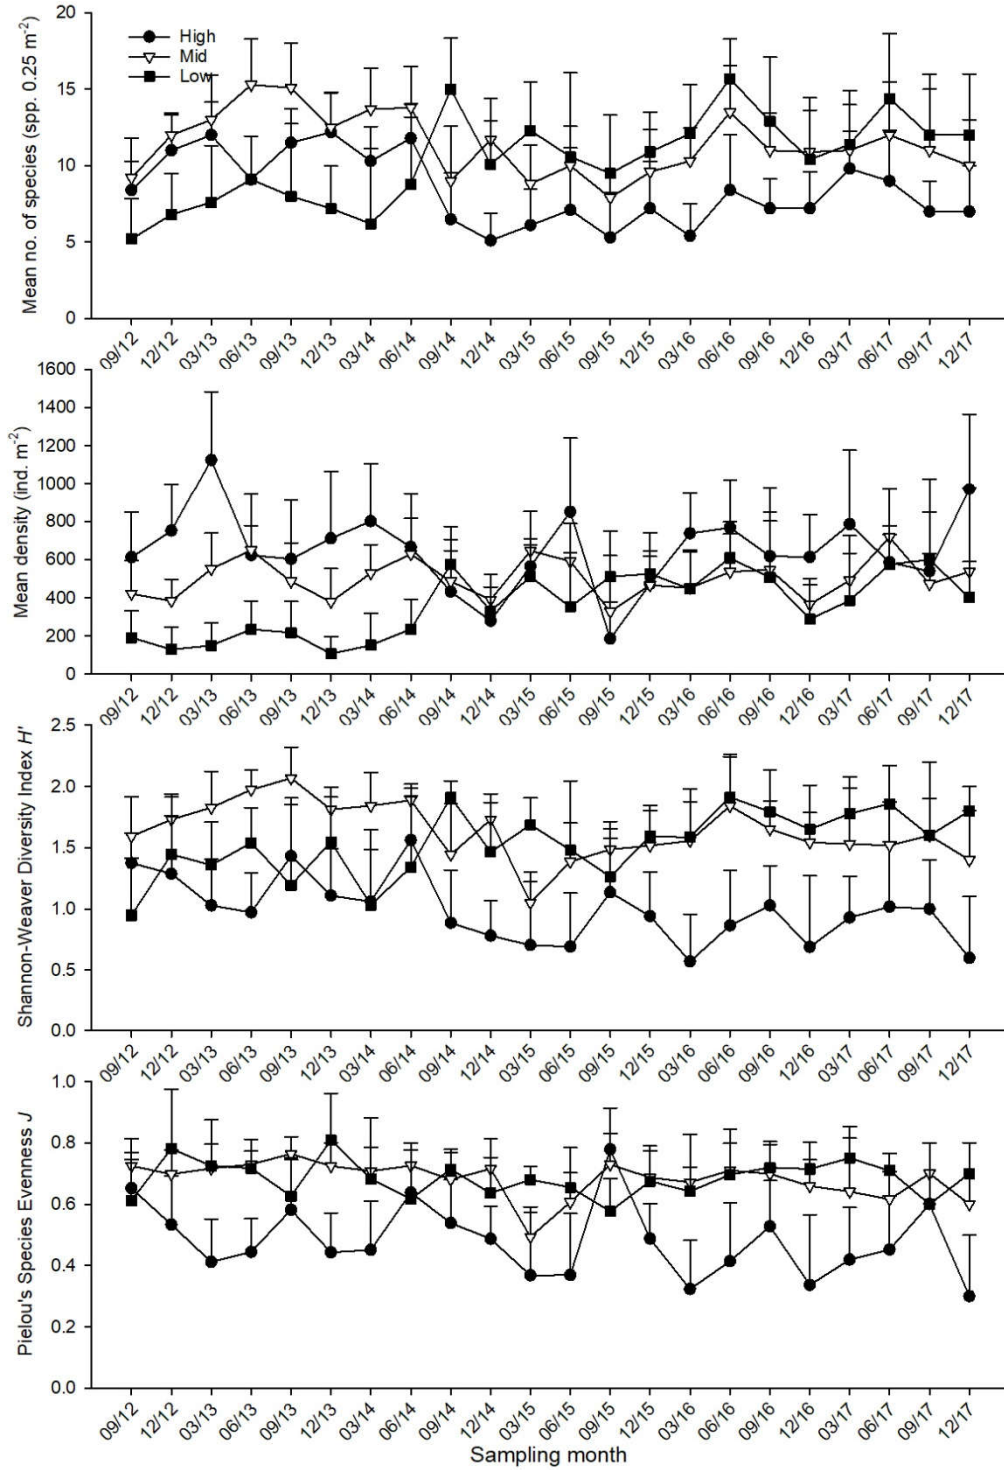
Figure 3.13. Temporal changes of mean number of species, mean density, Shannon-Weaver Diversity Index (H') and Pielou's Species Evenness (J) (mean + SD) at every tidal level in sampling zone TC1

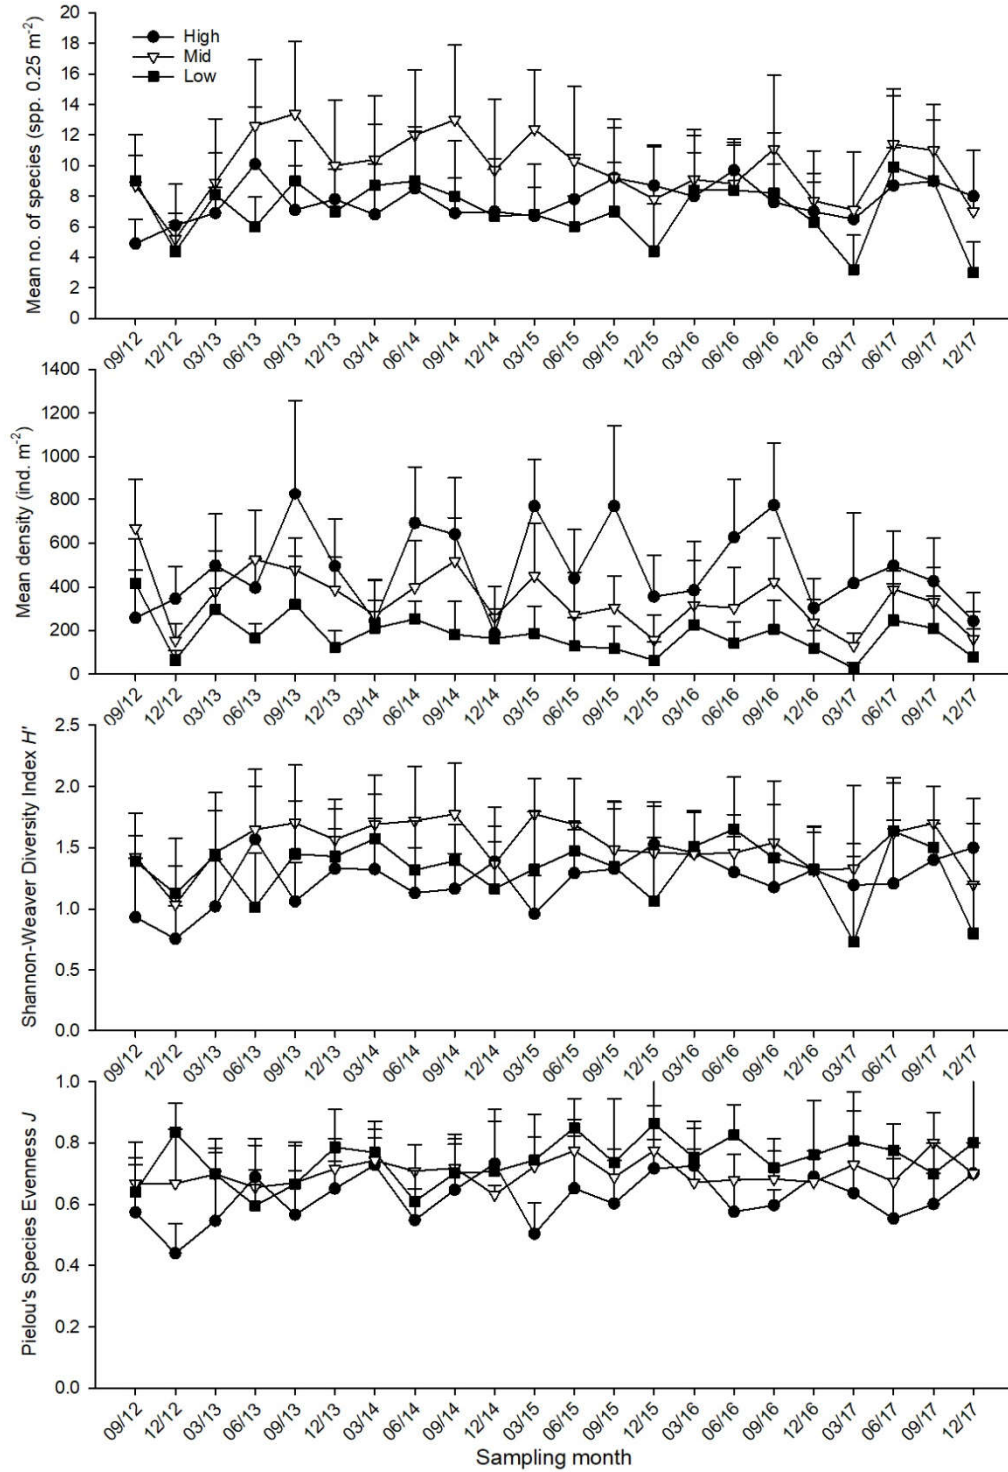
Figure 3.14. Temporal changes of mean number of species, mean density, Shannon-Weaver Diversity Index (H') and Pielou's Species Evenness (J) (mean + SD) at every tidal level in sampling zone TC2

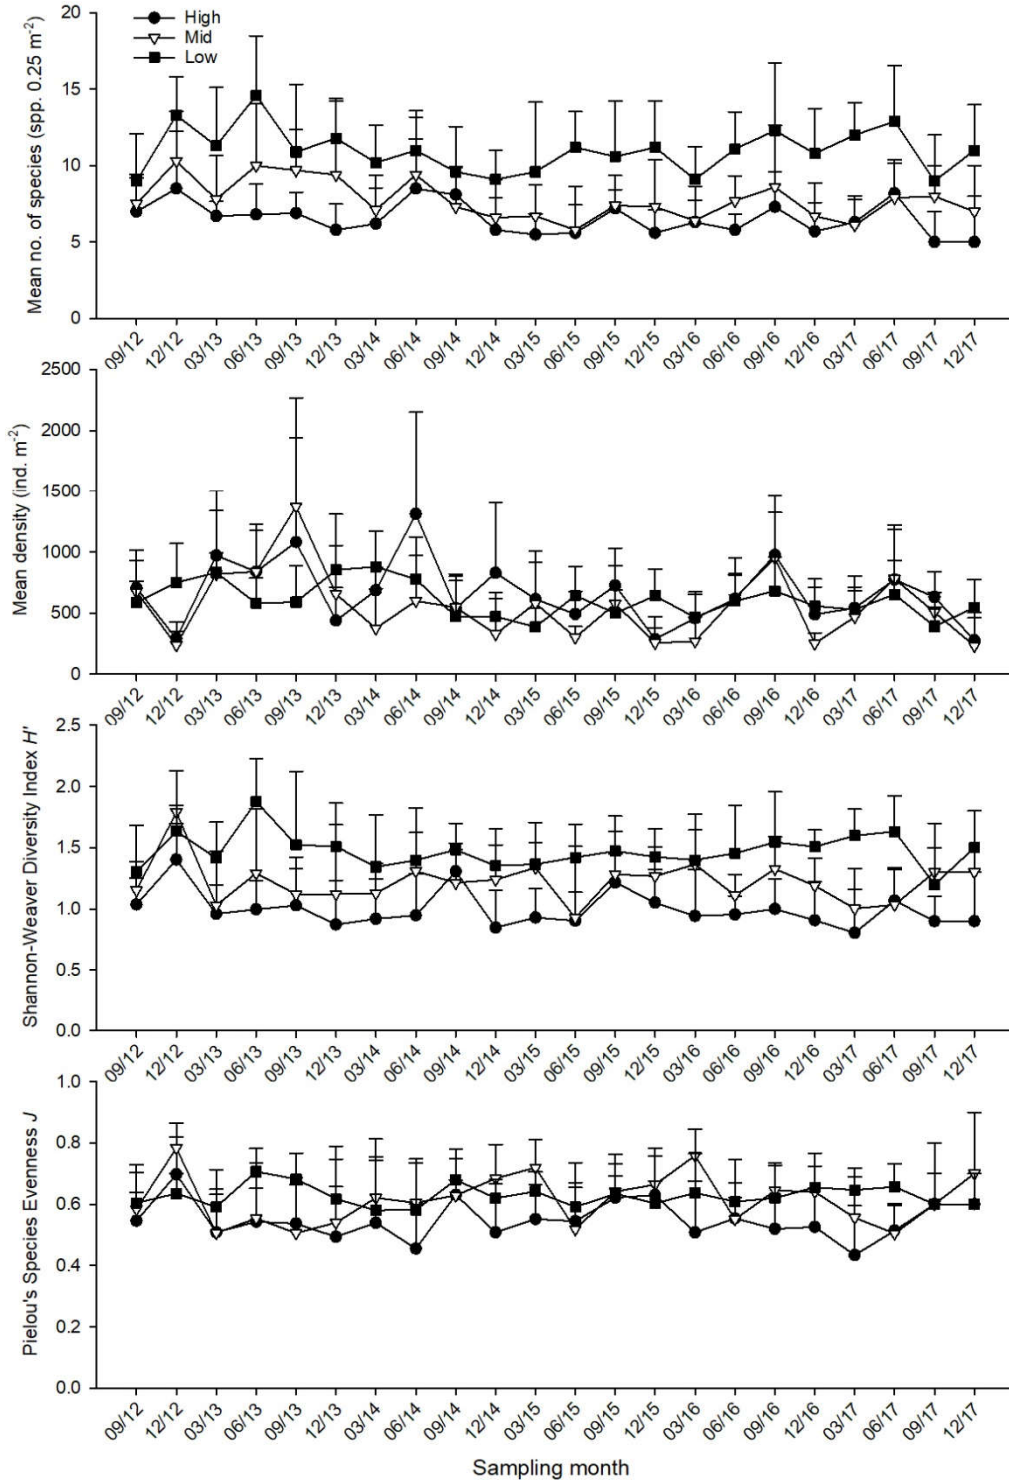
Figure 3.15. Temporal changes of mean number of species, mean density, Shannon-Weaver Diversity Index (H') and Pielou's Species Evenness (J) (mean + SD) at every tidal level in sampling zone TC3

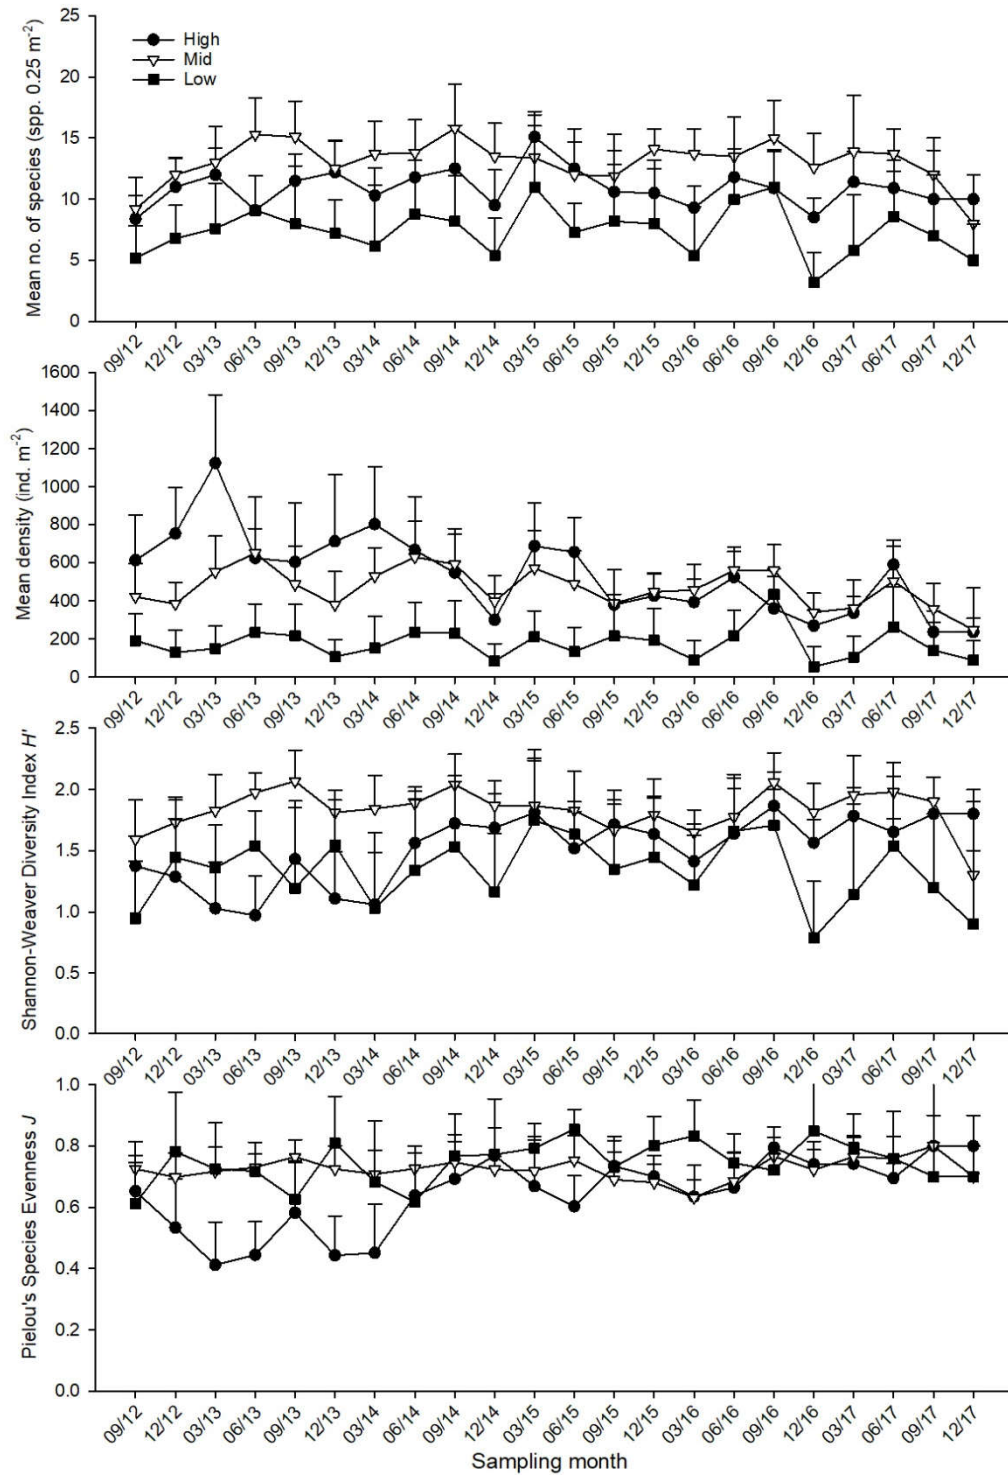
Figure 3.16. Temporal changes of mean number of species, mean density, Shannon-Weaver Diversity Index (H') and Pielou's Species Evenness (J) (mean + SD) at every tidal level in sampling zone ST
