Contract No. HY/2011/03

**Hong Kong-Zhuhai-Macao Bridge Hong Kong Link Road
Section between Scenic Hill and Hong Kong Boundary Crossing
Facilities**

Quarterly EM&A Report No. 23 (March 2018 to May 2018)

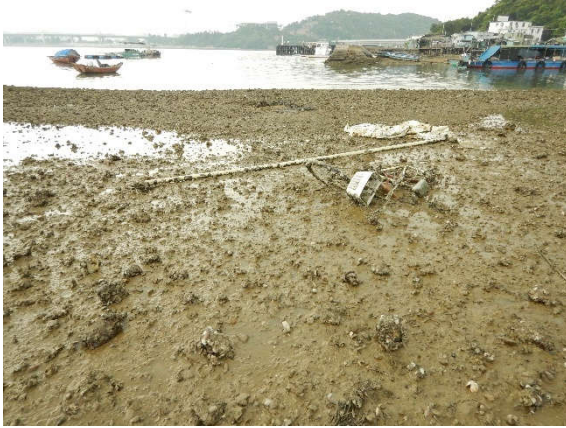
broken bike and plastic waste

- 3.6.7 Since the field survey of Jun. 2016, increasing number of trashes and even big trashes (**Figure 2.3 of Appendix O**) were found in every sampling zone. It raised a concern about the solid waste dumping and current-driven waste issues in Tung Chung Wan. Respective measures (e.g. manual clean-up) should be implemented by responsible units.

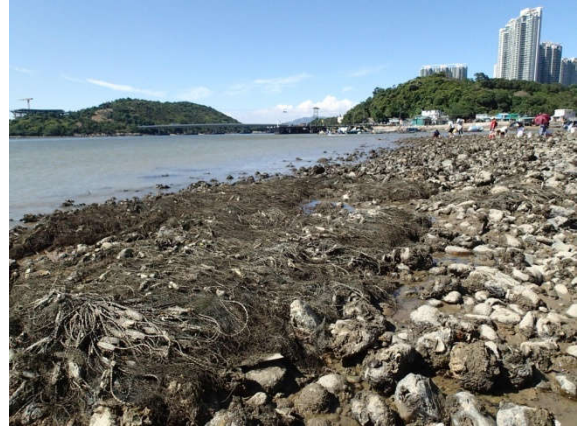
trash gill net
