Contract No. HY/2011/03

**Hong Kong-Zhuhai-Macao Bridge Hong Kong Link Road
Section between Scenic Hill and Hong Kong Boundary Crossing
Facilities**

Quarterly EM&A Report No. 25 (September 2018 to November 2018)

15 March 2019

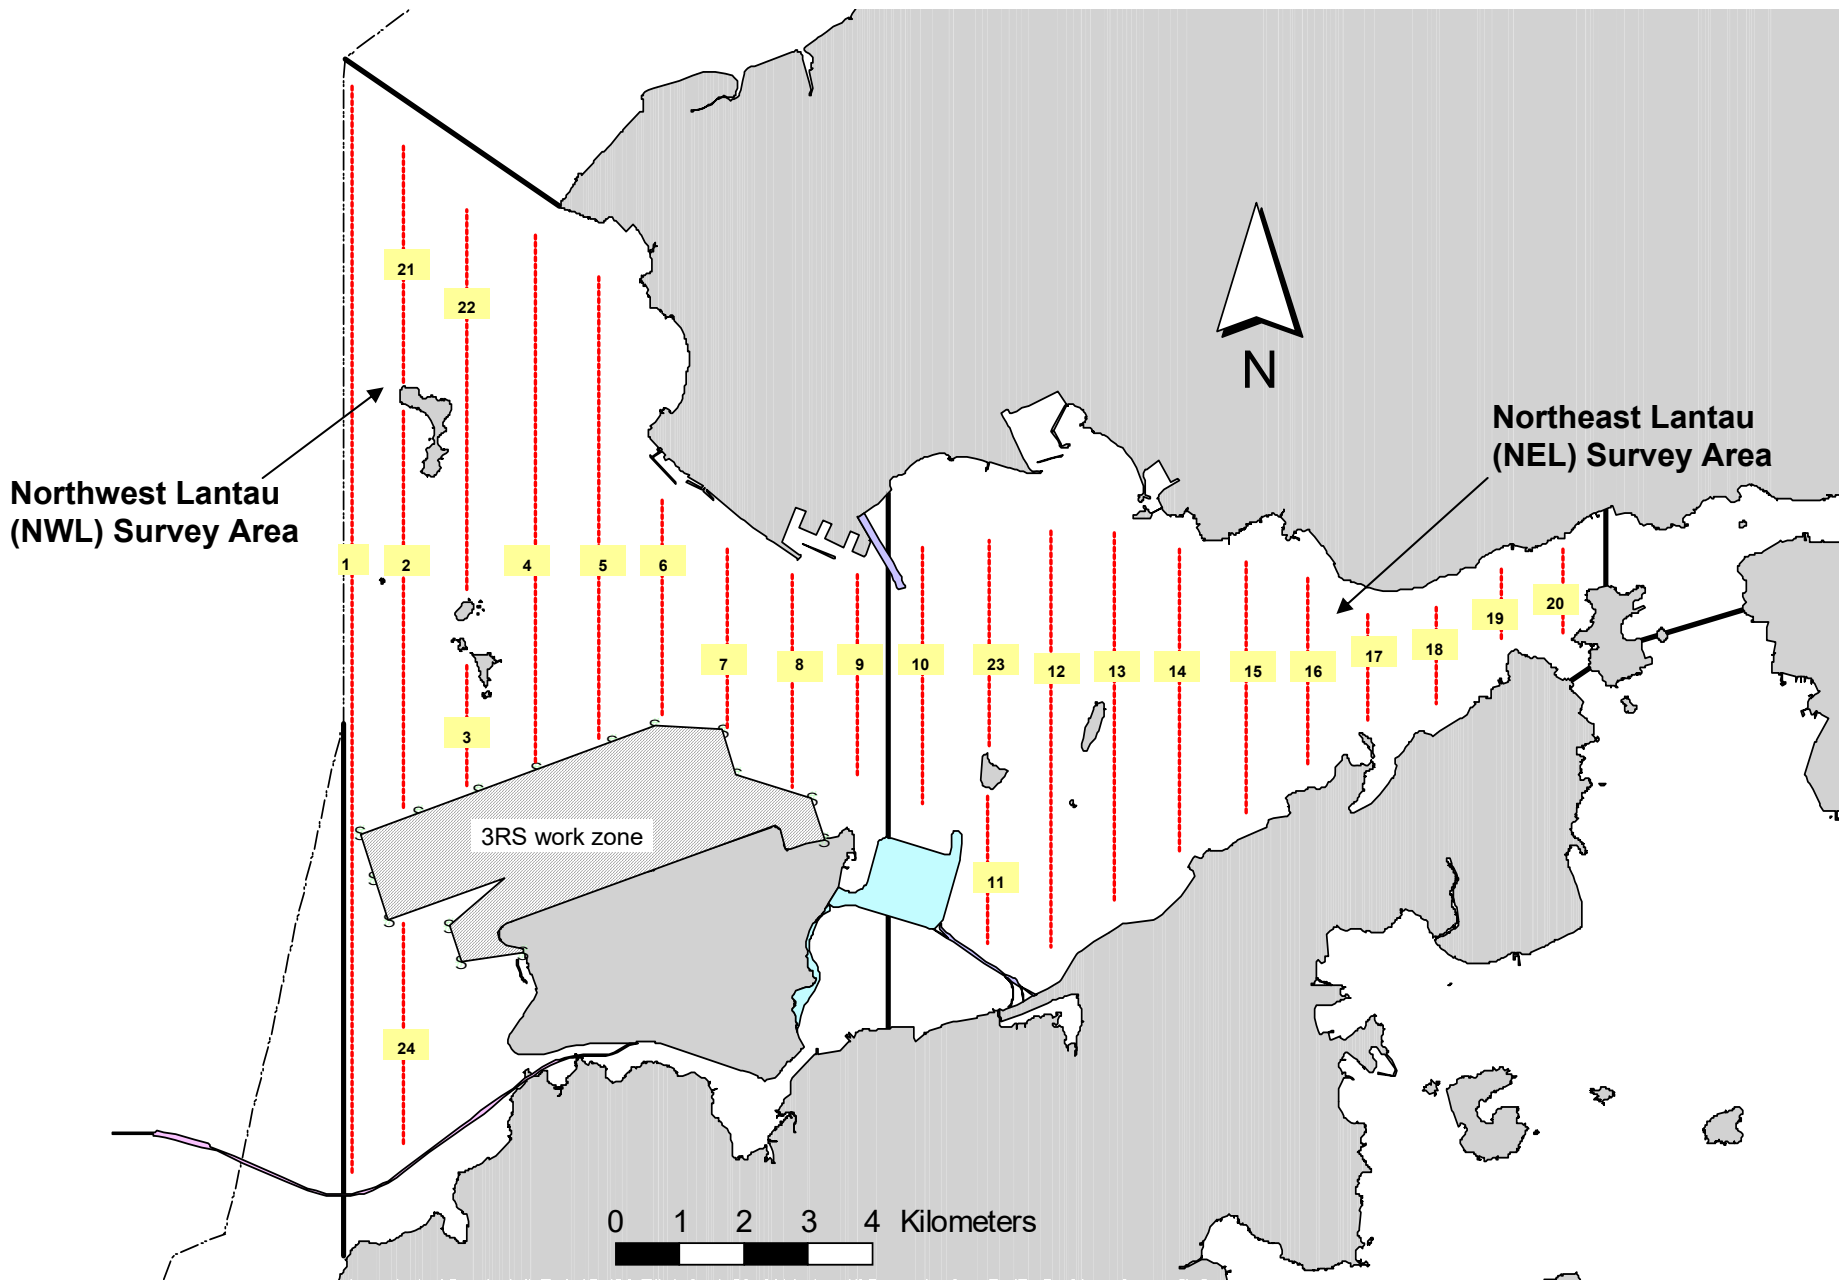
Figure 2.2. Transect Line Layout in Northwest and Northeast Lantau Survey Areas

- 3.5.10 From these surveys, a total of 797.27 km of survey effort was collected, with 93.8% of the total survey effort being conducted under favorable weather conditions (i.e. Beaufort Sea State 3 or below with good visibility). Among the two areas, 291.60 km and 505.67km of survey effort were conducted in NEL and NWL survey areas respectively.

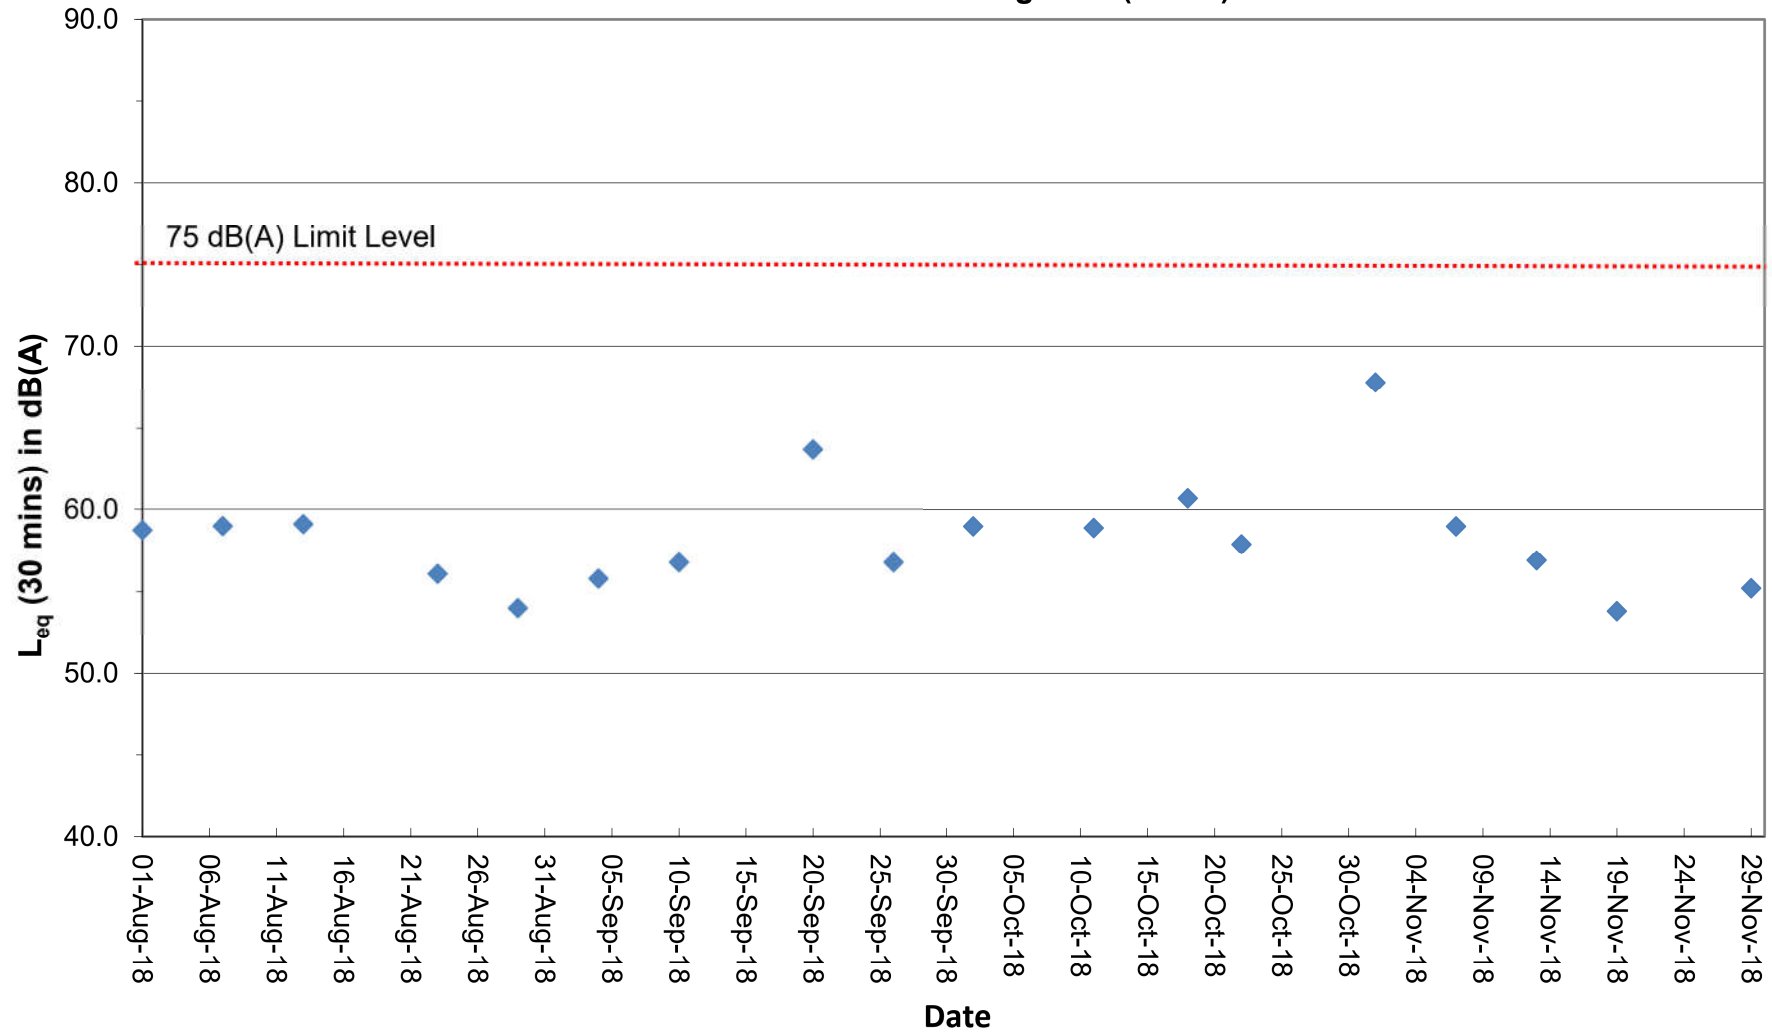
Continuous Noise Monitoring Data (NMS5)

Due to bad weather condition, the noise monitoring was rescheduled from 16 October 2018 to 18 October 2018.

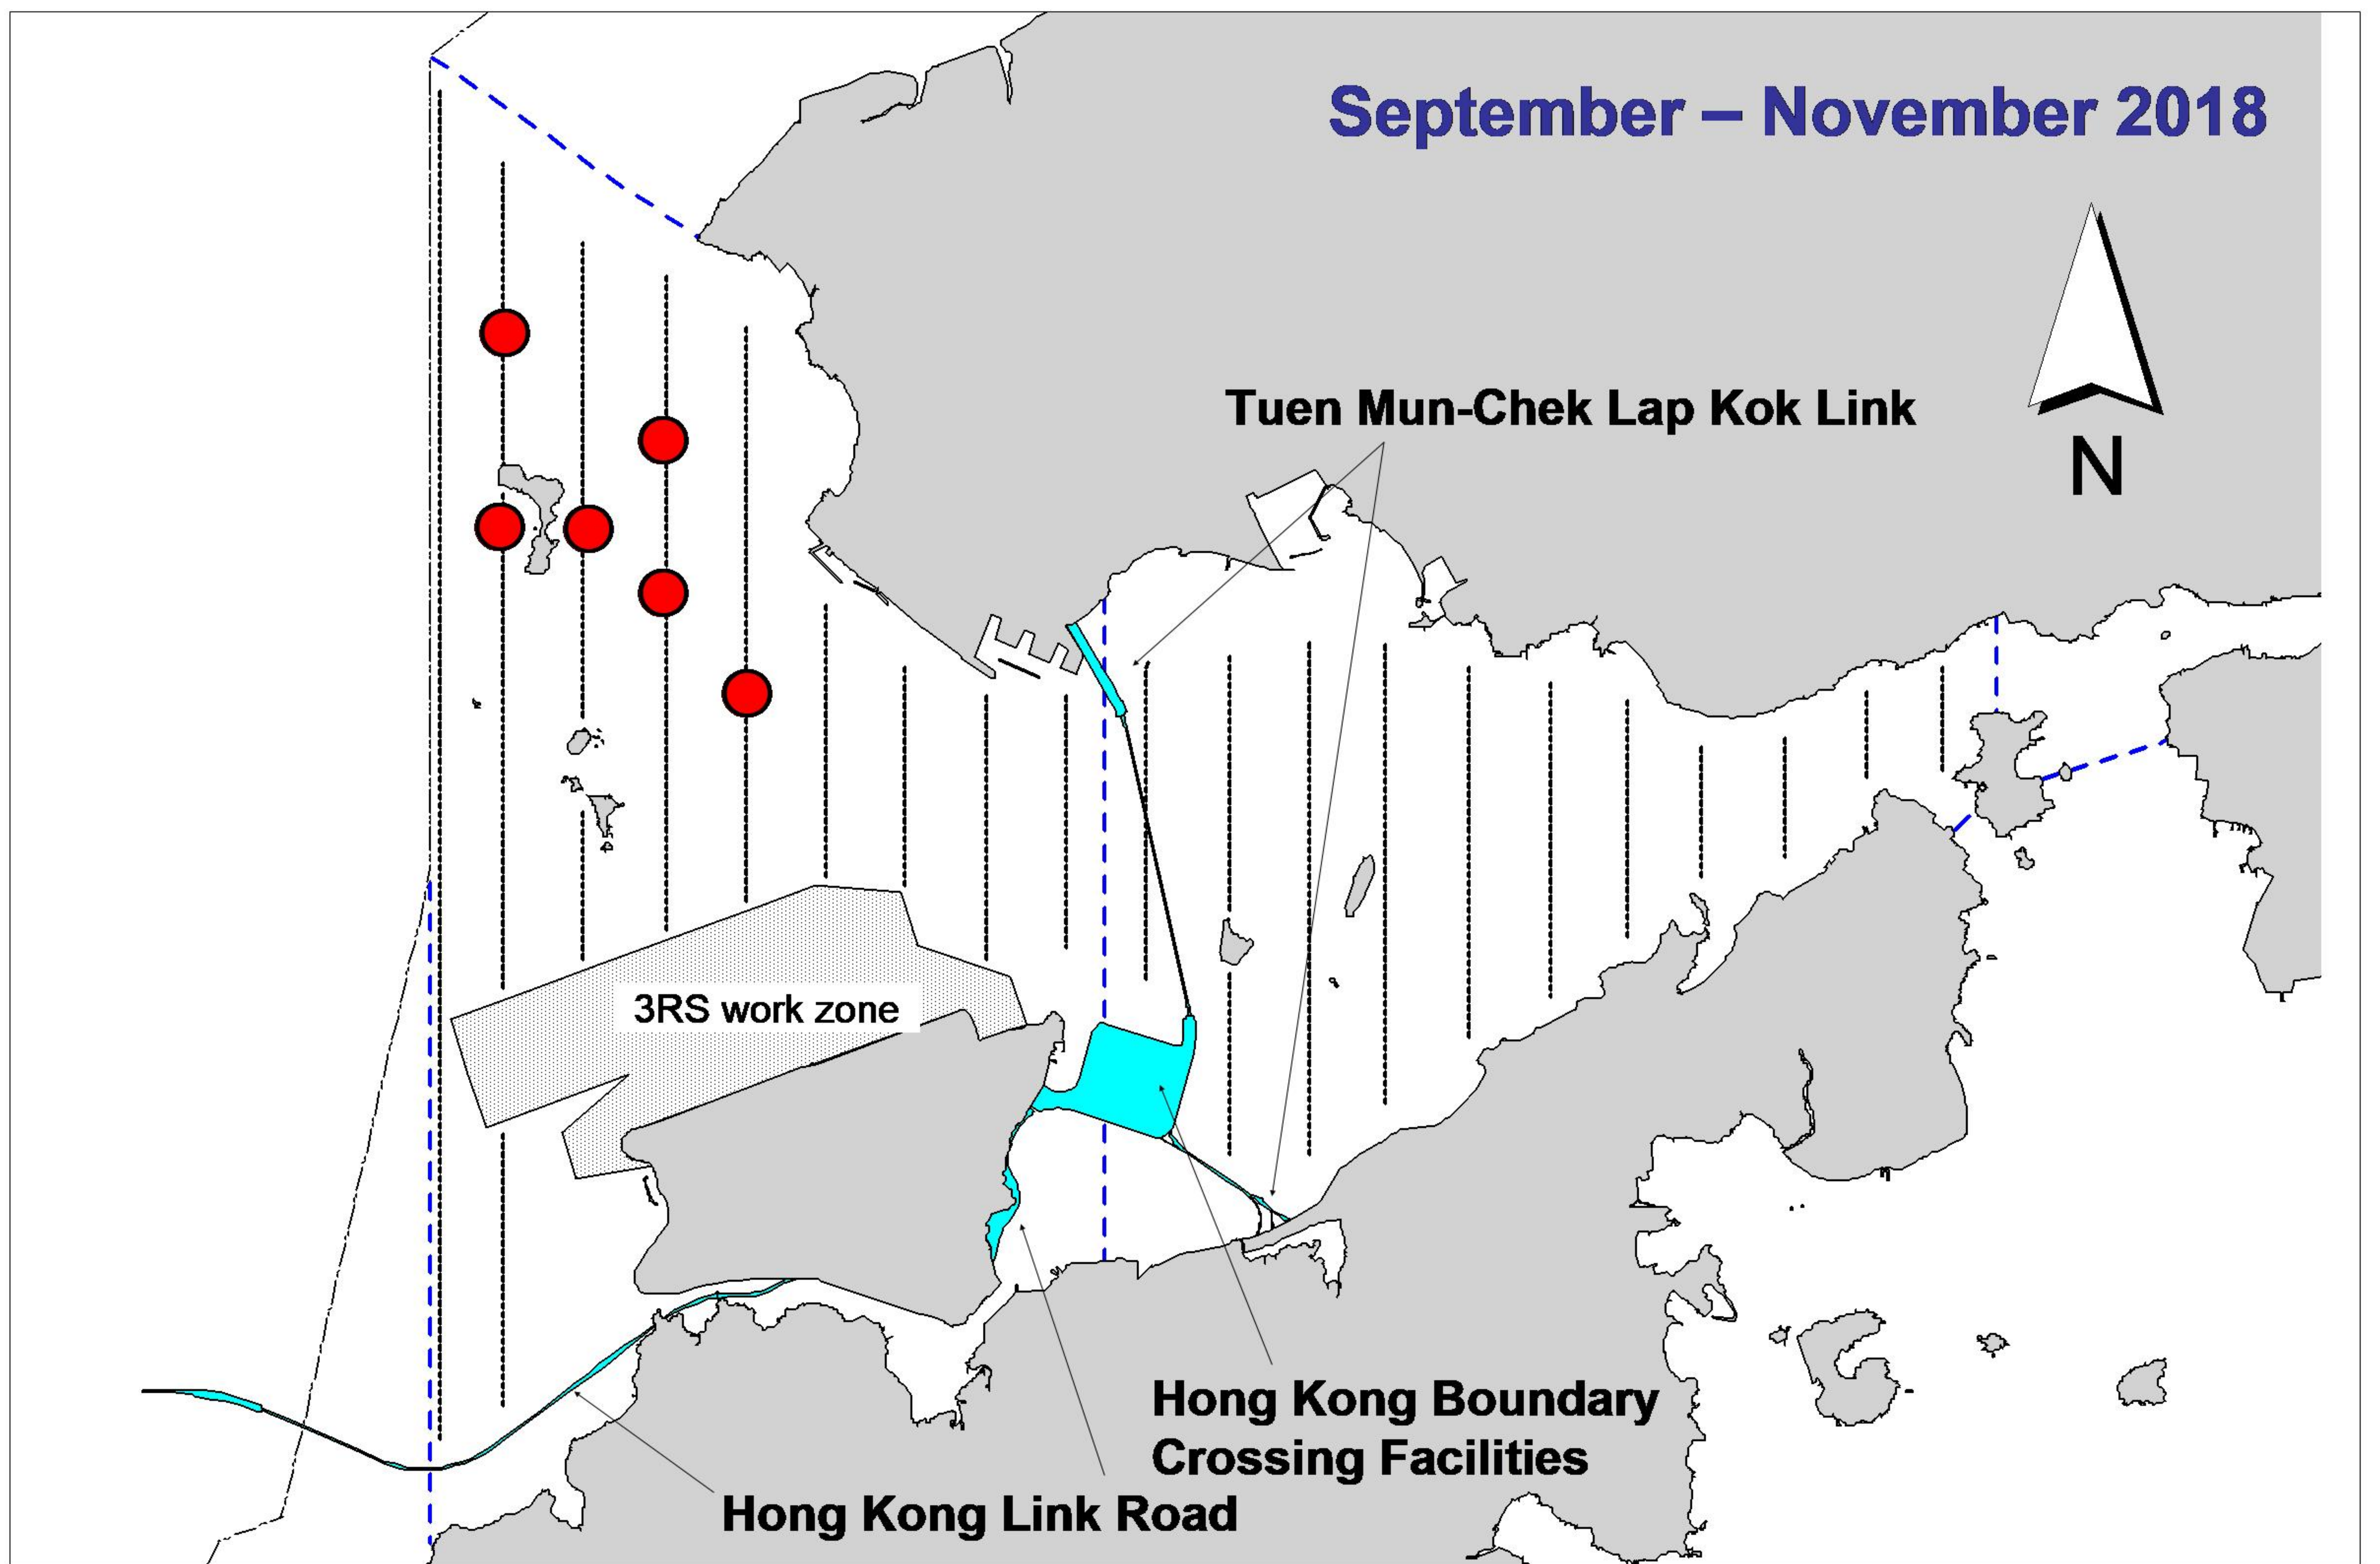
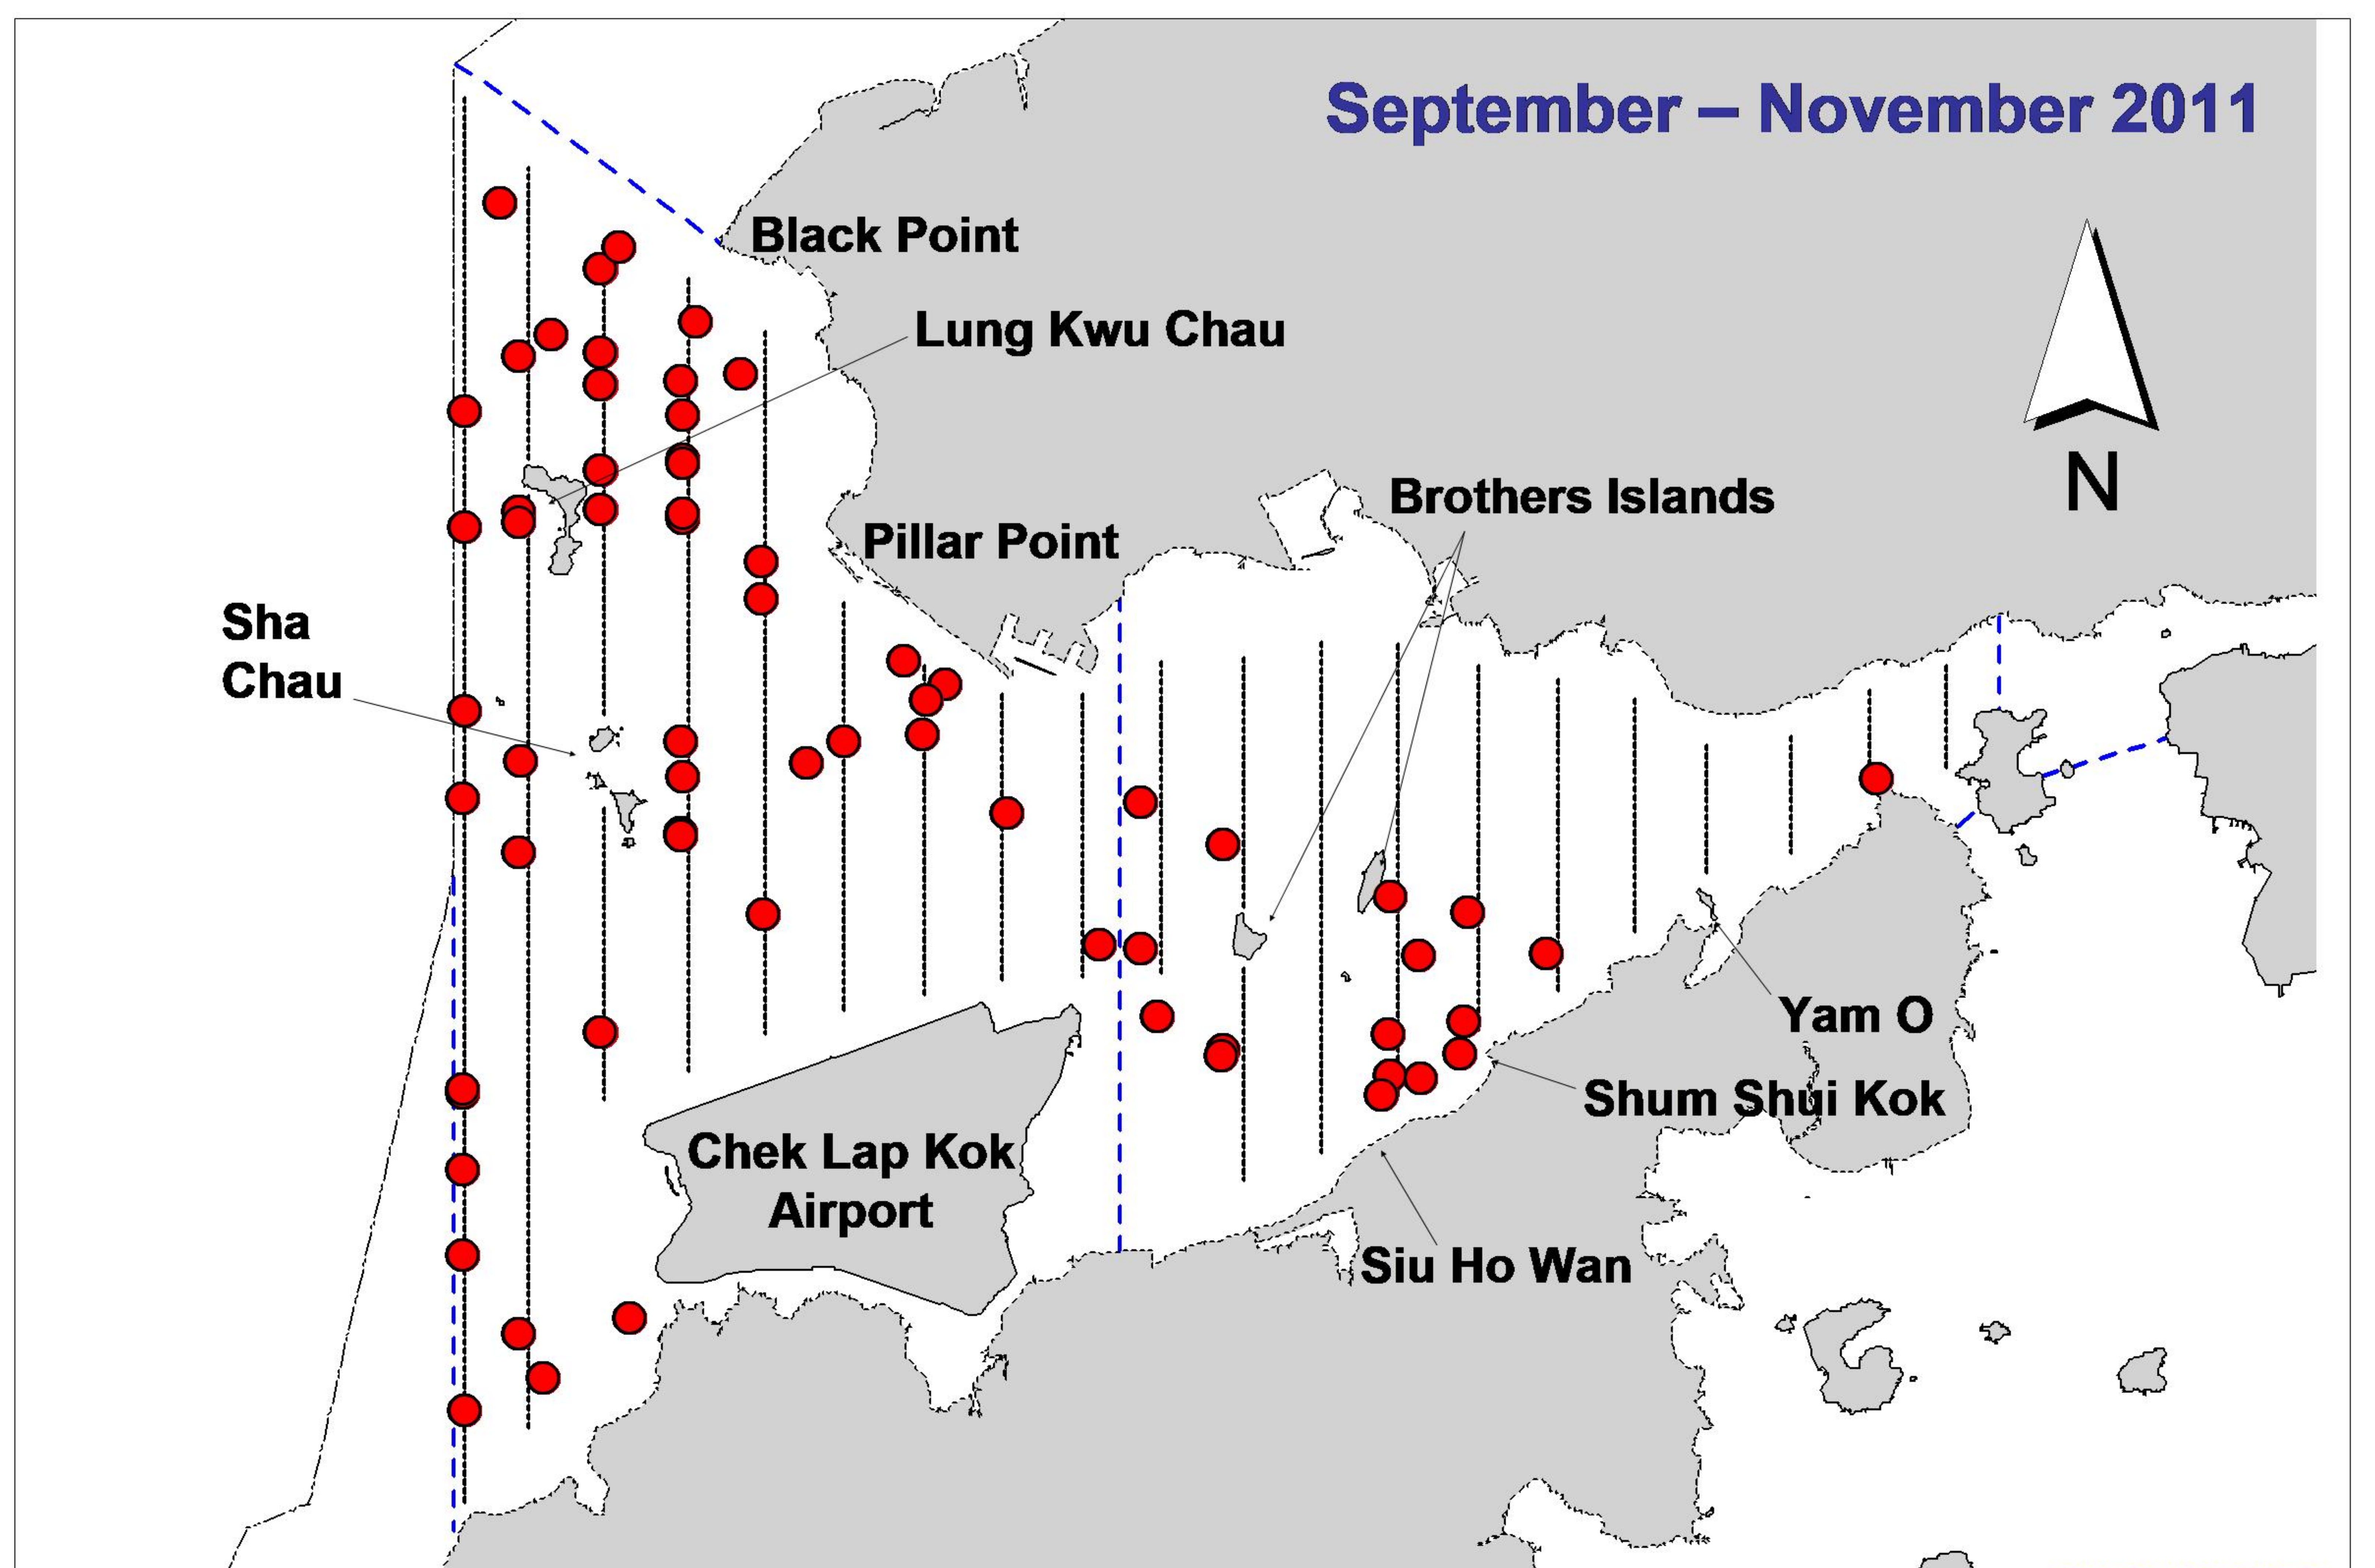
Figure 1. Distribution of Chinese white dolphin sighting in Northwest and Northeast Lantau during HKLR03 impact phase (top) and baseline monitoring surveys (bottom)
