Contract No. HY/2011/03

**Hong Kong-Zhuhai-Macao Bridge Hong Kong Link Road
Section between Scenic Hill and Hong Kong Boundary Crossing
Facilities**

Quarterly EM&A Report No. 25 (September 2018 to November 2018)

15 March 2019

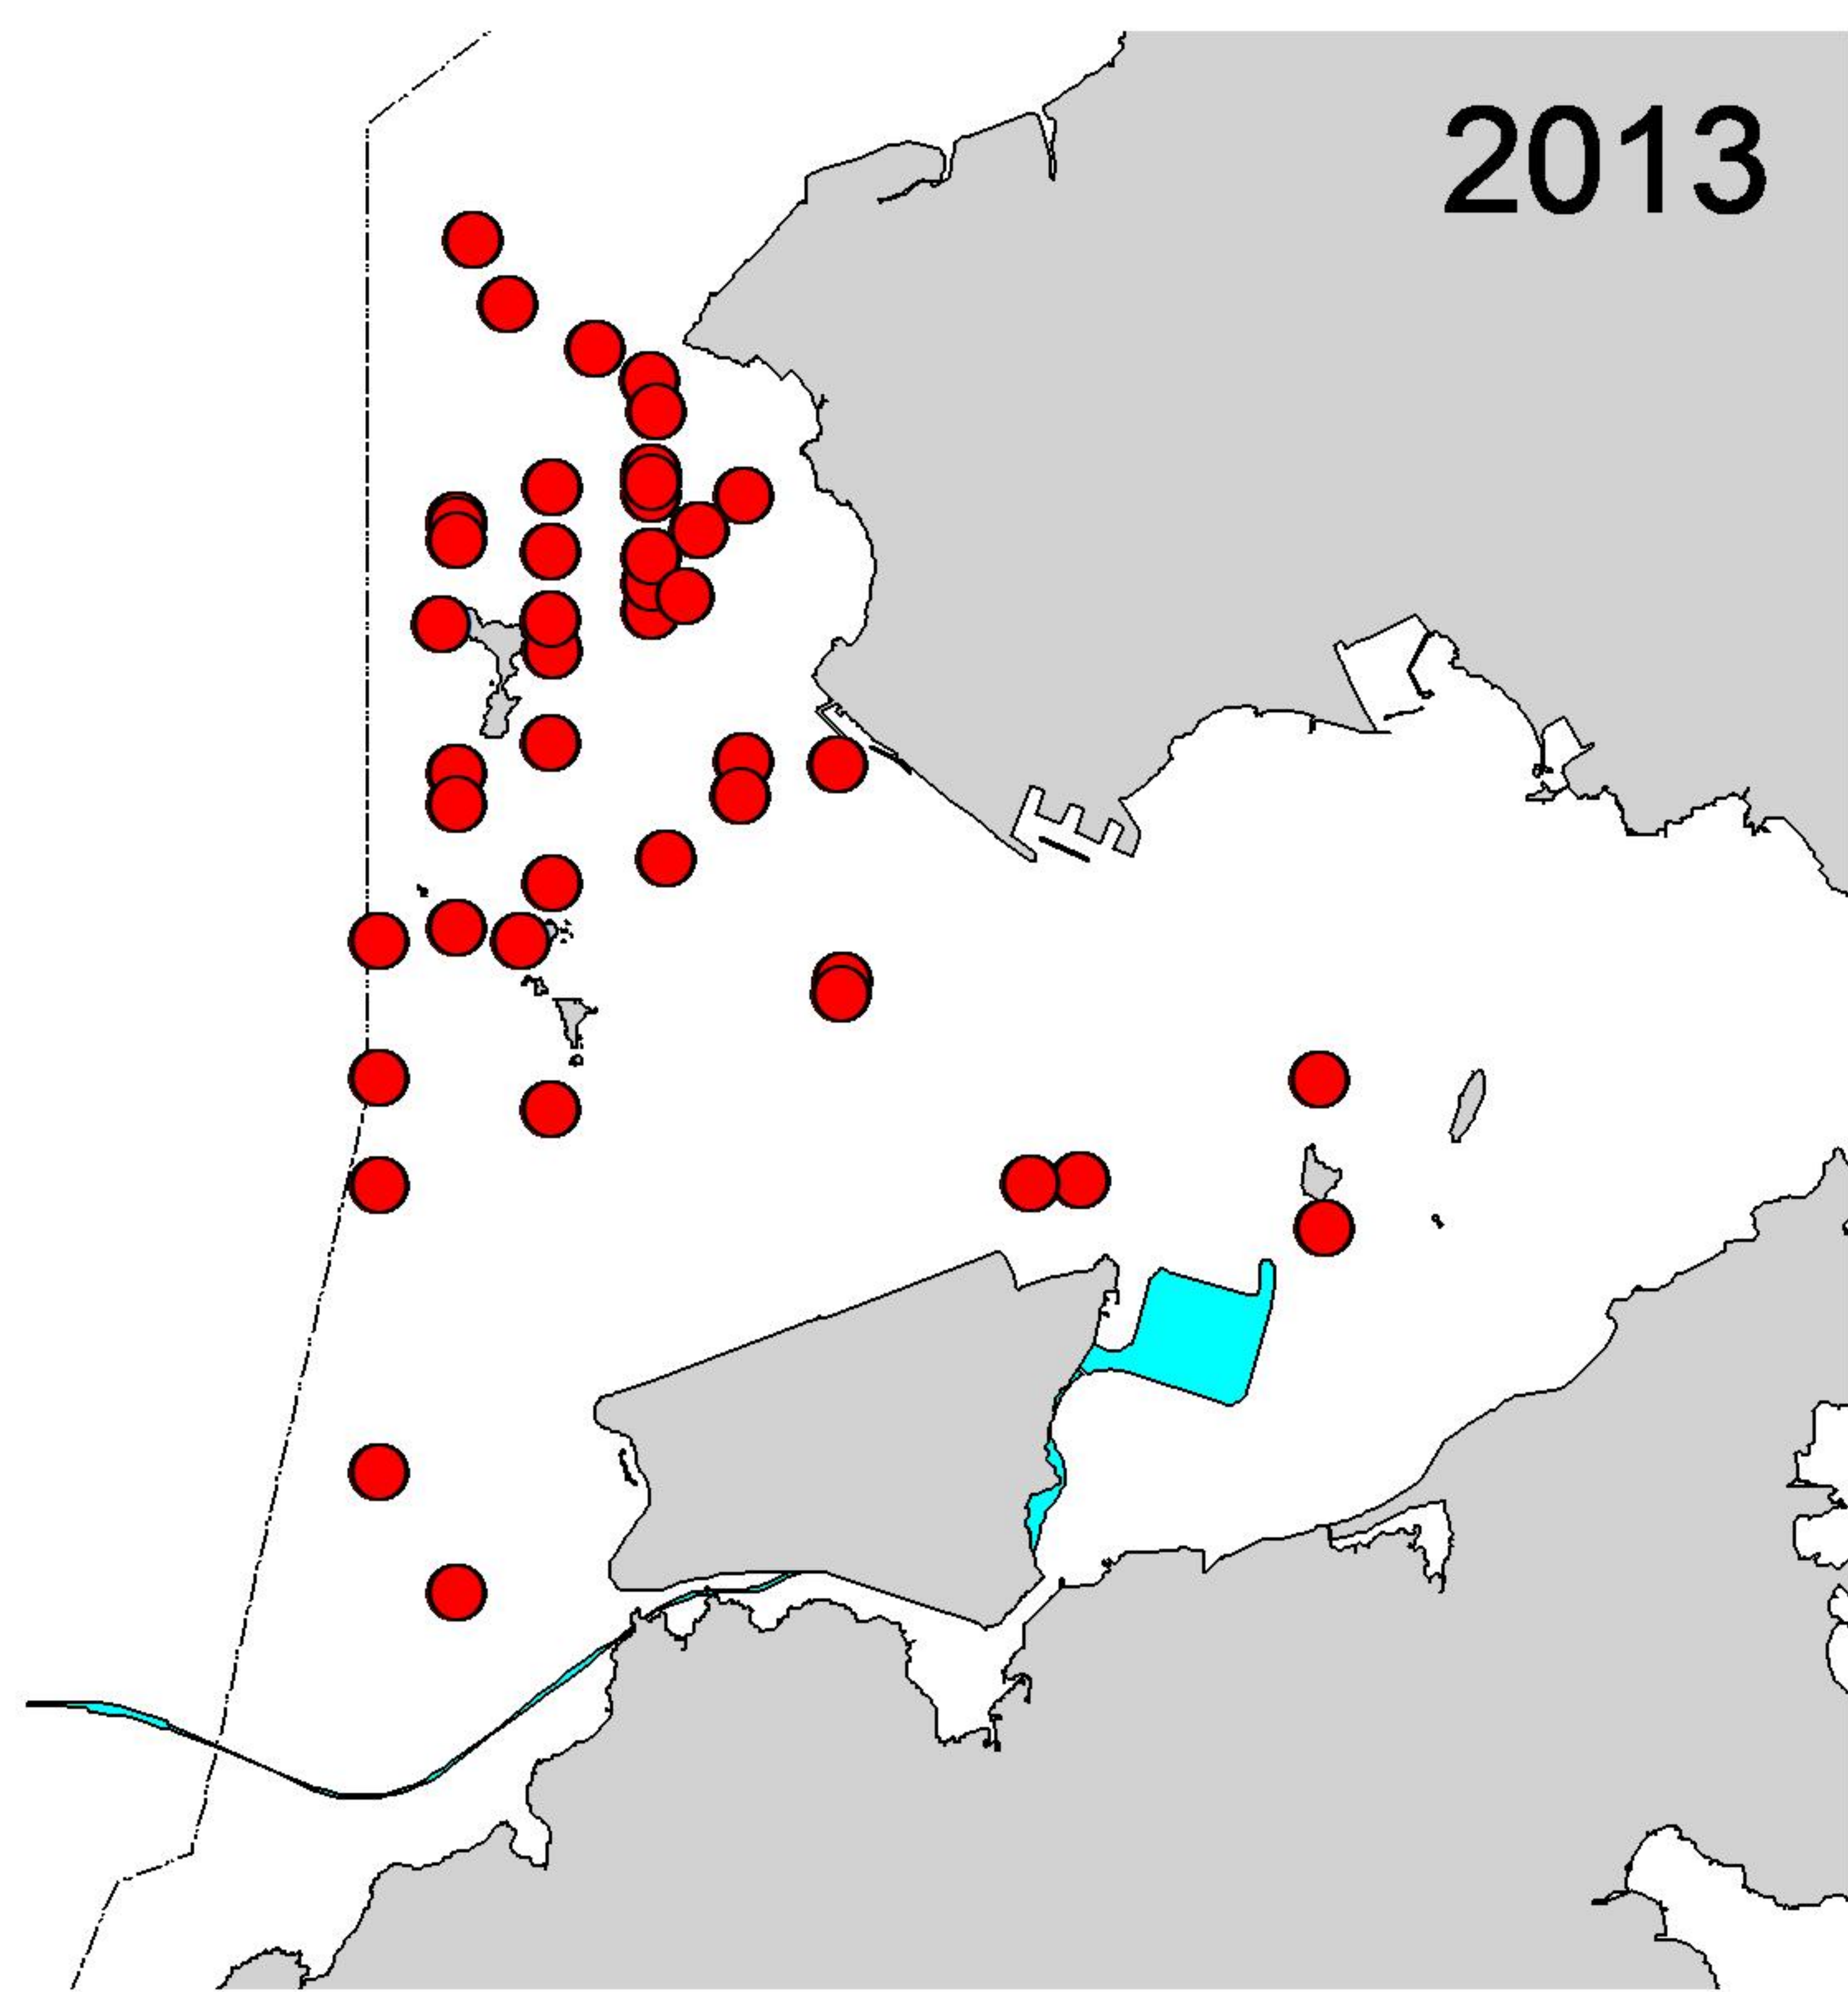
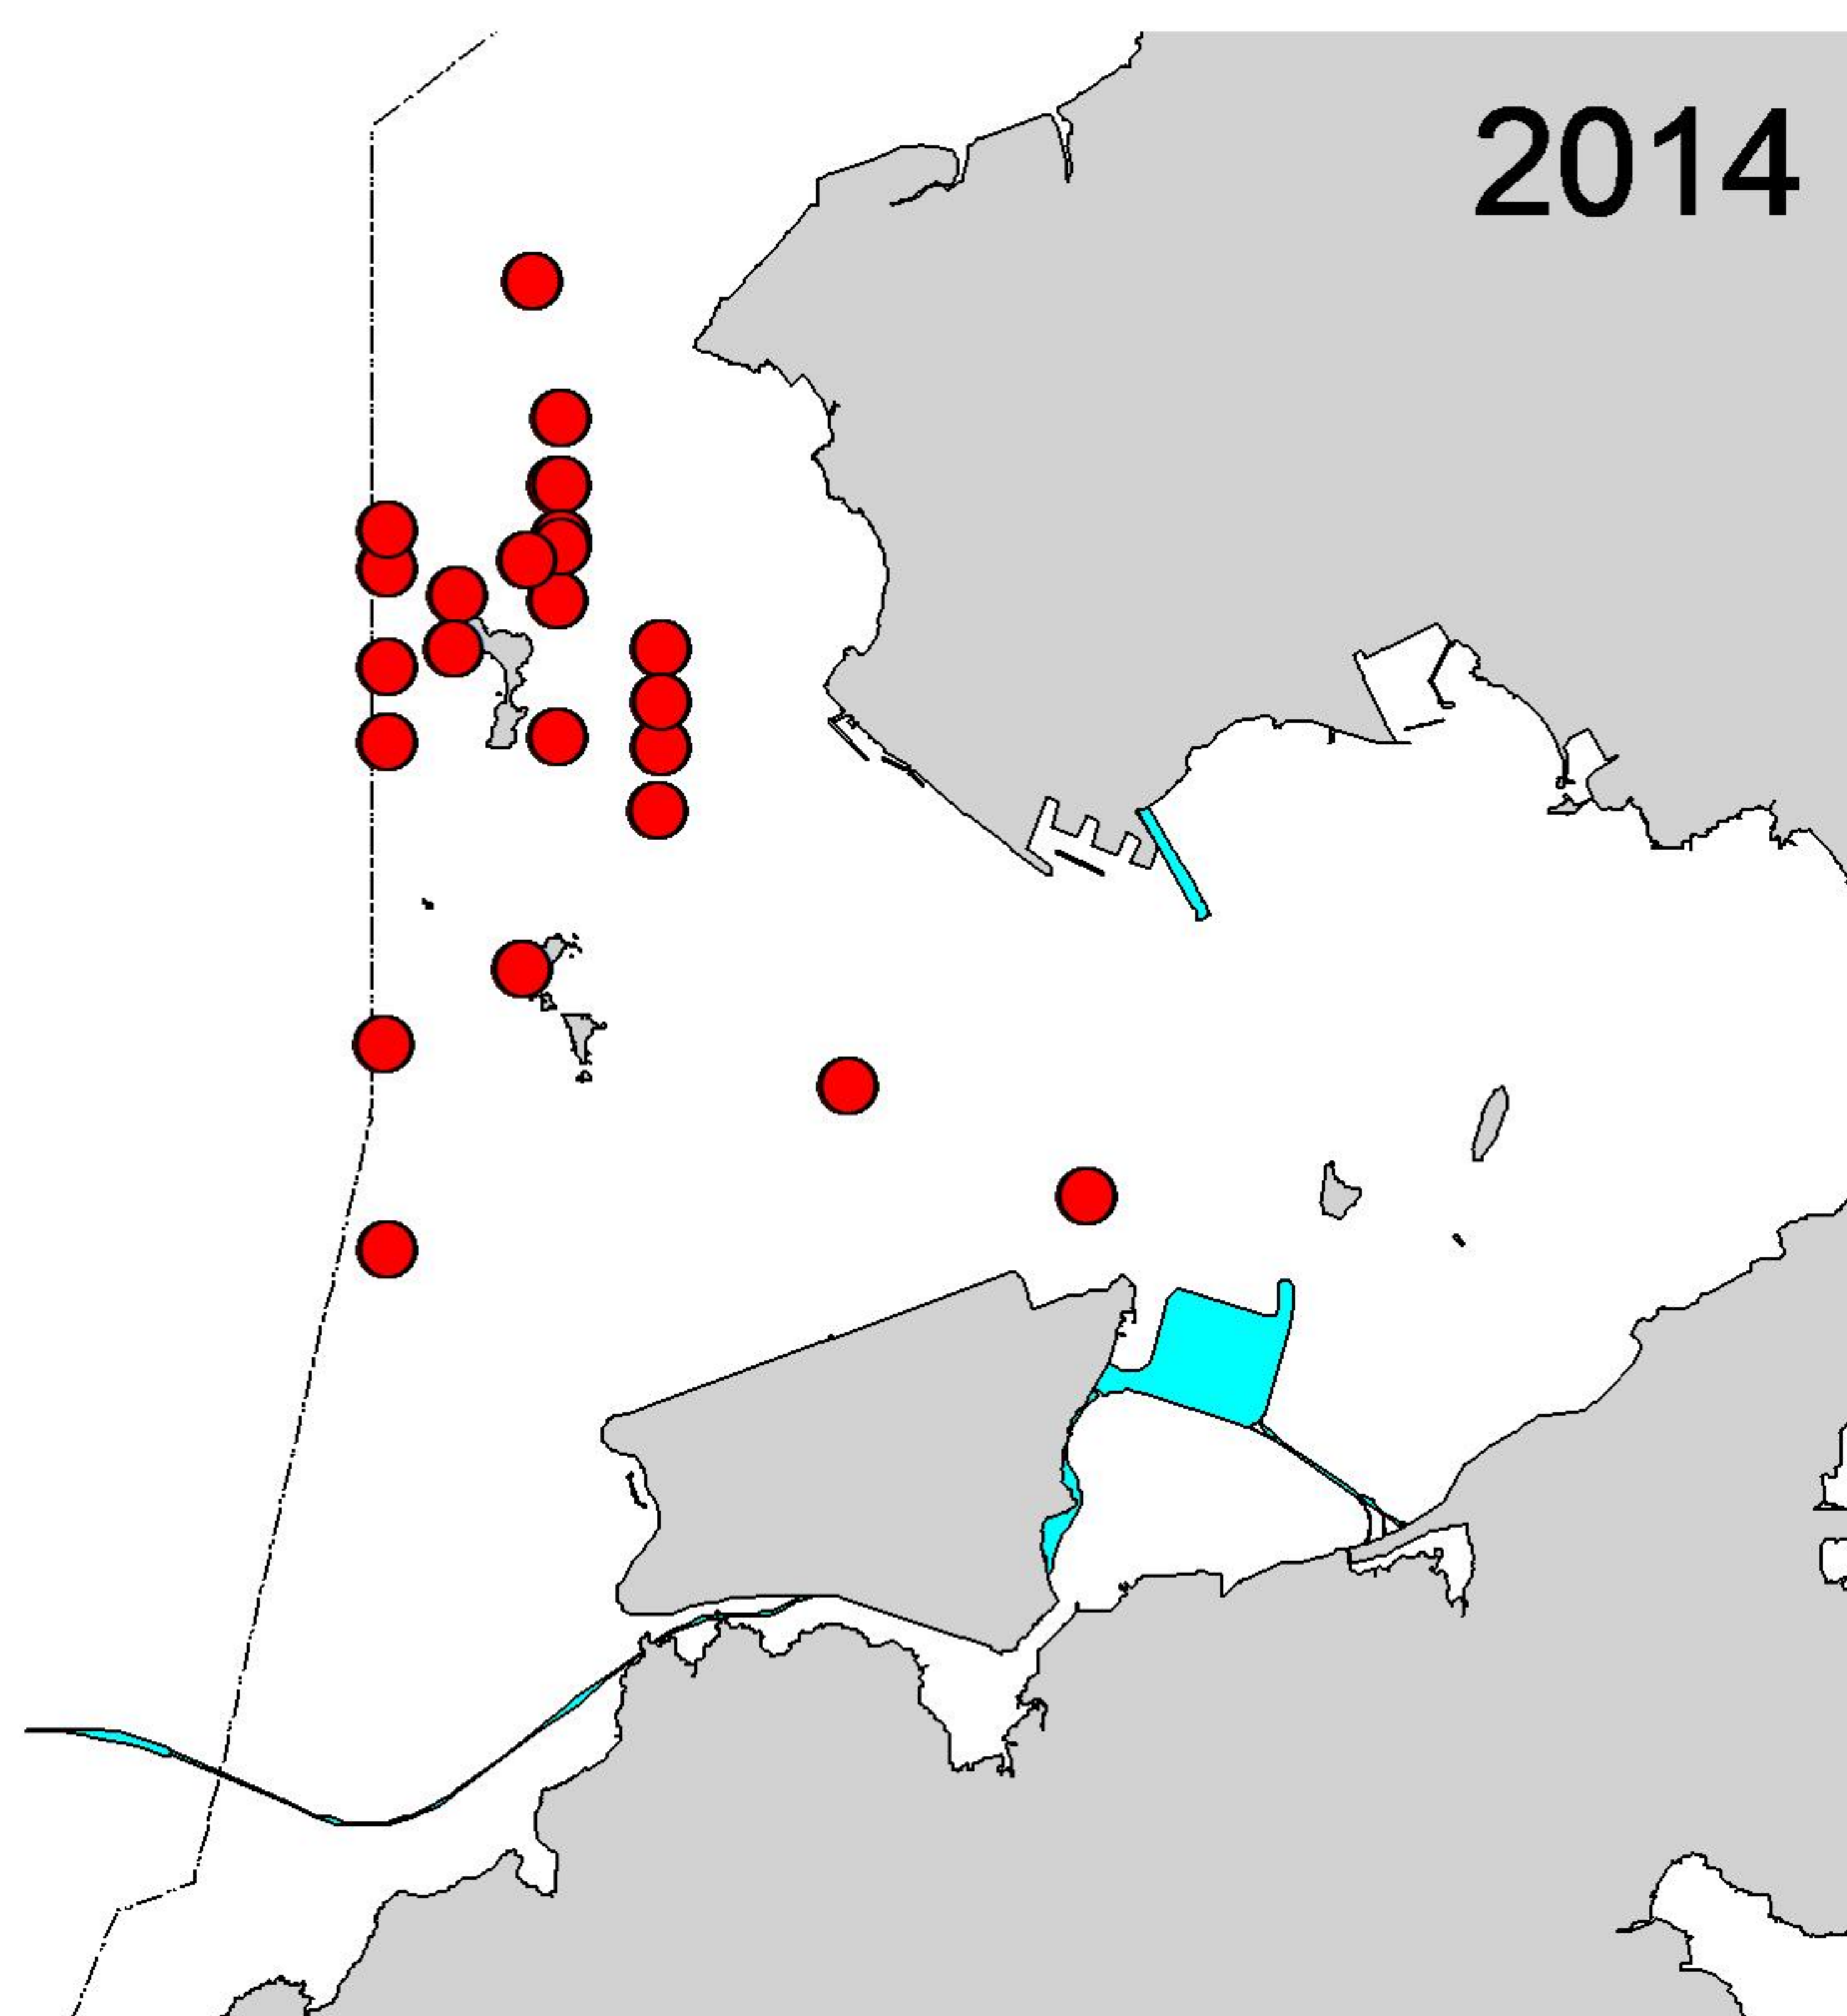
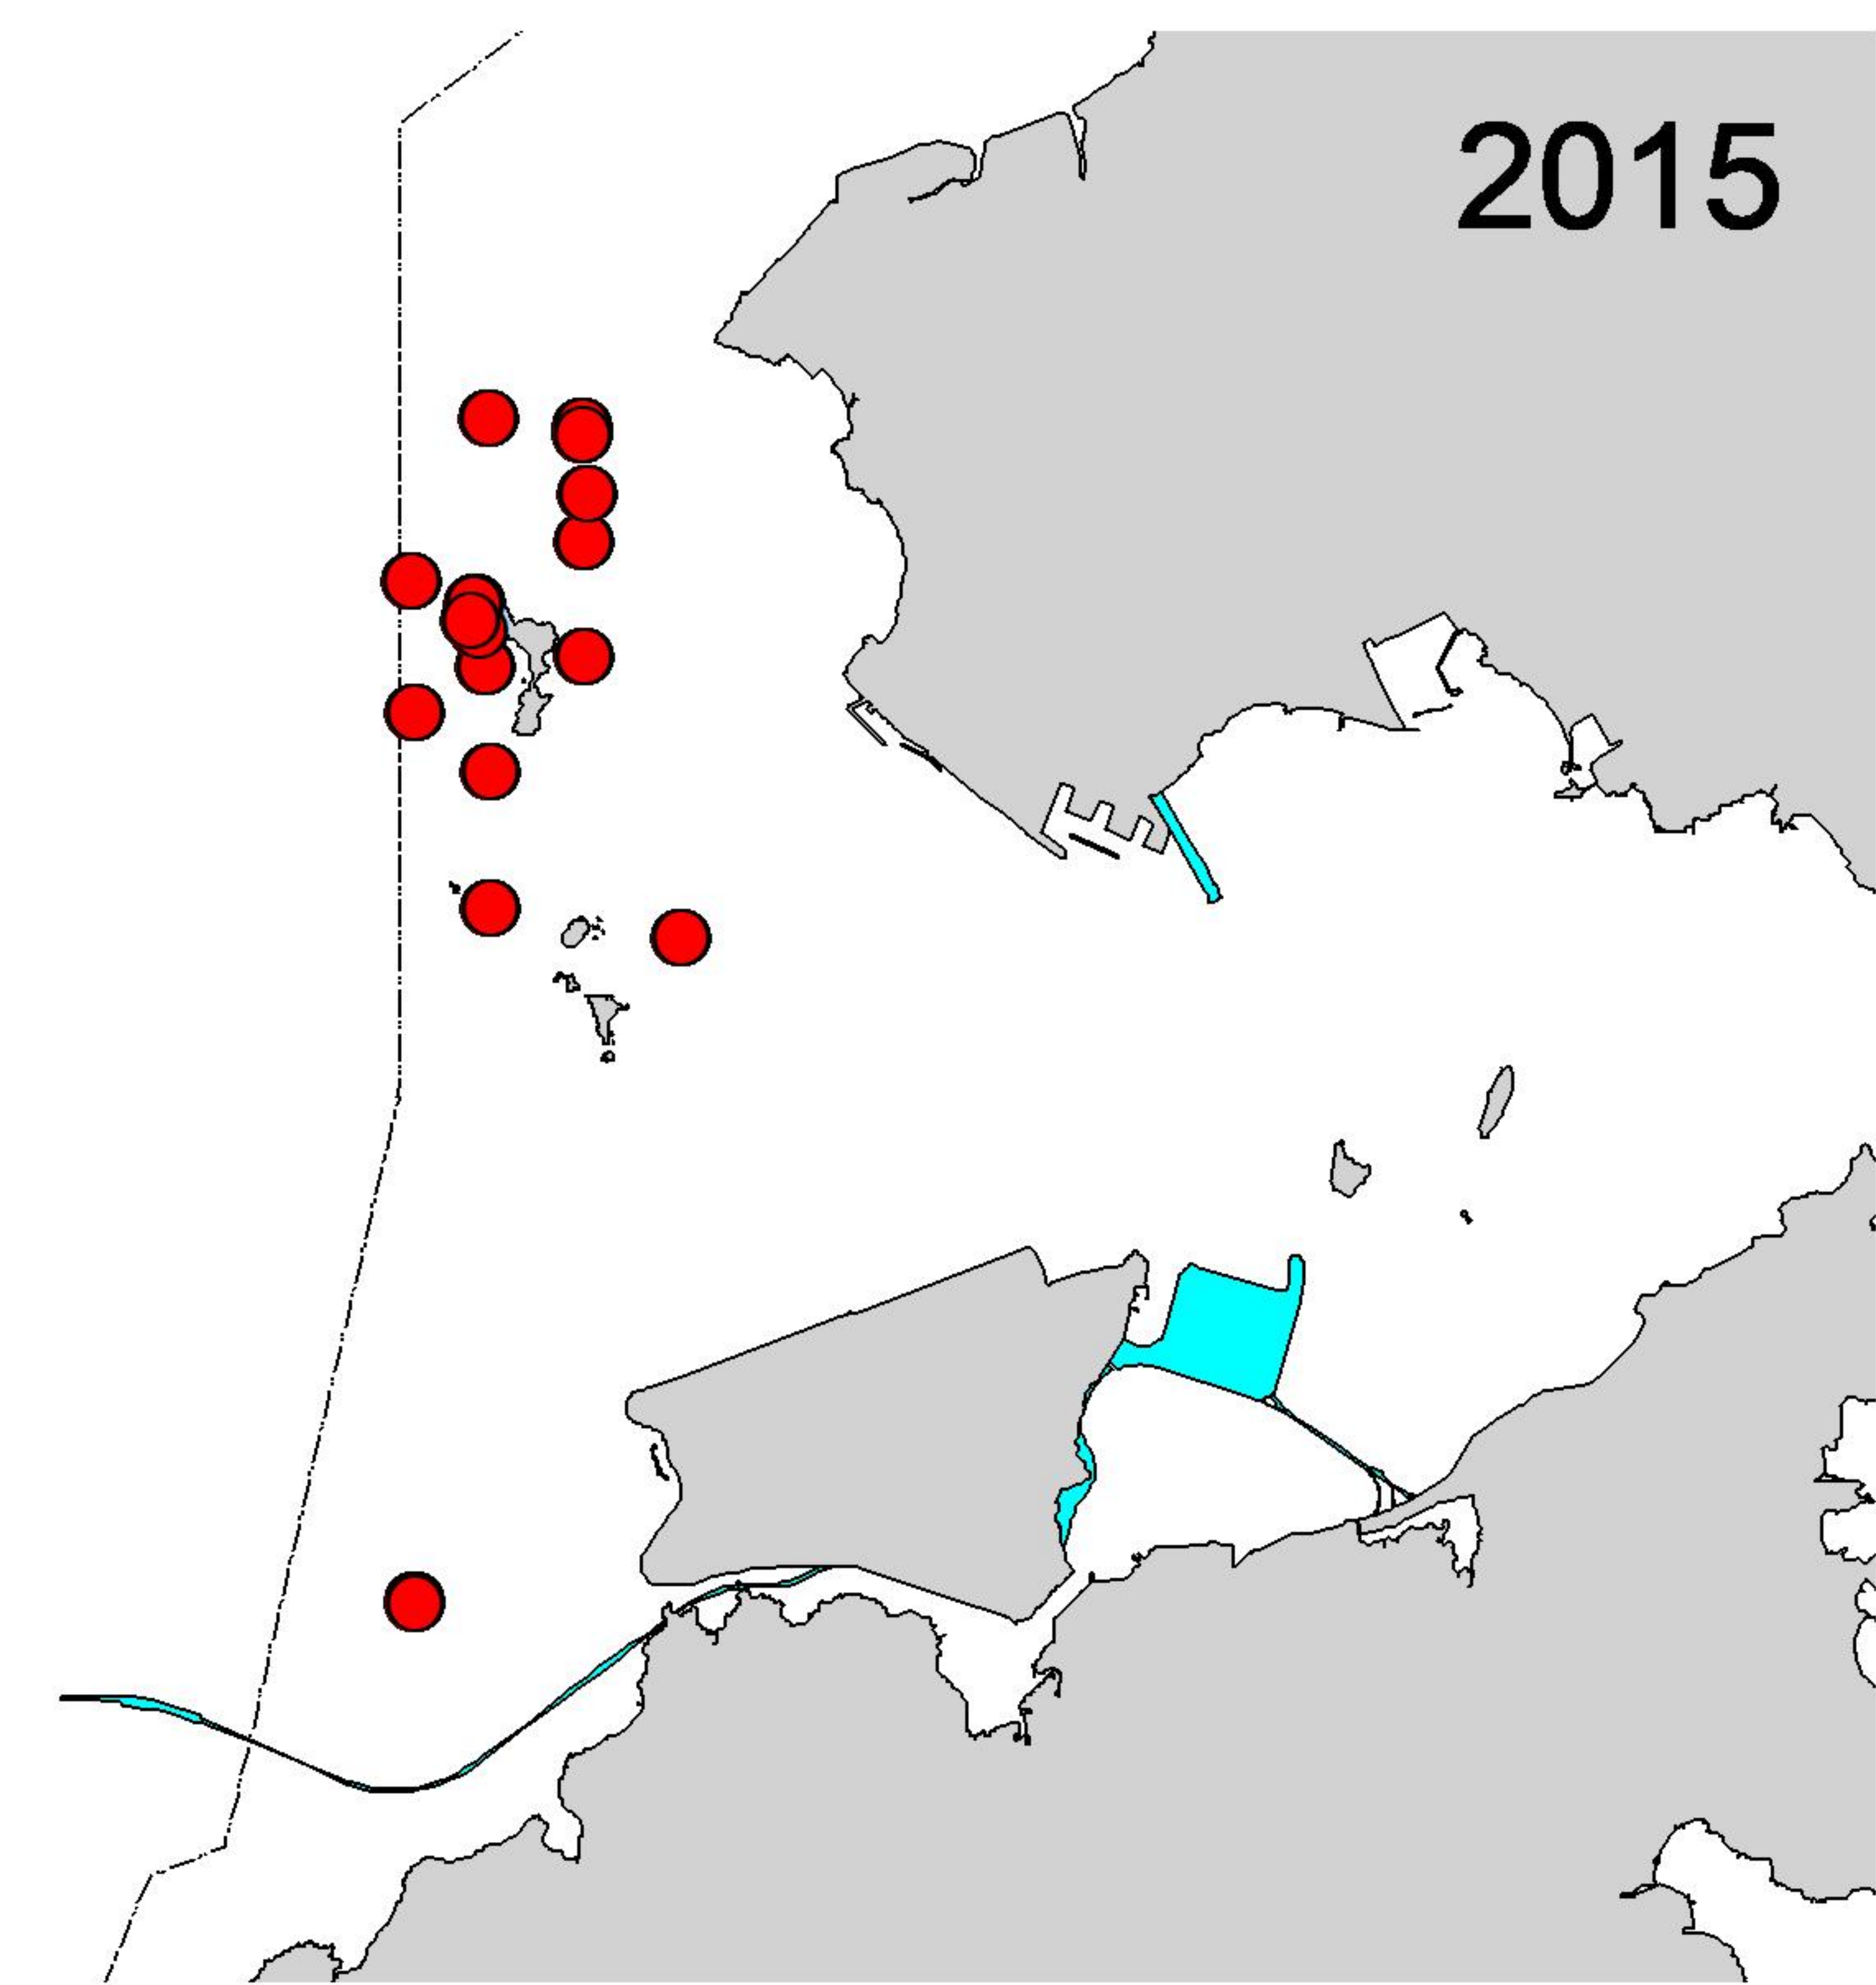
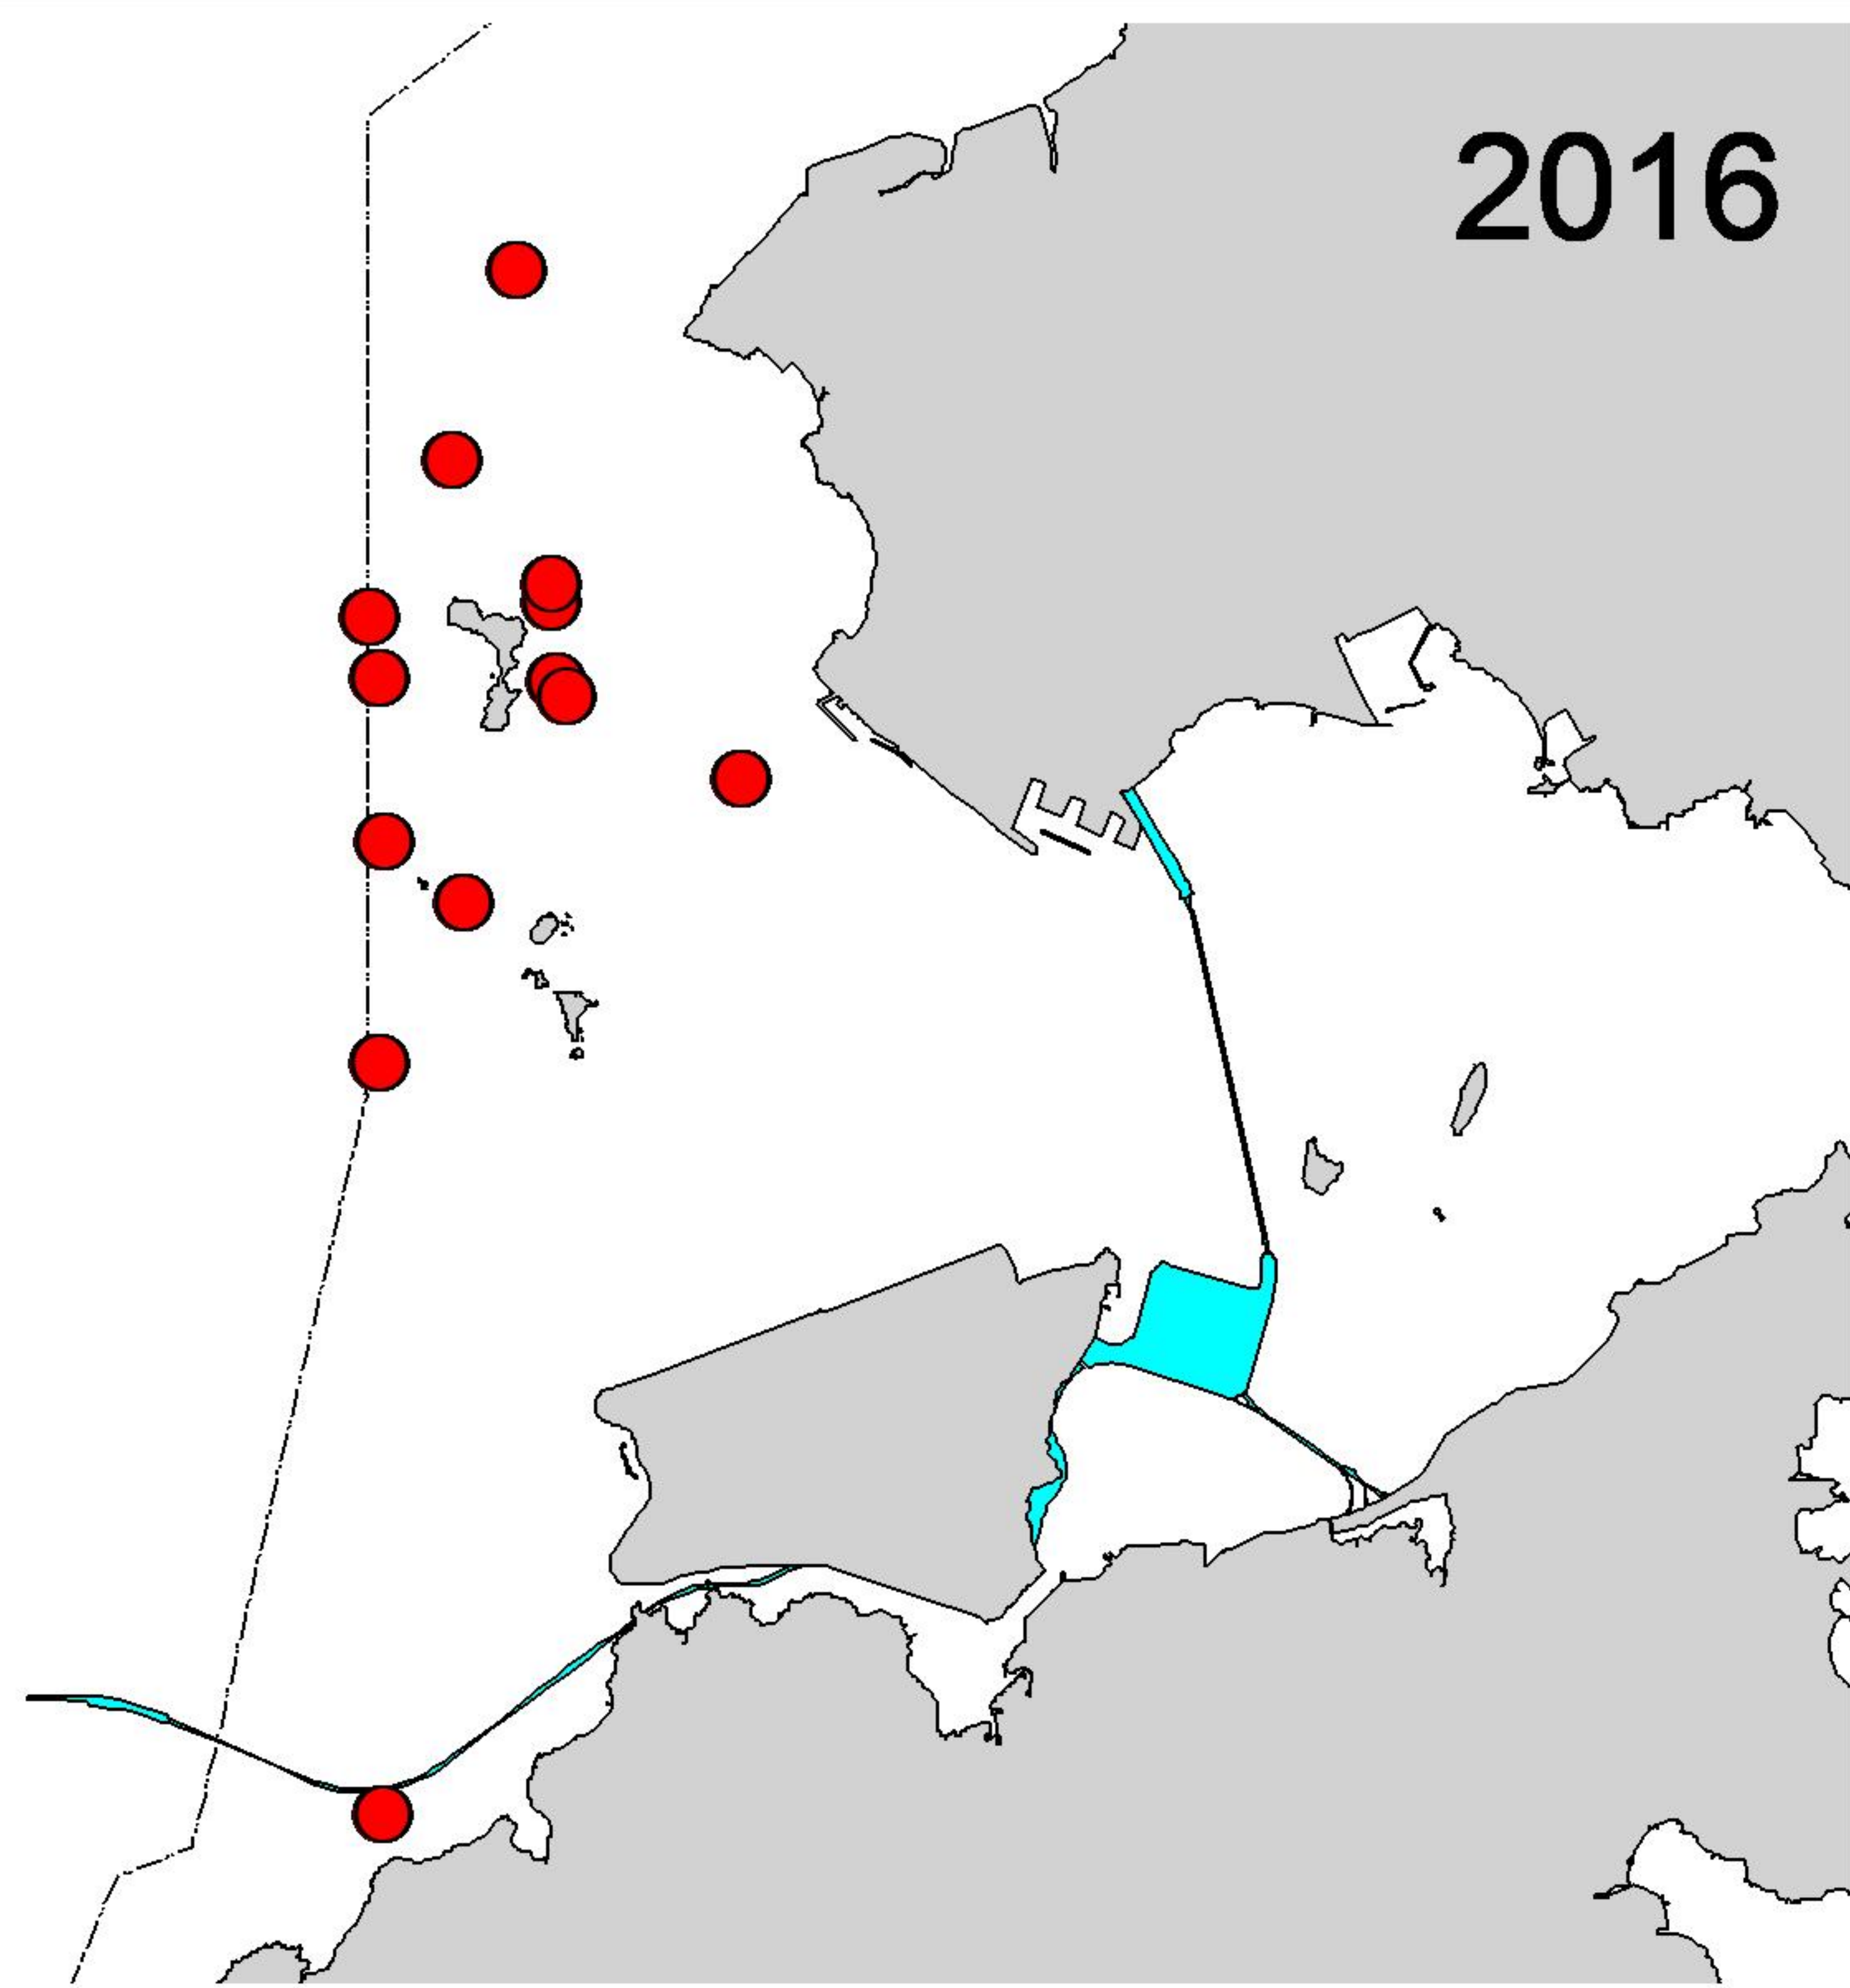
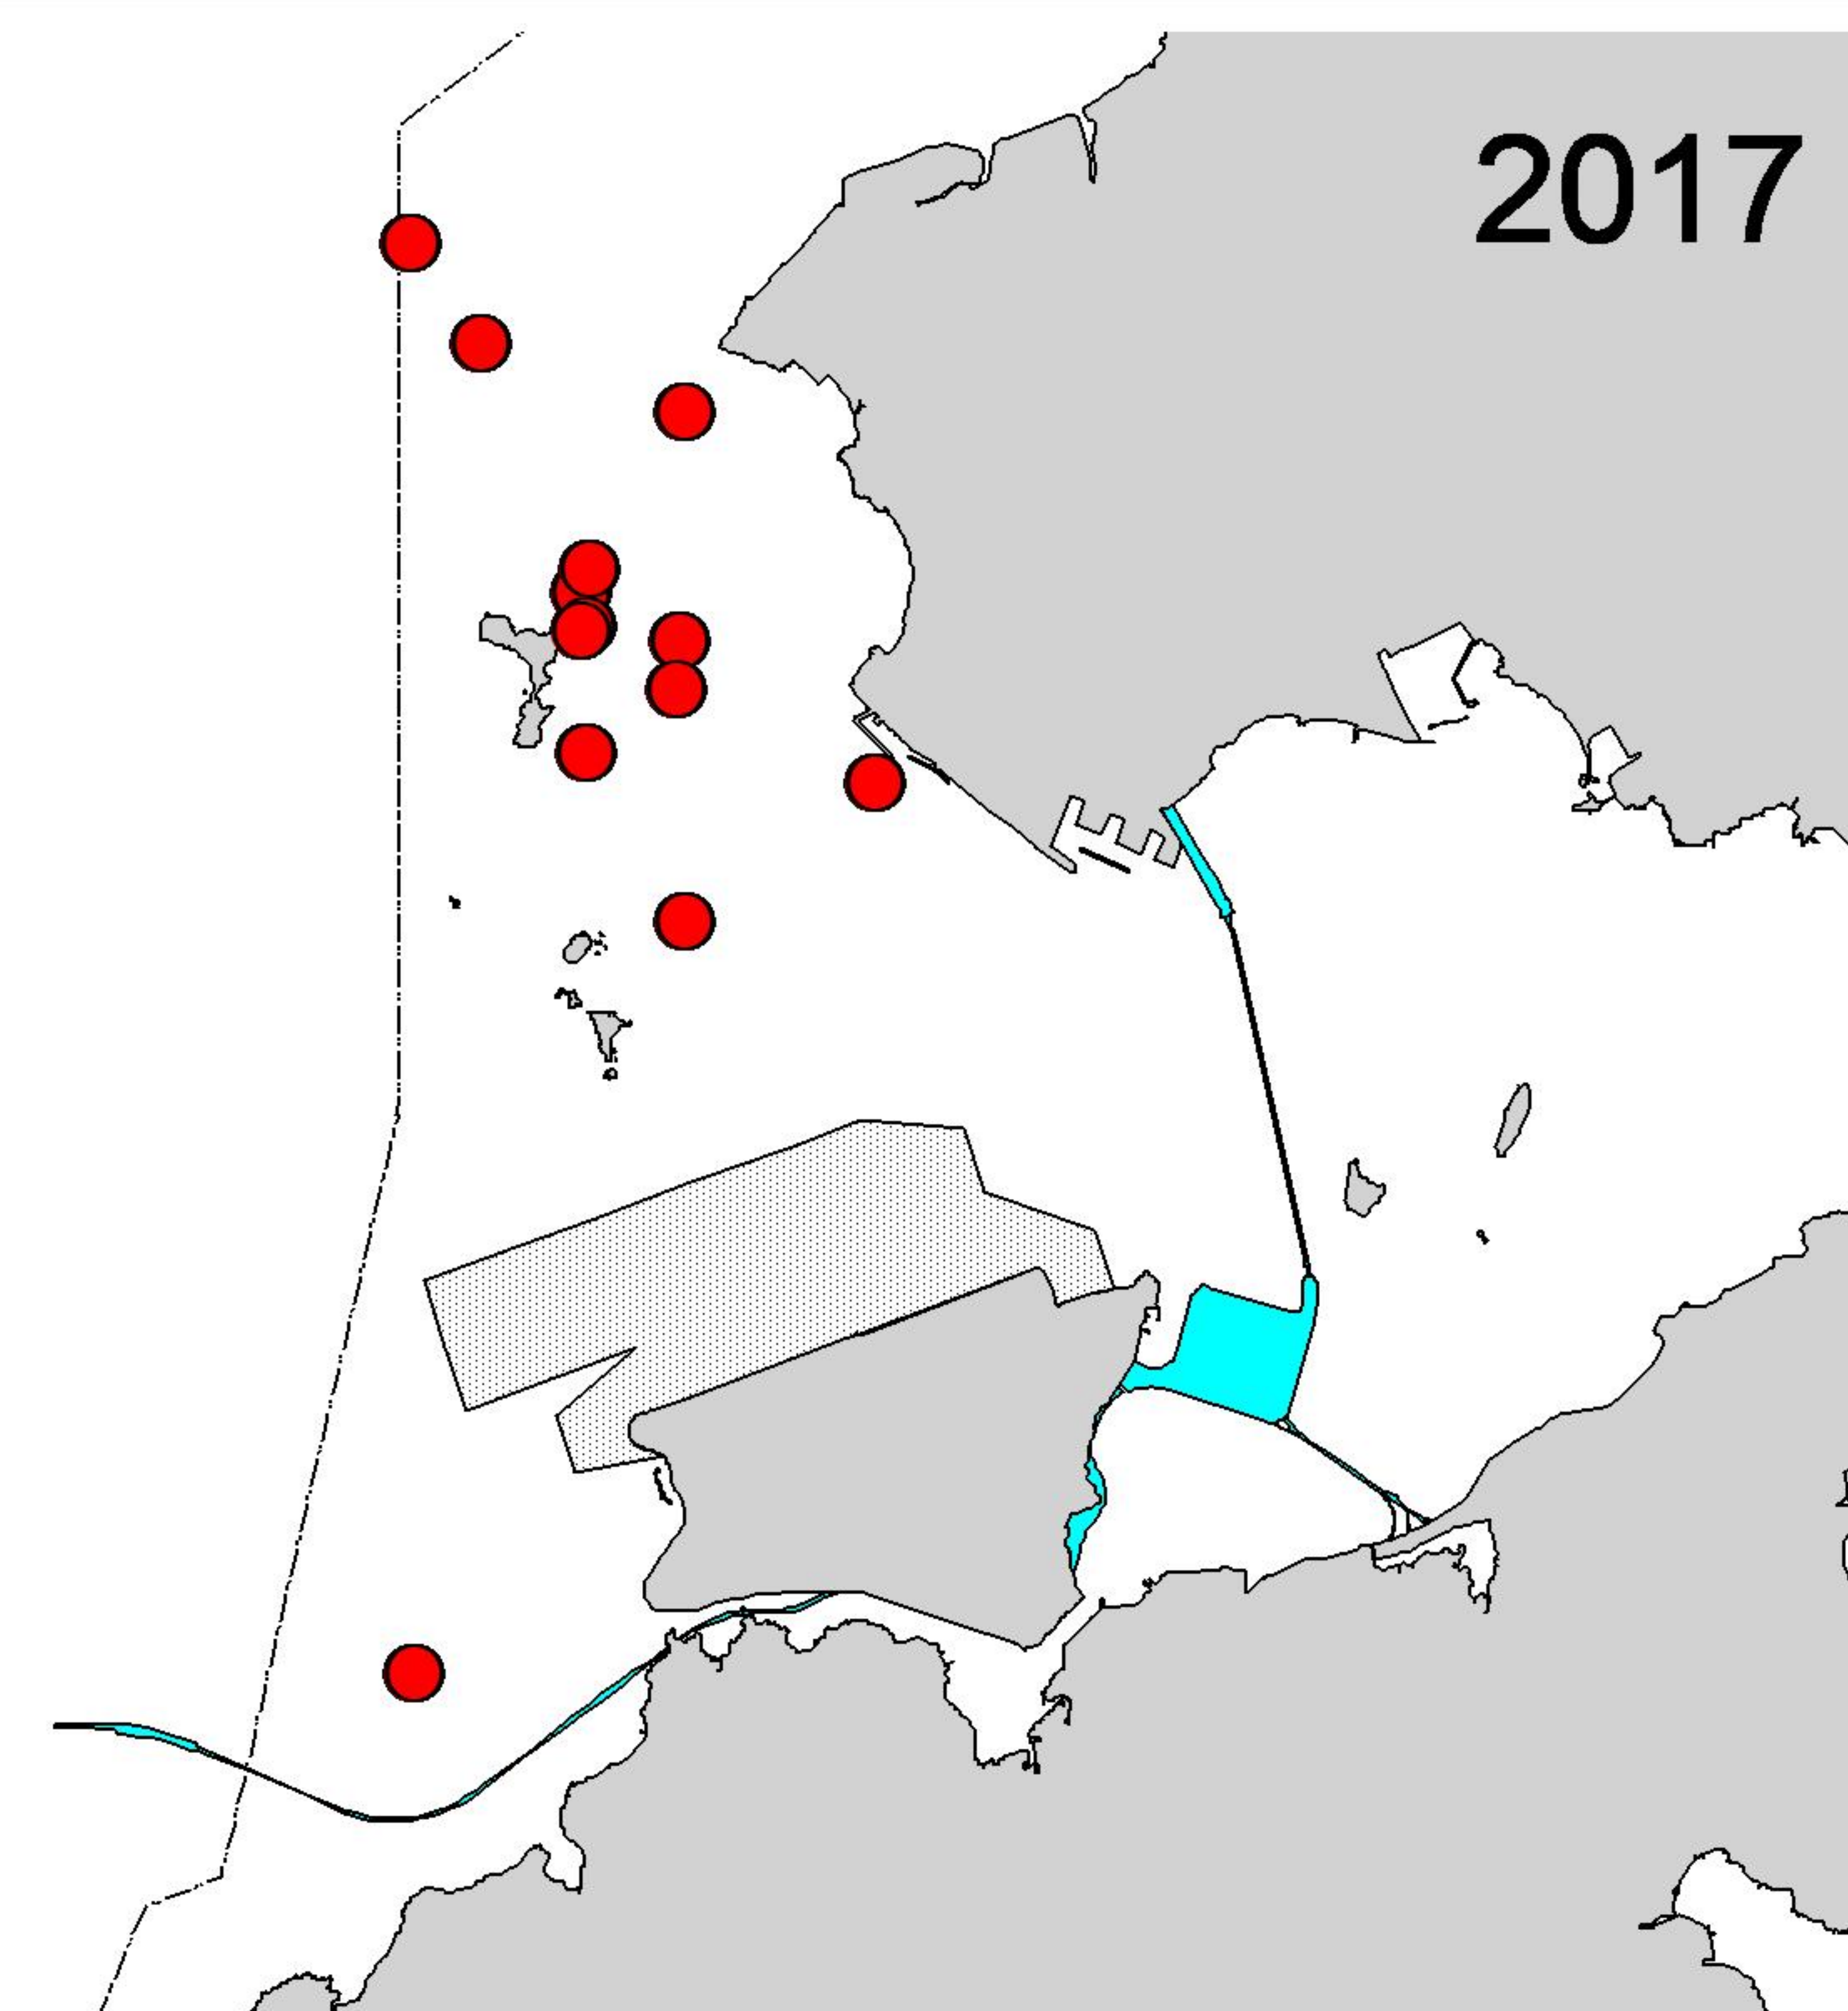
Figure 2. Distribution of Chinese white dolphin sightings in Northwest and Northeast Lantau during the past six autumn quarters (September-November) of HKLR03 impact phase in 2013-18

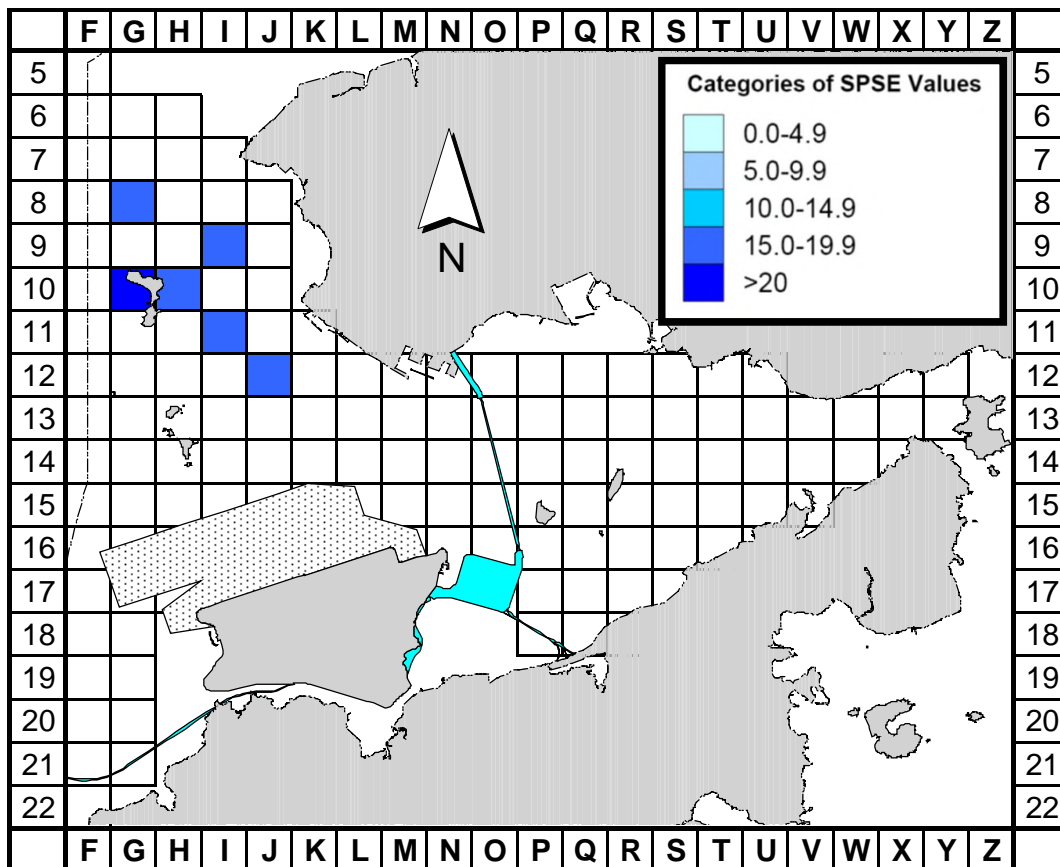
Figure 3a. Sighting density of Chinese white dolphins with corrected survey effort per km² in Northeast and Northwest Lantau survey areas, using data collected during HKLR03 impact monitoring period (Sep-Nov 18) (SPSE = no. of on-effort sightings per 100 units of survey effort)

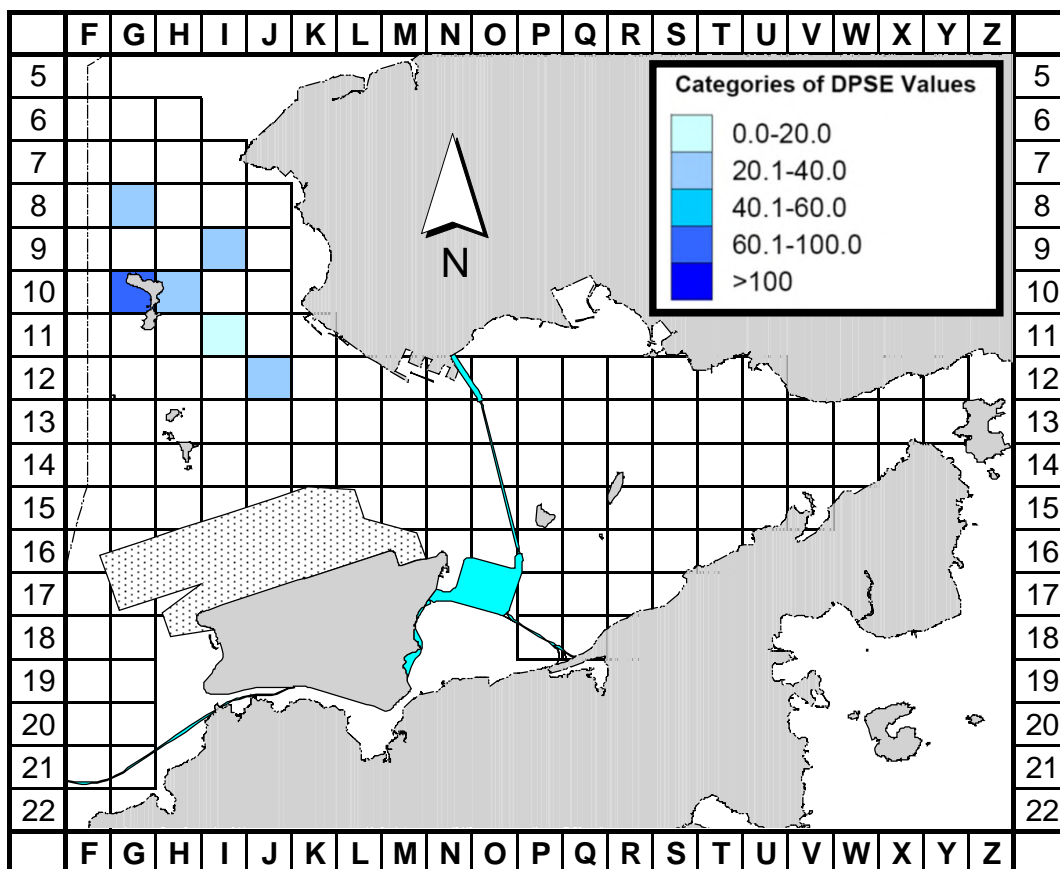
Figure 3b. Density of Chinese white dolphins with corrected survey effort per km² in Northeast and Northwest Lantau survey areas, using data collected during HKLR03 impact monitoring period (Sep-Nov 18) (DPSE = no. of dolphins per 100 units of survey effort)

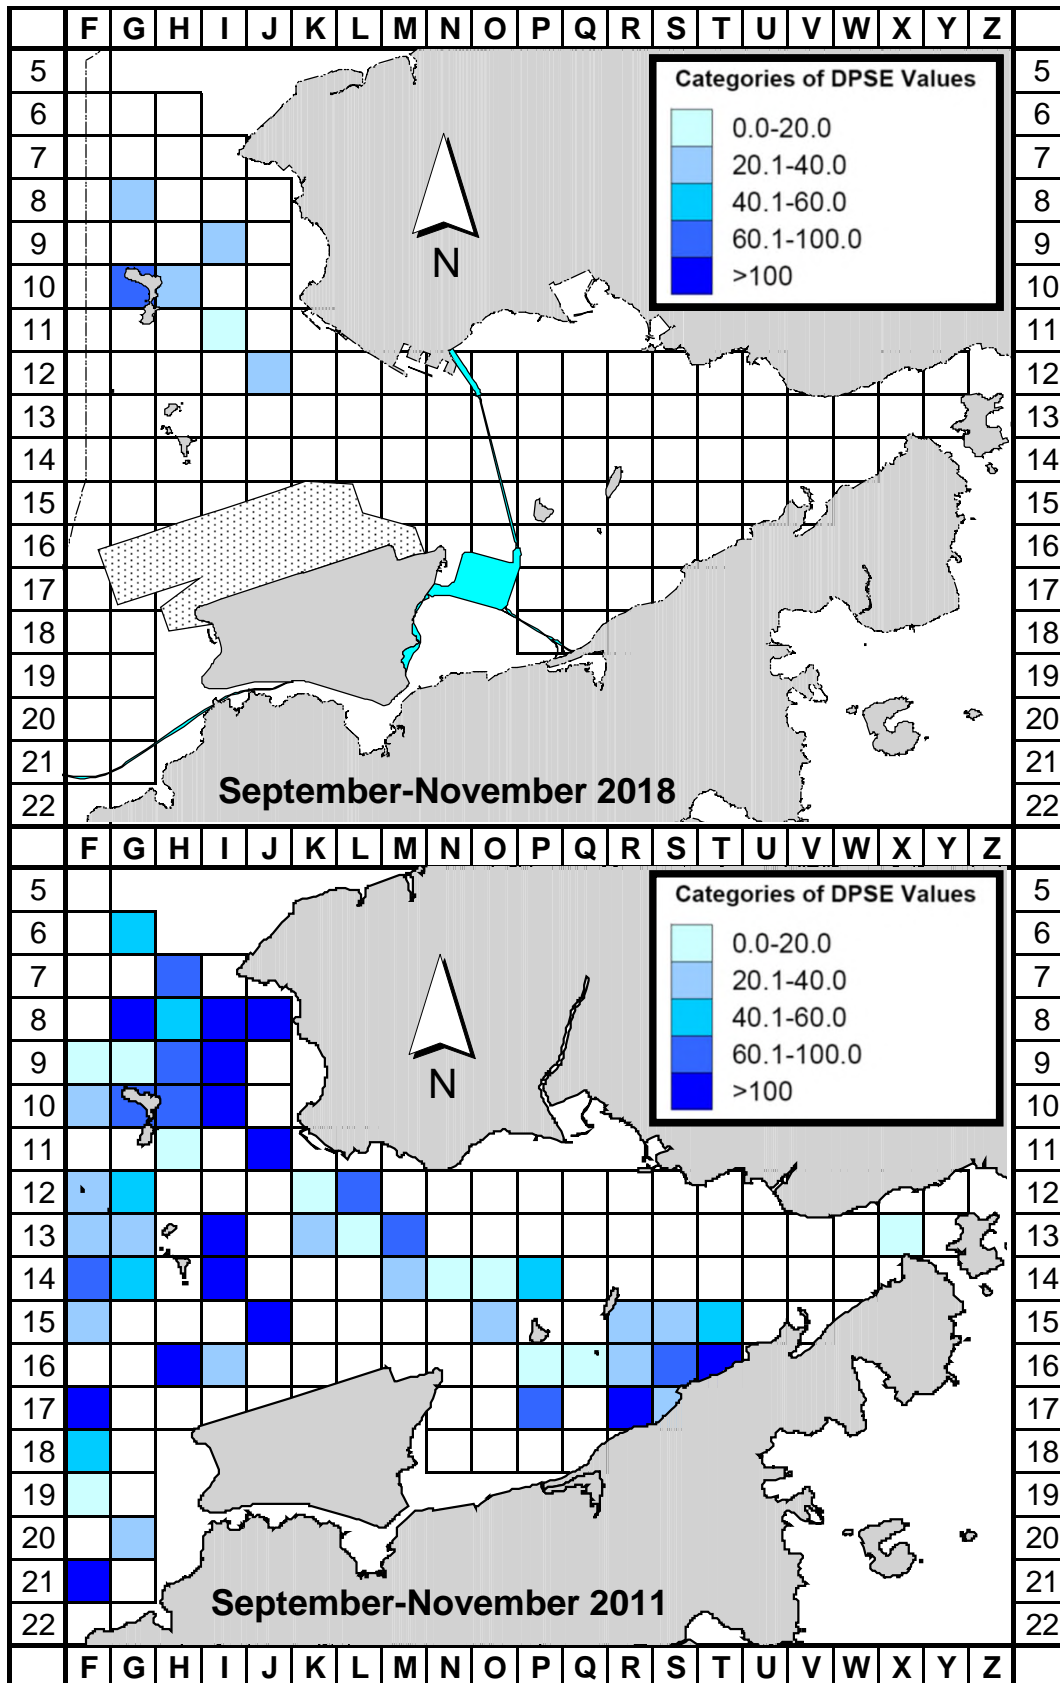
Figure 4. Comparison of density of Chinese white dolphins with corrected survey effort per km² in Northwest and Northeast Lantau survey area between the impact monitoring period (September - November 2018) and baseline monitoring period (September - November 2011) (DPSE = no. of dolphins per 100 units of survey effort)
