Contract No. HY/2011/03

**Hong Kong-Zhuhai-Macao Bridge Hong Kong Link Road
Section between Scenic Hill and Hong Kong Boundary Crossing
Facilities**

Quarterly EM&A Report No. 25 (September 2018 to November 2018)

15 March 2019

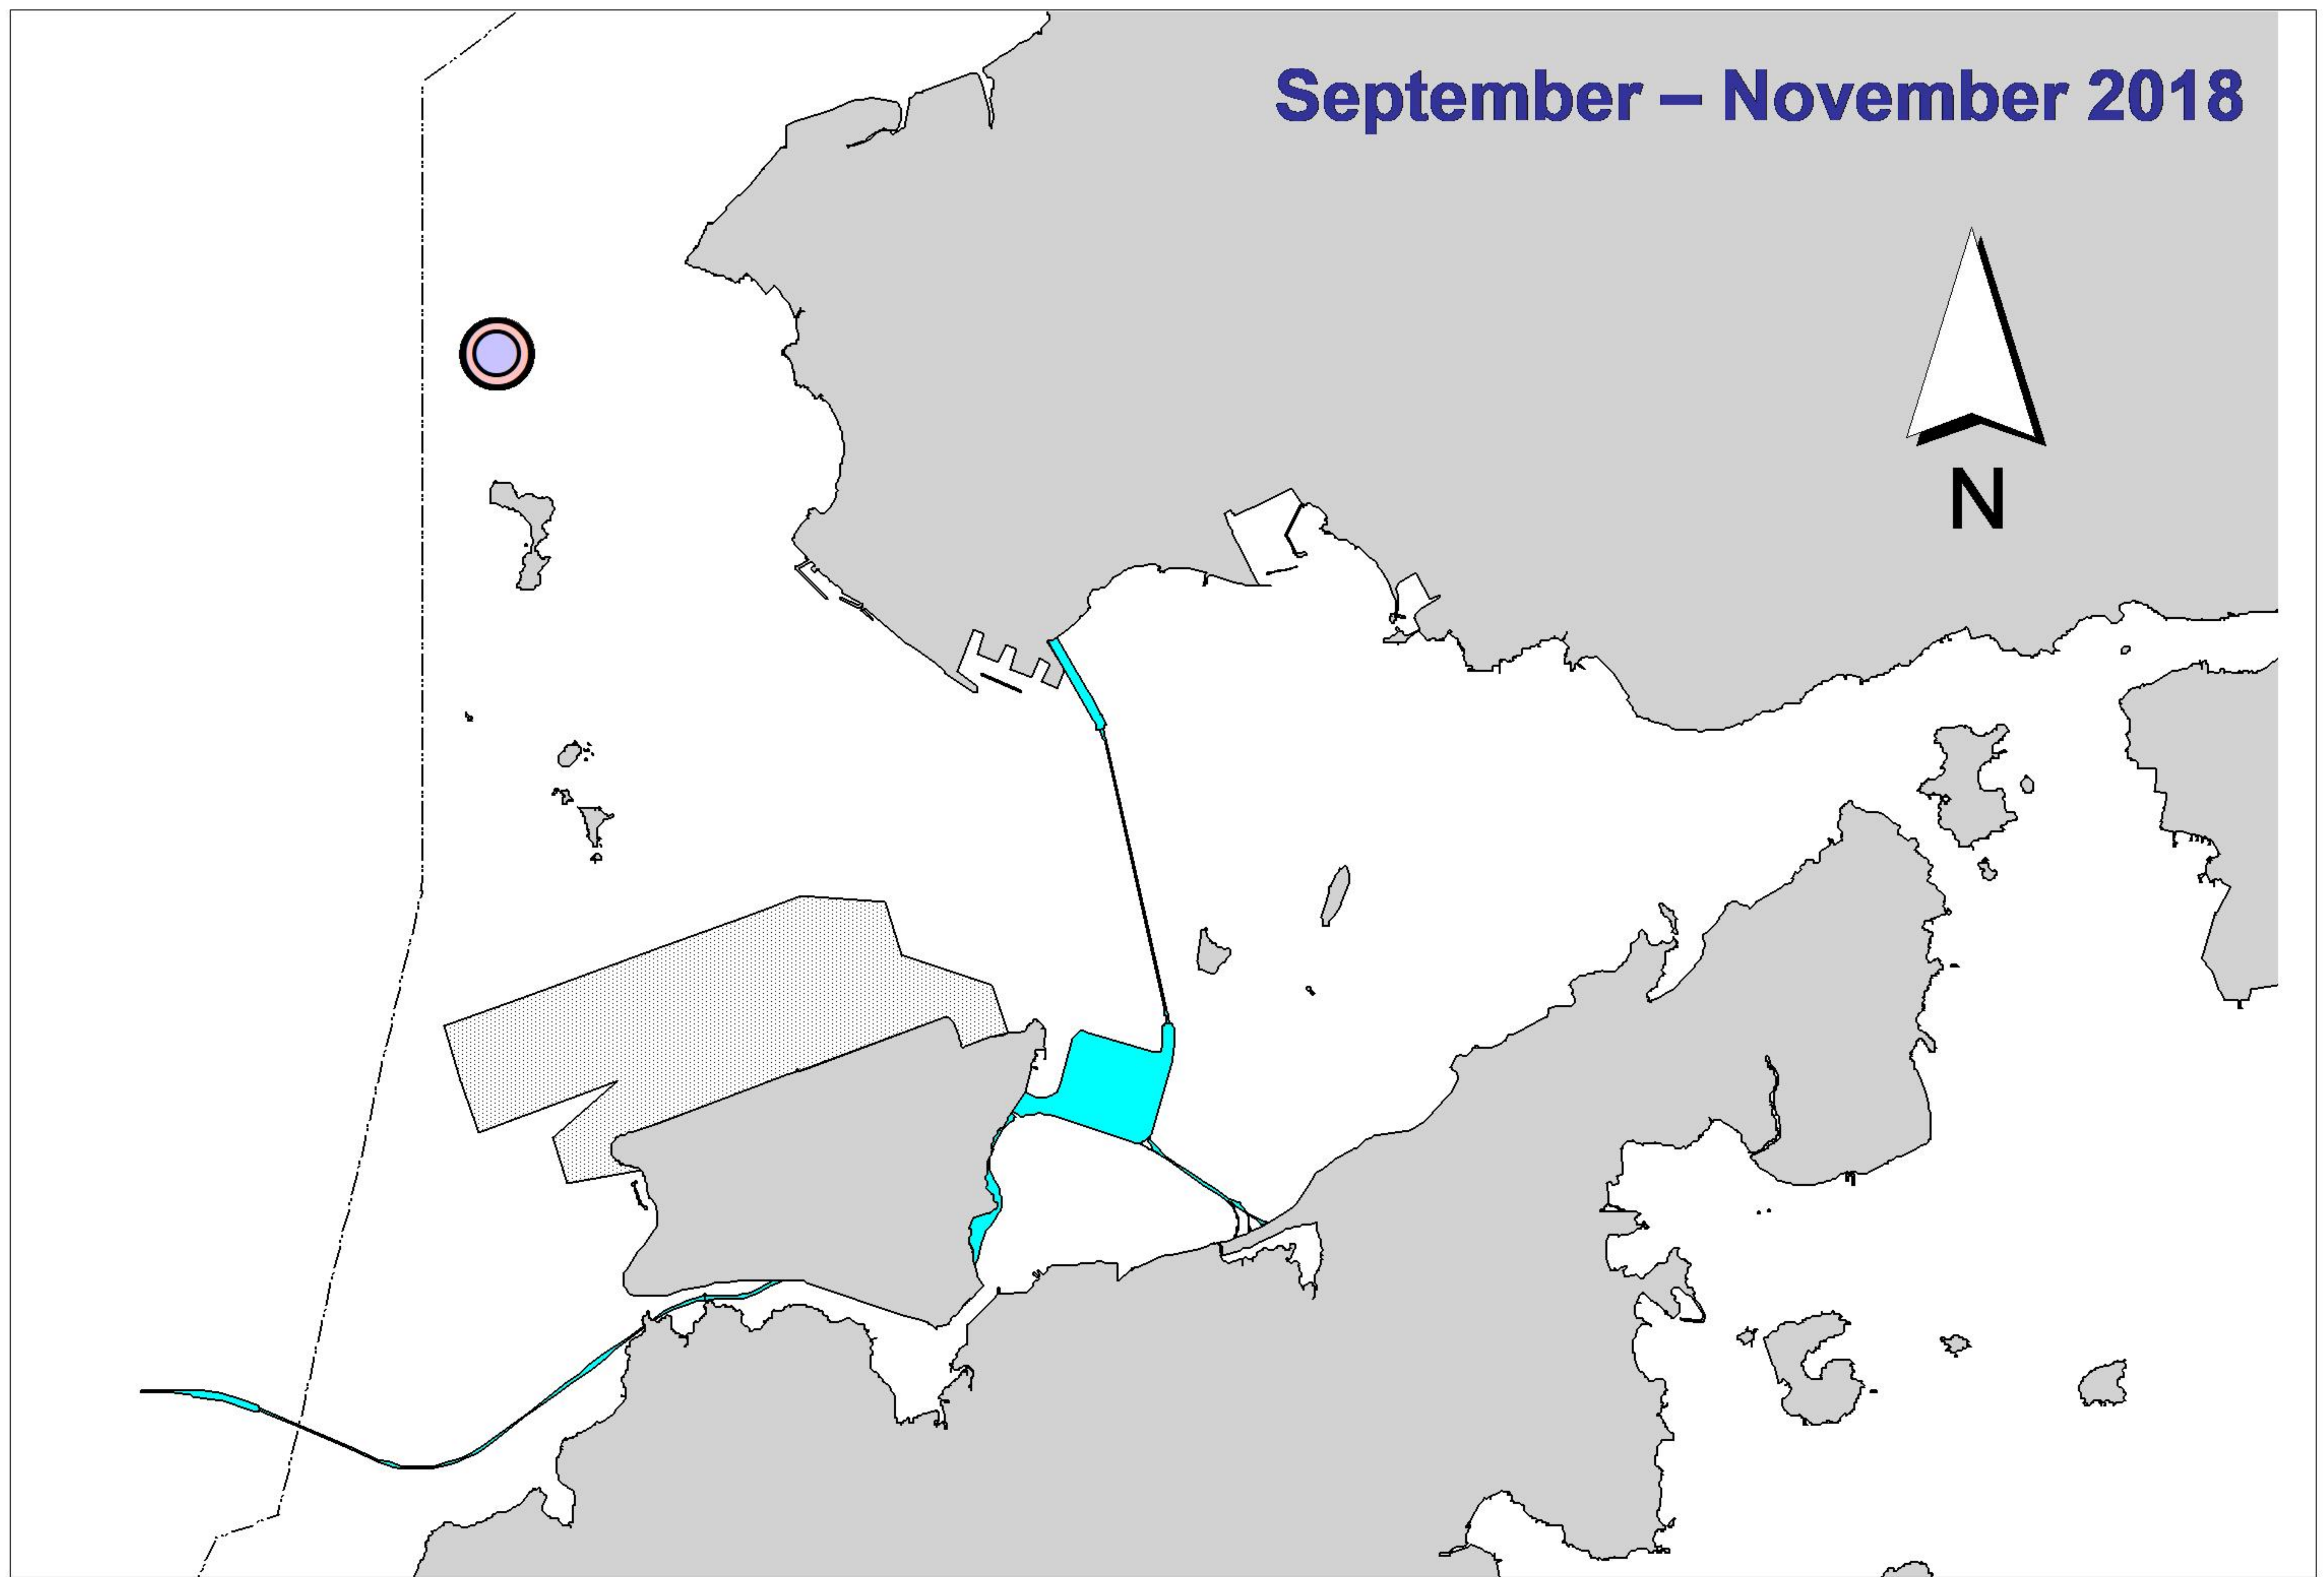
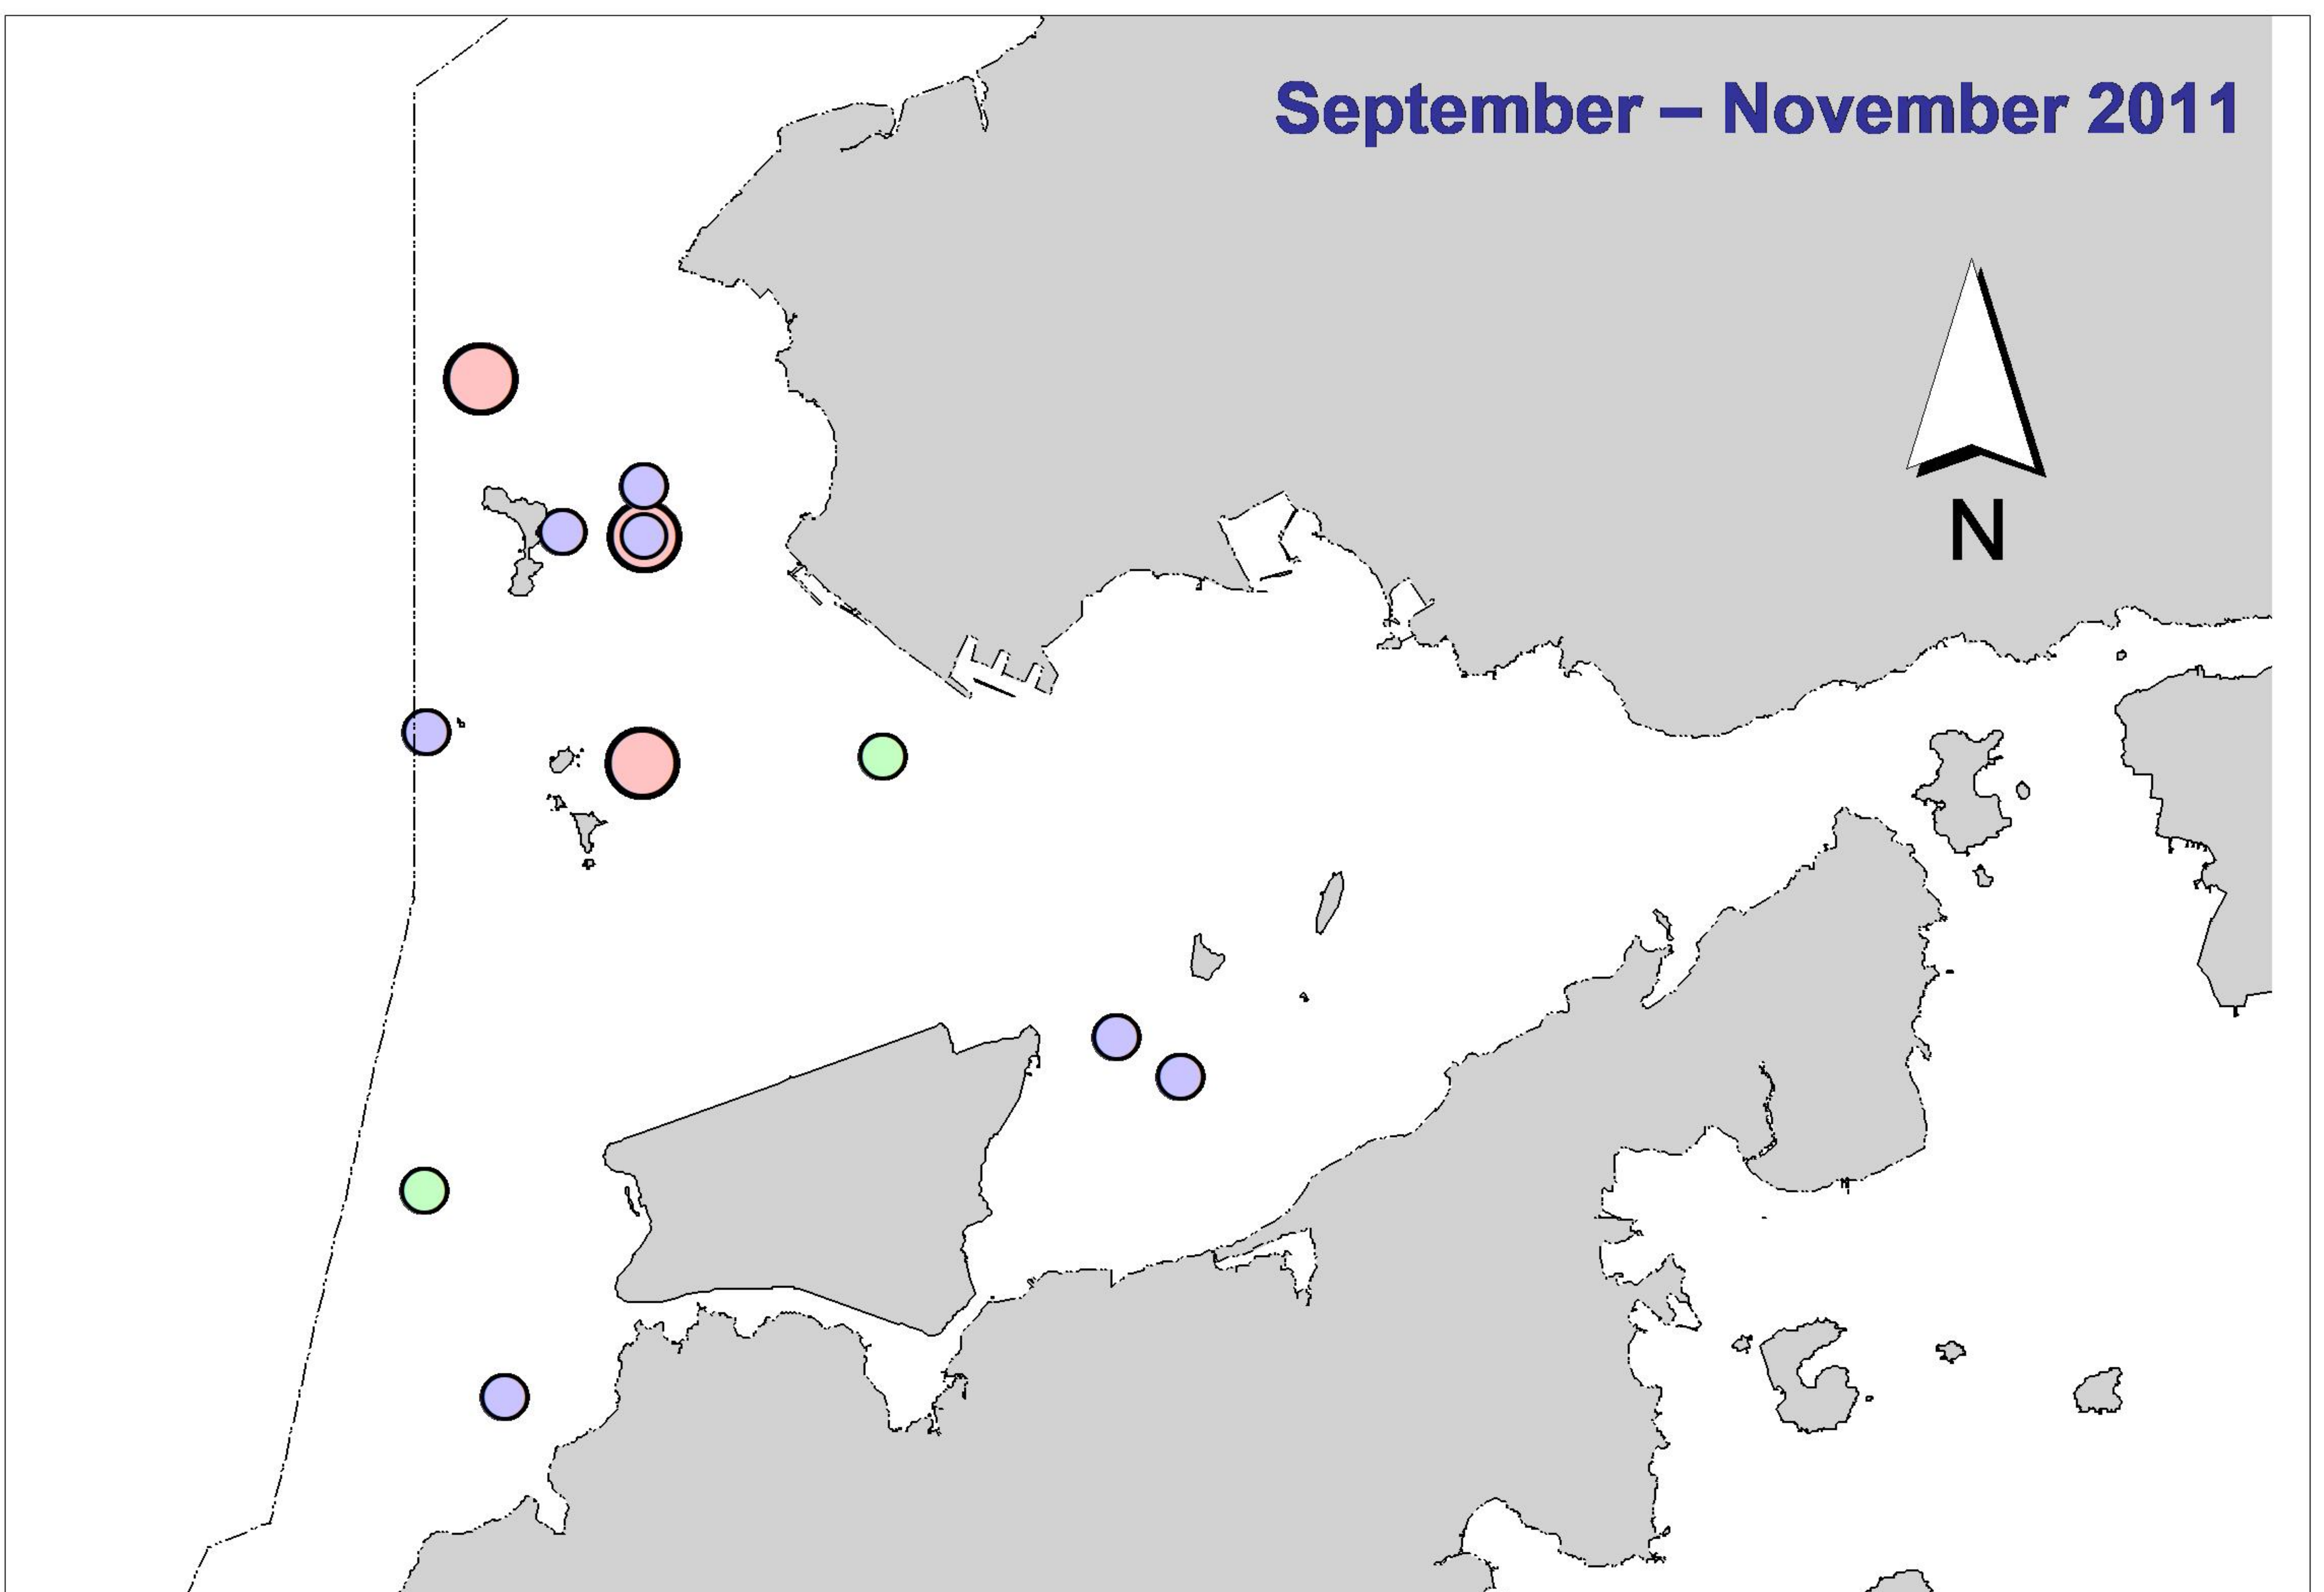
Figure 5. Distribution of Chinese white dolphins engaged in feeding (purple dots), socializing (pink dots) and traveling (green dots) activities during HKLR03 impact phase (top) and baseline monitoring surveys (bottom)

- 3.5.7 Behavioural analysis – When dolphins were sighted during vessel surveys, their behaviour was observed. Different activities were categorized (i.e. feeding, milling/resting, traveling, socializing) and recorded on sighting datasheets. This data was then input into a separate database with sighting information, which can be used to determine the distribution of behavioural data with a desktop GIS. Distribution of sightings of dolphins engaged in different activities and behaviours would then be plotted on GIS and carefully examined to identify important areas for different activities of the dolphins.

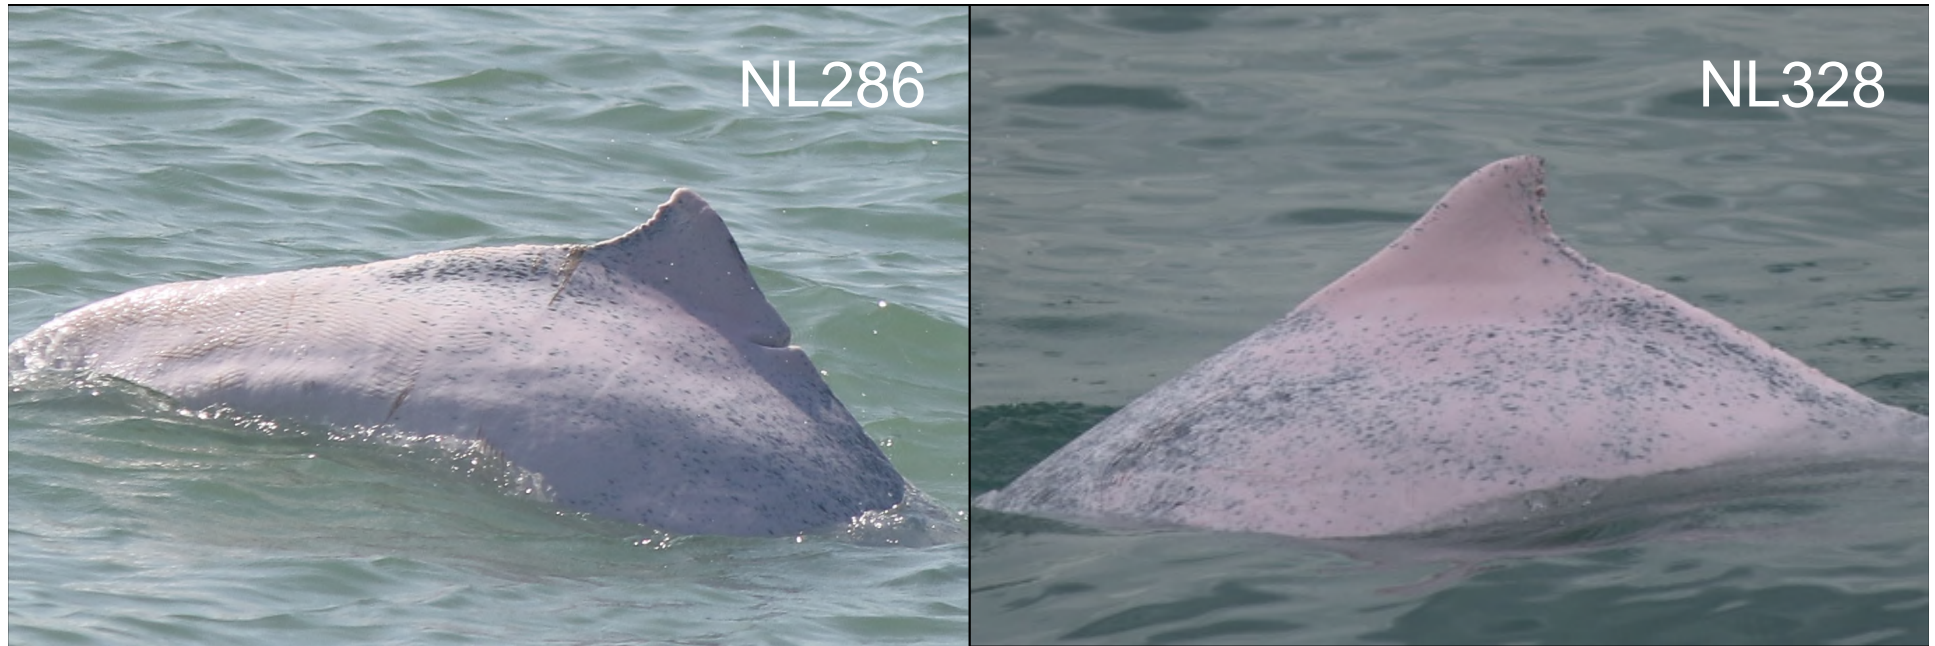
Annex V. Ranging patterns (95% kernel ranges) of six individual dolphins that were sighted during HKLR03 impact phase monitoring period (note: yellow dots indicate sightings made in September-October 2018 during HKLR03 monitoring surveys; the yellow dots with the red circles indicate the ones made during HKBCF monitoring surveys)

- 3.5.44 Ranging patterns of the six individuals identified during the three-month study period were determined by fixed kernel method, and are shown in **Annex V of Appendix J**.
- 3.5.45 All identified dolphins sighted in the present quarter were utilizing NWL waters only, but have completely avoided NEL waters where many of them have utilized as their core areas in the past (**Annex V of Appendix J**). This is in contrary to the extensive movements between NEL and NWL survey areas observed in the earlier impact monitoring quarters as well as the baseline period.

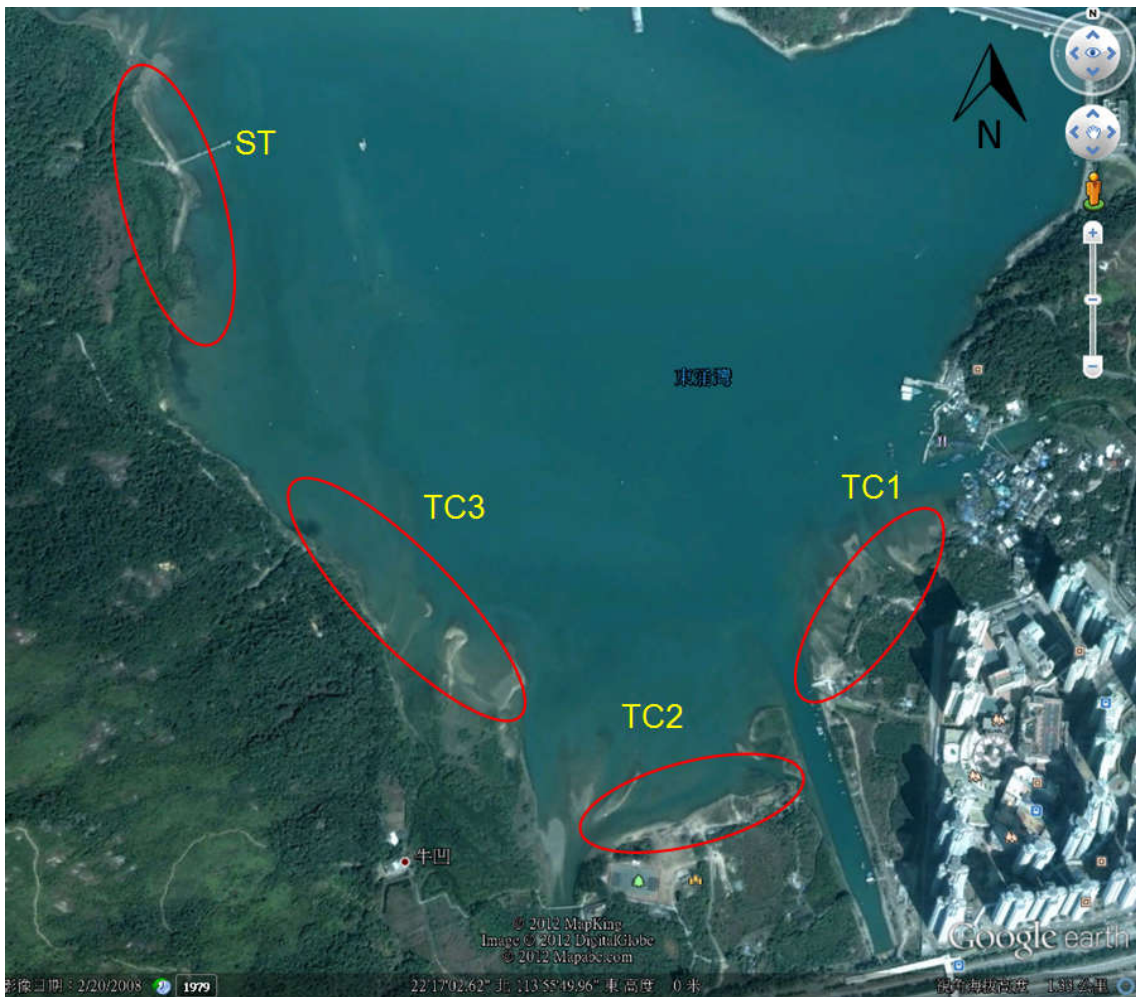
Figure 2.1. Locations of sampling zones. The study site was divided into three sampling zones (TC1, TC2, TC3) in Tung Chung Bay and one zone in San Tau (ST) (map generated from Google Map).

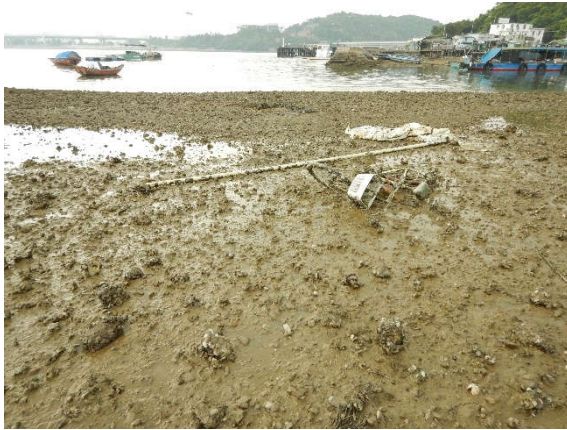
- 3.6.7 Since the field survey of Jun. 2016, increasing number of trashes and even big trashes (**Figure 2.3 of Appendix O**) were found in every sampling zone. It raised a concern about the solid waste dumping and current-driven waste issues in Tung Chung Wan. Respective measures (e.g. manual clean-up) should be implemented by responsible government agency units.

broken bike and plastic waste

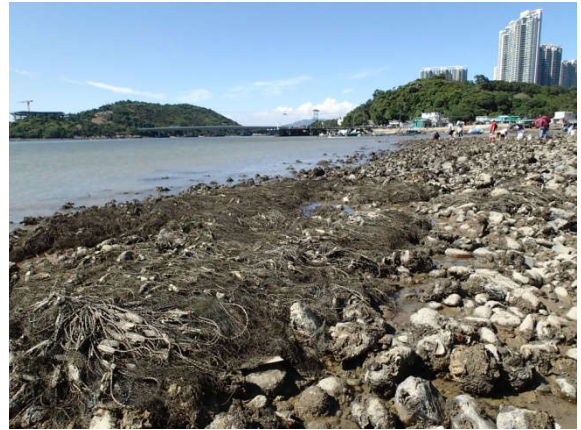
trash gill net

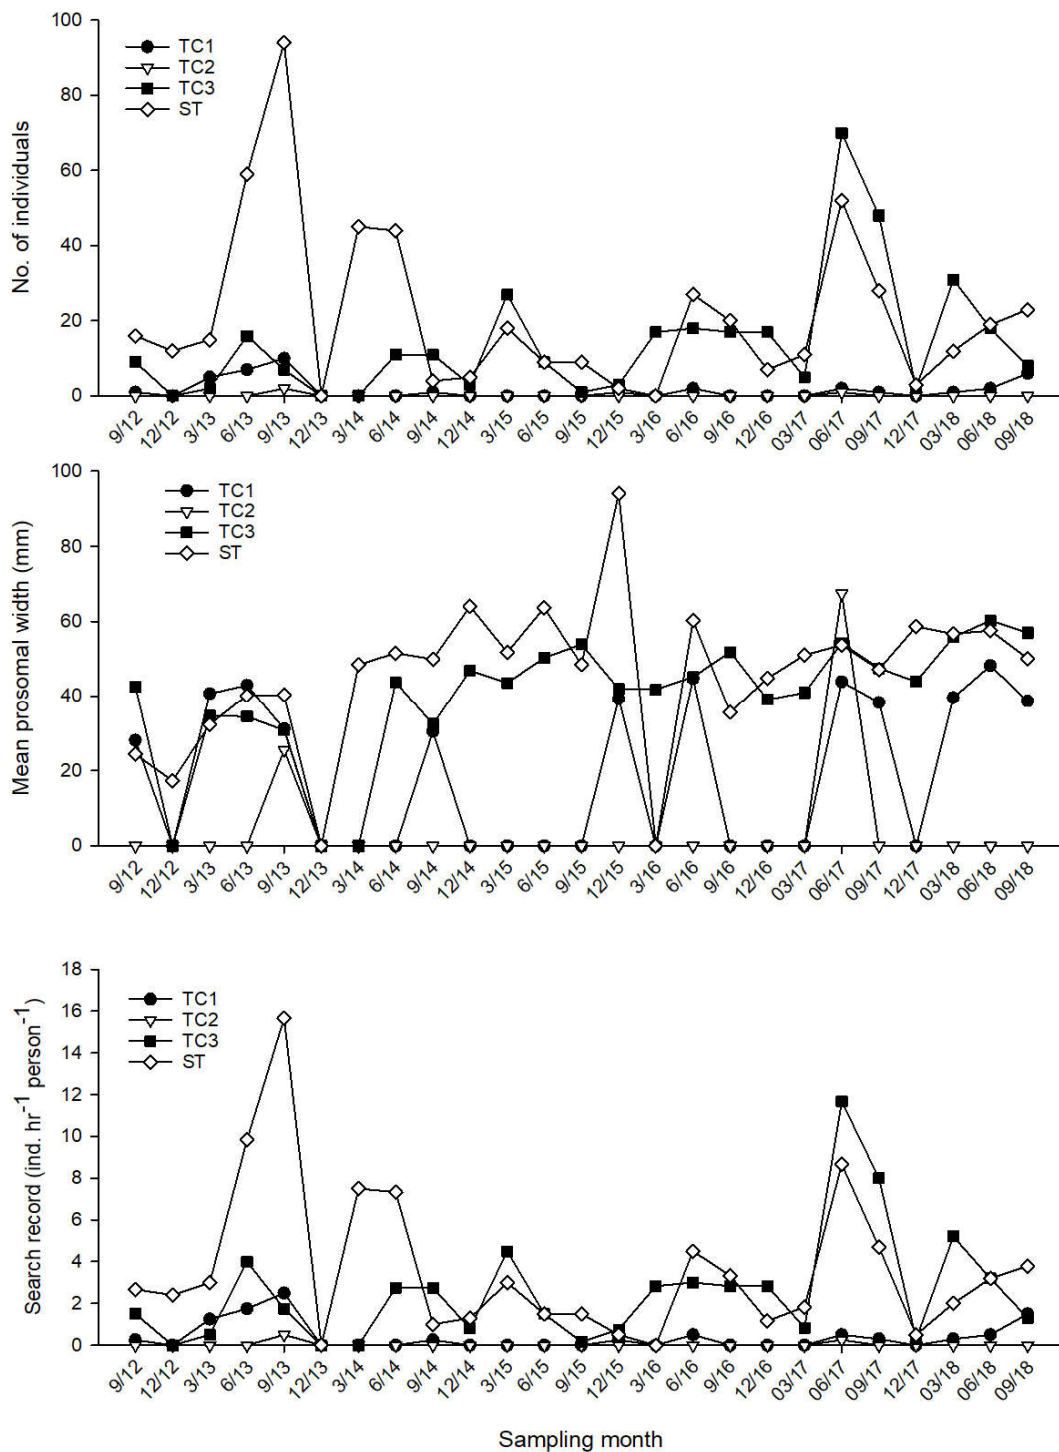
Figure 3.6. Changes of number of individuals, mean prosomal width and search record of horseshoe crab *Tachypleus tridentatus* in every sampling zone along the sampling months

- 3.6.16 In the present survey, two species of horseshoe crab *Carcinoscorpius rotundicauda* (total 115 ind.) and *Tachypleus tridentatus* (total 37 ind.) were recorded. The recorded individuals were mainly distributed along the shoreline from TC3 to ST. Grouping of 2-25 individuals was usually observed on similar substratum (fine sand or soft mud, slightly submerged). Photo records were shown in **Figure 3.1 of Appendix O** while the complete survey records were listed in **Annex II of Appendix O**.

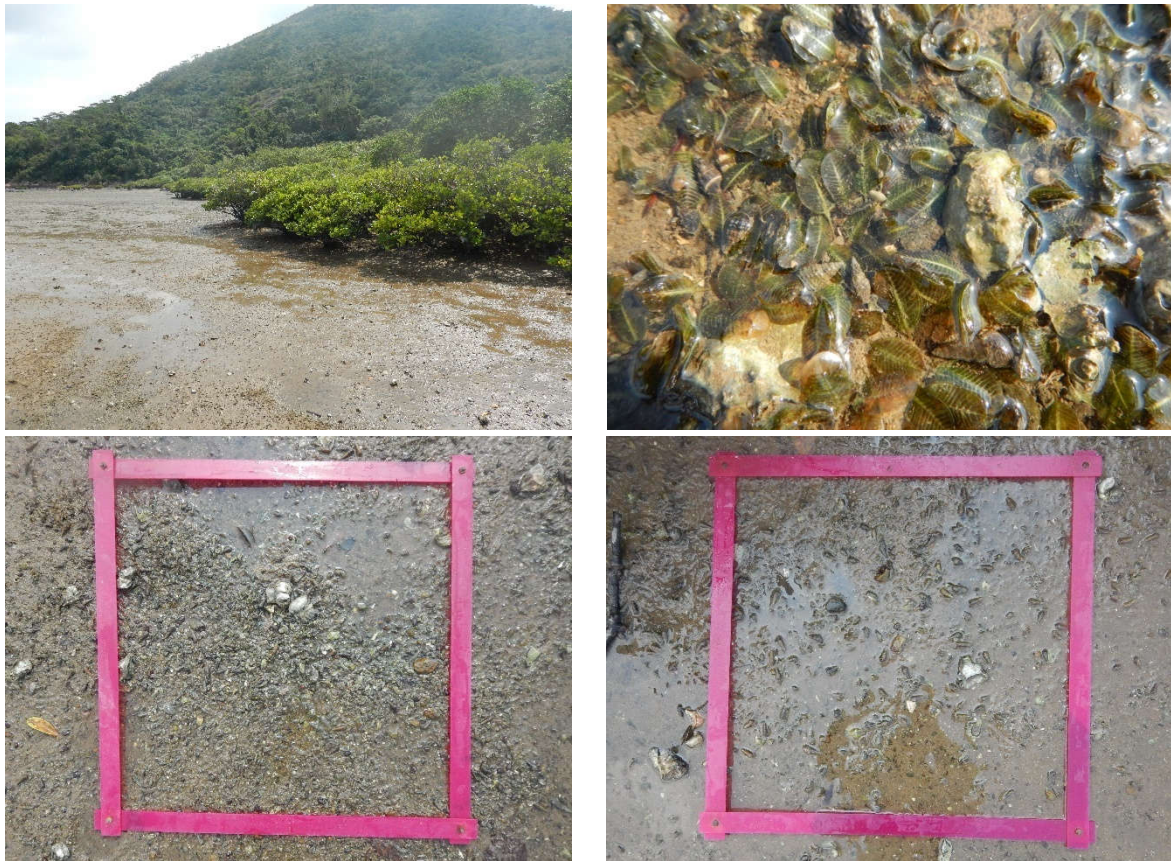
Figure 3.10. *Photographic record of seagrass beds in present survey.*

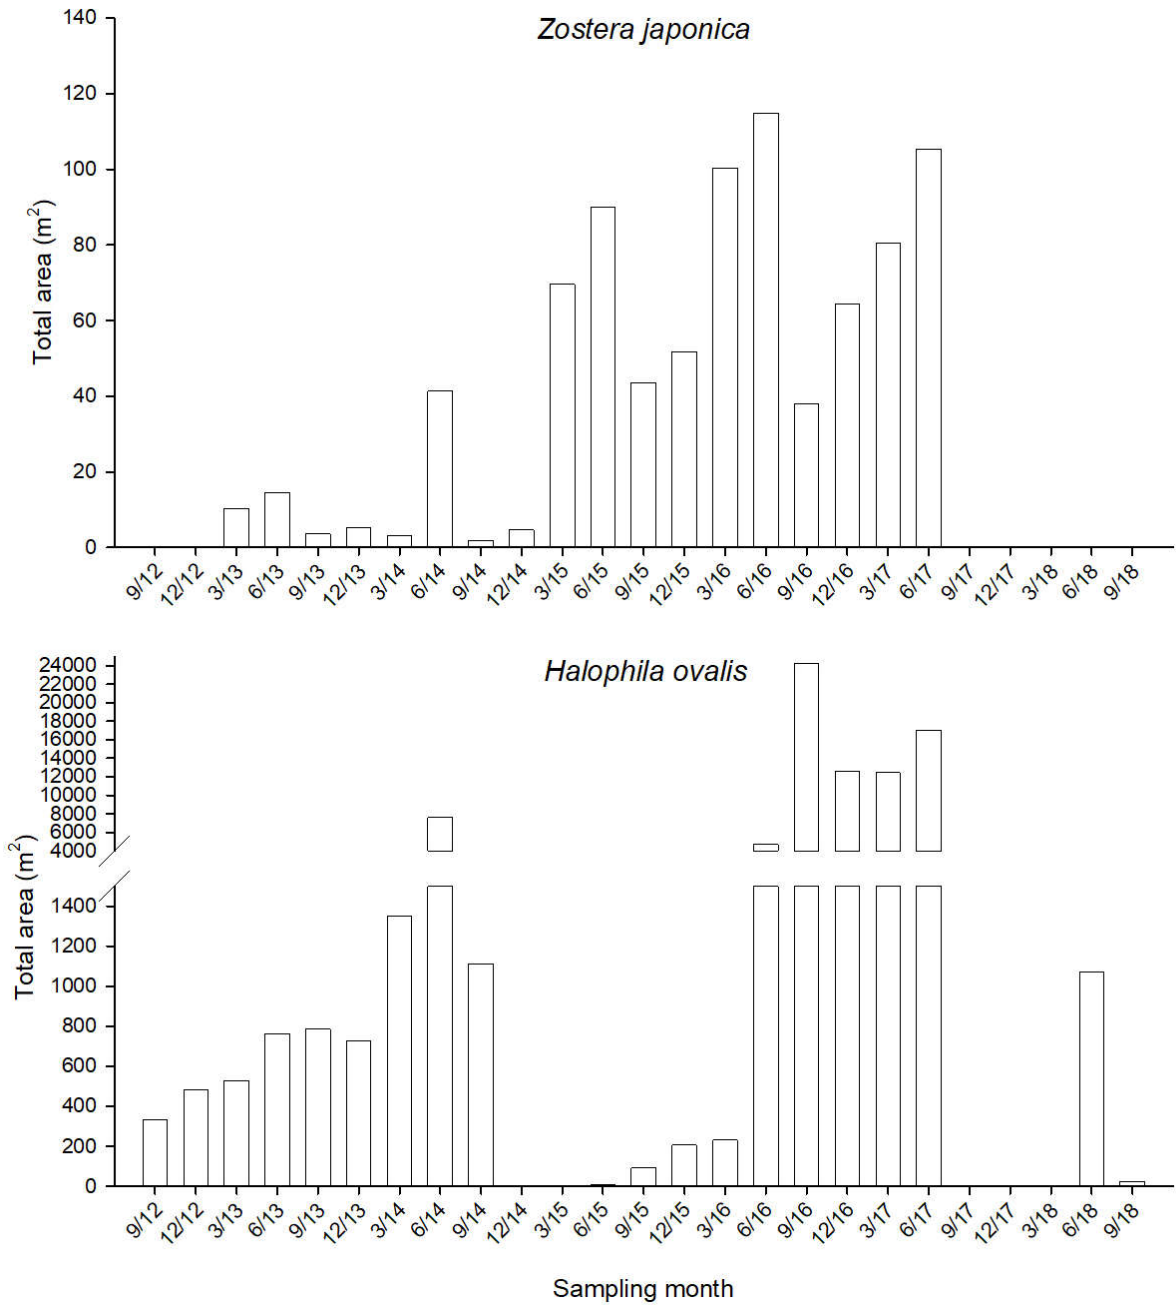
Figure 3.11. Temporal changes of estimated total area of seagrass beds in ST

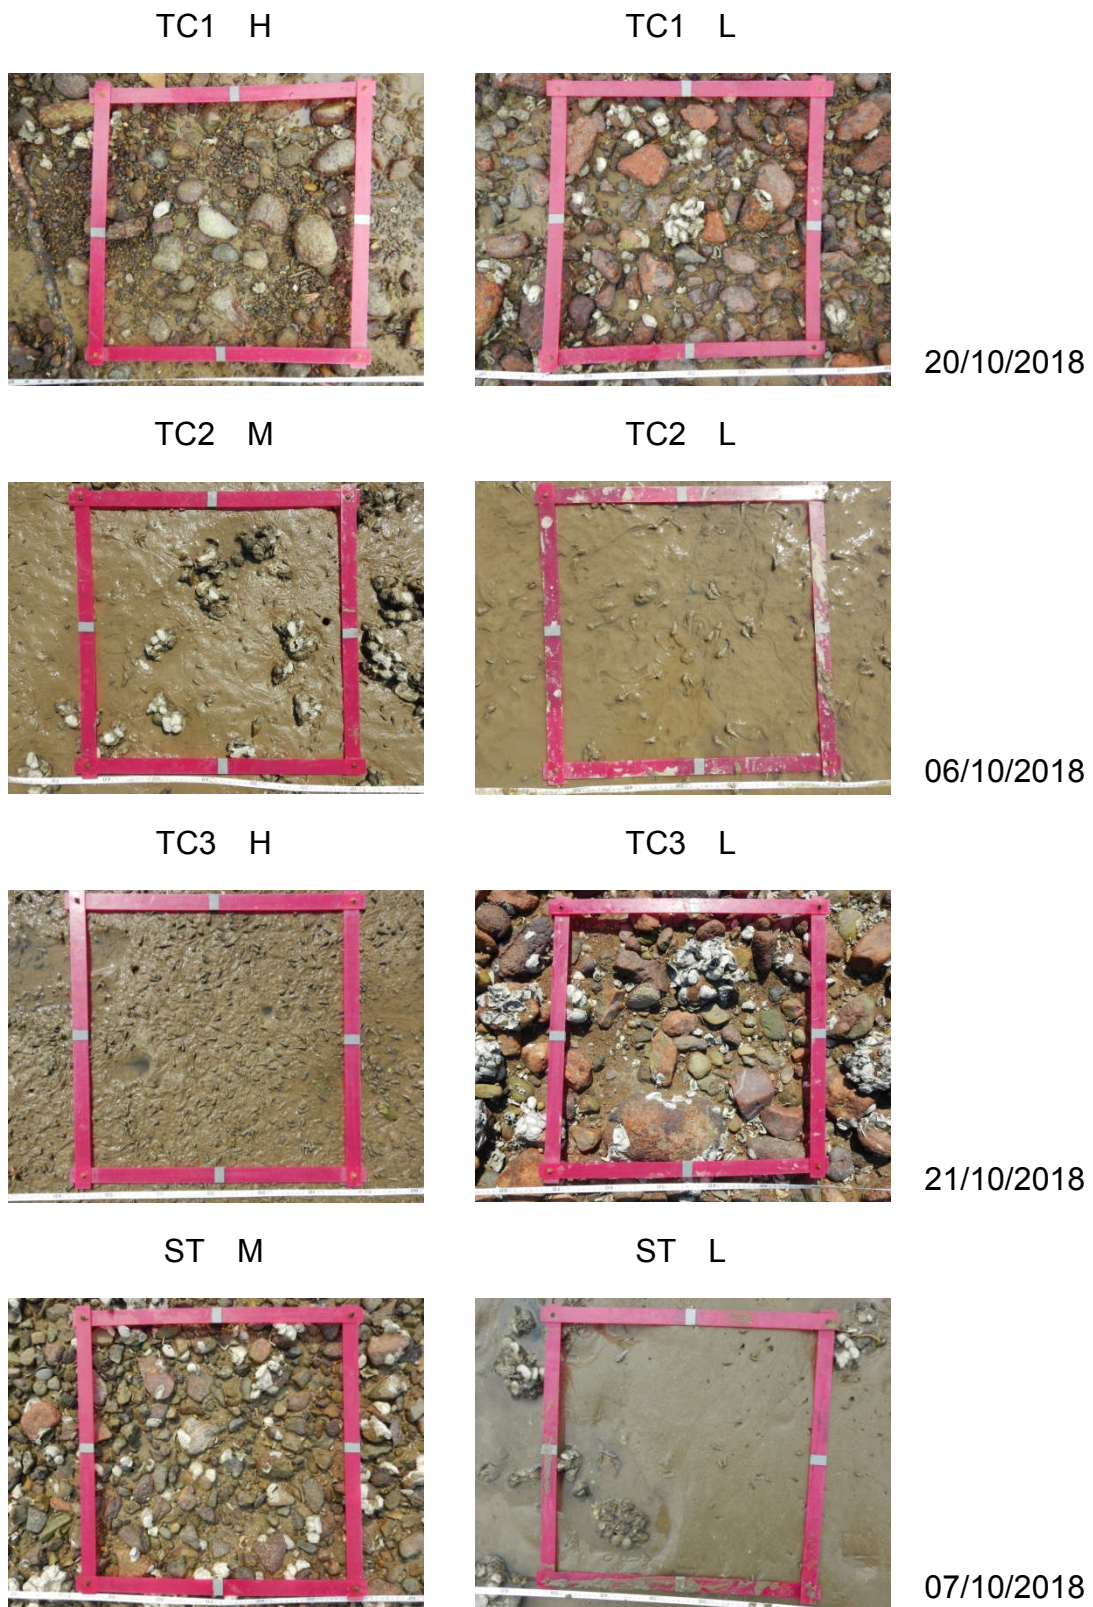
Figure 3.13. *Examples of photographic records of quadrat for intertidal soft shore community survey (H: 2.0 m above C.D.; M: 1.5 m above C.D.; L: 1.0 m above C.D.)*

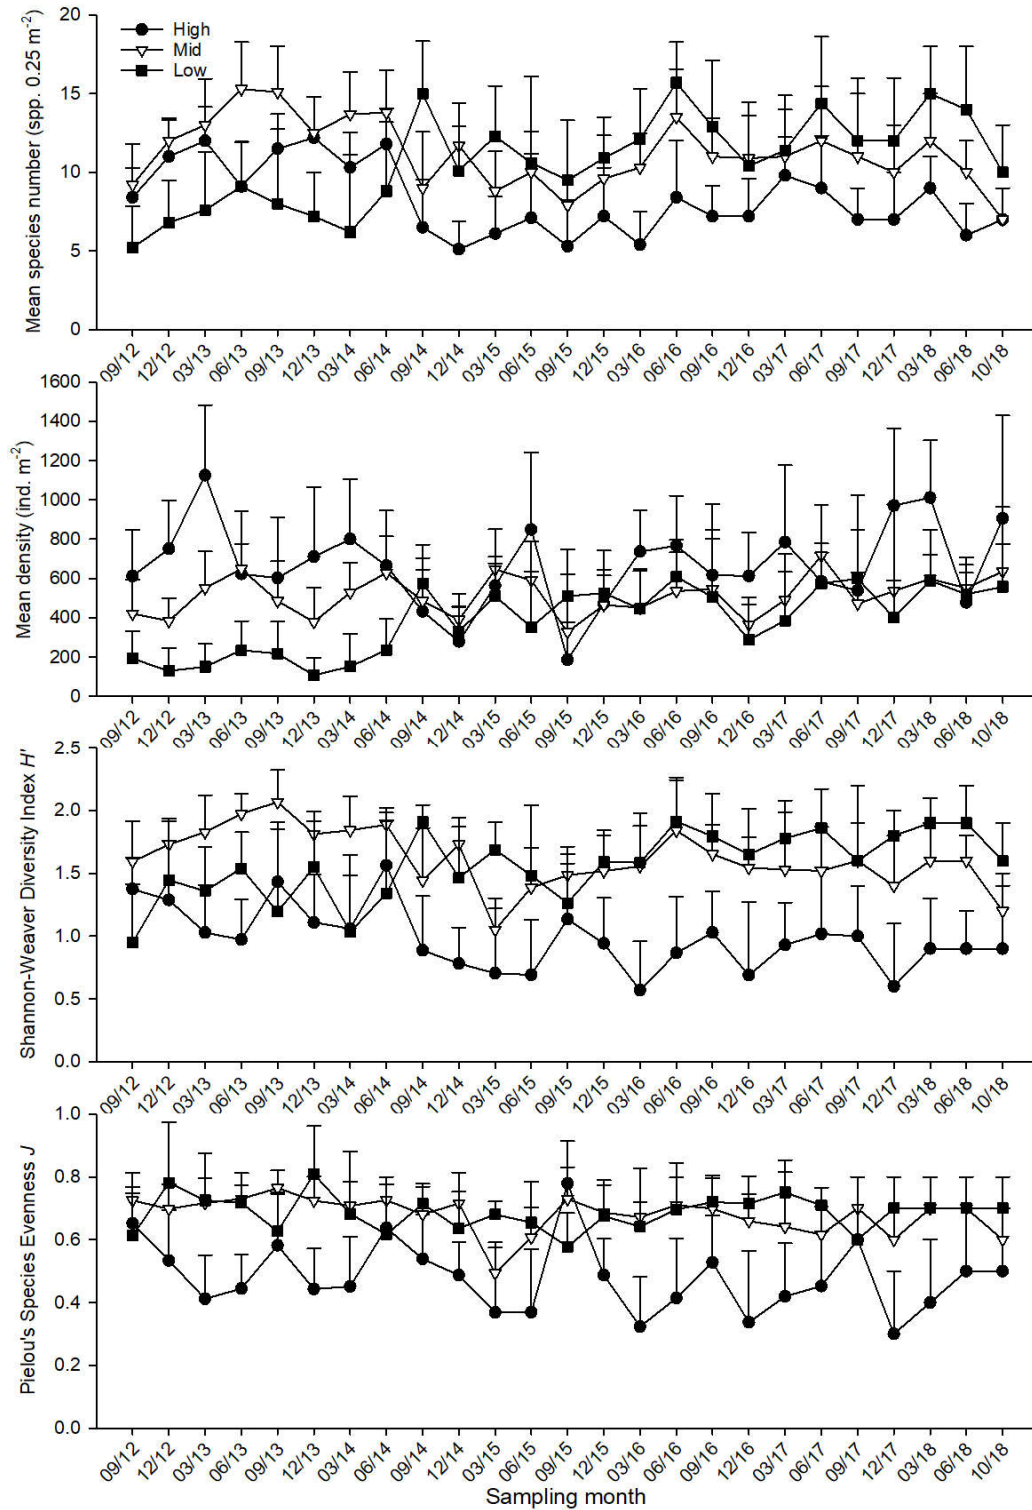
Figure 3.14. Temporal changes of mean number of species, mean density, Shannon-Weaver Diversity Index (H') and Pielou's Species Evenness (J) (mean + SD) at every tidal level in sampling zone TC1

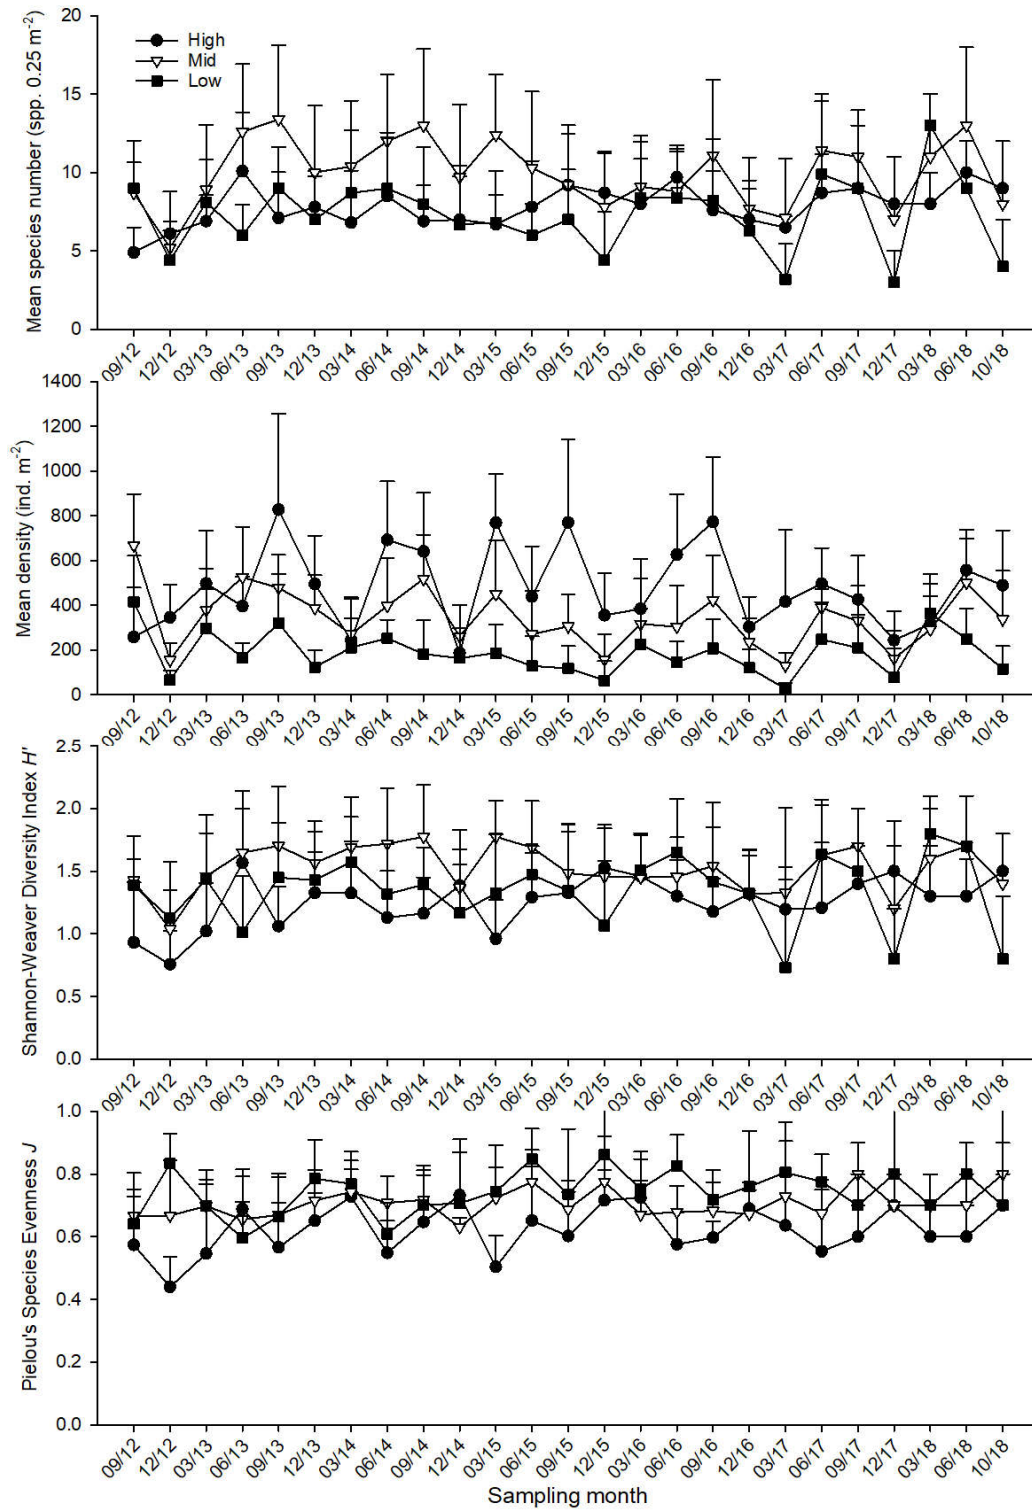
Figure 3.15. Temporal changes of mean number of species, mean density, Shannon-Weaver Diversity Index (H') and Pielou's Species Evenness (J) (mean + SD) at every tidal level in sampling zone TC2

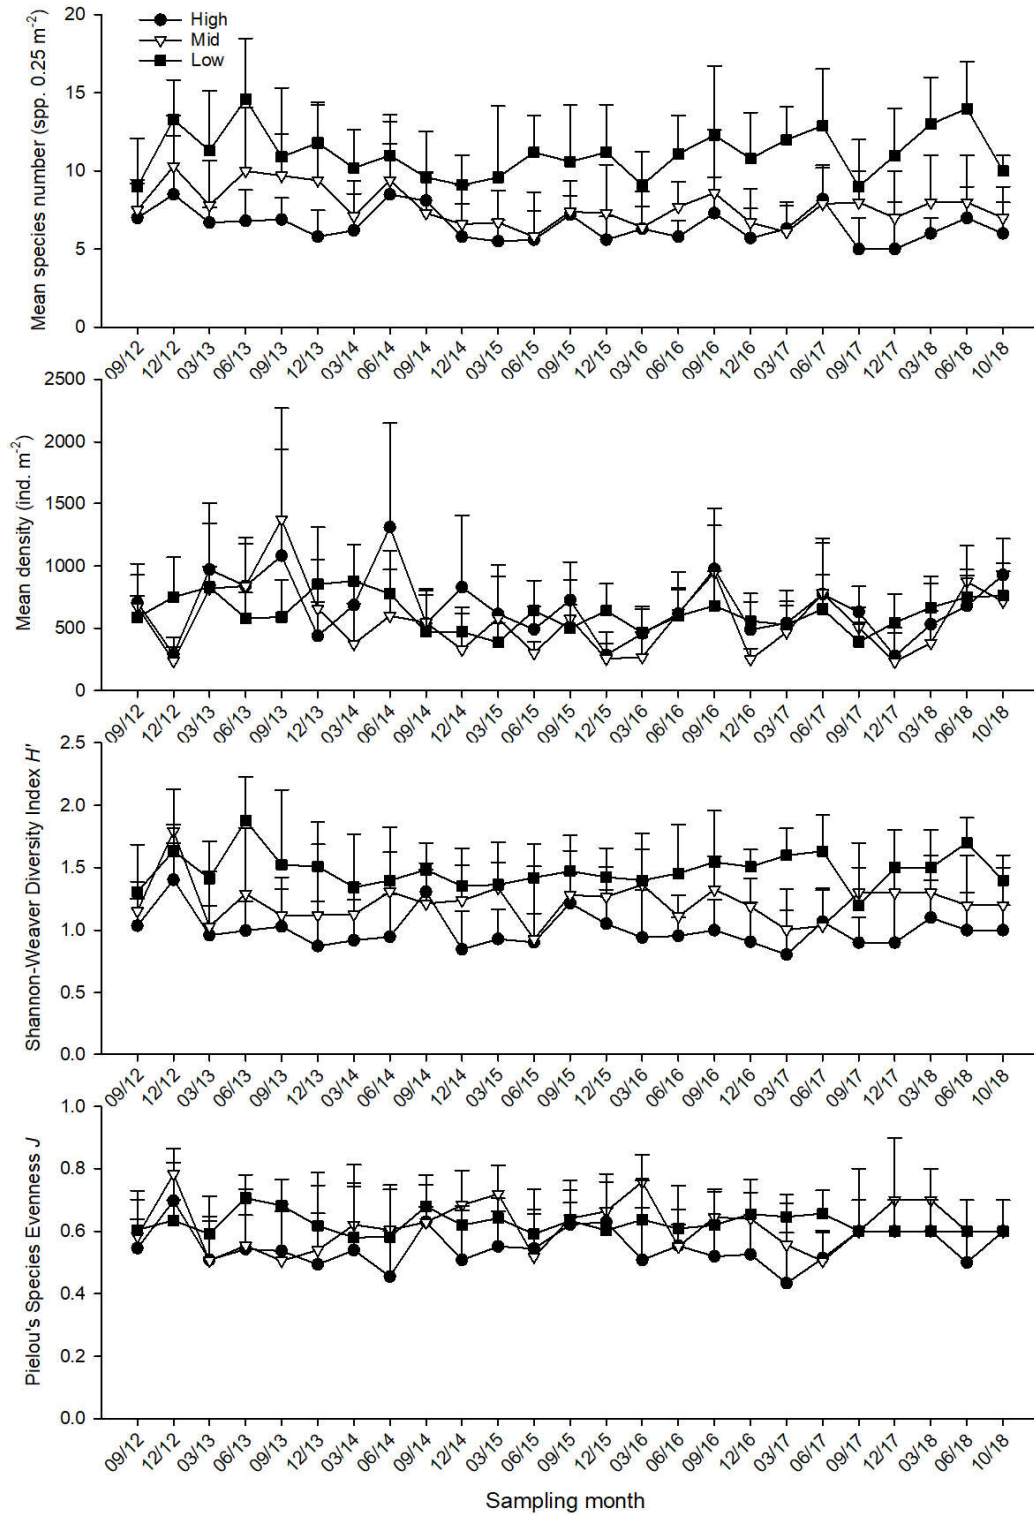
Figure 3.16. Temporal changes of mean number of species, mean density, Shannon-Weaver Diversity Index (H') and Pielou's Species Evenness (J) (mean + SD) at every tidal level in sampling zone TC3
