Contract No. HY/2011/03

**Hong Kong-Zhuhai-Macao Bridge Hong Kong Link Road
Section between Scenic Hill and Hong Kong Boundary Crossing
Facilities**

Quarterly EM&A Report No. 25 (September 2018 to November 2018)

15 March 2019

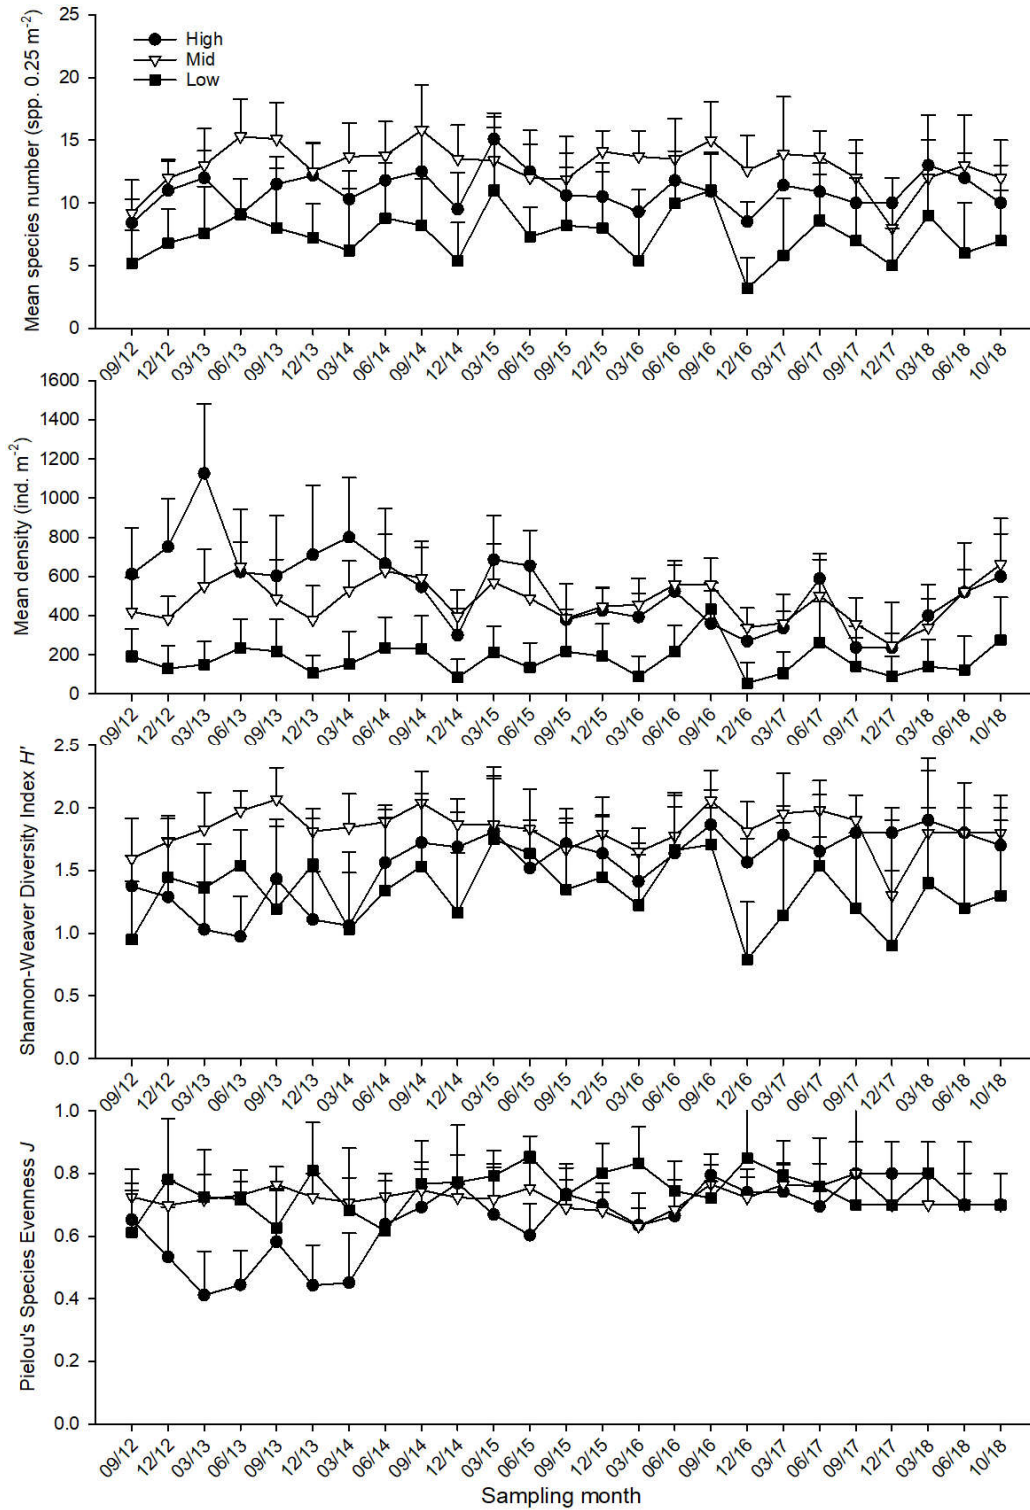
Figure 3.17. Temporal changes of mean number of species, mean density, Shannon-Weaver Diversity Index (H') and Pielou's Species Evenness (J) (mean + SD) at every tidal level in sampling zone ST
