Contract No. HY/2011/03

**Hong Kong-Zhuhai-Macao Bridge Hong Kong Link Road
Section between Scenic Hill and Hong Kong Boundary Crossing
Facilities**

Monthly EM&A Report No.75 (December 2018)

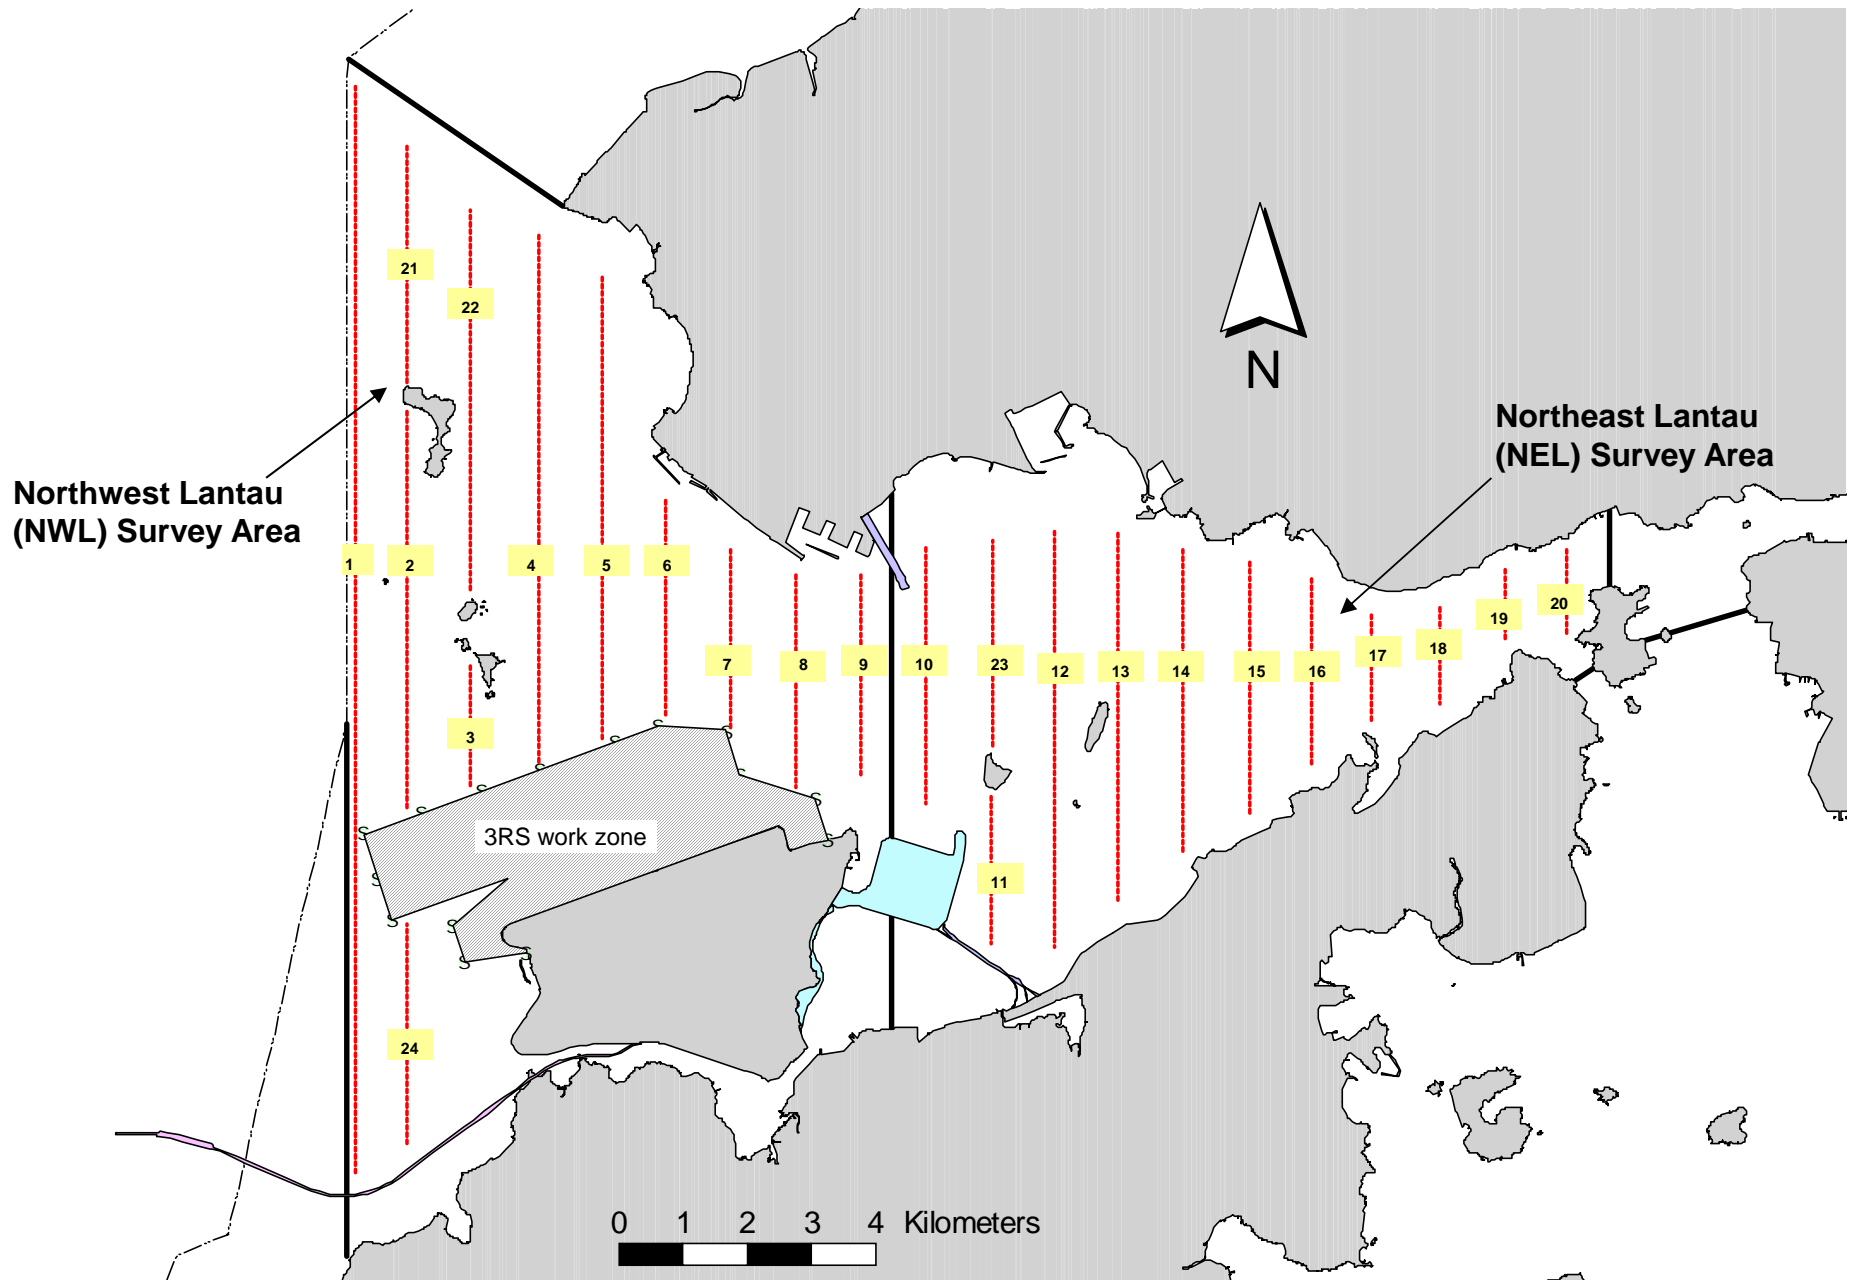
Figure 1. Transect Line Layout in Northwest and Northeast Lantau Survey Areas

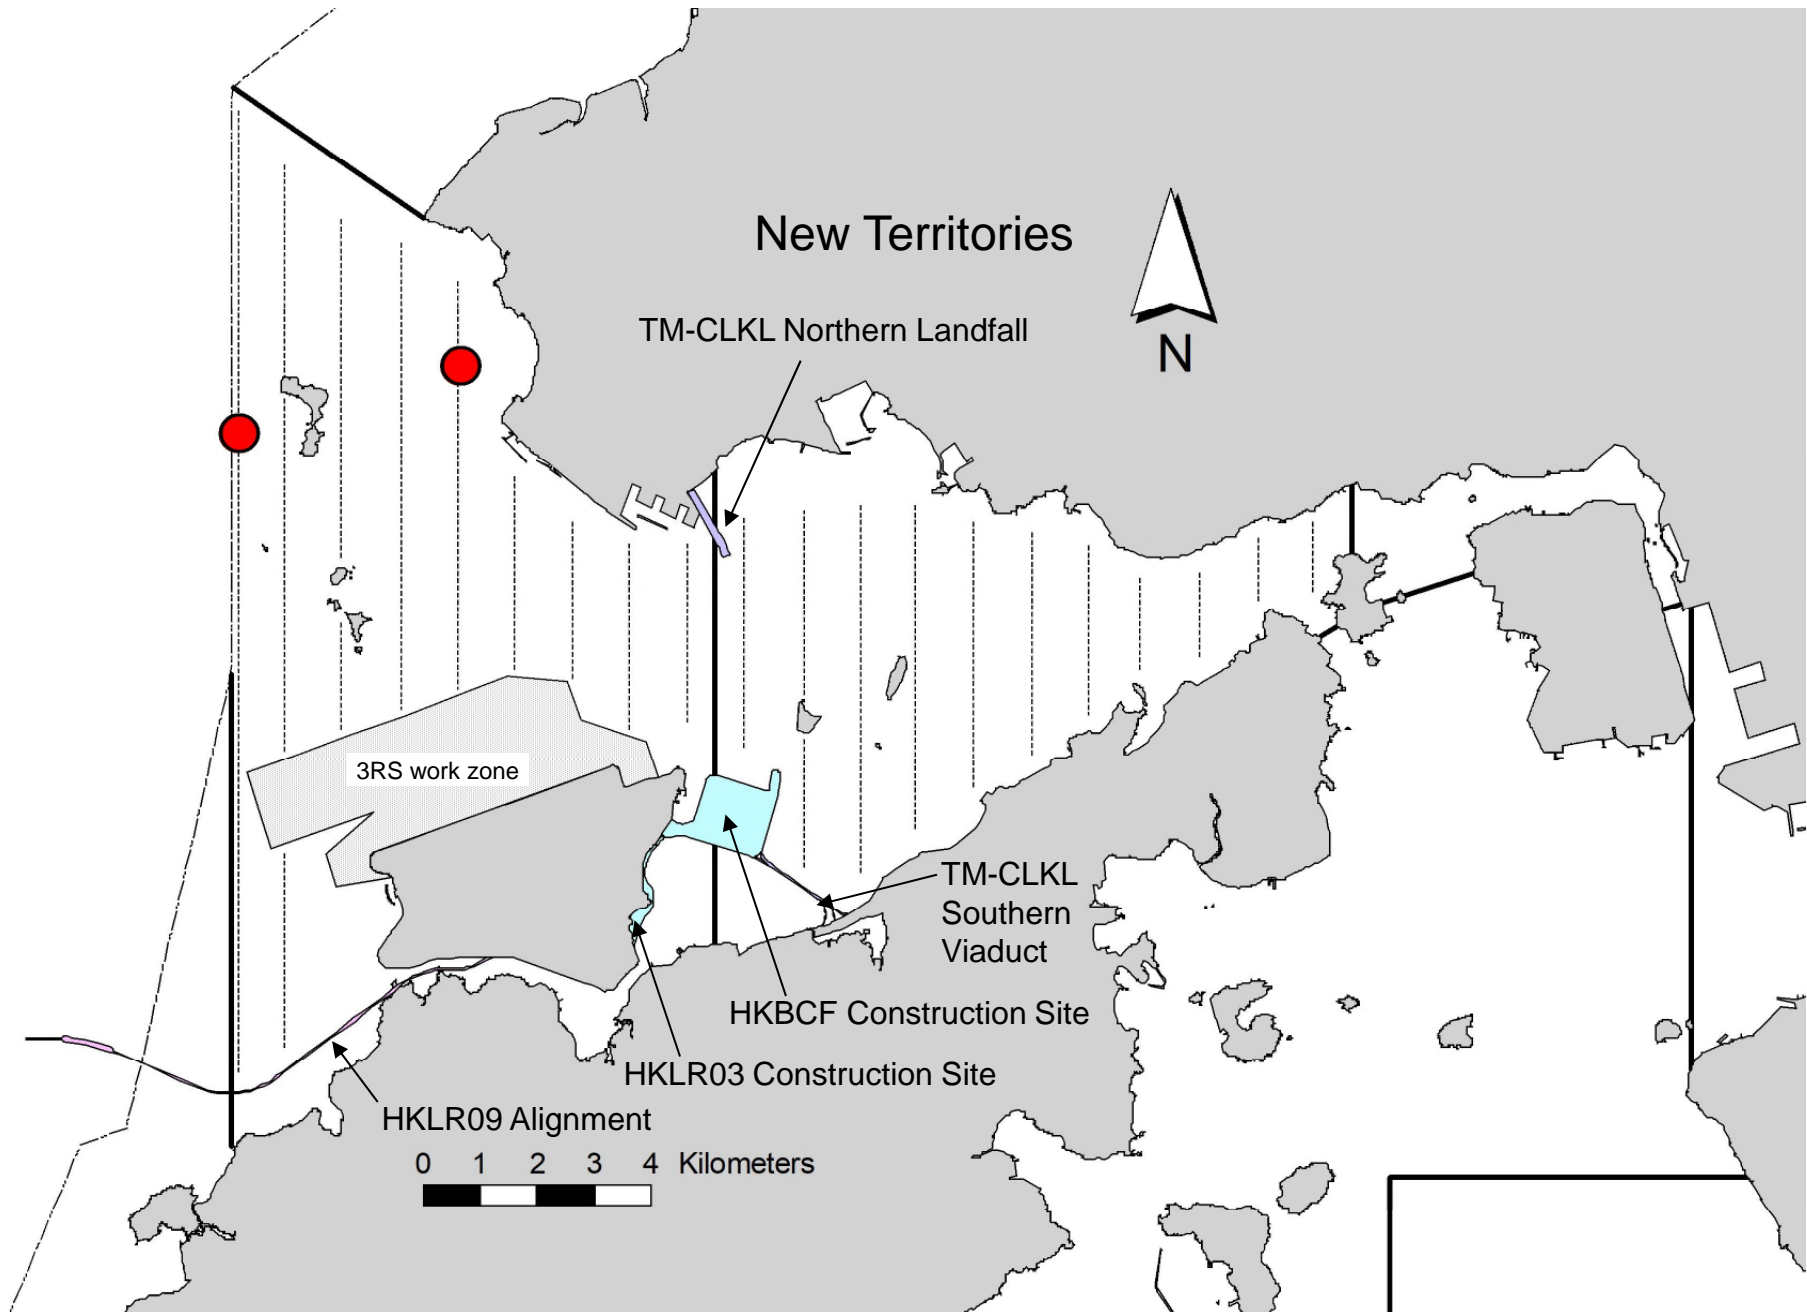
Figure 6. Distribution of Chinese White Dolphin Sightings during December 2018 HKLR03 Monitoring Surveys

- 5.3.6 Distribution of the two dolphin sightings made in December 2018 is shown in **Figure 6 of Appendix H**. They were sighted to the west of Lung Kwu Chau and near Lung Kwu Tan respectively (**Figure 6 of Appendix H**).
- 5.3.7 During the December's surveys, encounter rates of Chinese White Dolphins deduced from the survey effort and on-effort sighting data made under favourable conditions (Beaufort 3 or below) are shown in **Tables 5.3 and 5.4**.

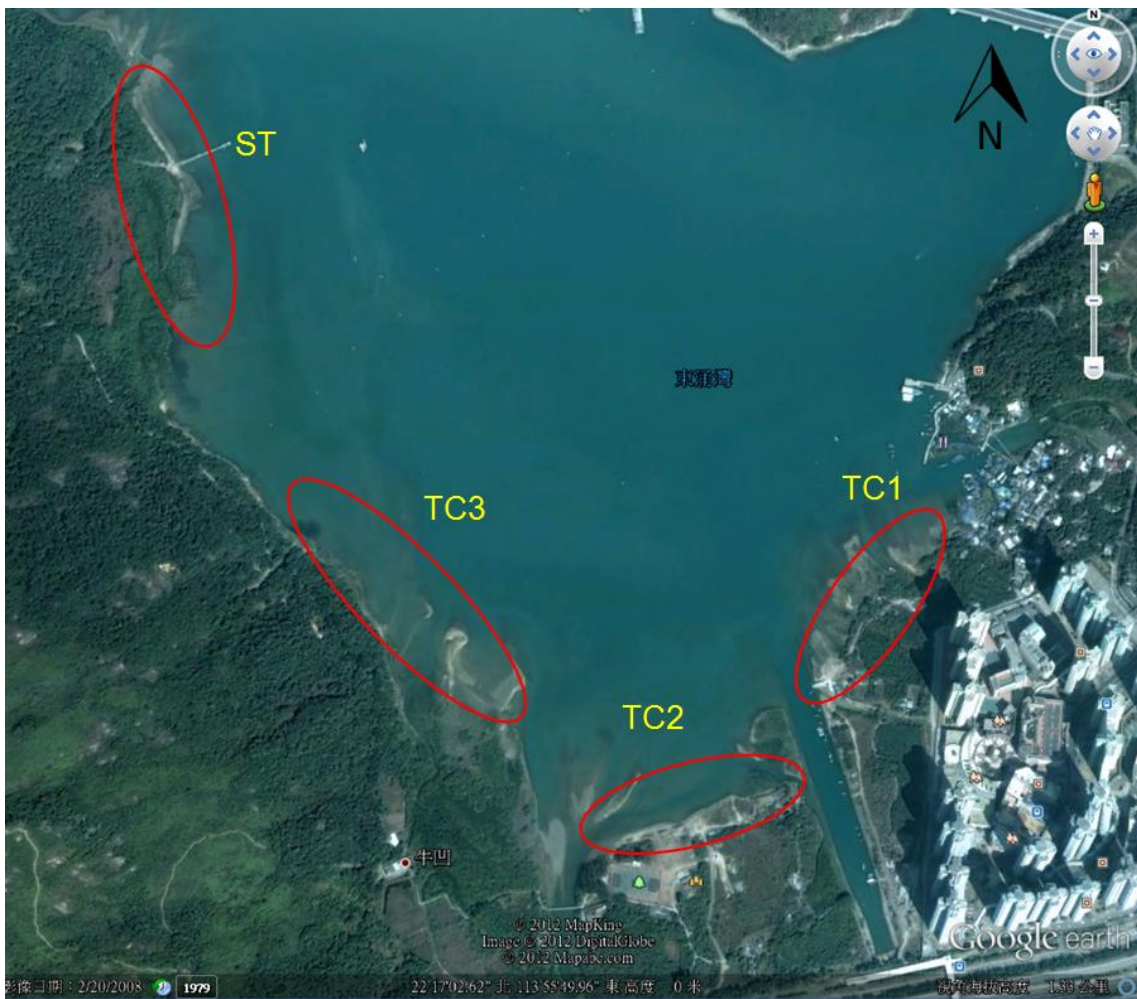
Figure 2.1. Locations of sampling zones. The study site was divided into three sampling zones (TC1, TC2, TC3) in Tung Chung Bay and one zone in San Tau (ST) (map generated from Google Map).

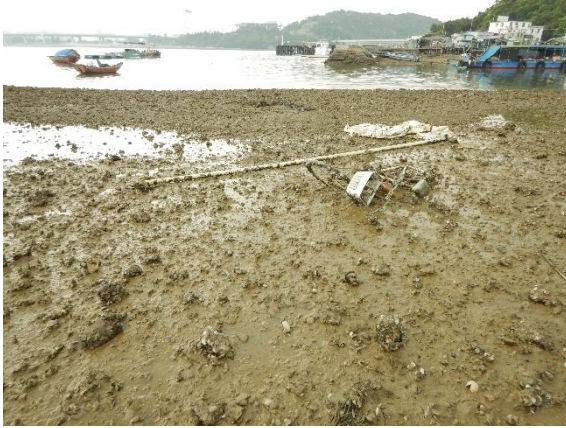
TC1

broken bike and plastic waste

- 6.3.2 Since the field survey of Jun. 2016, increasing number of trashes and even big trashes (**Figure 2.3 of Appendix I**) were found in every sampling zone. It raised a concern about the solid waste dumping and current-driven waste issues in Tung Chung Wan. Respective measures (e.g. manual clean-up) should be implemented by responsible government agency units.

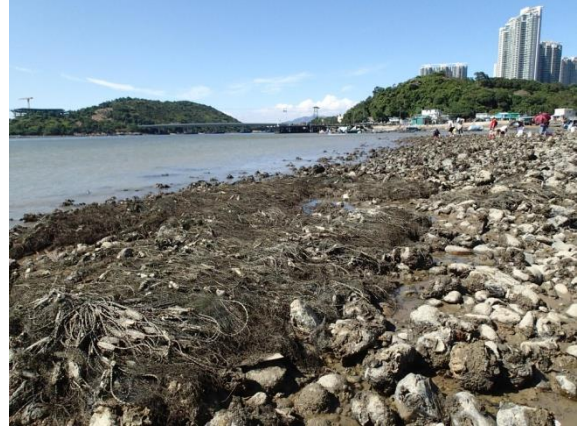
trash gill net

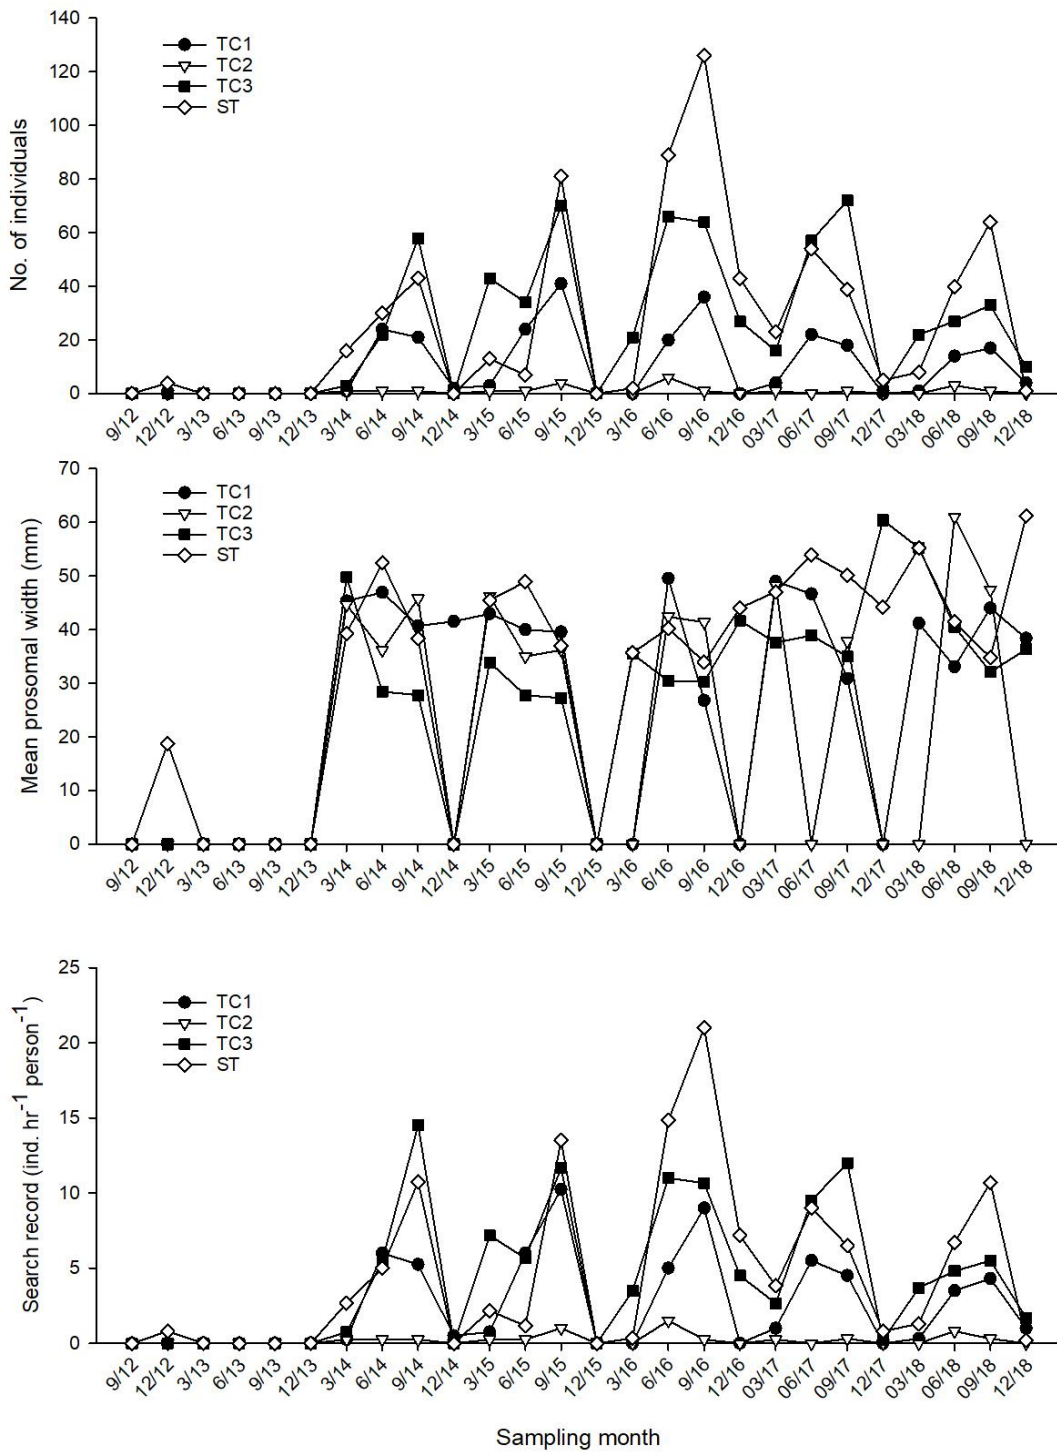
Figure 3.5. Changes of number of individuals, mean prosomal width and search record of horseshoe crab *Carcinoscorpius rotundicauda* in every sampling zone along the sampling months

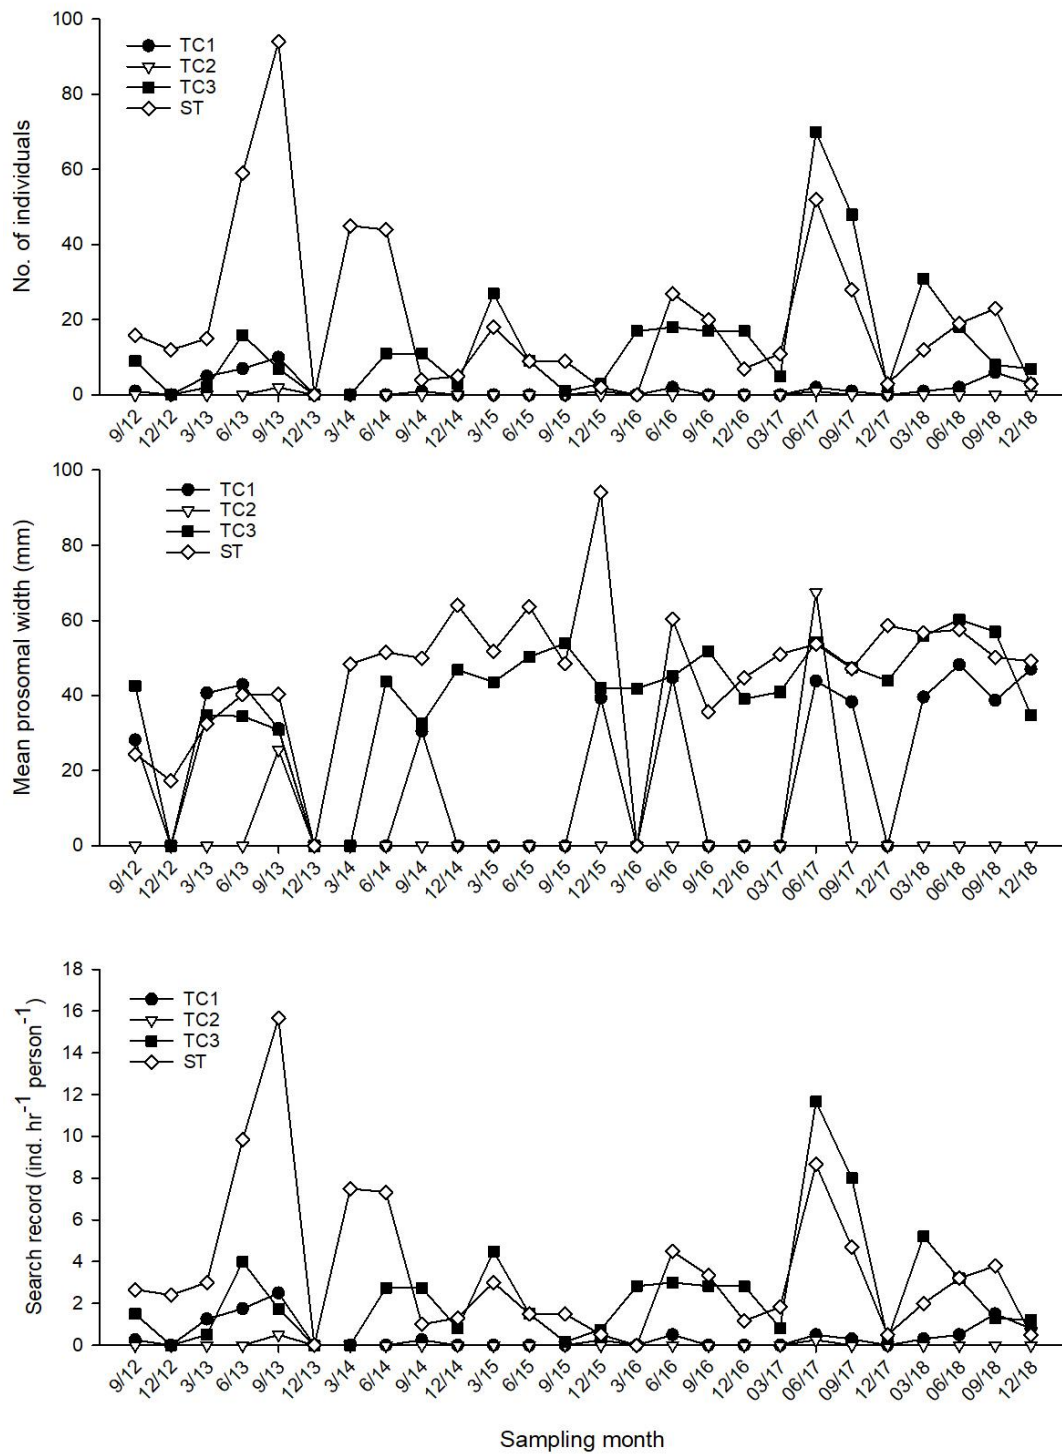
Figure 3.6. Changes of number of individuals, mean prosomal width and search record of horseshoe crab *Tachypleus tridentatus* in every sampling zone along the sampling months

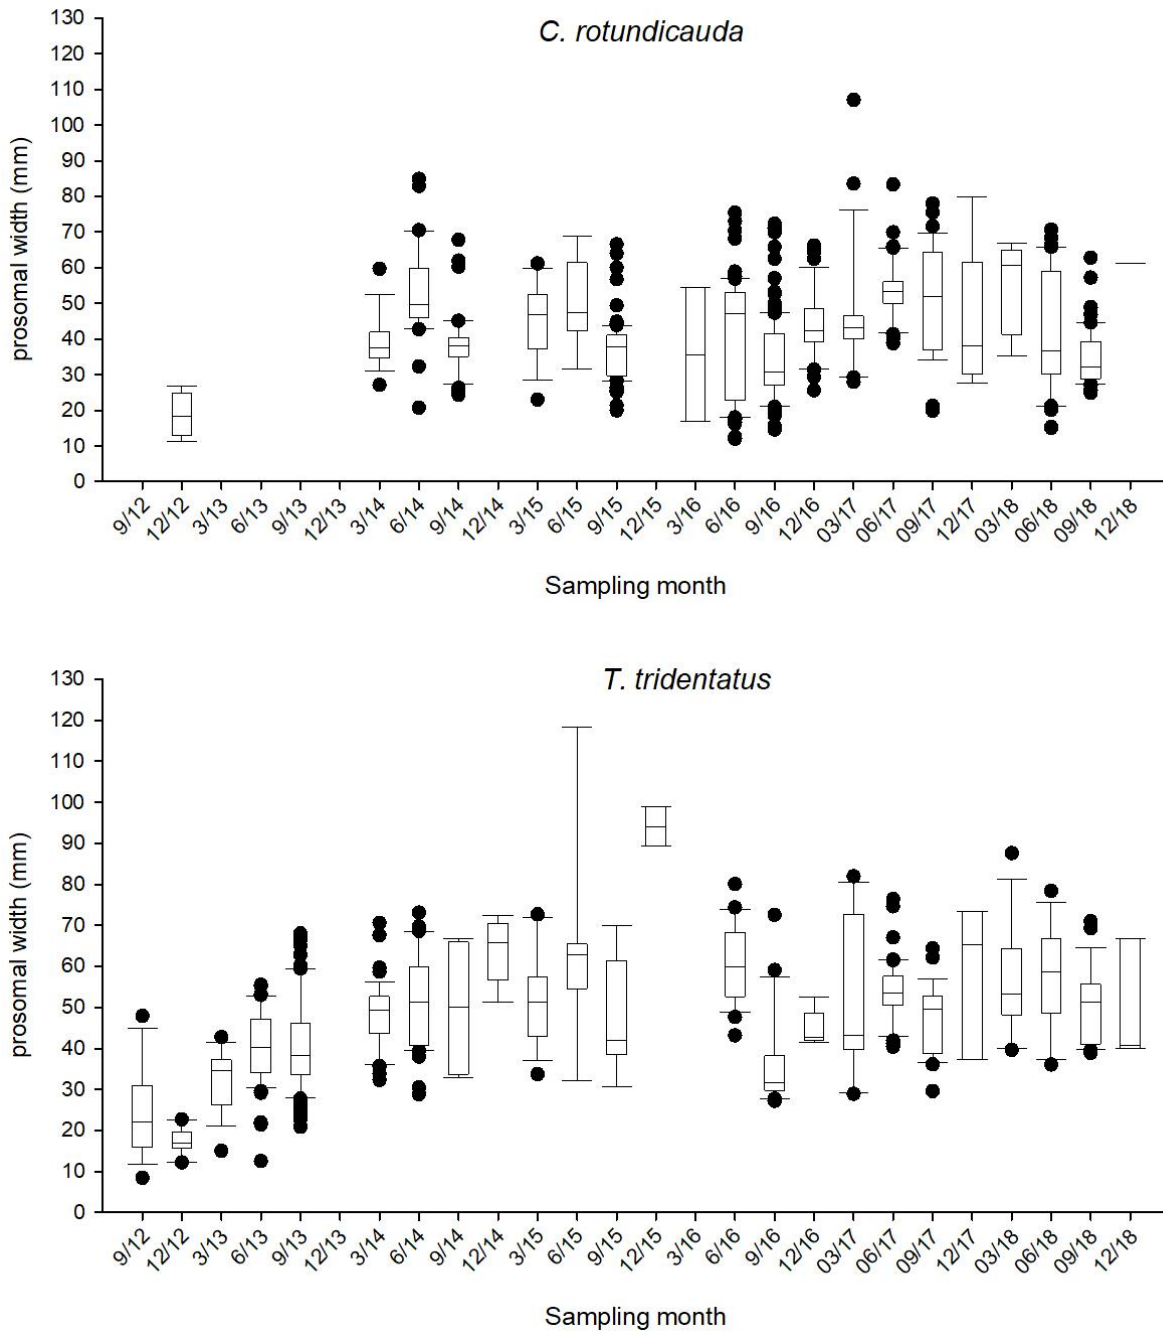
Figure 3.8. Box plot of prosomal width of horseshoe crab in the sampling zone ST along the sampling months. (The box represents 50% of the sample (upper to lower quartile) with a middle line showing the median value. The upper whisker and lower whisker showed the 25% of sample above upper quartile and below the lower quartile respectively.)

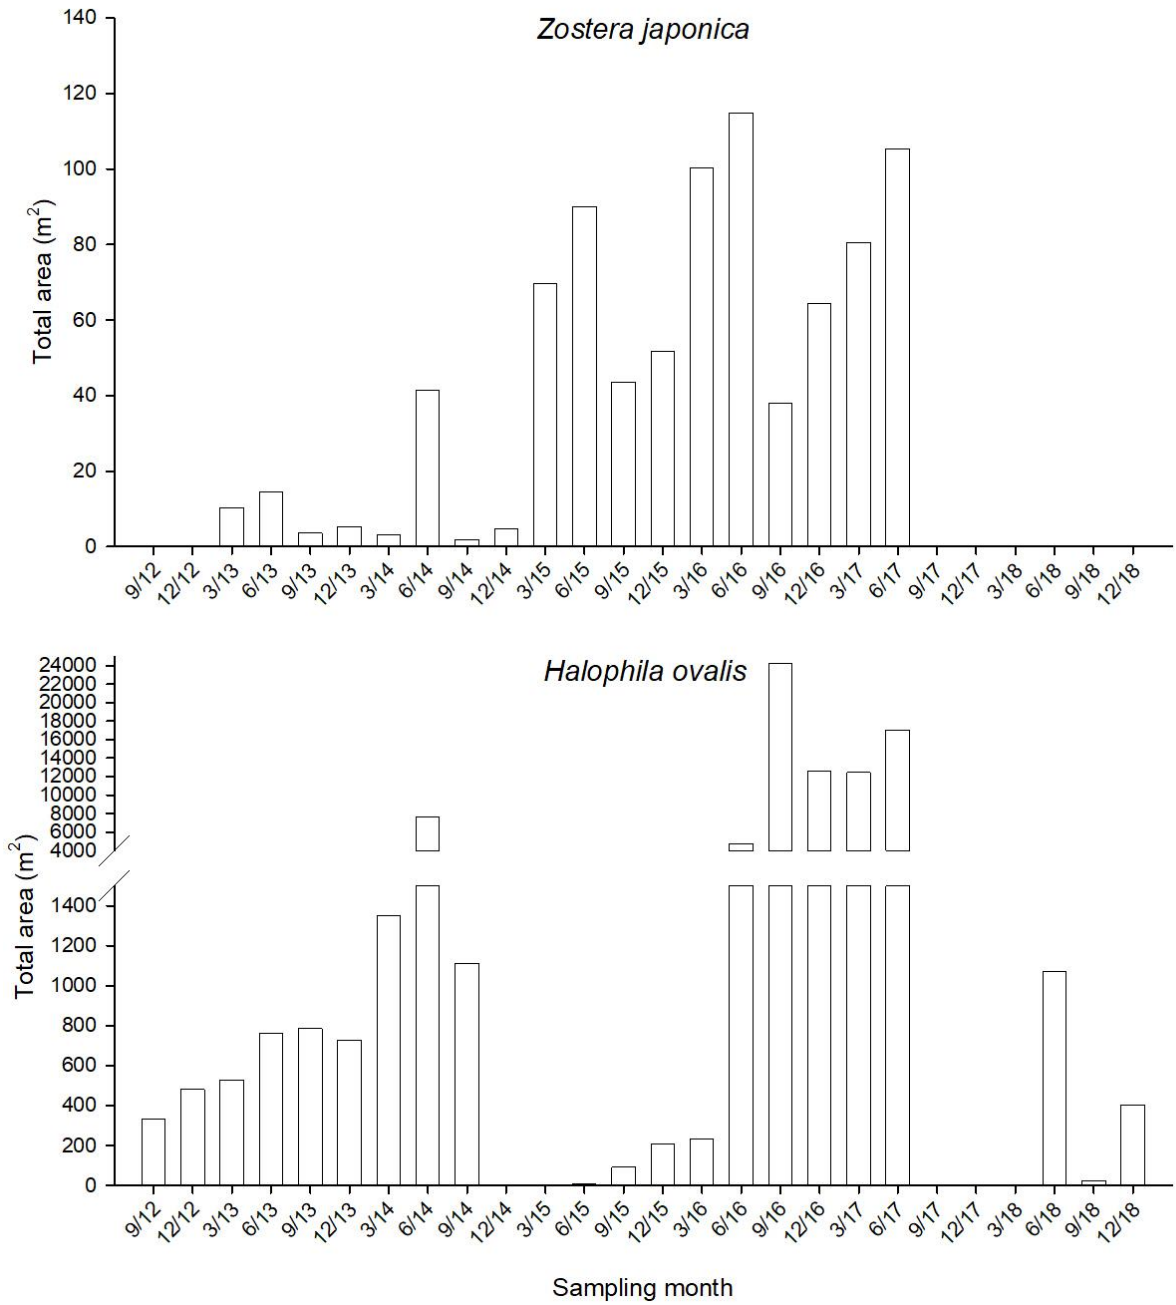
Figure 3.11. Temporal changes of estimated total area of seagrass beds in ST

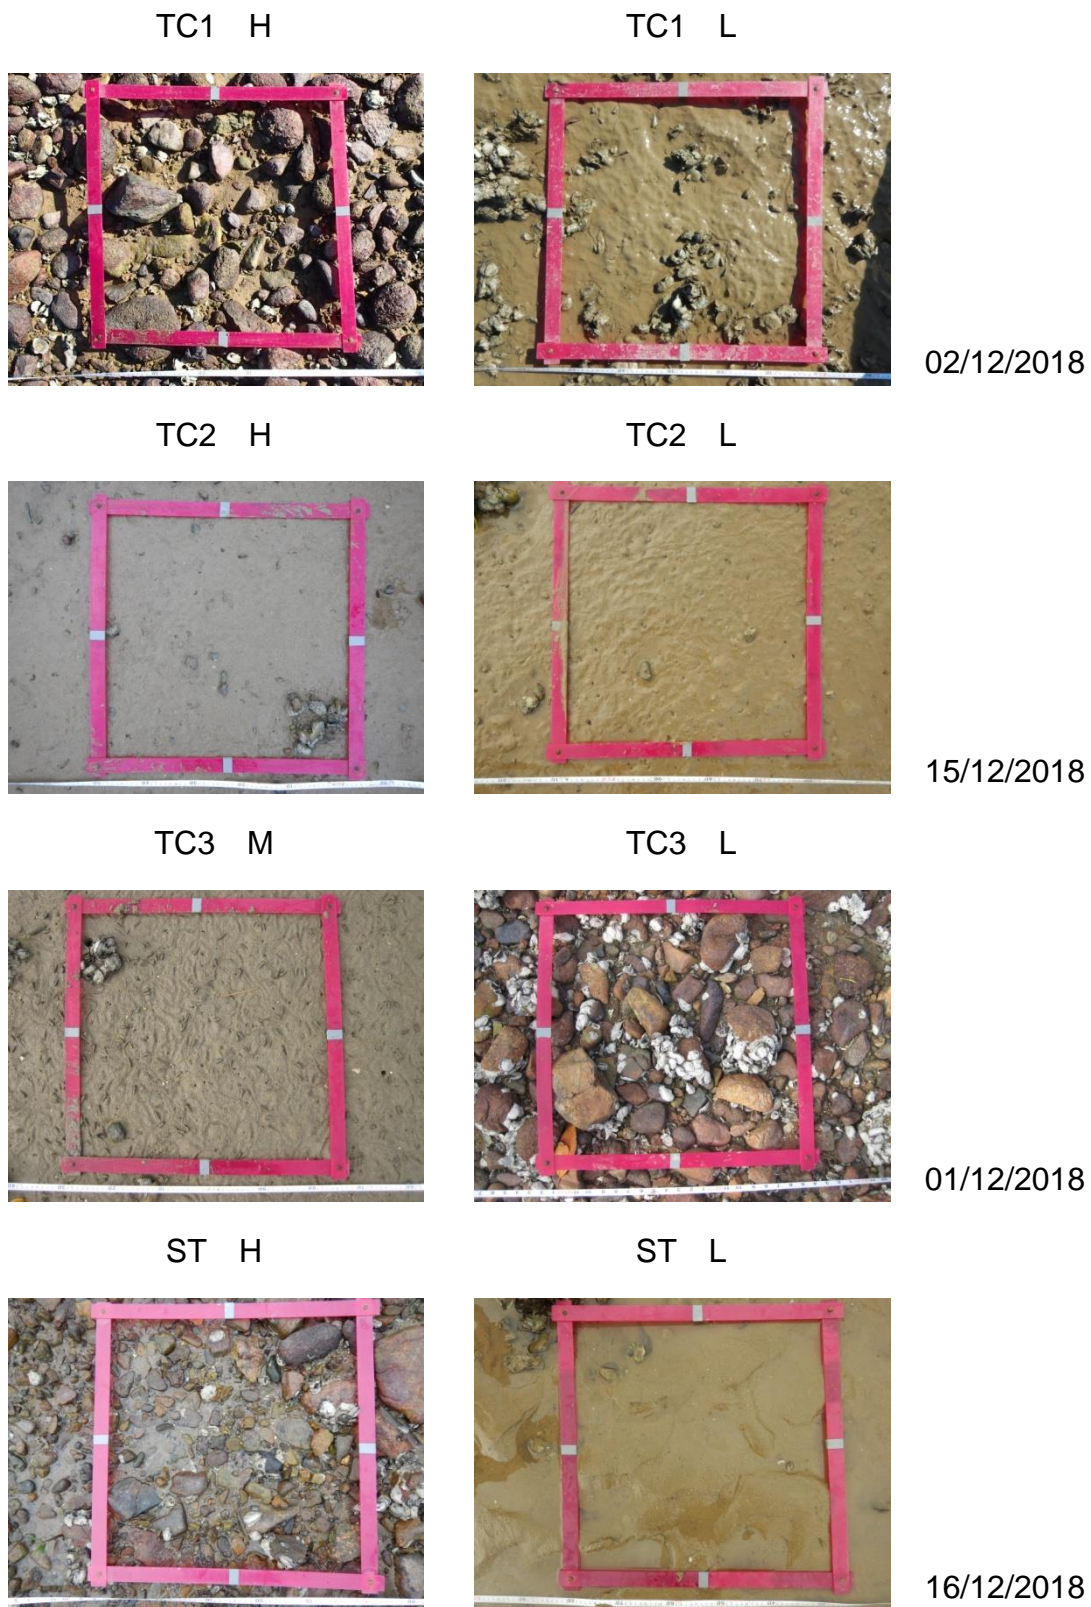
Figure 3.13. *Examples of photographic records of quadrat for intertidal soft shore community survey (H: 2.0 m above C.D.; M: 1.5 m above C.D.; L: 1.0 m above C.D.)*

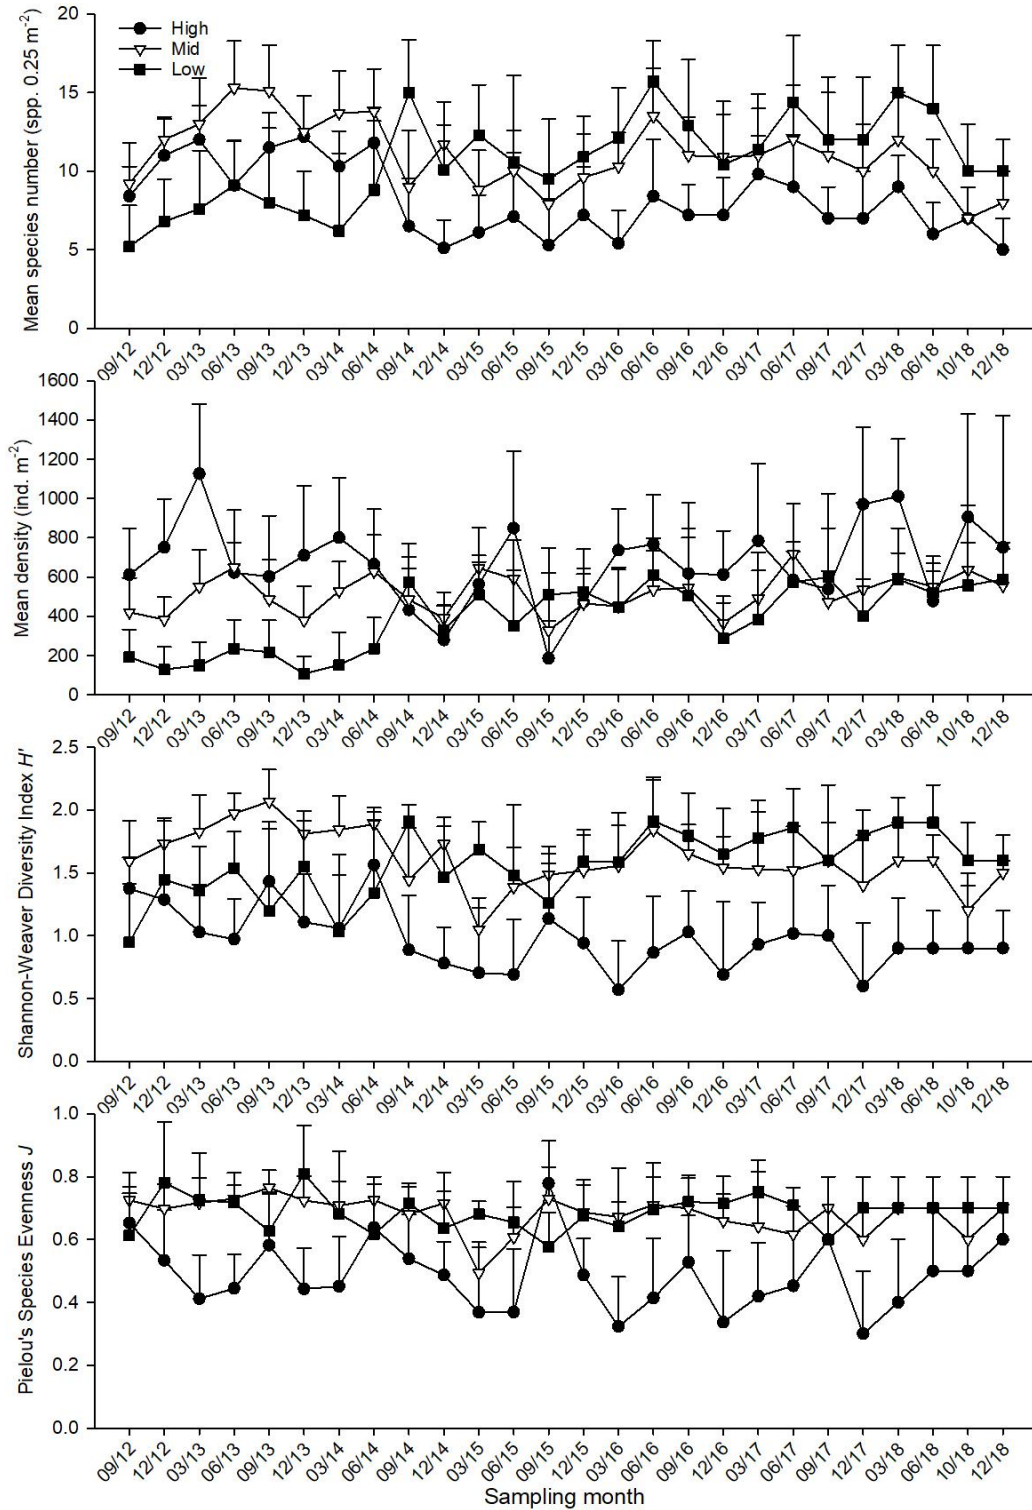
Figure 3.14. Temporal changes of mean number of species, mean density, Shannon-Weaver Diversity Index (H') and Pielou's Species Evenness (J) (mean + SD) at every tidal level in sampling zone TC1

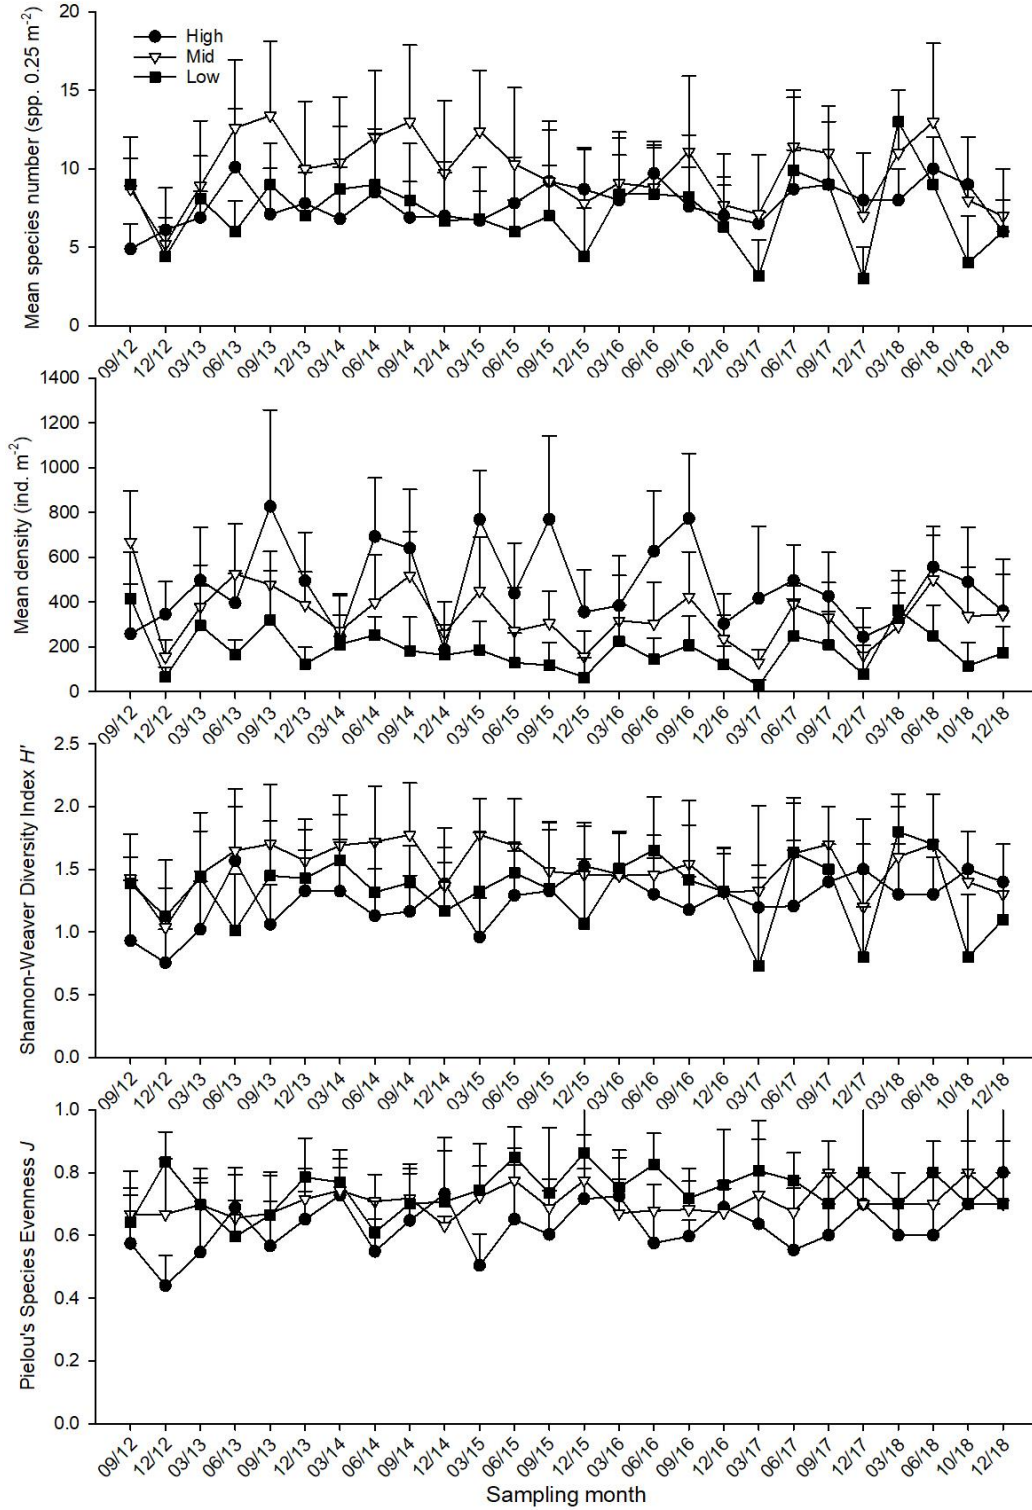
Figure 3.15. Temporal changes of mean number of species, mean density, Shannon-Weaver Diversity Index (H') and Pielou's Species Evenness (J) (mean + SD) at every tidal level in sampling zone TC2

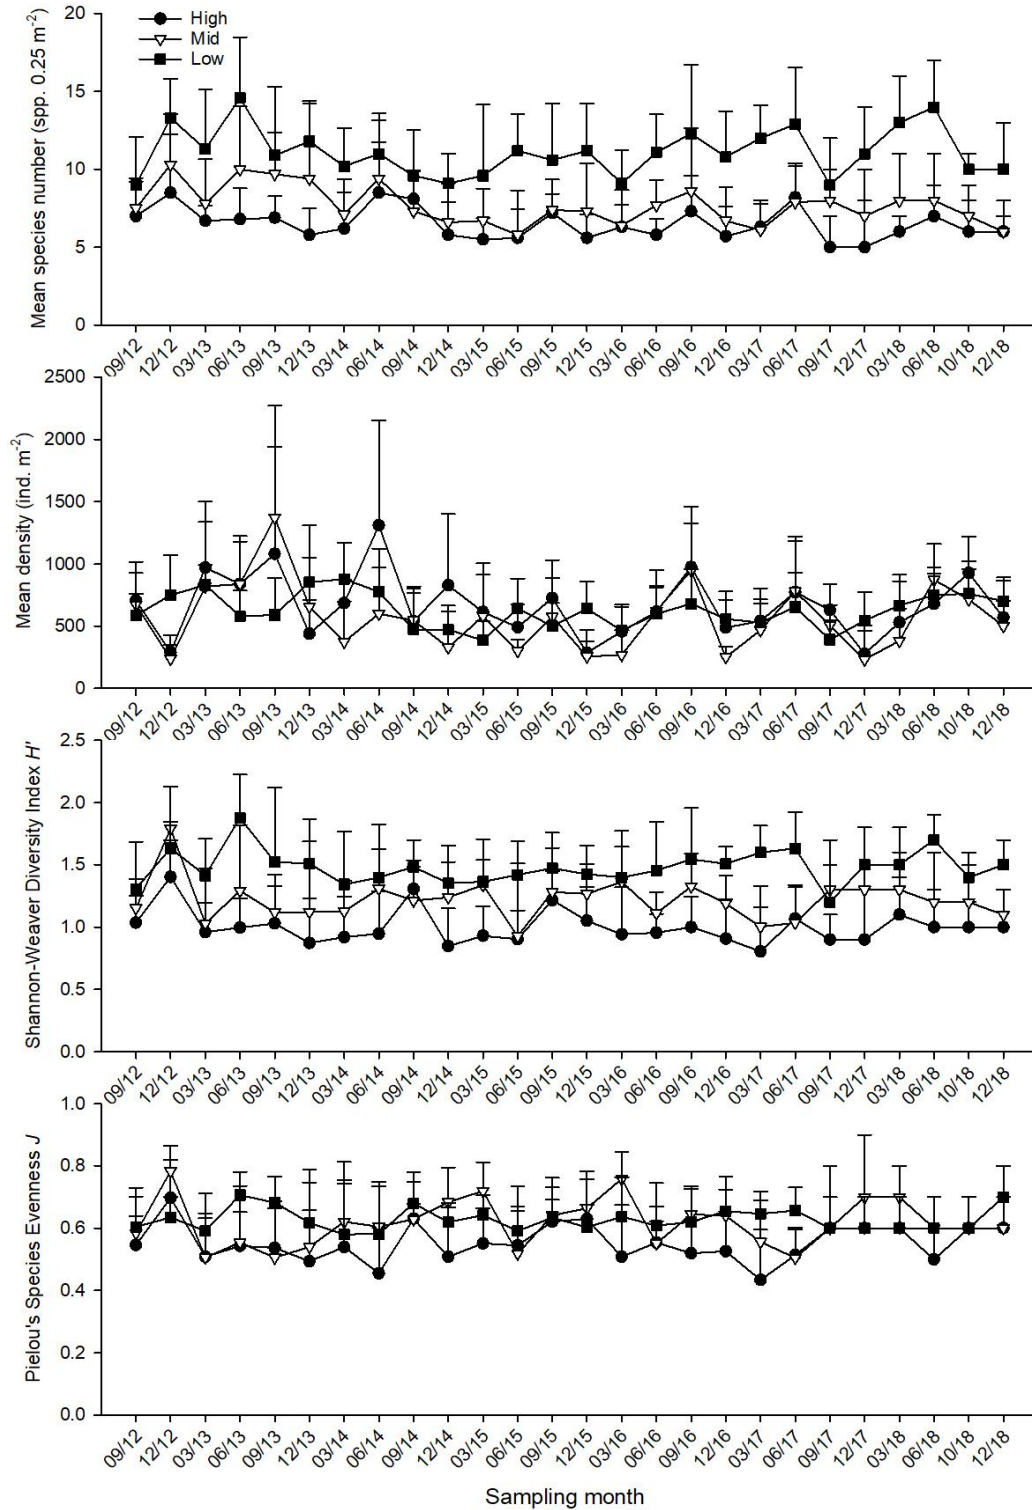
Figure 3.16. Temporal changes of mean number of species, mean density, Shannon-Weaver Diversity Index (H') and Pielou's Species Evenness (J) (mean + SD) at every tidal level in sampling zone TC3

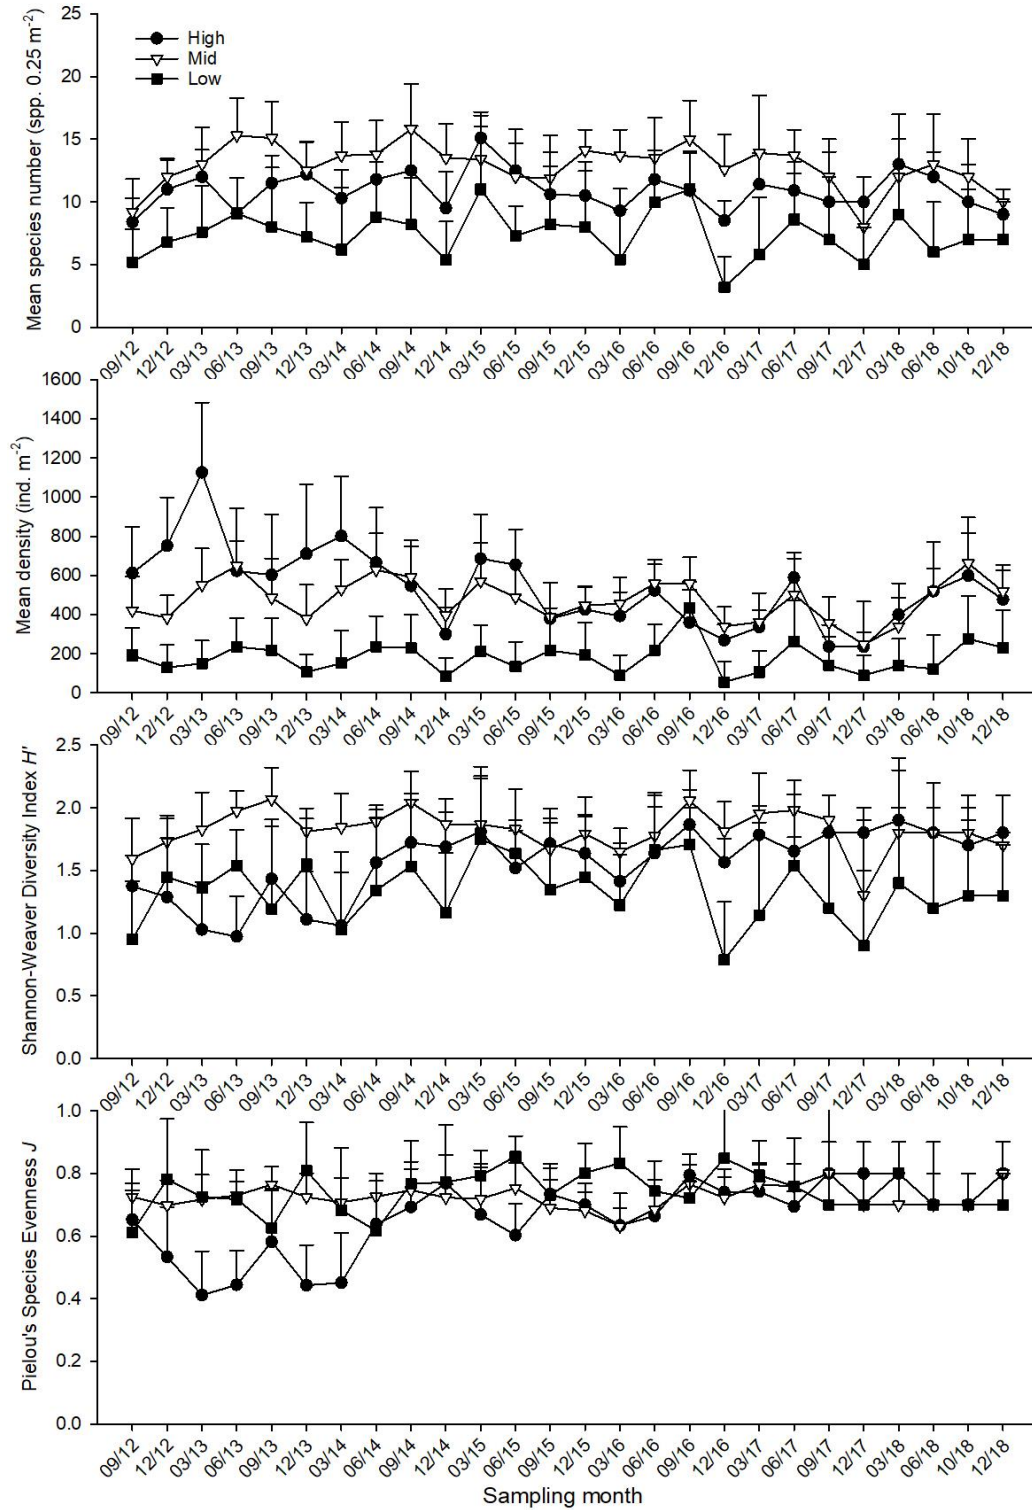
Figure 3.17. Temporal changes of mean number of species, mean density, Shannon-Weaver Diversity Index (H') and Pielou's Species Evenness (J) (mean + SD) at every tidal level in sampling zone ST
