Contract No. HY/2011/03

**Hong Kong-Zhuhai-Macao Bridge Hong Kong Link Road
Section between Scenic Hill and Hong Kong Boundary Crossing
Facilities**

Monthly EM&A Report No.137 (February 2024)

14 March 2024

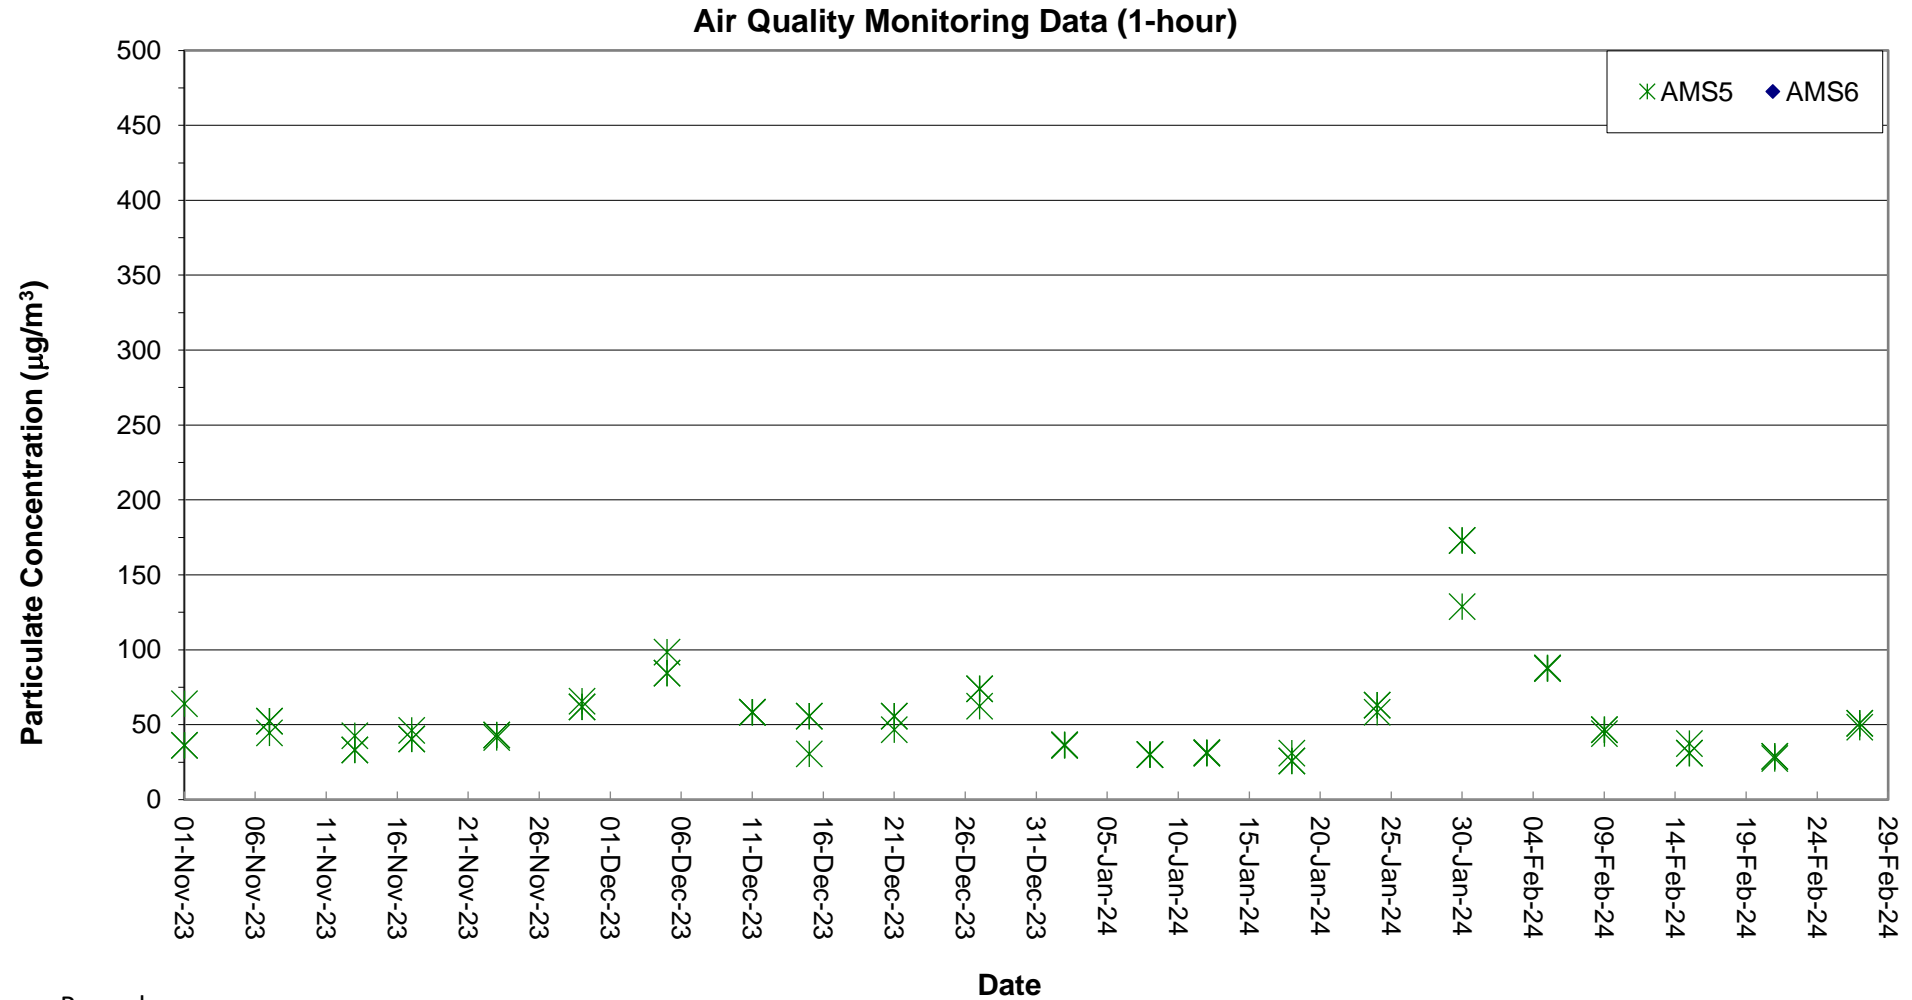
Graphical Plot of 1-hour TSP at AMS5 and AMS6

1) The existing air quality monitoring location AMS6 - Dragonair / CNAC (Group) Building (HKIA) was handed over to Airport Authority Hong Kong on 31 March 2021. 1-hr TSP monitoring at AMS6 was temporarily suspended starting from 1 April 2021.
