MTR Corporation Limited

Kwun Tong Line Extension (KTE)

Monthly EM&A Report (May 2015)

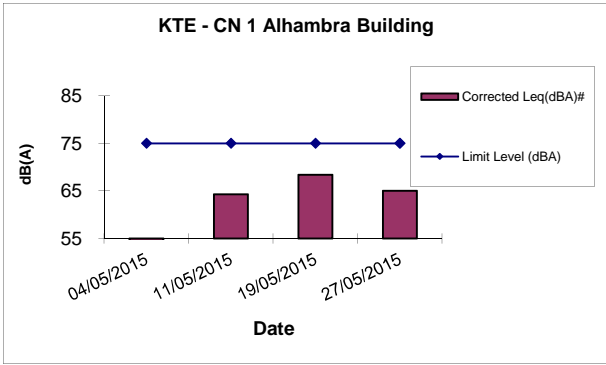
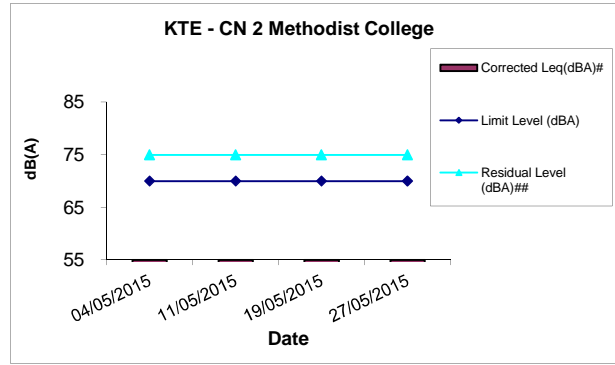
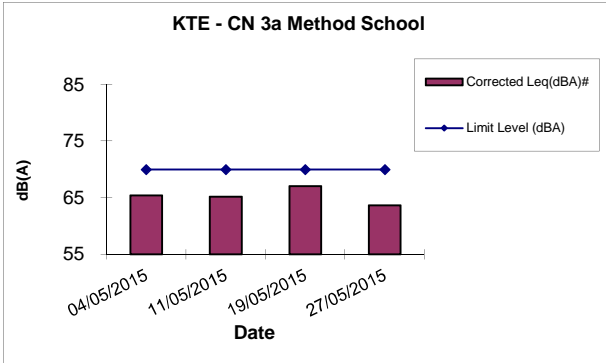
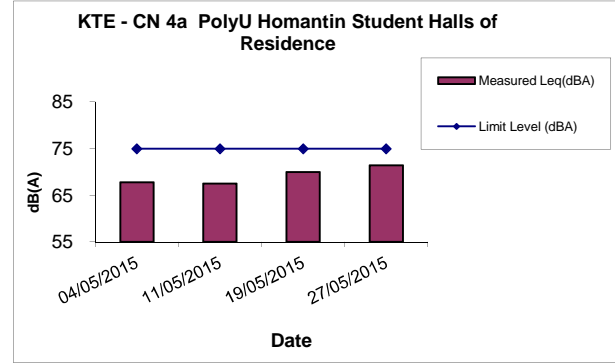
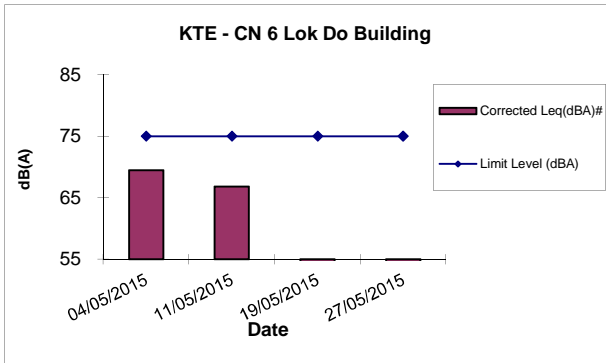
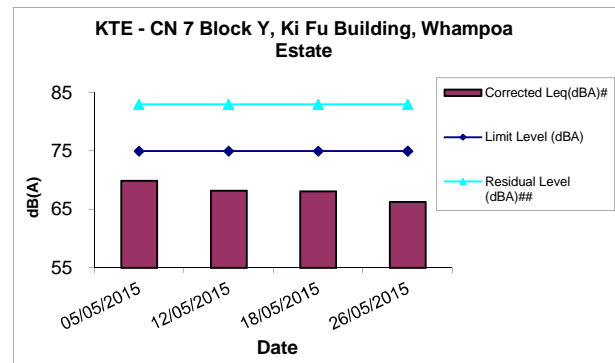
# Appendix F - Impact Noise Monitoring Results

# As some of the measured Leq is lower than the baseline level, correction against baseline level cannot be applied.
