MTR Corporation Limited

Kwun Tong Line Extension (KTE)

Monthly EM&A Report (November 2015)

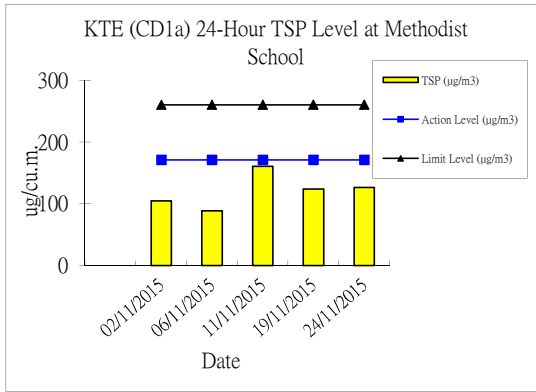
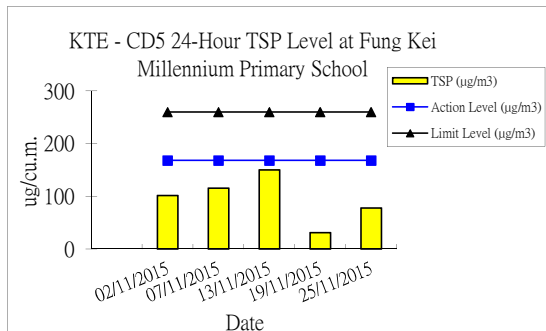
Appendix F - Air Quality Monitoring Results

CD1a Methodist School					
Date	TSP (µg/m ³)	Action Level (µg/m ³)	Limit Level (µg/m ³)	Compliance (Yes /No)	Weather Condition
02/11/2015	104.8	171.0	260.0	Yes	Sunny
06/11/2015	88.7	171.0	260.0	Yes	Sunny
11/11/2015	160.8	171.0	260.0	Yes	Cloudy
19/11/2015	123.9	171.0	260.0	Yes	Sunny
24/11/2015	126.7	171.0	260.0	Yes	Cloudy
CD2a PolyU Homantin Student Halls of Residence

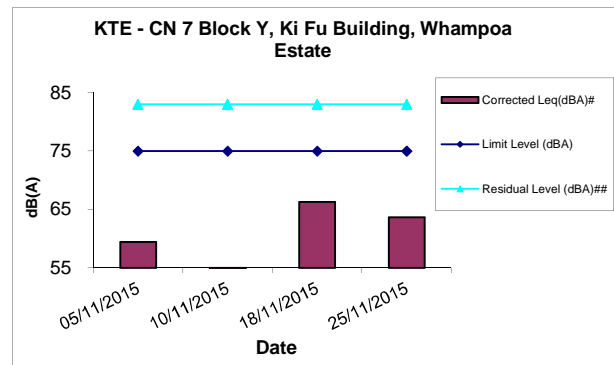
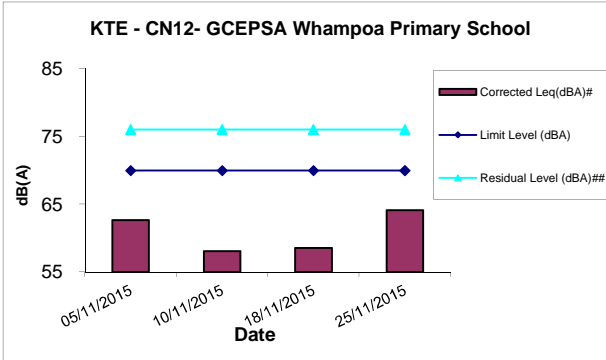
Appendix F - Impact Noise Monitoring Results

As some of the measured Leq is lower than the baseline level, correction against baseline level cannot be applied.
