Kwun Tong Line Extension (KTE)

Monthly EM&A Report (December 2015)

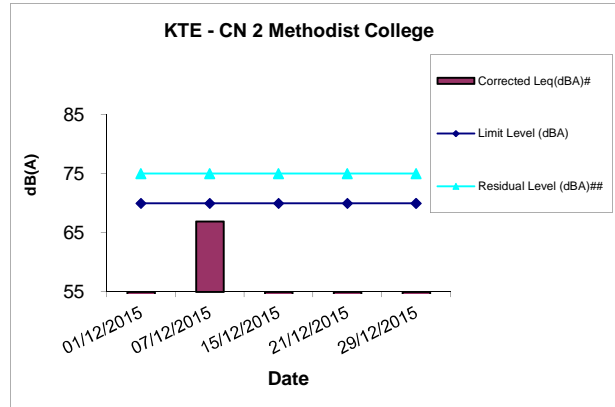
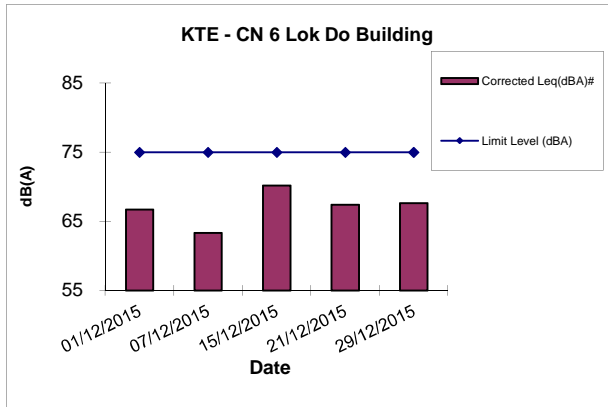
# Appendix F - Impact Noise Monitoring Results

# As some of the measured Leq is lower than the baseline level, correction against baseline level cannot be applied.
