## ENVIRONMENTAL MONITORING & AUDIT MONTHLY REPORT

**Contract Name** : Castle Peak Road Trunk Sewer and Tuen Mun Village Sewerage (Sewage Pumping Station at Lok Chui Street near Castle Peak Villas)

**Contract No.** : DC/2014/01

**Report No.** : 0367/15/ED/0383B

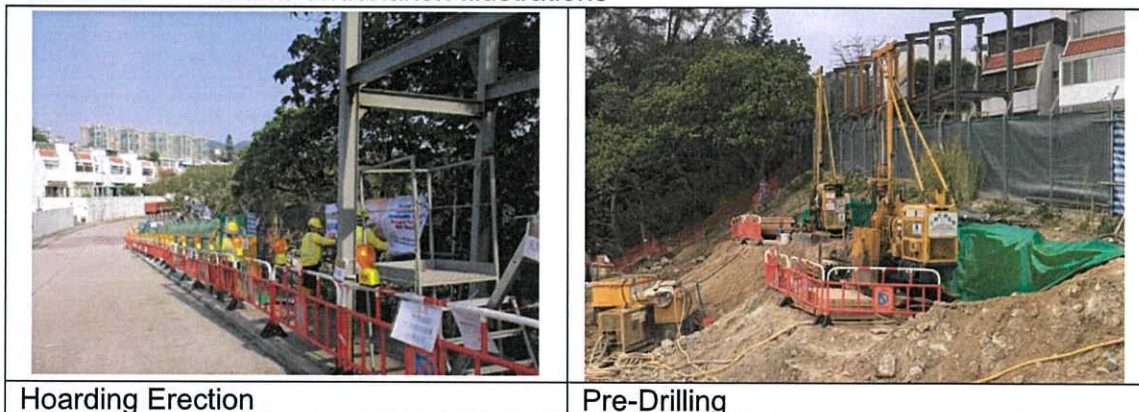
Table 1.2 Works undertaken Illustrations

- Hoarding Erection
- Pre-Drilling
- Earth Excavation
- Plant Mobilization

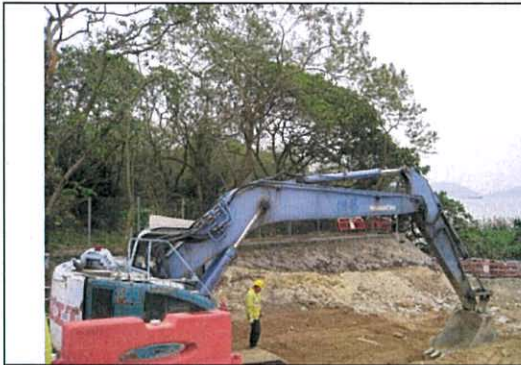
Earth Excavation

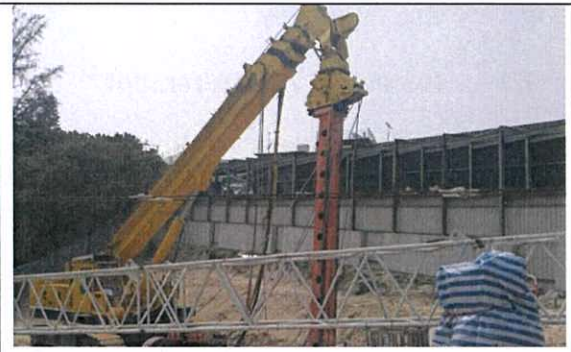
Plant Mobilization

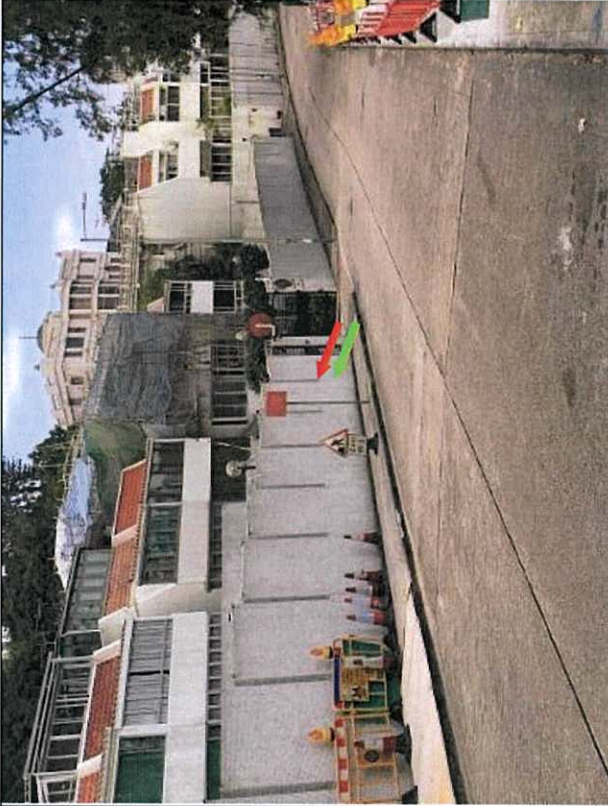
LC6a: The Castle Bay

1) LC6a: The air and noise monitoring station is set at a point 1m from the exterior of the sensitive receiver fence wall, and set at a position 1.2m above ground. Façade measurement will be carried out for noise monitoring.

- Monitoring Stations:
  - LC6a: The monitoring station was set at a point 1m from the exterior of the sensitive receiver fence wall and set at a position 1.2m above the ground. Façade measurement is carried out for noise monitoring.

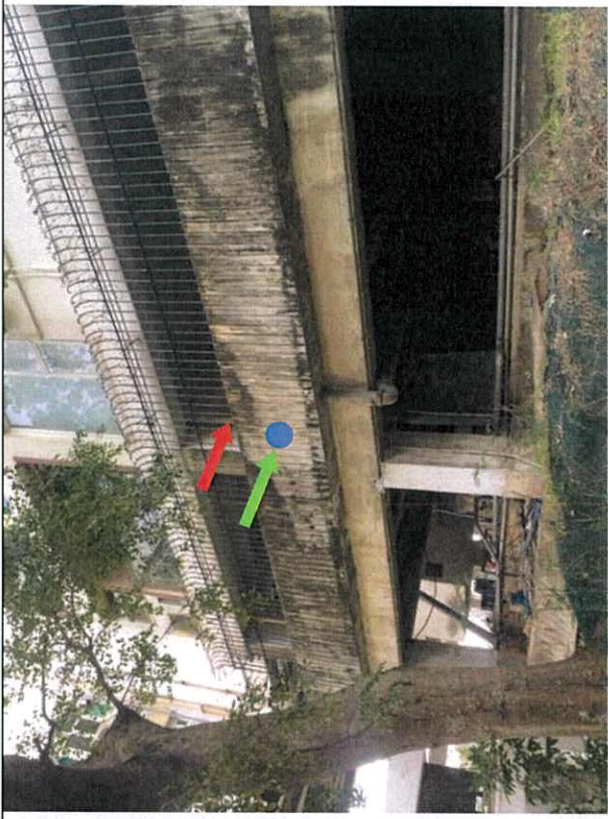
LC9: Castle Peak Villas Block C

2) LC9: The air monitoring station is set at the top of parapet wall of sensitive receivers building and the noise monitoring station is set at a point 1m from the exterior of the sensitive receivers building façade and set at a position 5m above the ground.

- LC9: The monitoring station was set at the top of parapet wall of sensitive receivers building and the noise monitoring station is set at a point 1m from the exterior of the sensitive receivers building façade and set at a position 5m above the ground.
