## ENVIRONMENTAL MONITORING & AUDIT MONTHLY REPORT

March 2016

**Contract Name** : Castle Peak Road Trunk Sewer and Tuen Mun Village Sewerage (Sewage Pumping Station at Lok Chui Street near Castle Peak Villas)

**Contract No.** : DC/2014/01

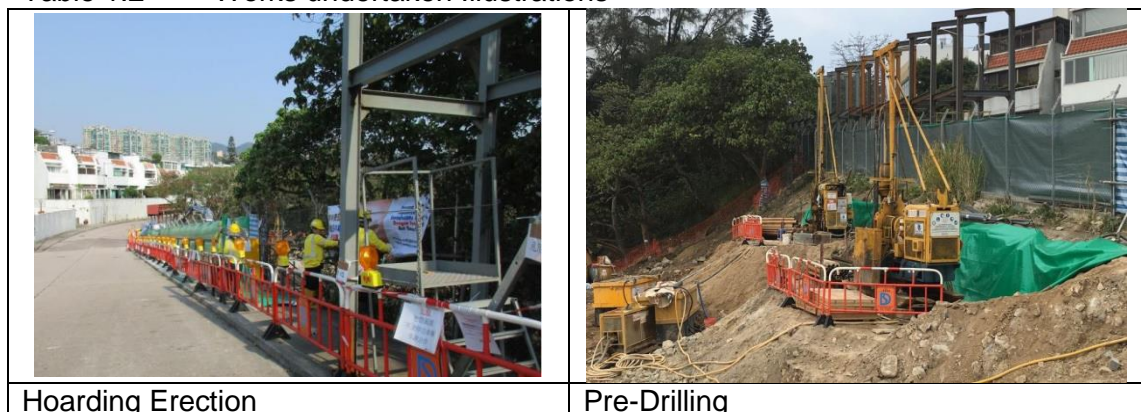
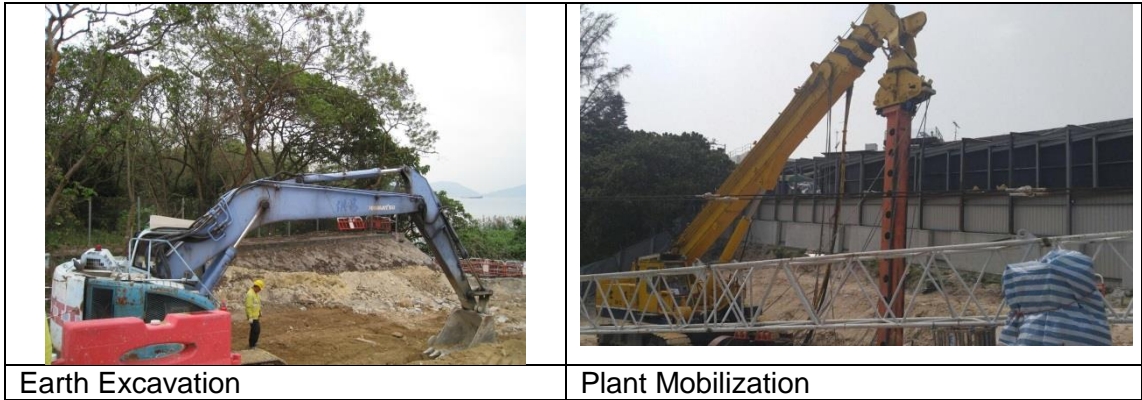
Table 1.2 Works undertaken Illustrations

1.4.2 Illustrations of works undertaken during the reporting period are shown in Table 1.2:
