ENVIRONMENTAL MONITORING & AUDIT MONTHLY REPORT

April 2016

Contract Name : Castle Peak Road Trunk Sewer and Tuen Mun Village Sewerage (Sewage Pumping Station at Lok Chui Street near Castle Peak Villas)

Report No. : 0367/15/ED/0418

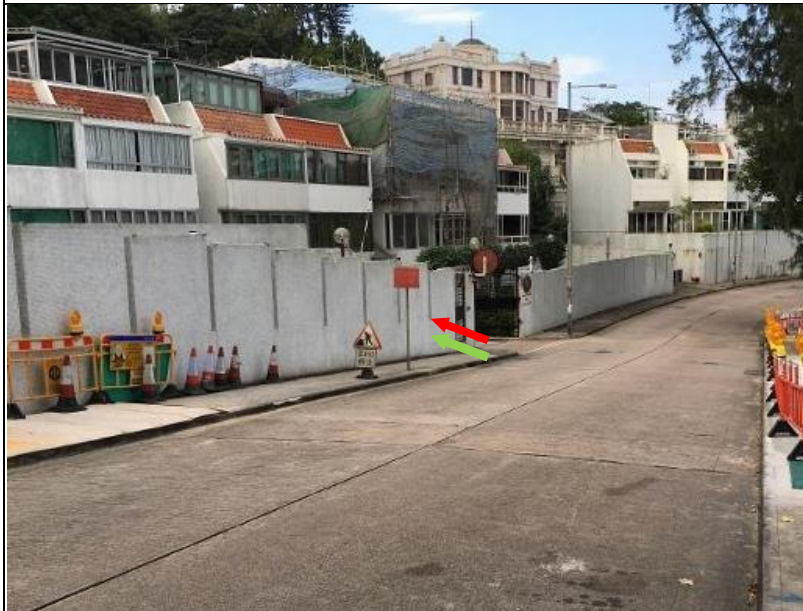
LC6a: The Castle Bay

1) LC6a: The air and noise monitoring station is set at a point 1m from the exterior of the sensitive receiver fence wall, and set at a position 1.2m above ground. Façade measurement will be carried out for noise monitoring.

- Monitoring Stations:
 - LC6a: The monitoring station was set at a point 1m from the exterior of the sensitive receiver fence wall and set at a position 1.2m above the ground. Façade measurement is carried out for noise monitoring.
