## ENVIRONMENTAL MONITORING & AUDIT MONTHLY REPORT

May 2016

**Contract Name** : Castle Peak Road Trunk Sewer and Tuen Mun Village Sewerage (Sewage Pumping Station at Lok Chui Street near Castle Peak Villas)

**Contract No.** : DC/2014/01

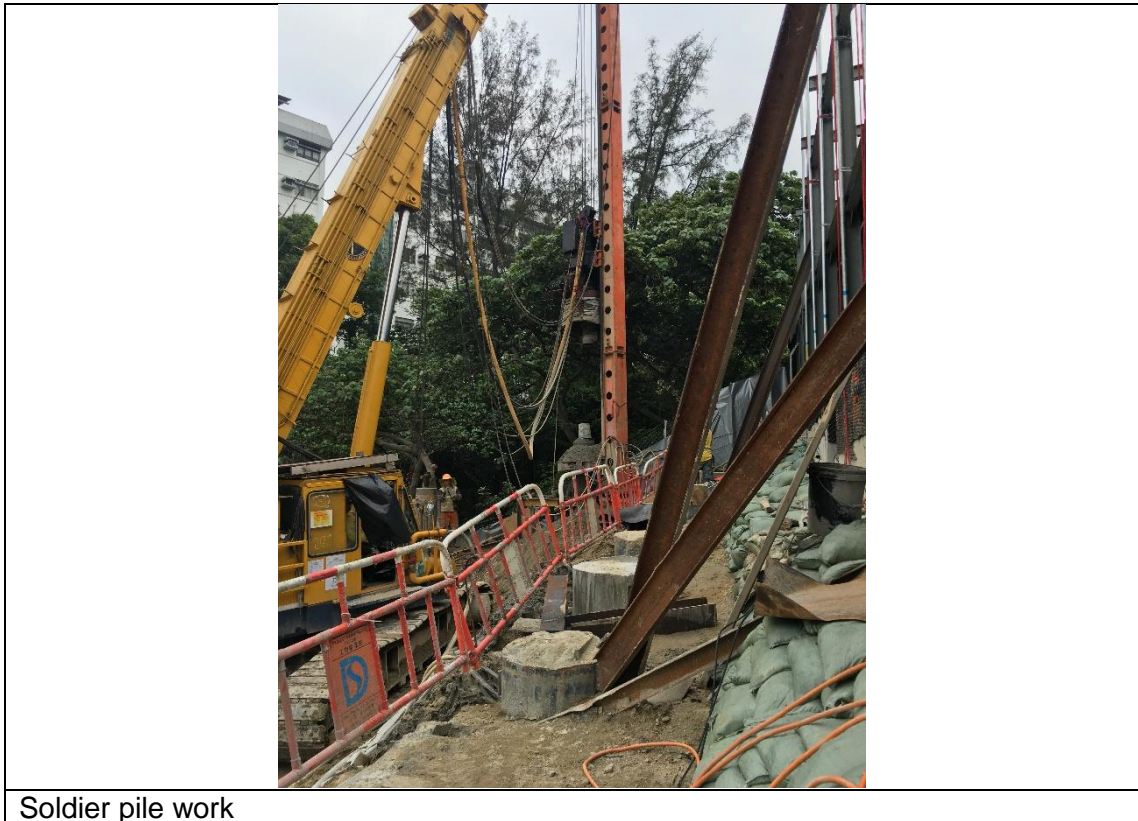
**Table 1.2 Works undertaken Illustrations**

Soldier pile work
