**ENVIRONMENTAL MONITORING & AUDIT
MONTHLY REPORT**

August 2016

Contract Name : Castle Peak Road Trunk Sewer and Tuen Mun Village Sewerage (Sewage Pumping Station at Lok Chui Street near Castle Peak Villas)

Contract No. : DC/2014/01

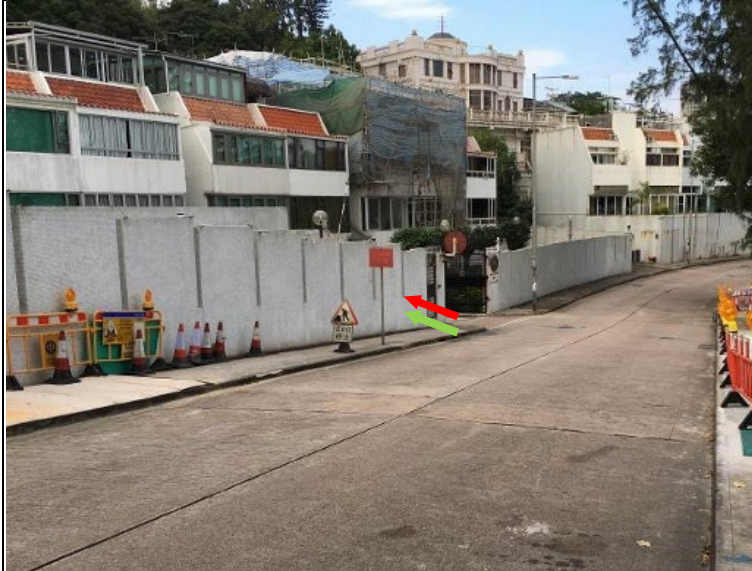
LC6a: The Castle Bay

1) LC6a: The air and noise monitoring station is set at a point 1m from the exterior of the sensitive receiver fence wall, and set at a position 1.2m above ground. Façade measurement will be carried out for noise monitoring.

- Monitoring Stations:
 - LC6a: The monitoring station was set at a point 1m from the exterior of the sensitive receiver fence wall and set at a position 1.2m above the ground. Façade measurement is carried out for noise monitoring.
