**ENVIRONMENTAL MONITORING & AUDIT
MONTHLY REPORT**

October 2016

Contract Name : Castle Peak Road Trunk Sewer and Tuen Mun Village Sewerage (Sewage Pumping Station at Lok Chui Street near Castle Peak Villas)

Contract No. : DC/2014/01

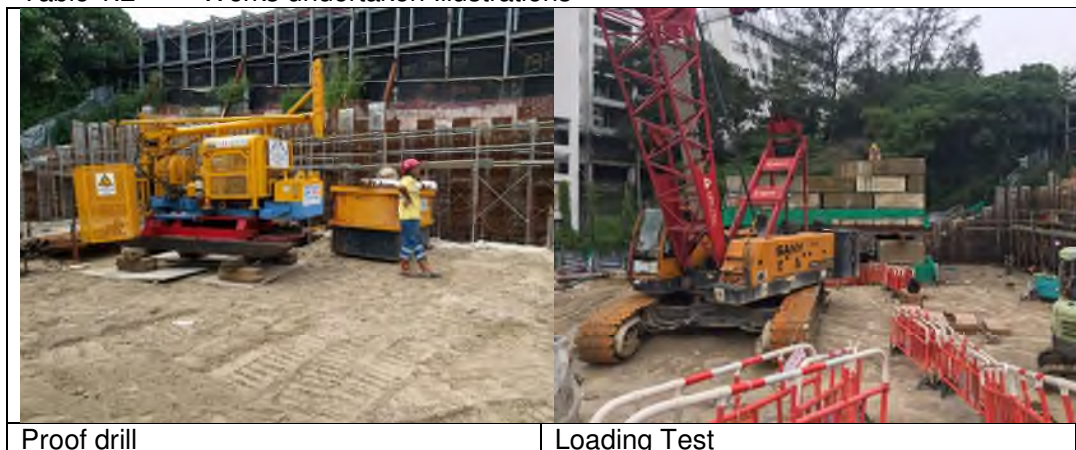
Table 1.2 Works undertaken Illustrations

Proof drill

Loading Test

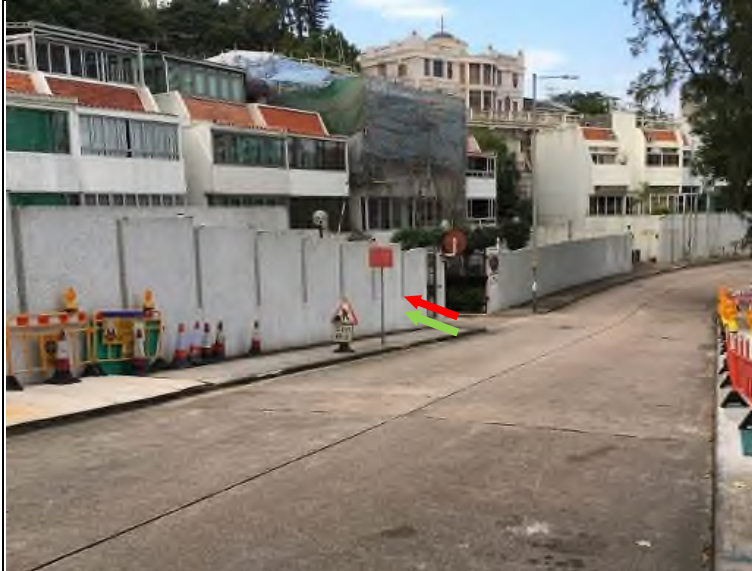
LC6a: The Castle Bay

1) LC6a: The air and noise monitoring station is set at a point 1m from the exterior of the sensitive receiver fence wall, and set at a position 1.2m above ground. Façade measurement will be carried out for noise monitoring.

- Monitoring Stations:
 - LC6a: The monitoring station was set at a point 1m from the exterior of the sensitive receiver fence wall and set at a position 1.2m above the ground. Façade measurement is carried out for noise monitoring.
