### ENVIRONMENTAL MONITORING & AUDIT MONTHLY REPORT

December 2016

**Contract Name** : Castle Peak Road Trunk Sewer and Tuen Mun Village Sewerage (Sewage Pumping Station at Lok Chui Street near Castle Peak Villas)

**Contract No.** : DC/2014/01

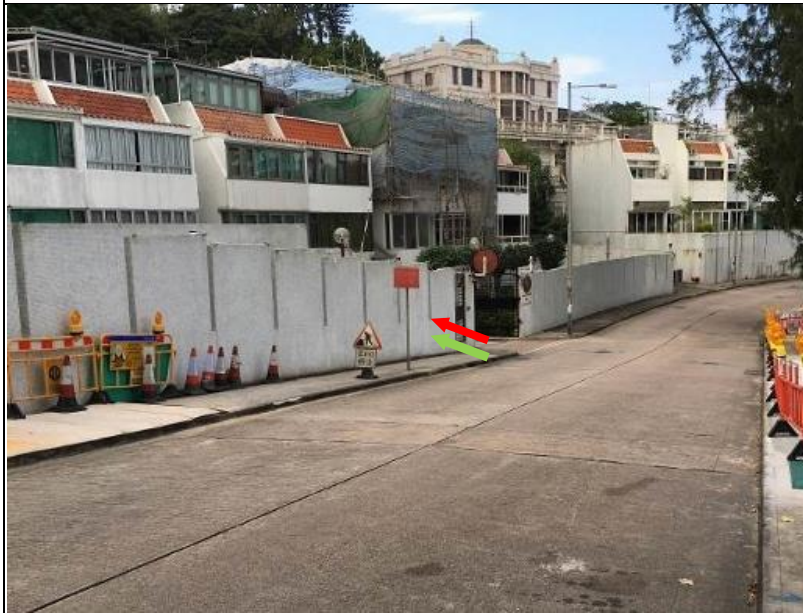
LC6a: The Castle Bay

1) LC6a: The air and noise monitoring station is set at a point 1m from the exterior of the sensitive receiver fence wall, and set at a position 1.2m above ground. Façade measurement will be carried out for noise monitoring.

- Monitoring Stations:
  - LC6a: The monitoring station was set at a point 1m from the exterior of the sensitive receiver fence wall and set at a position 1.2m above the ground. Façade measurement is carried out for noise monitoring.
