ENVIRONMENTAL MONITORING & AUDIT MONTHLY REPORT

January 2017

Contract Name : Castle Peak Road Trunk Sewer and Tuen Mun Village Sewerage (Sewage Pumping Station at Lok Chui Street near Castle Peak Villas)

Contract No. : DC/2014/01

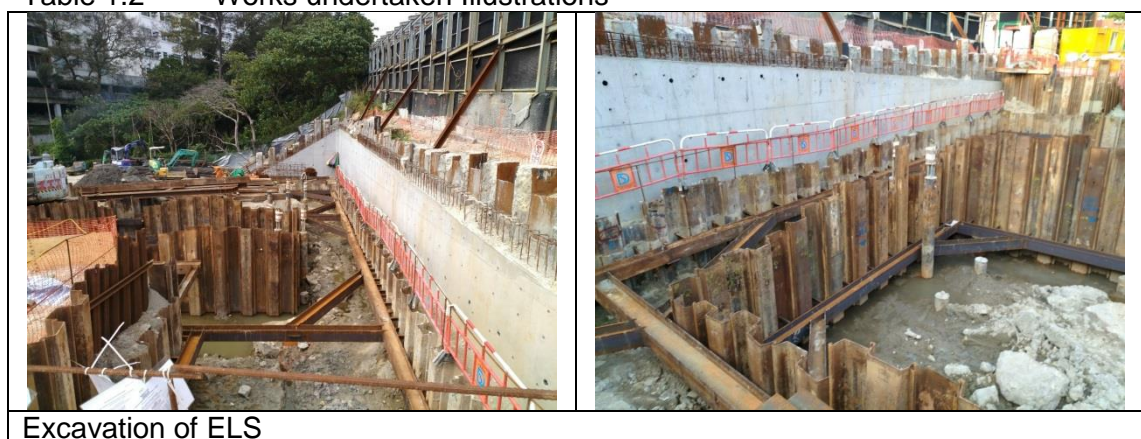
Table 1.2 Works undertaken Illustrations

- Excavation of ELS

1.4.2 Illustrations of works undertaken during the reporting period are shown in **Table 1.2**:
