ENVIRONMENTAL MONITORING & AUDIT MONTHLY REPORT

February 2017

Contract Name : Castle Peak Road Trunk Sewer and Tuen Mun Village Sewerage (Sewage Pumping Station at Lok Chui Street near Castle Peak Villas)

Report No. : 0367/15/ED/0723

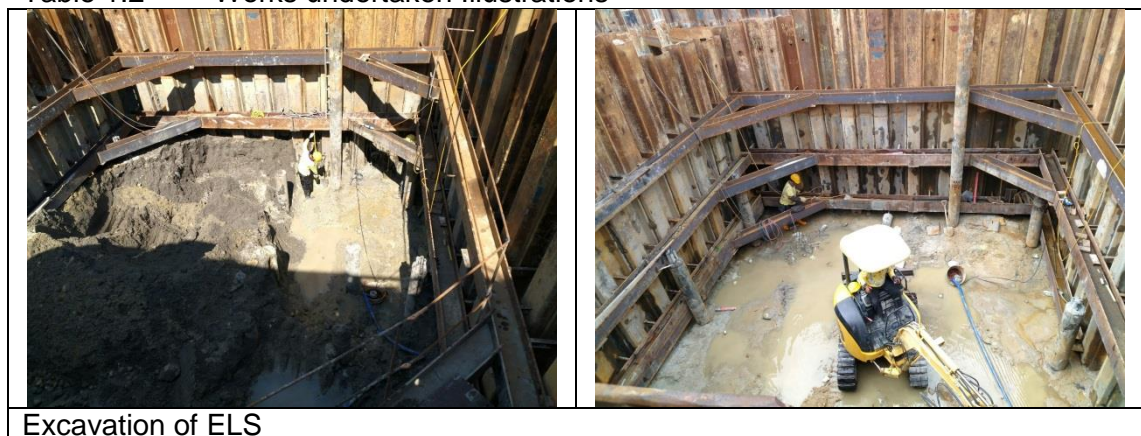
Table 1.2 Works undertaken Illustrations

- Excavation of ELS

1.4.2 Illustrations of works undertaken during the reporting period are shown in **Table 1.2**:

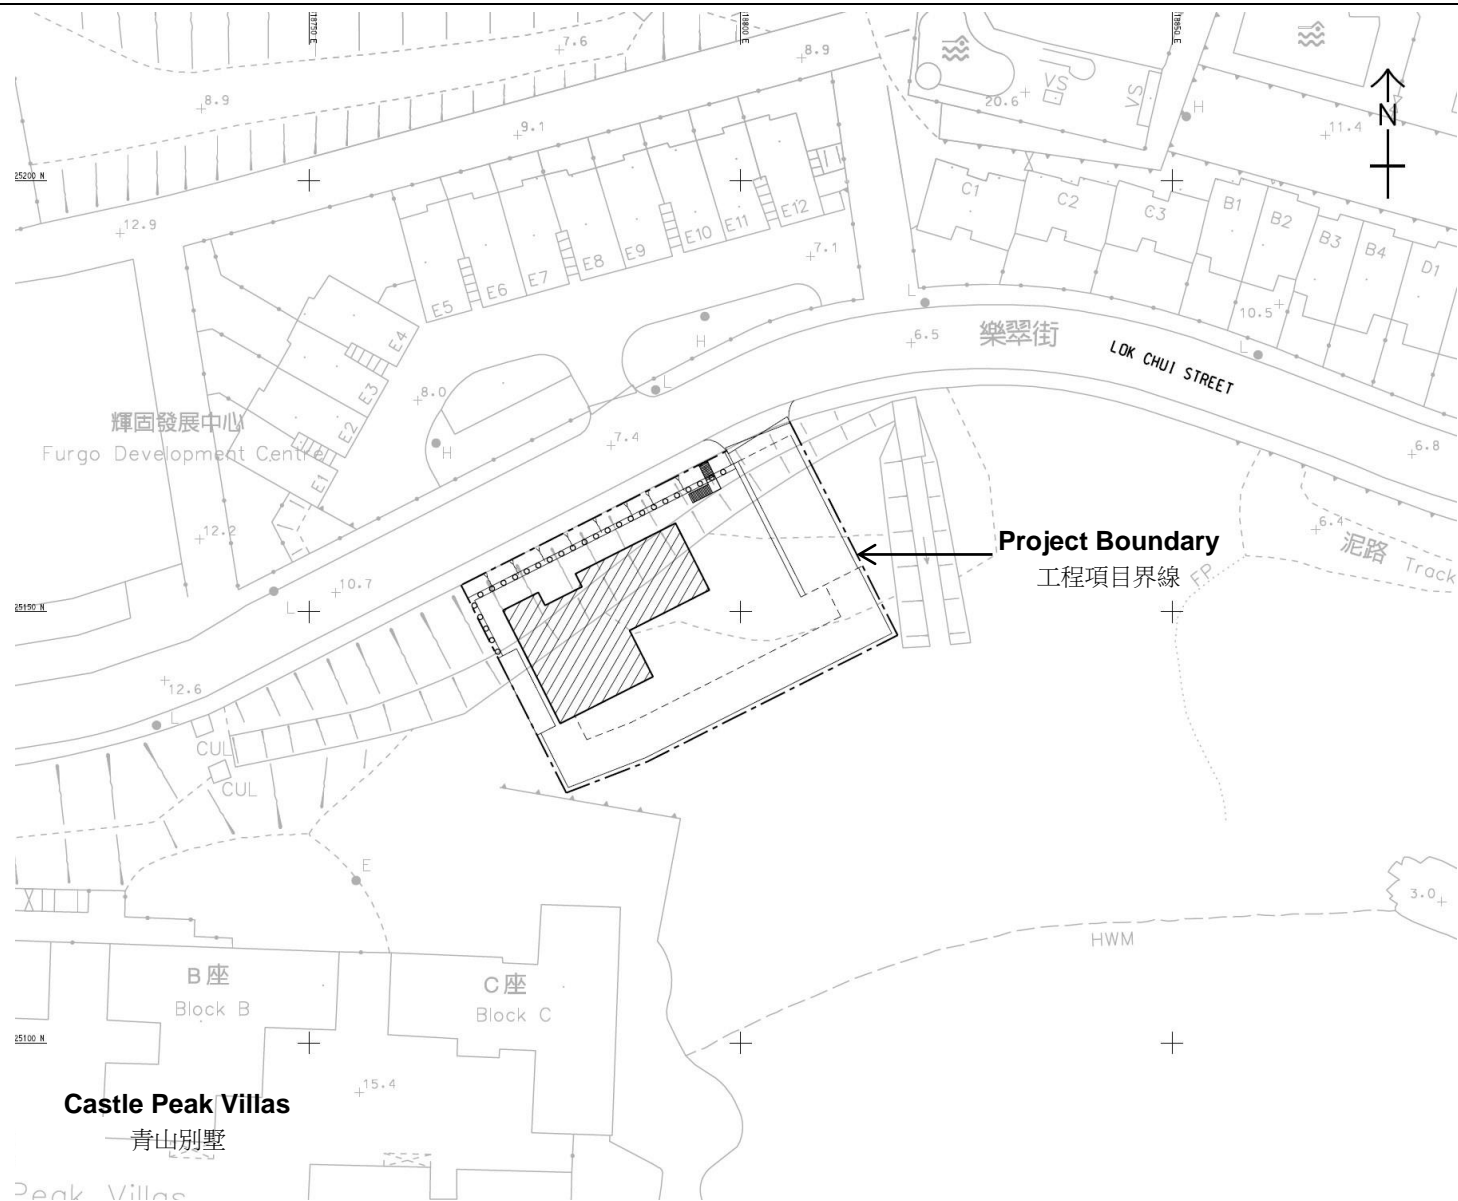
Figure 1

Project General Layout

Location of the Proposed Sewage Pumping Station at Lok Chui Street near Castle Peak Villas
 位於樂翠街近青山別墅的擬建污水泵水站

- 1.1.1 Contract No. DC/2014/01 – Castle Peak Road Trunk Sewer and Tuen Mun Village Sewerage (“the Project”) includes the construction of a sewage pumping station at Lok Chui Street near Castle Peak Villas as shown in **Figure 1**.

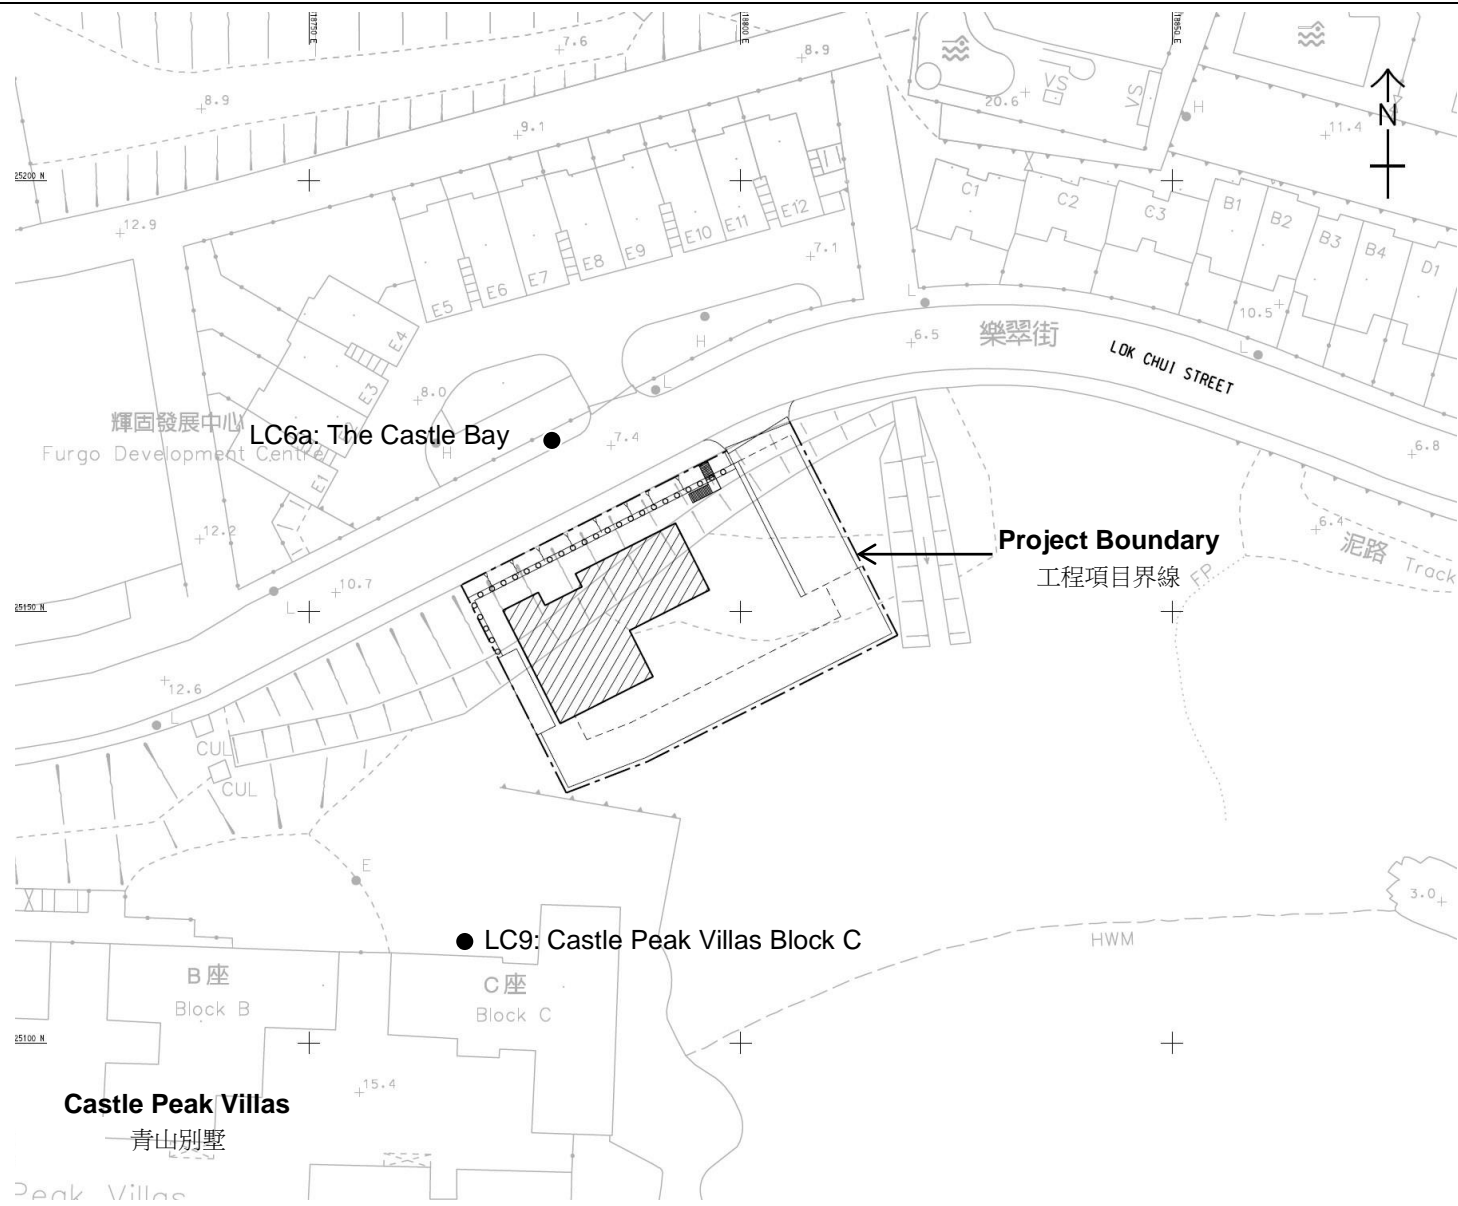
Figure 2

Air and Noise Monitoring Locations

2.4.1 In accordance with the updated EM&A Manual, two designated air quality monitoring stations, LC6a and LC9 are selected for the Project Area of constructing a sewage pumping station at Lok Chui Street near Castle Peak Villas as they are the representative air sensitive receivers located near to the Project site. All designated air quality monitoring stations listed in the updated EM&A Manual and the air quality monitoring stations are shown in **Table 2.3** and the monitoring locations are shown in **Figure 2**.

3.4.1 Noise monitoring were conducted at two designated monitoring stations as described in **Table 3.3** and the monitoring locations are shown in **Figure 2**.

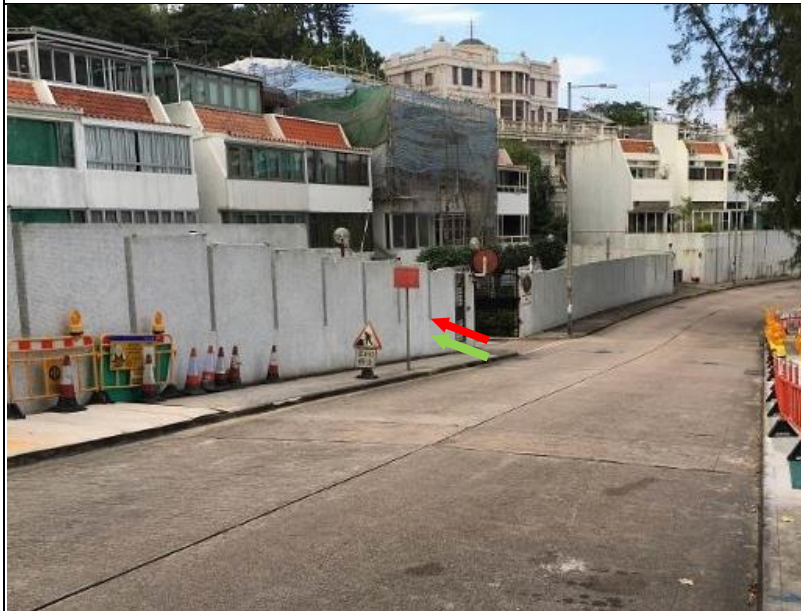
LC6a: The Castle Bay

1) LC6a: The air and noise monitoring station is set at a point 1m from the exterior of the sensitive receiver fence wall, and set at a position 1.2m above ground. Façade measurement will be carried out for noise monitoring.

- Monitoring Stations:
 - LC6a: The monitoring station was set at a point 1m from the exterior of the sensitive receiver fence wall and set at a position 1.2m above the ground. Façade measurement is carried out for noise monitoring.
