ENVIRONMENTAL MONITORING & AUDIT MONTHLY REPORT

March 2017

Contract Name : Castle Peak Road Trunk Sewer and Tuen Mun Village Sewerage (Sewage Pumping Station at Lok Chui Street near Castle Peak Villas)

Report No. : 0367/15/ED/0759A

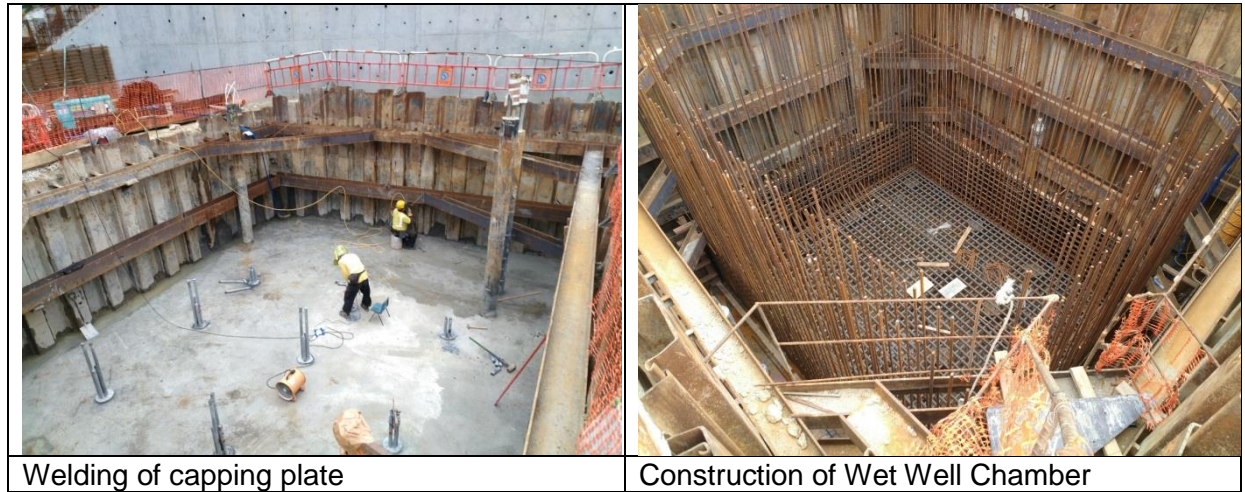
Table 1.2 Works undertaken Illustrations

- Welding of capping plate
- Construction of Wet Well Chamber

1.4.2 Illustrations of works undertaken during the reporting period are shown in **Table 1.2**:

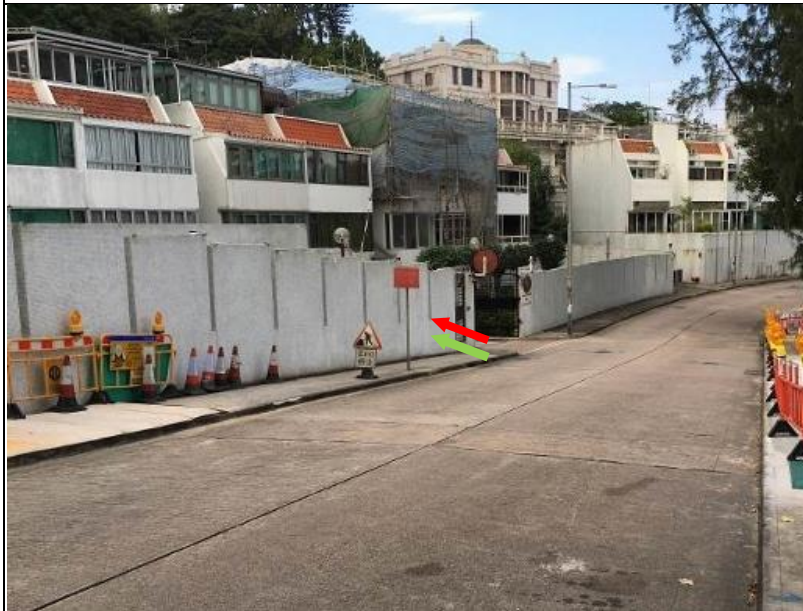
LC6a: The Castle Bay

1) LC6a: The air and noise monitoring station is set at a point 1m from the exterior of the sensitive receiver fence wall, and set at a position 1.2m above ground. Façade measurement will be carried out for noise monitoring.

- Monitoring Stations:
 - LC6a: The monitoring station was set at a point 1m from the exterior of the sensitive receiver fence wall and set at a position 1.2m above the ground. Façade measurement is carried out for noise monitoring.
