ENVIRONMENTAL MONITORING & AUDIT MONTHLY REPORT

April 2017

Contract Name : Castle Peak Road Trunk Sewer and Tuen Mun Village Sewerage (Sewage Pumping Station at Lok Chui Street near Castle Peak Villas)

Contract No. : DC/2014/01

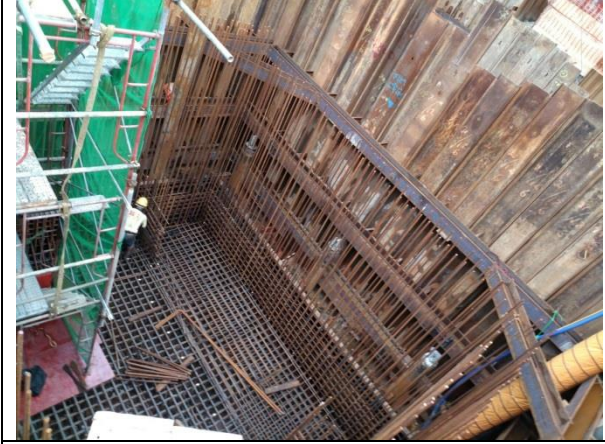
Table 1.2 Works undertaken Illustrations

Construction of Wet Well Chamber

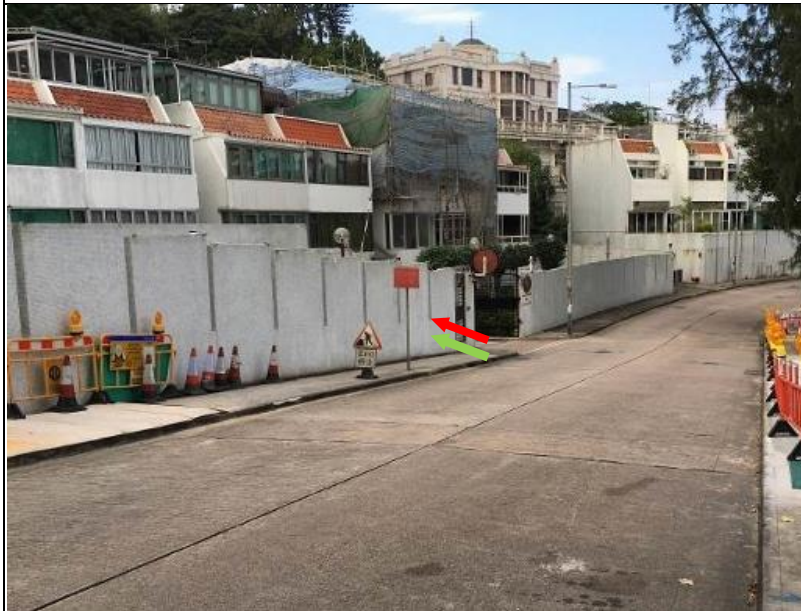
LC6a: The Castle Bay

- Monitoring Stations:
 - LC6a: The monitoring station was set at a point 1m from the exterior of the sensitive receiver fence wall and set at a position 1.2m above the ground. Façade measurement is carried out for noise monitoring.

1) LC6a: The air and noise monitoring station is set at a point 1m from the exterior of the sensitive receiver fence wall, and set at a position 1.2m above ground. Façade measurement will be carried out for noise monitoring.

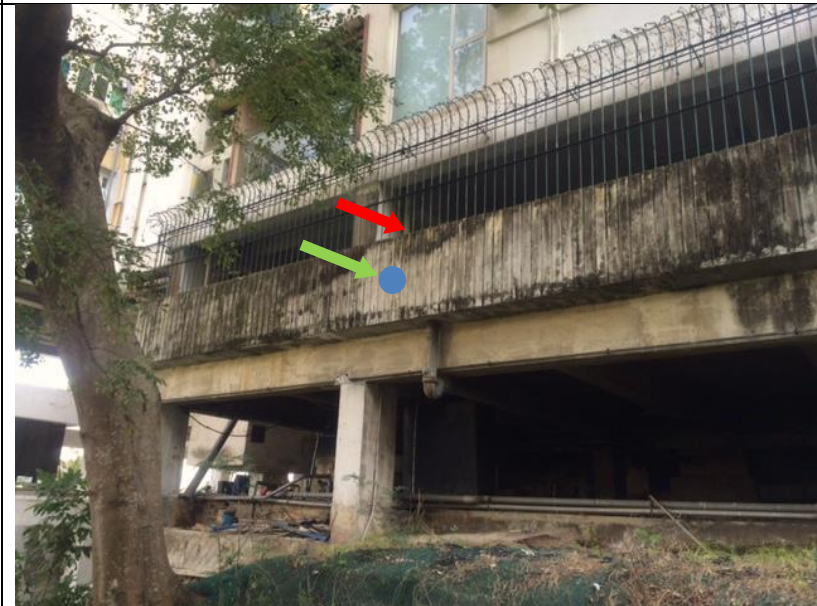
LC9: Castle Peak Villas Block C

- LC9: The monitoring station was set at the top of parapet wall of sensitive receivers building and the noise monitoring station is set at a point 1m from the exterior of the sensitive receivers building façade and set at a position 5m above the ground.
