ENVIRONMENTAL MONITORING & AUDIT MONTHLY REPORT

May 2017

Contract Name : Castle Peak Road Trunk Sewer and Tuen Mun Village Sewerage (Sewage Pumping Station at Lok Chui Street near Castle Peak Villas)

Contract No. : DC/2014/01

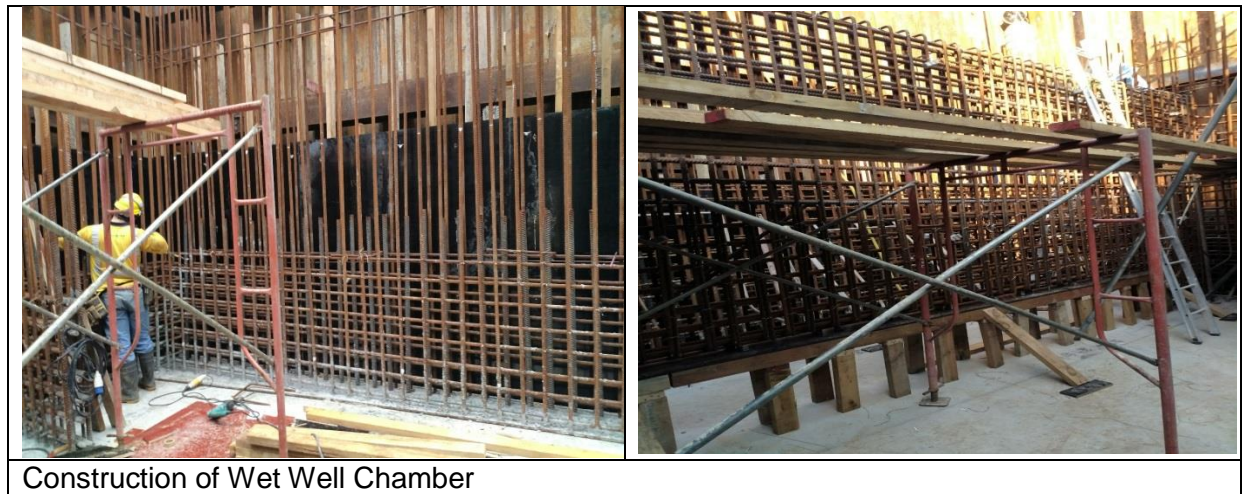
Table 1.2 Works undertaken Illustrations

Construction of Wet Well Chamber

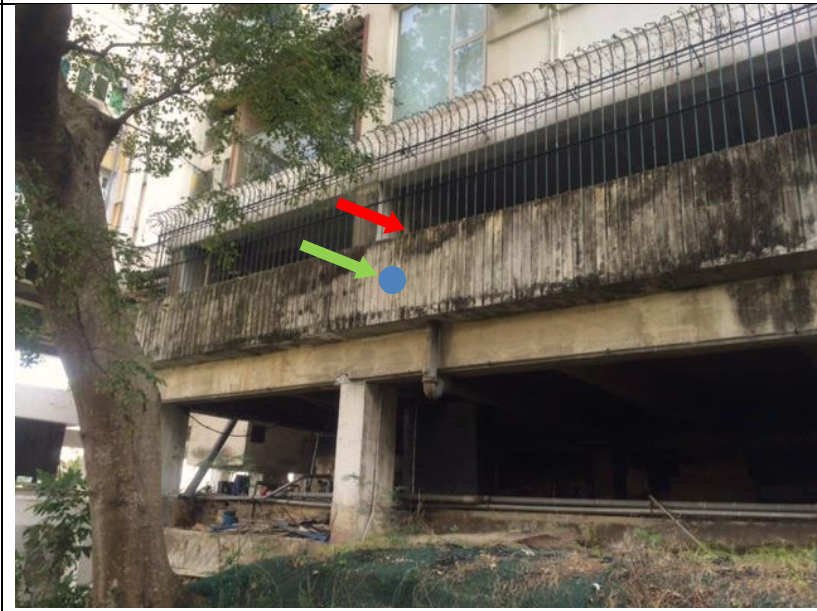
LC9: Castle Peak Villas Block C

- LC9: The monitoring station was set at the top of parapet wall of sensitive receivers building and the noise monitoring station is set at a point 1m from the exterior of the sensitive receivers building façade and set at a position 5m above the ground.
