ENVIRONMENTAL MONITORING & AUDIT MONTHLY REPORT

June 2017

Contract Name : Castle Peak Road Trunk Sewer and Tuen Mun Village Sewerage (Sewage Pumping Station at Lok Chui Street near Castle Peak Villas)

Contract No. : DC/2014/01

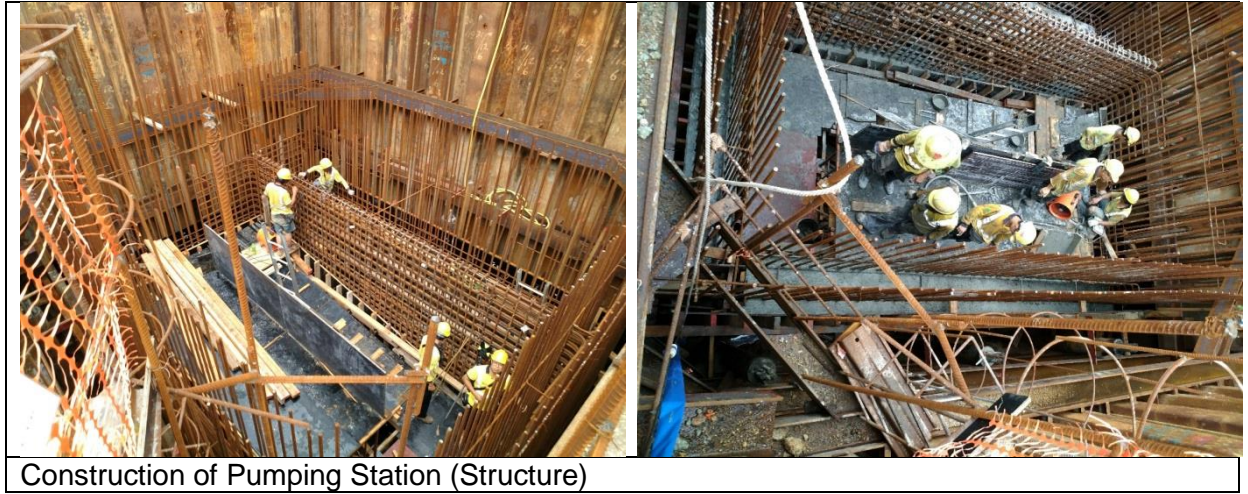
Table 1.2 Works undertaken Illustrations

1.4.2 Illustrations of works undertaken during the reporting period are shown in **Table 1.2**:

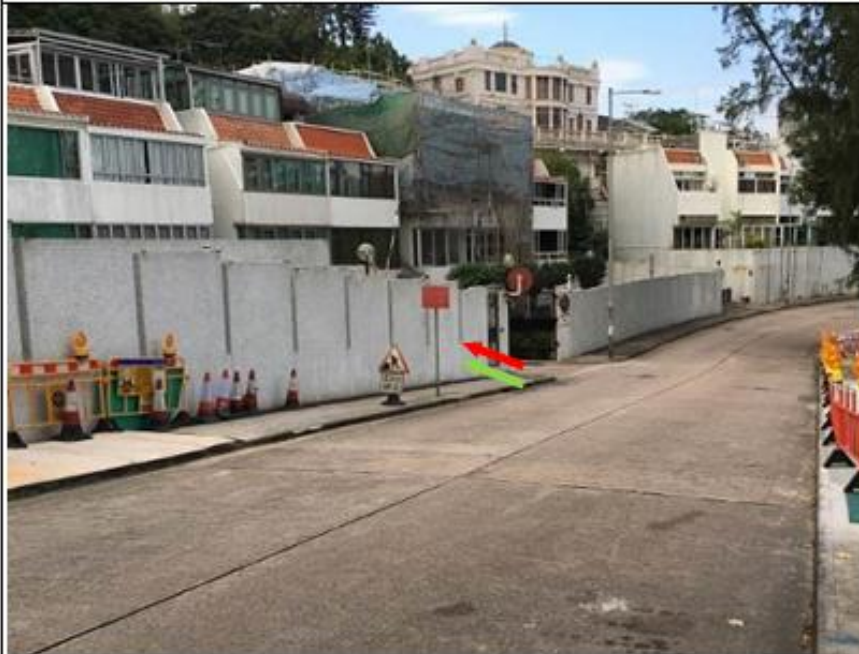
LC6a: The Castle Bay

1) LC6a: The air and noise monitoring station is set at a point 1m from the exterior of the sensitive receiver fence wall, and set at a position 1.2m above ground. Façade measurement will be carried out for noise monitoring.

- Monitoring Stations:
 - LC6a: The monitoring station was set at a point 1m from the exterior of the sensitive receiver fence wall and set at a position 1.2m above the ground. Façade measurement is carried out for noise monitoring.
