## ENVIRONMENTAL MONITORING & AUDIT MONTHLY REPORT

July 2017

**Contract Name** : Castle Peak Road Trunk Sewer and Tuen Mun Village Sewerage (Sewage Pumping Station at Lok Chui Street near Castle Peak Villas)

**Contract No.** : DC/2014/01

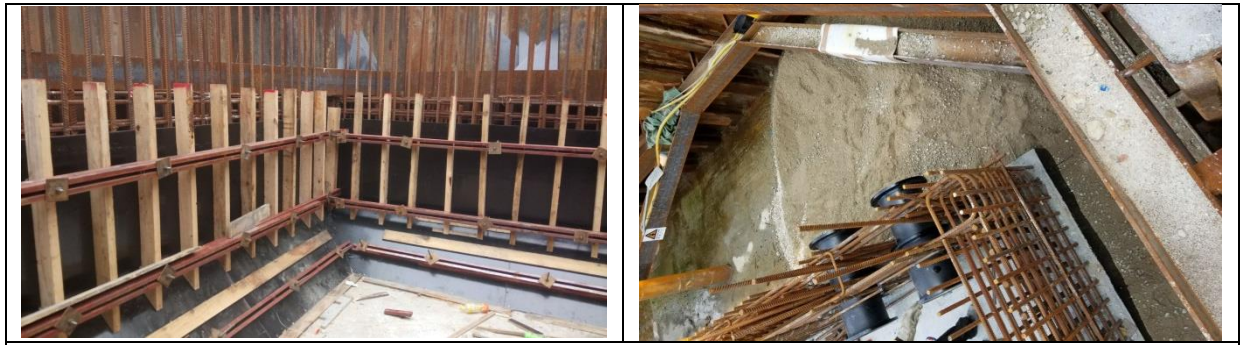
**Table 1.2 Works undertaken Illustrations**

**Construction of Pumping Station**
