## ENVIRONMENTAL MONITORING & AUDIT MONTHLY REPORT

September 2017

**Contract Name** : Castle Peak Road Trunk Sewer and Tuen Mun Village Sewerage (Sewage Pumping Station at Lok Chui Street near Castle Peak Villas)

**Contract No.** : DC/2014/01

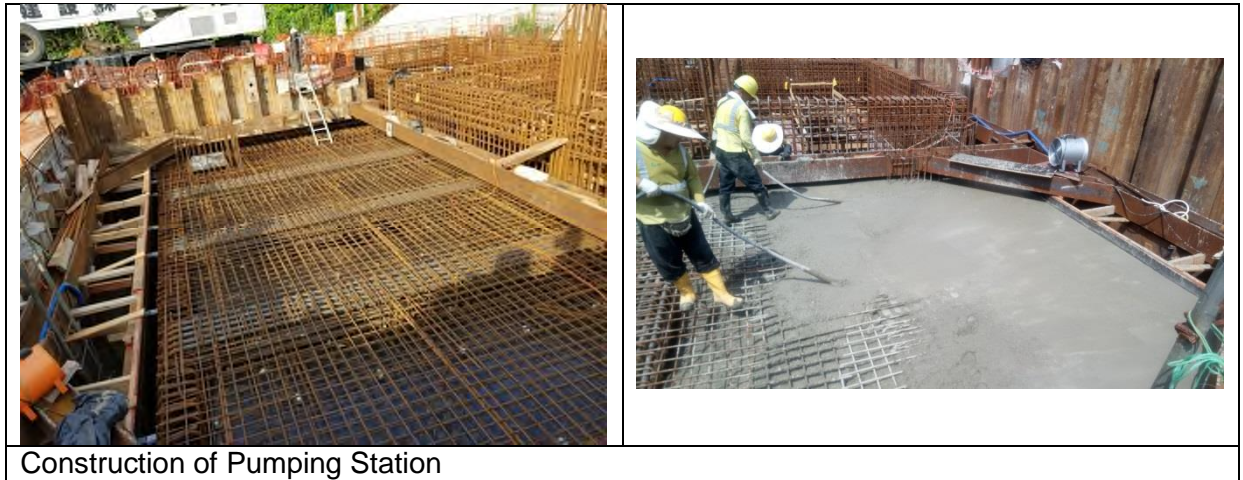
**Table 1.2 Works undertaken Illustrations**

Construction of Pumping Station

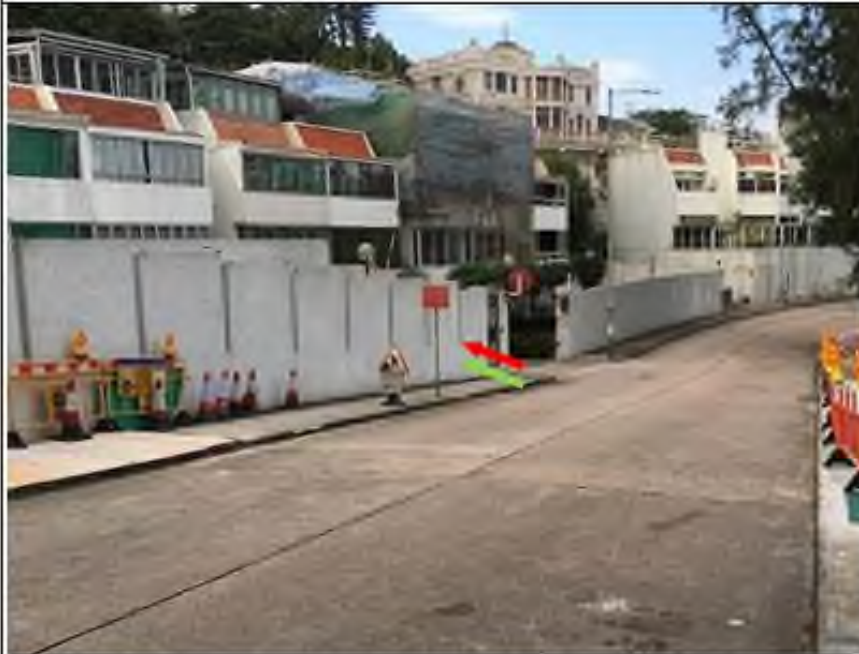
LC6a: The Castle Bay

- 1) LC6a: The air and noise monitoring station is set at a point 1m from the exterior of the sensitive receiver fence wall, and set at a position 1.2m above ground. Façade measurement will be carried out for noise monitoring.
- 2) LC9: The air monitoring station is set at the top of parapet wall of sensitive receivers building and the noise monitoring station is set at a point 1m from the exterior of the sensitive receivers building façade and set at a position 5m above the ground.

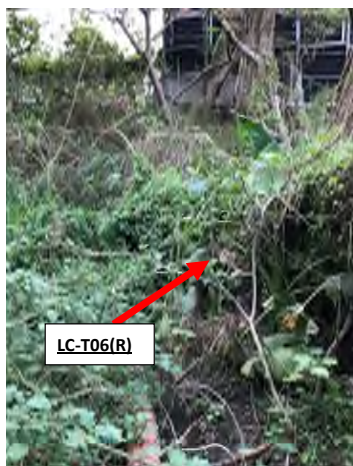
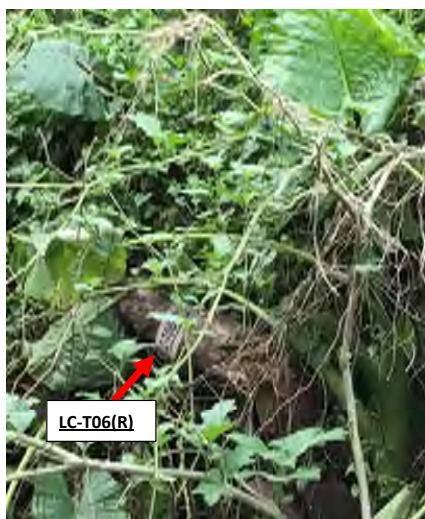
LC-T06(R)

4.3.1 As reported by Contractor, Tree Nos. LC-T06(R), LCSD15-T018(R), LCS15-T019(R) and LCS15-T021(R) were found collapsed outside the permanent works boundary on 5 September 2017 after the hoisting of tropical cyclone warning signal no. 3 on 3 September 2017. The record of trees locations and photos are shown in **Appendix O**.
