## ENVIRONMENTAL MONITORING & AUDIT MONTHLY REPORT

October 2017

**Contract Name** : Castle Peak Road Trunk Sewer and Tuen Mun Village Sewerage (Sewage Pumping Station at Lok Chui Street near Castle Peak Villas)

**Report No.** : 0367/15/ED/0942

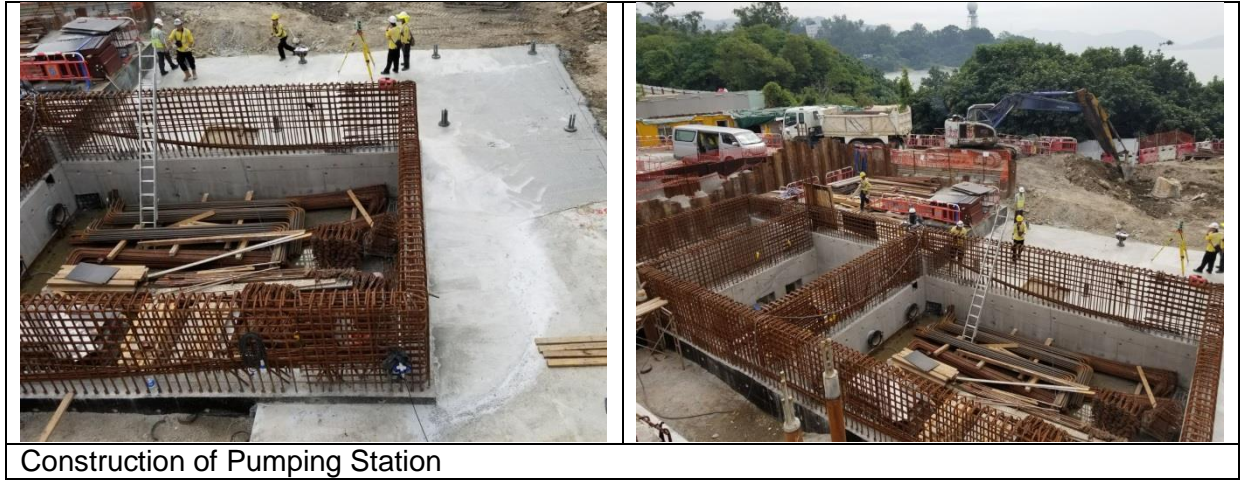
**Table 1.2 Works undertaken Illustrations**

Construction of Pumping Station

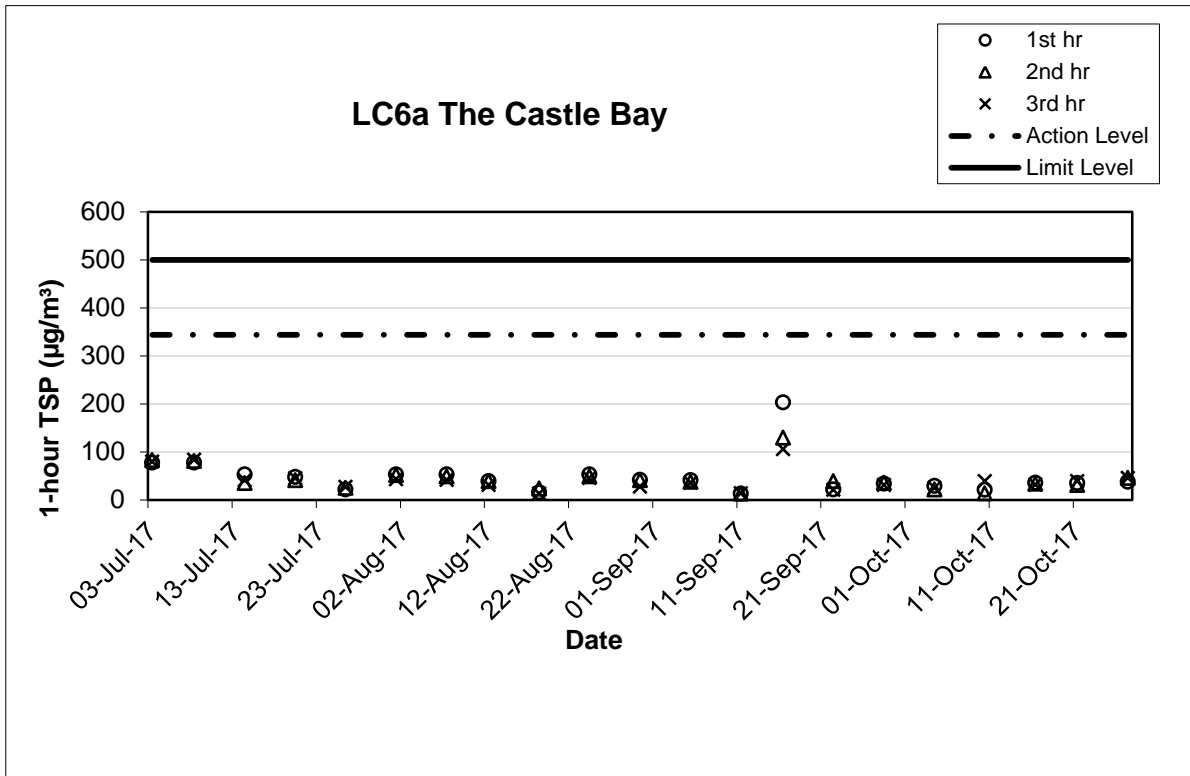
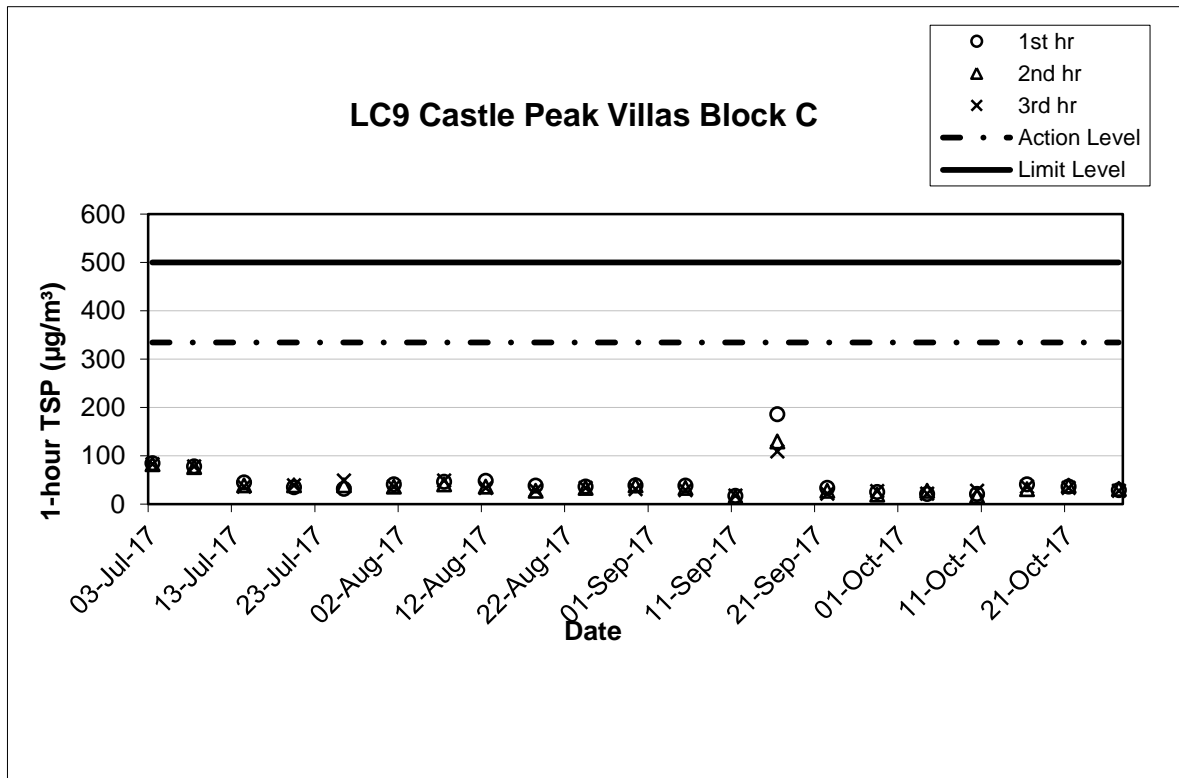
**LC9 Castle Peak Villas Block C**

1-hour TSP ( $\mu\text{g}/\text{m}^3$ )					
Date	Start Time	1st hr	2nd hr	3rd hr	Weather
04-Oct-17	08:48	21	28	22	Fine
10-Oct-17	14:02	21	17	28	Fine
16-Oct-17	09:24	41	31	36	Fine
21-Oct-17	10:39	36	38	34	Fine
27-Oct-17	08:35	29	32	28	Fine
	<b>Average</b>	29			
	<b>Max</b>	41			
	<b>Min</b>	17

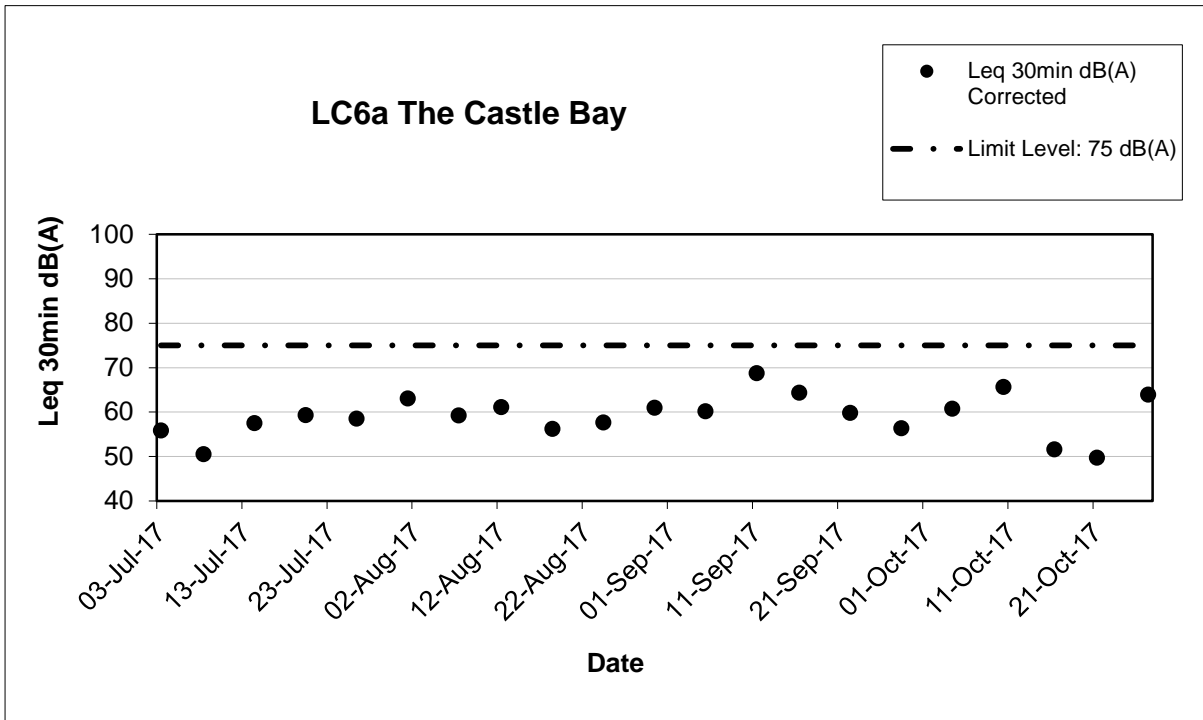
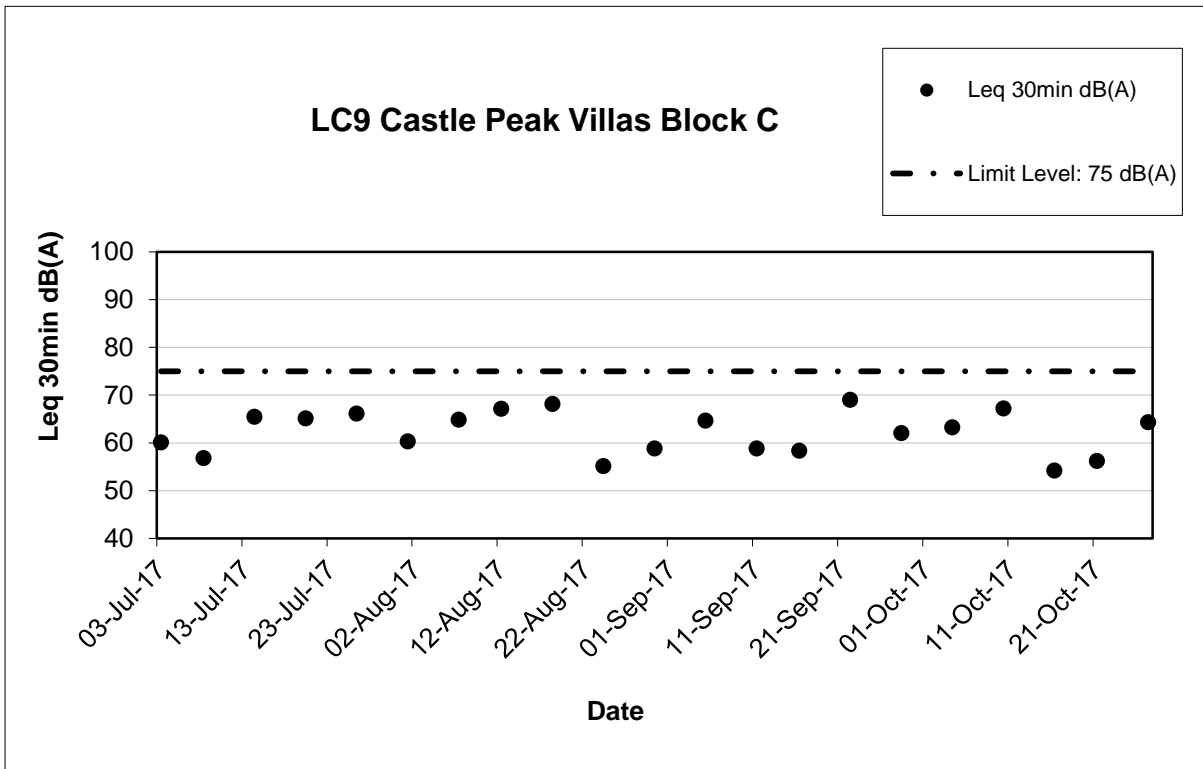
### LC9 Castle Peak Villas Block C

Date	Start Time	L <sub>eq</sub> 30min dB(A)	Corrected L <sub>eq</sub> 30min dB(A)	L <sub>90</sub> dB(A)	L <sub>10</sub> dB(A)	Weather
04-Oct-17	08:52	63	N.A	62	67	Fine
10-Oct-17	14:43	67	N.A	62	70	Fine
16-Oct-17	09:24	54	N.A	51	57	Fine
21-Oct-17	10:39	56	N.A	52	58	Fine
27-Oct-17	09:57	64	N.A	60	68	Fine
