ENVIRONMENTAL MONITORING & AUDIT MONTHLY REPORT

November 2017

Contract Name : Castle Peak Road Trunk Sewer and Tuen Mun Village Sewerage (Sewage Pumping Station at Lok Chui Street near Castle Peak Villas)

Contract No. : DC/2014/01

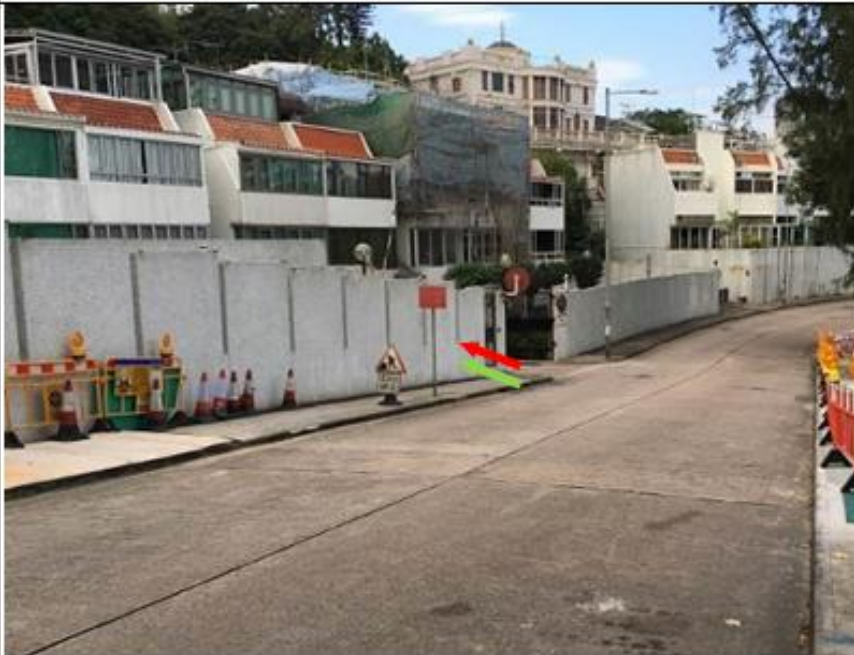
LC6a: The Castle Bay

1) LC6a: The air and noise monitoring station is set at a point 1m from the exterior of the sensitive receiver fence wall, and set at a position 1.2m above ground. Façade measurement will be carried out for noise monitoring.

- Monitoring Stations:
 - LC6a: The monitoring station was set at a point 1m from the exterior of the sensitive receiver fence wall and set at a position 1.2m above the ground. Façade measurement is carried out for noise monitoring.

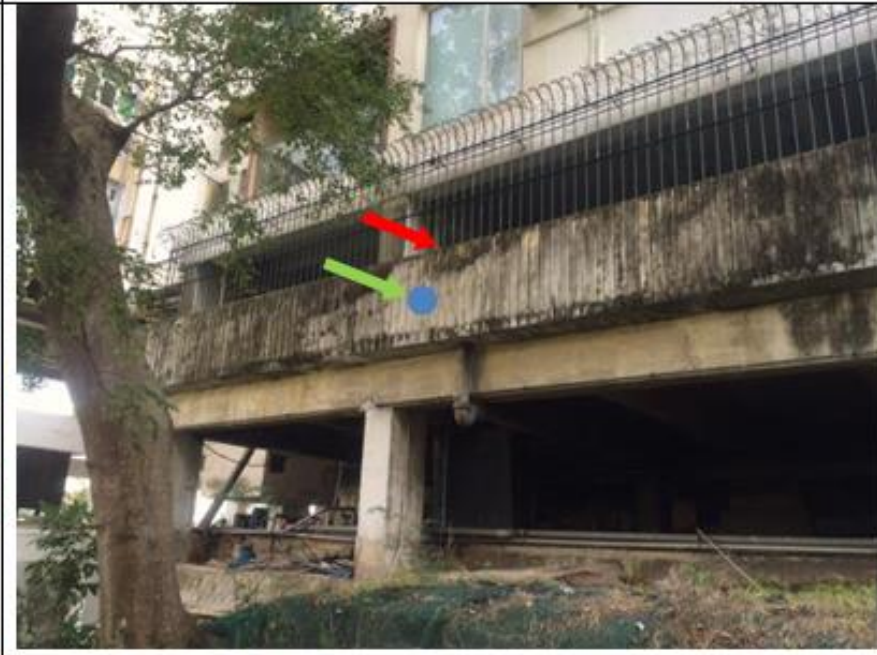
LC9: Castle Peak Villas Block C

- LC9: The monitoring station was set at the top of parapet wall of sensitive receivers building and the noise monitoring station is set at a point 1m from the exterior of the sensitive receivers building façade and set at a position 5m above the ground.
