## ENVIRONMENTAL MONITORING & AUDIT MONTHLY REPORT

December 2017

**Contract Name** : Castle Peak Road Trunk Sewer and Tuen Mun Village Sewerage (Sewage Pumping Station at Lok Chui Street near Castle Peak Villas)

**Report No.** : 0367/15/ED/0966A

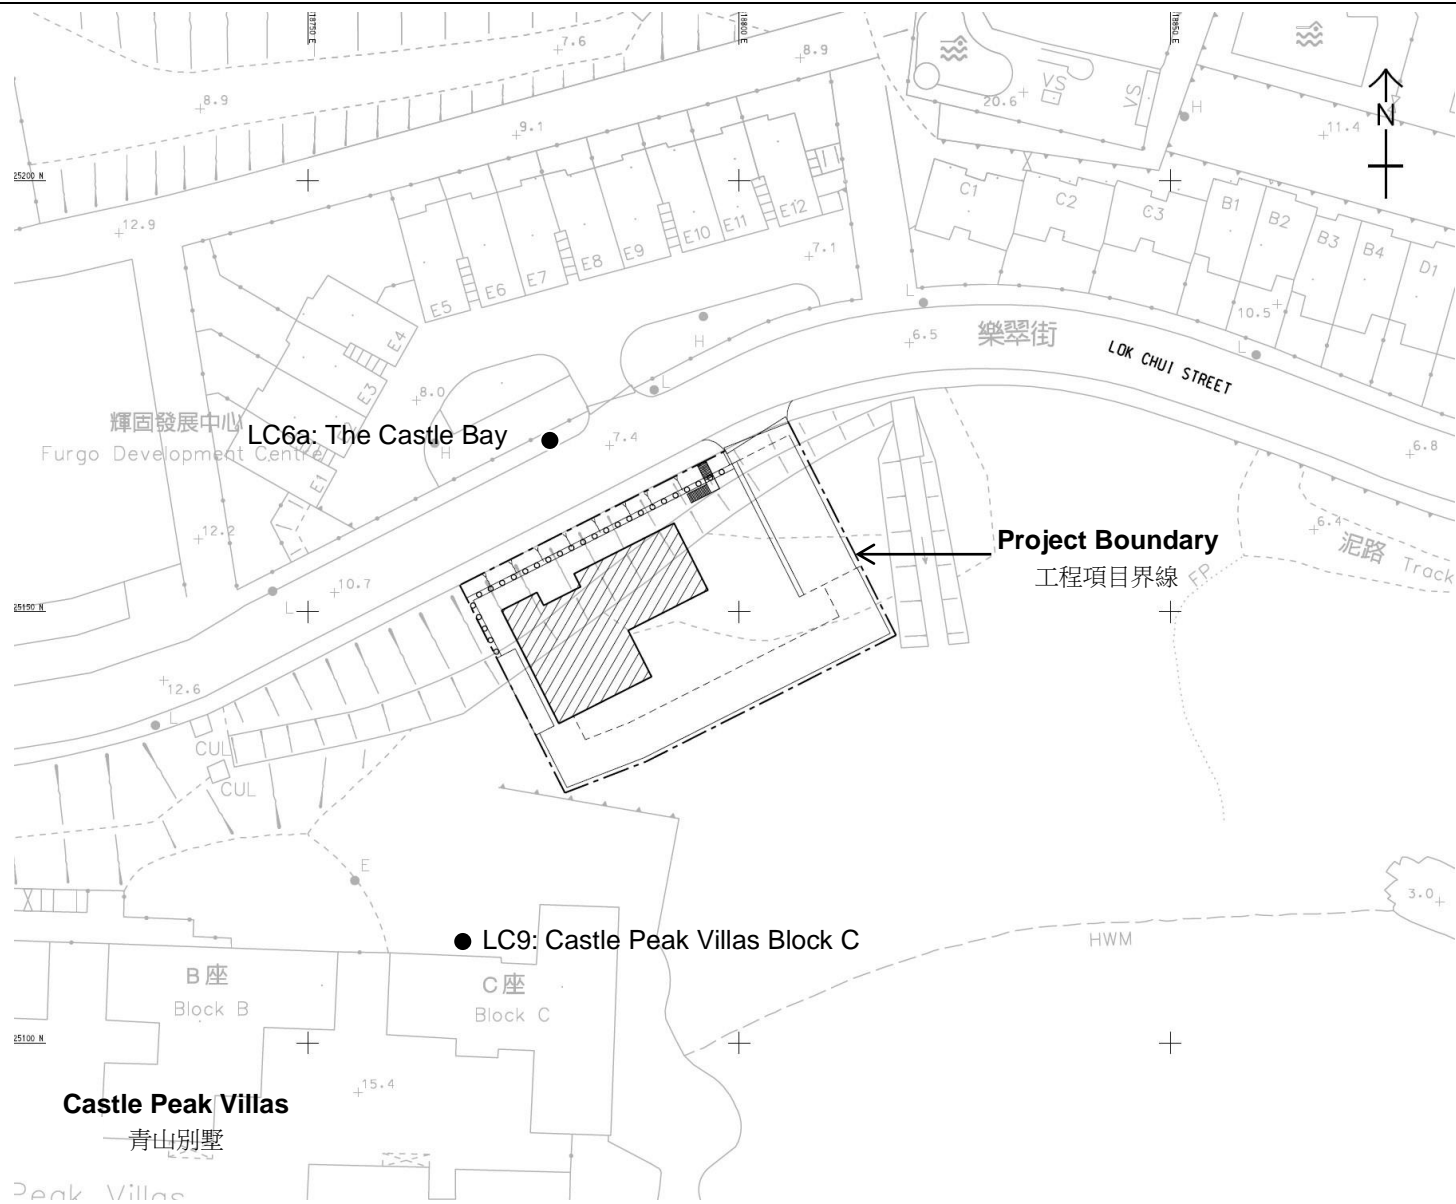
**Figure 2**

**Air and Noise Monitoring Locations**

2.4.1 In accordance with the updated EM&A Manual, two designated air quality monitoring stations, LC6a and LC9 are selected for the Project Area of constructing a sewage pumping station at Lok Chui Street near Castle Peak Villas as they are the representative air sensitive receivers located near to the Project site. All designated air quality monitoring stations listed in the updated EM&A Manual and the air quality monitoring stations are shown in **Table 2.3** and the monitoring locations are shown in **Figure 2**.

3.4.1 Noise monitoring were conducted at two designated monitoring stations as described in **Table 3.3** and the monitoring locations are shown in **Figure 2**.

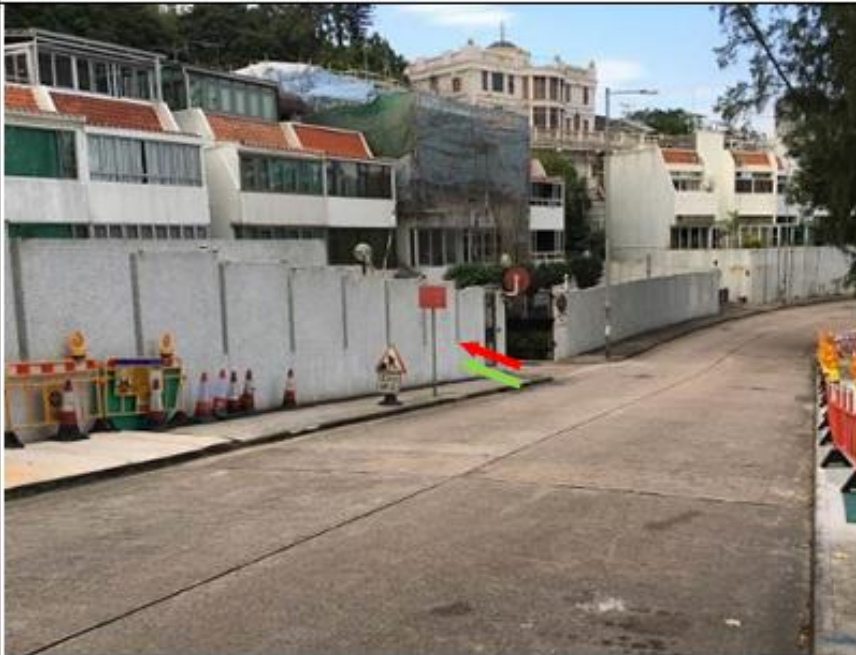
LC6a: The Castle Bay

1) LC6a: The air and noise monitoring station is set at a point 1m from the exterior of the sensitive receiver fence wall, and set at a position 1.2m above ground. Façade measurement will be carried out for noise monitoring.

- Monitoring Stations:
  - LC6a: The monitoring station was set at a point 1m from the exterior of the sensitive receiver fence wall and set at a position 1.2m above the ground. Façade measurement is carried out for noise monitoring.

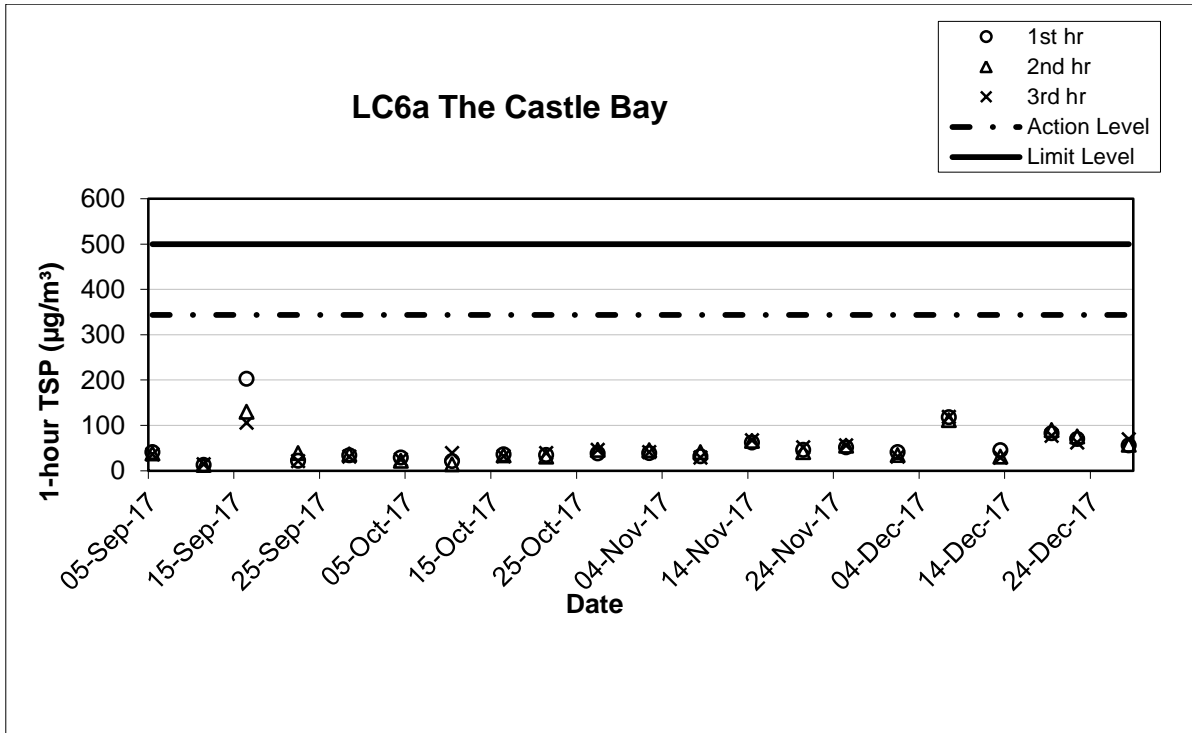
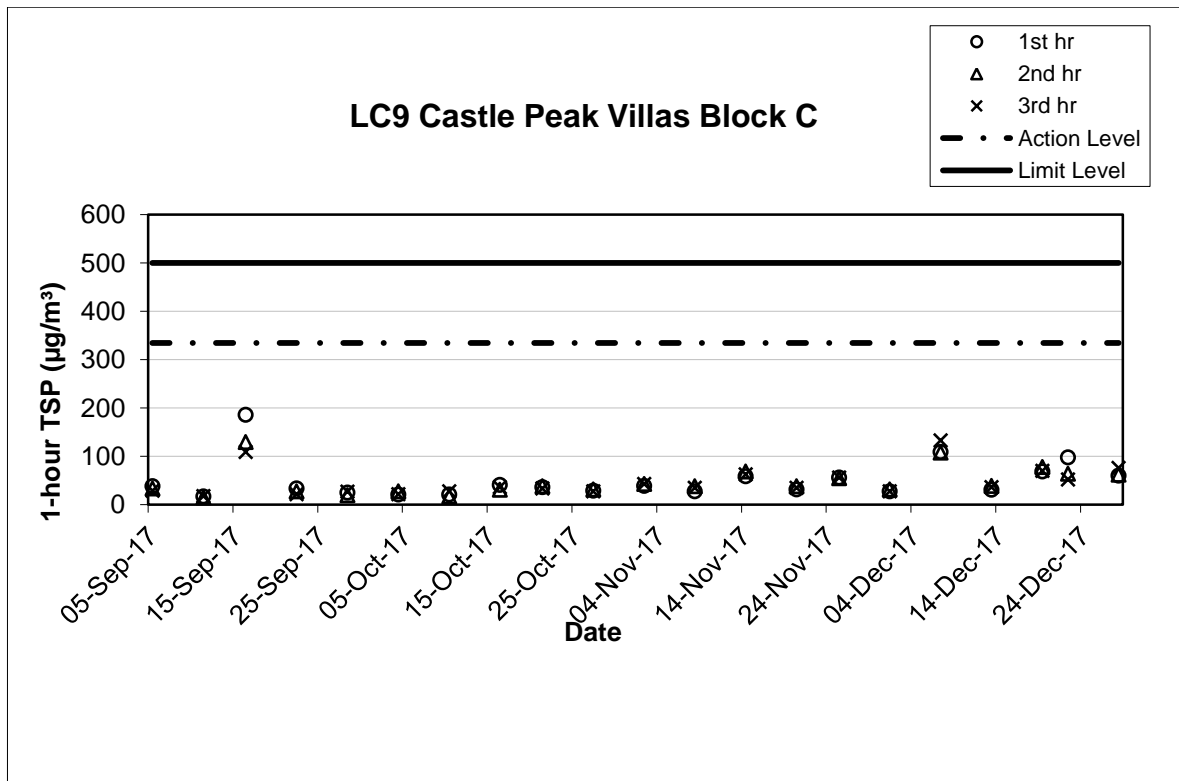
- 1) The QA/QC procedures and detection Limits refer to section 2.2 and 2.5.
- 2) The other factors influencing the monitoring results refer to section 2.7.

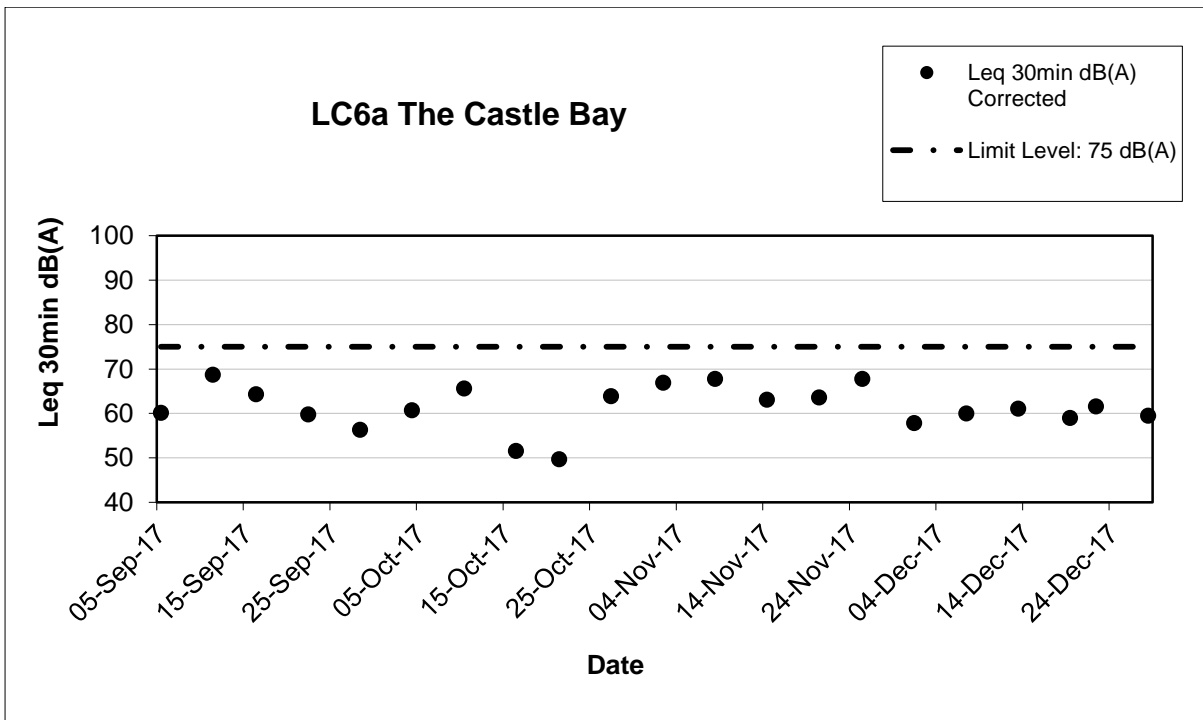
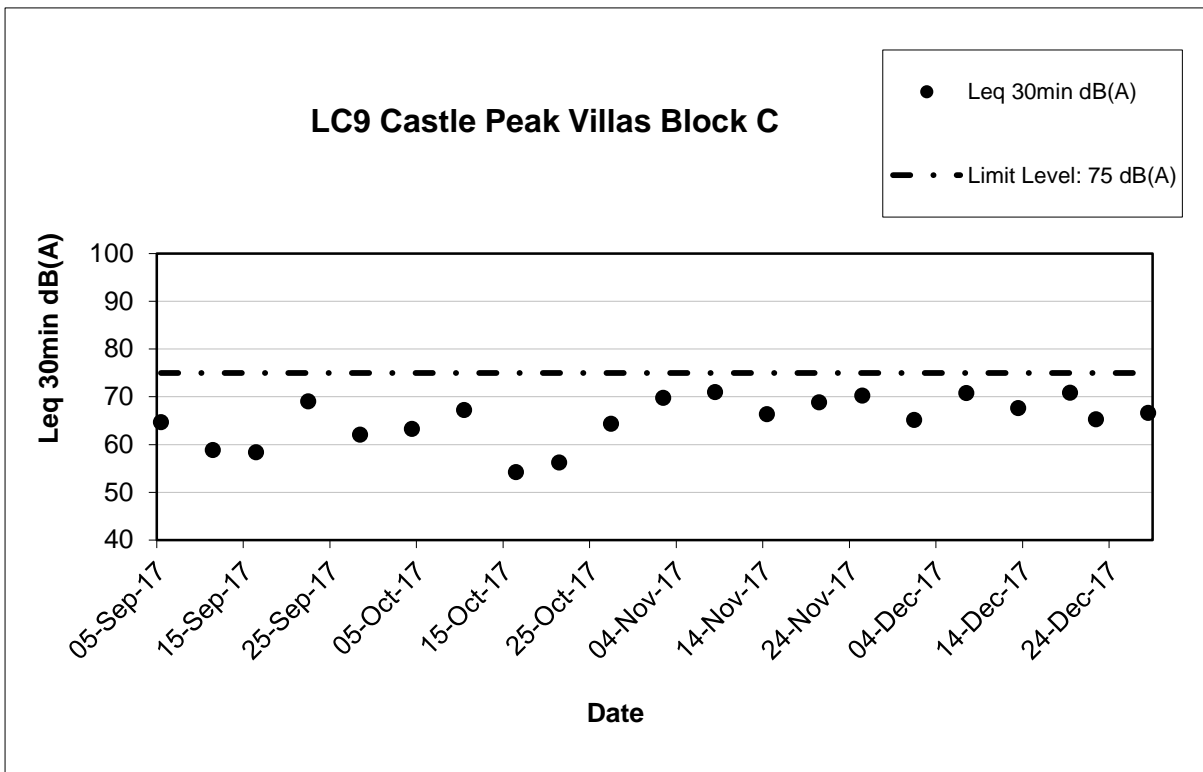
- 1) The QA/QC procedures and detection Limits refer to section 3.2 and 3.5.
- 2) The other factors influencing the monitoring results refer to section 3.7.
